Environmental Protection Agency
 Office of Environmental Enforcement

14th December 2004

Shannon Vermicomposting make the following submission firstly on 78-2 application. Secondly on the overall none-compliance of 78-1 licence Ballaghveny Landfil site owned and run by North Tipperary County Council.

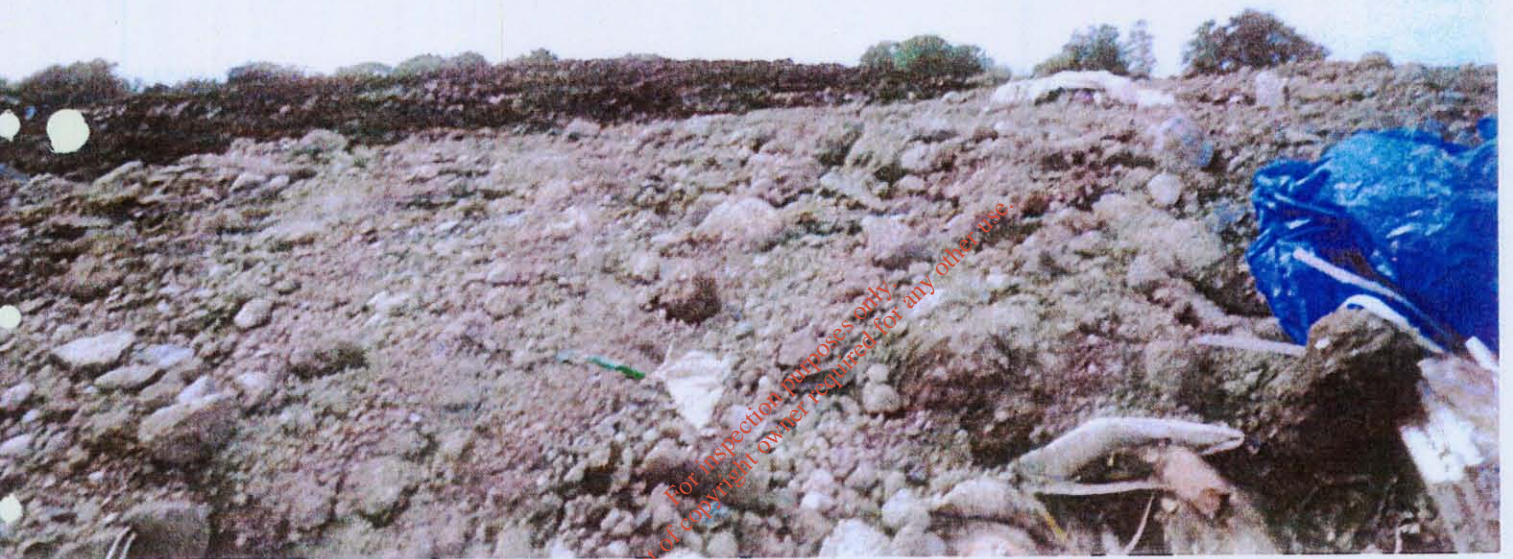
SEWAGE SLUDGE DEPOSITED CELL 8,
ON TOP OF LANDFILL, LEFT FOR HOURS
UNCOVERED, BREACH OF COMPLIANCE 5.12.1

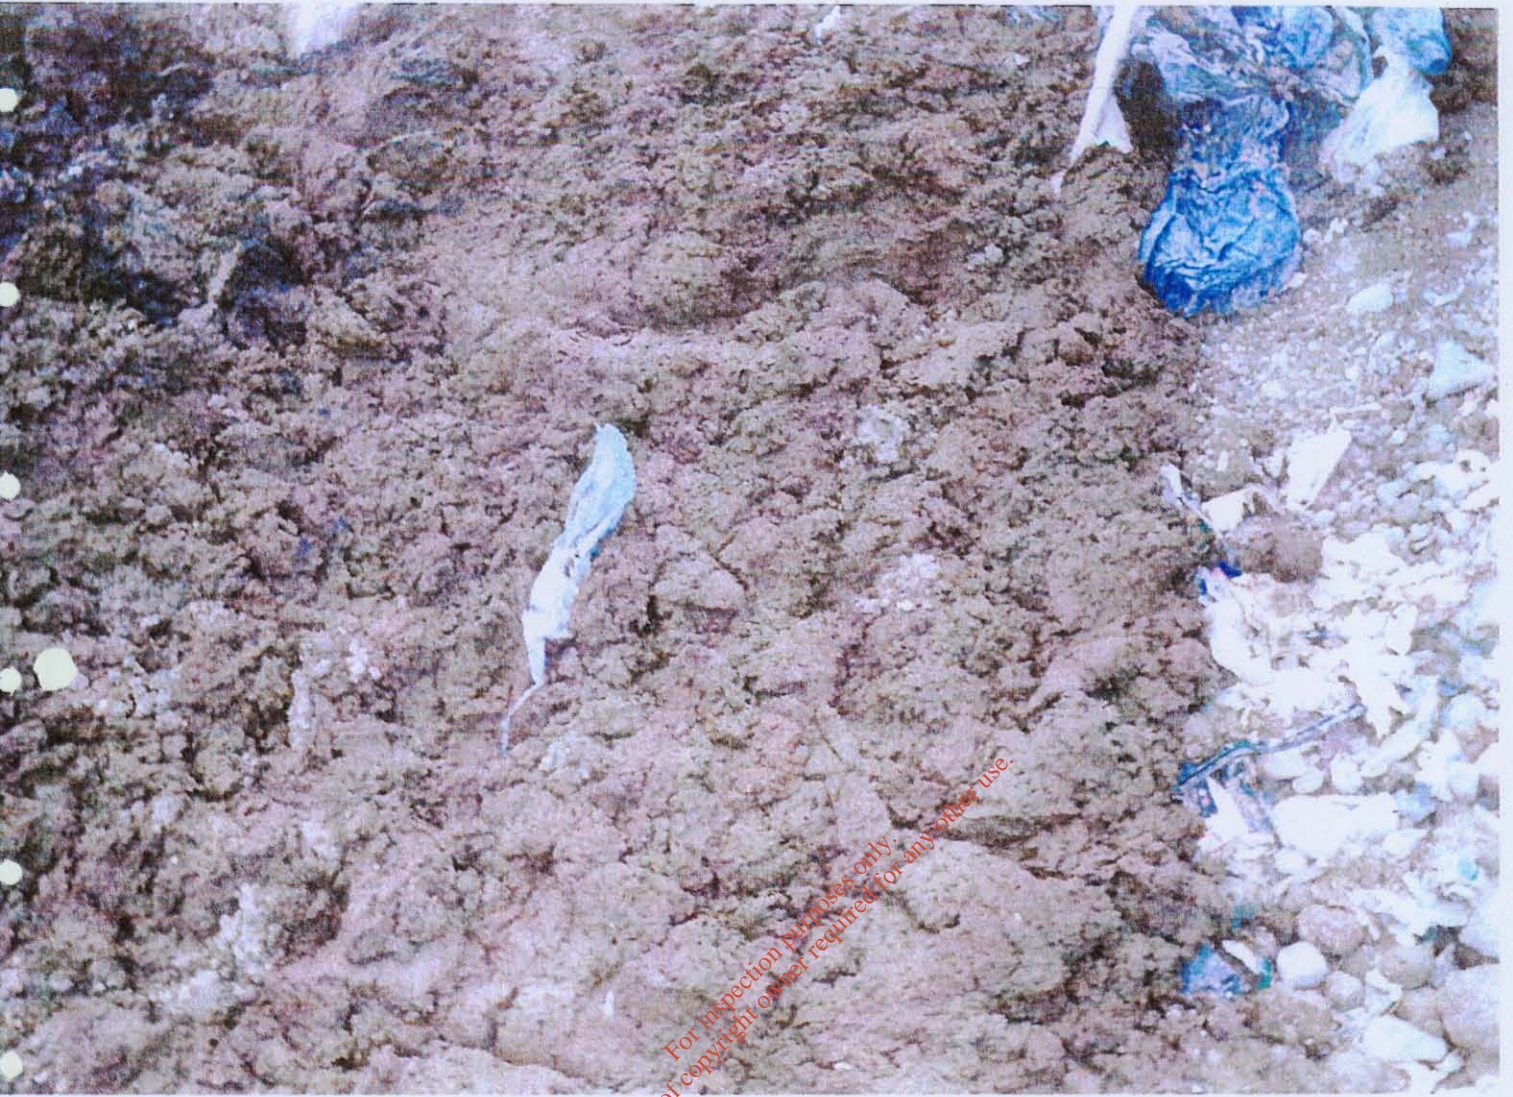
CLOSE UP OF SLUDGE LEFT UNCOVERED
BREACH OF CONDITION S.12.1

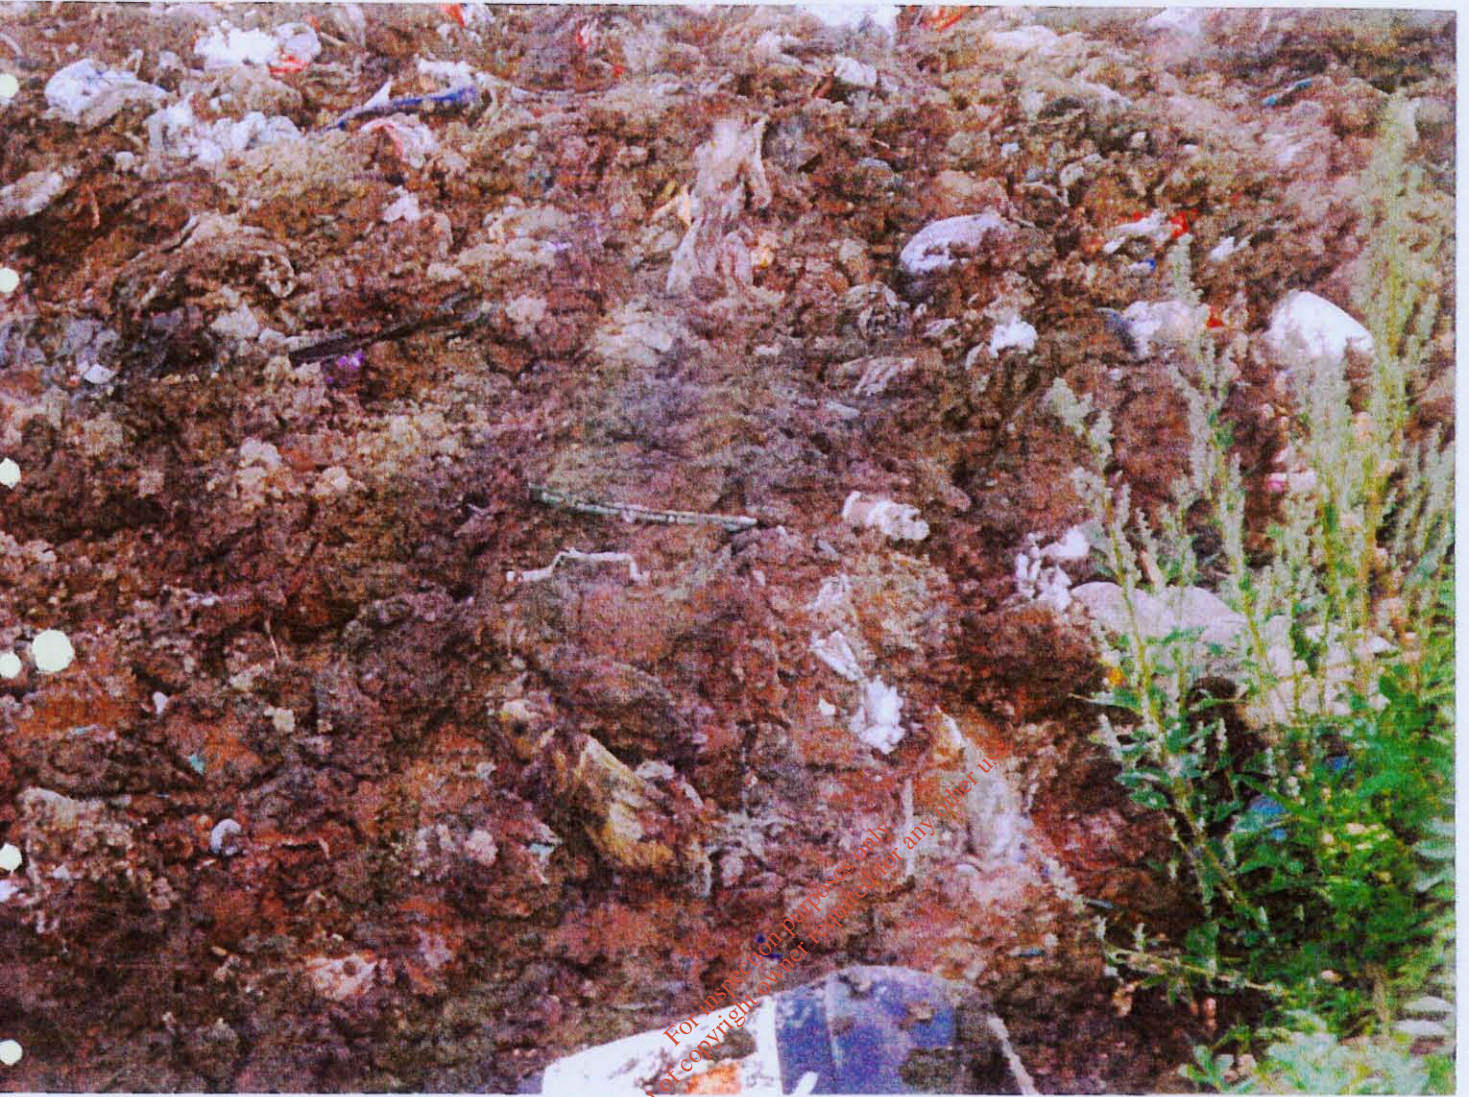
CLOSE UP OF SLUDGE LEFT UNCOVERED
ALL WEEKEND, BREACH OF CONDITION S.12.1
FLIES HORRENDOUS

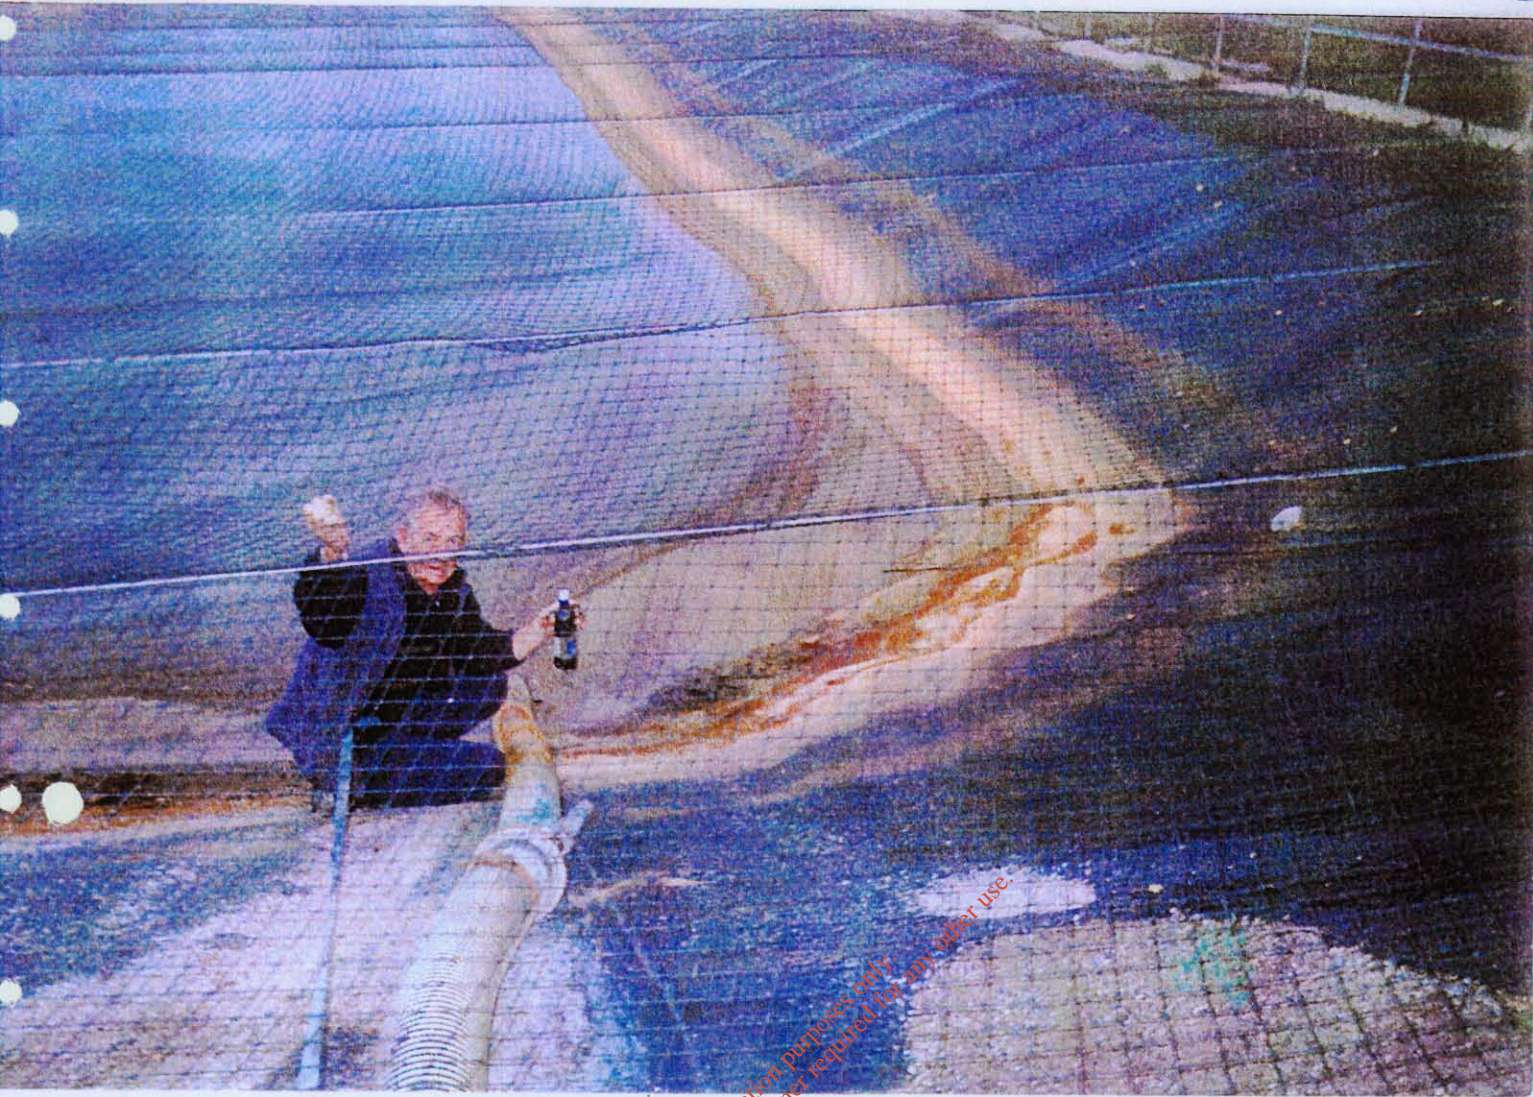
LEACHATE SAMPLE COLLECTED
FROM LEACHATE LAGOON, TWO SETS
OF SAMPLES DIFFERENT LABORATORIES

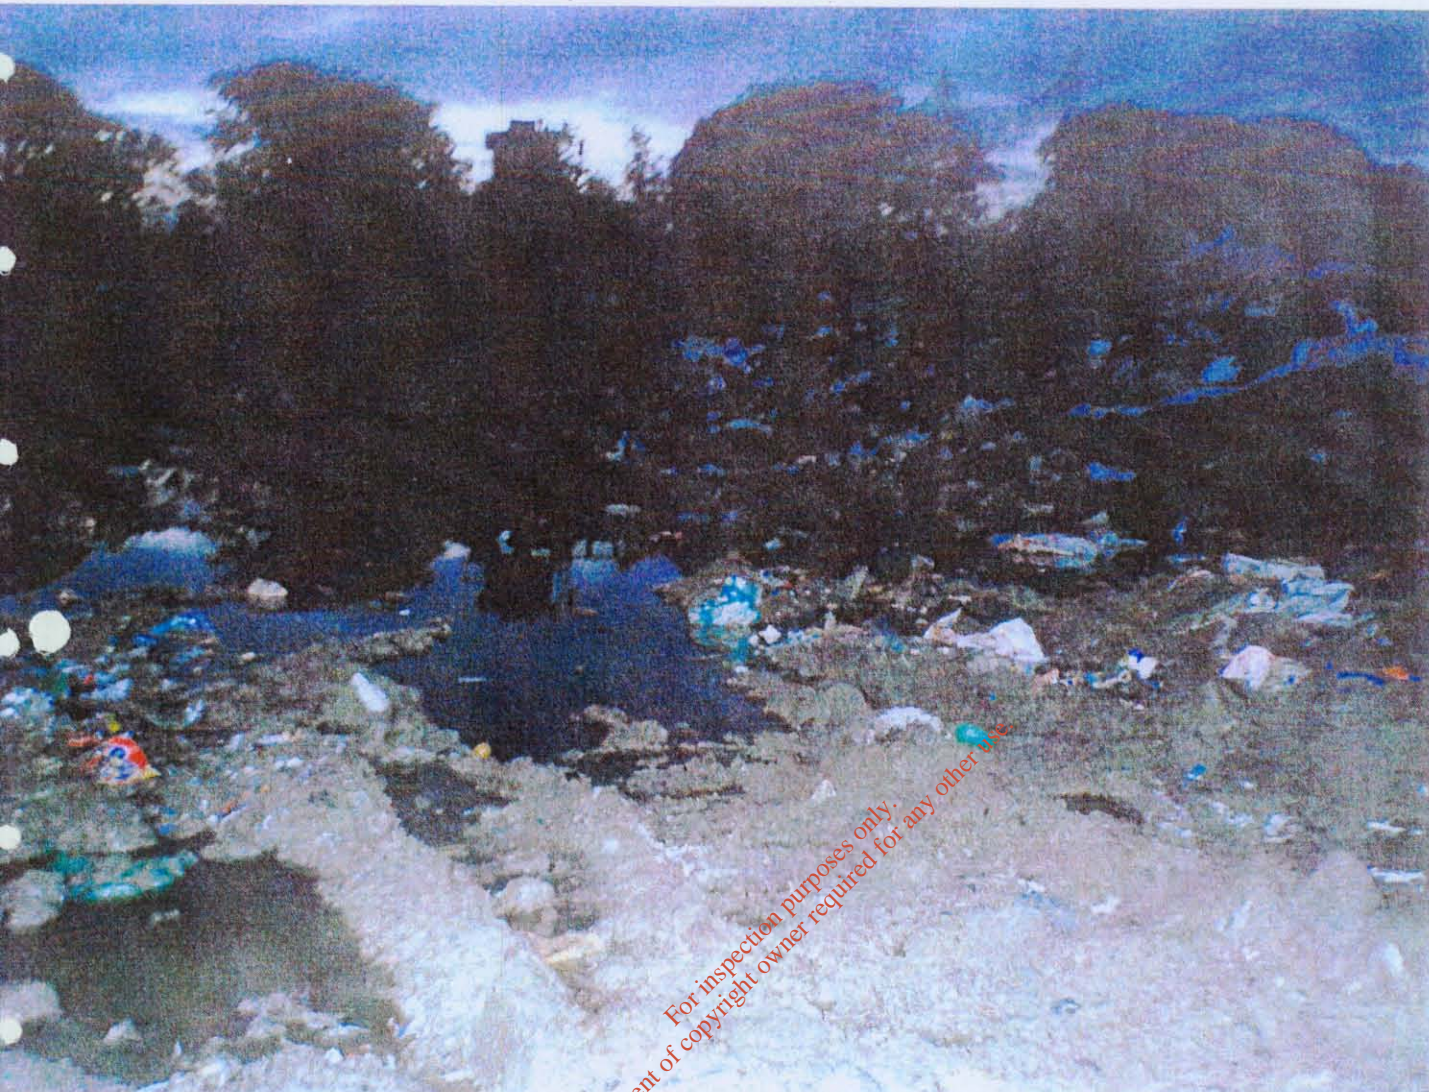
SURFACE WATER TIP # CELL 8,
 Head
 TOTALLY UNCOVERED OR COMPACTED,
 FLIES, VERMIN, BIRDS, FEEDING GROUND
 BREACH OF CONDITIONS

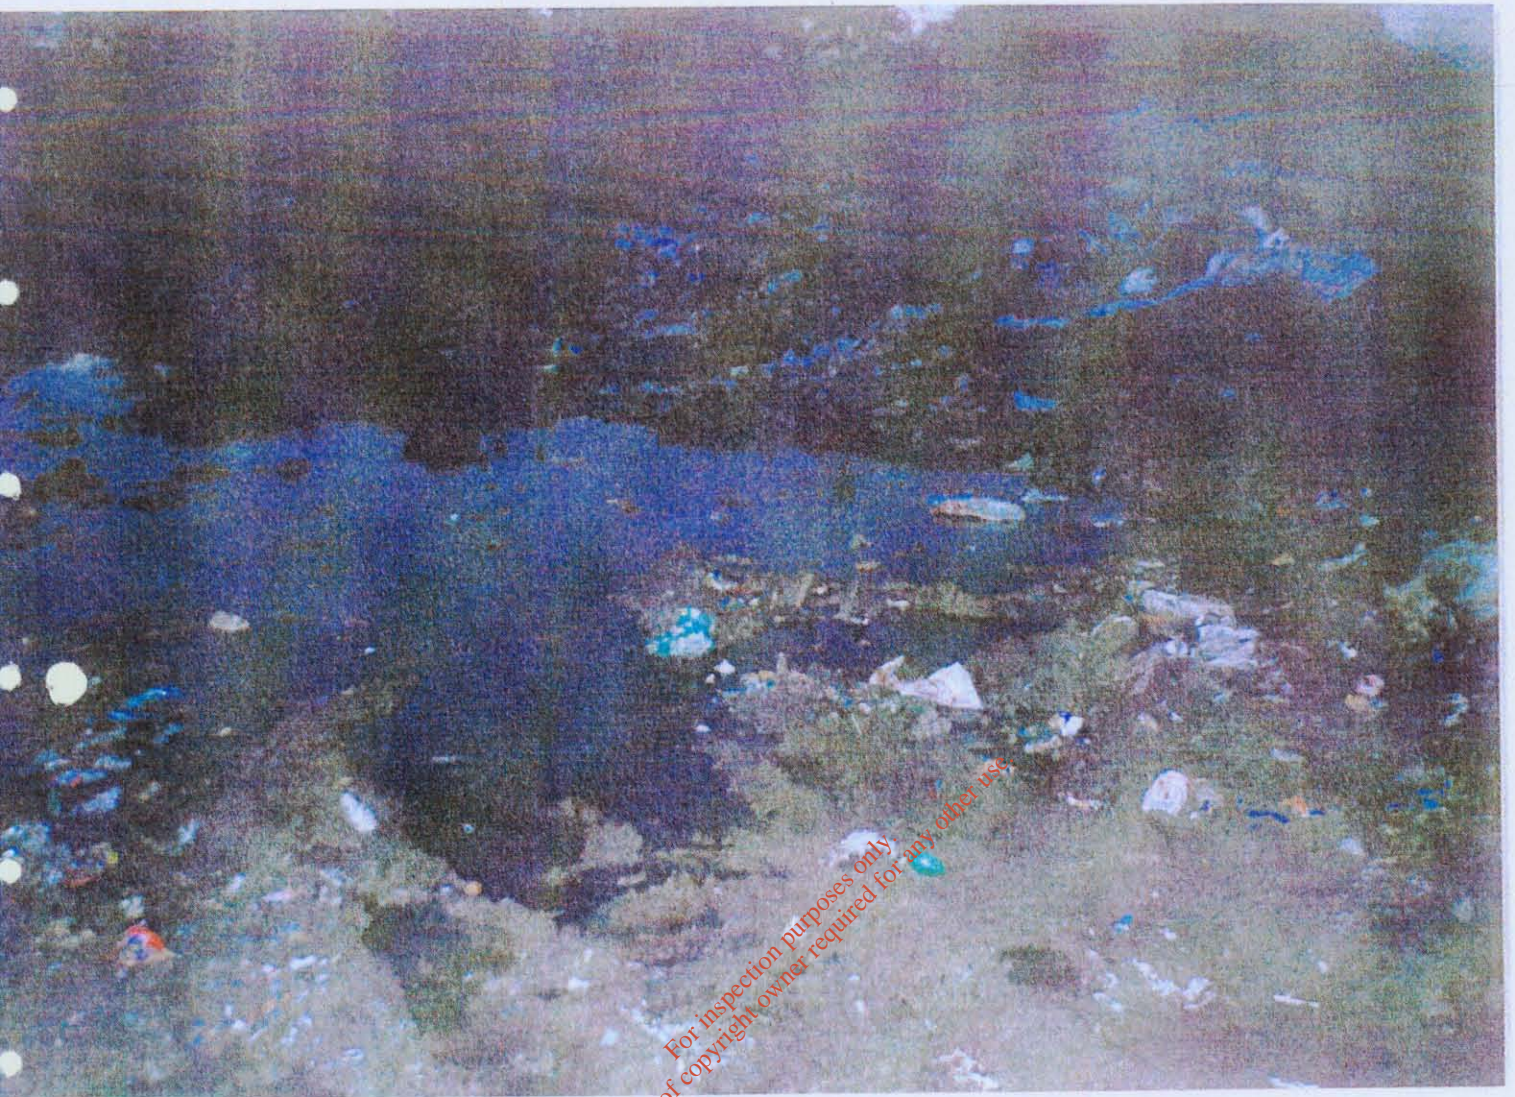
SURFACE WATER COLLECTION, NO COMPACTION,
COVER, TOTALLY UNSAFE FOR MACHINERY
TO WORK ON, BREACH OF CONDITIONS CELL 8

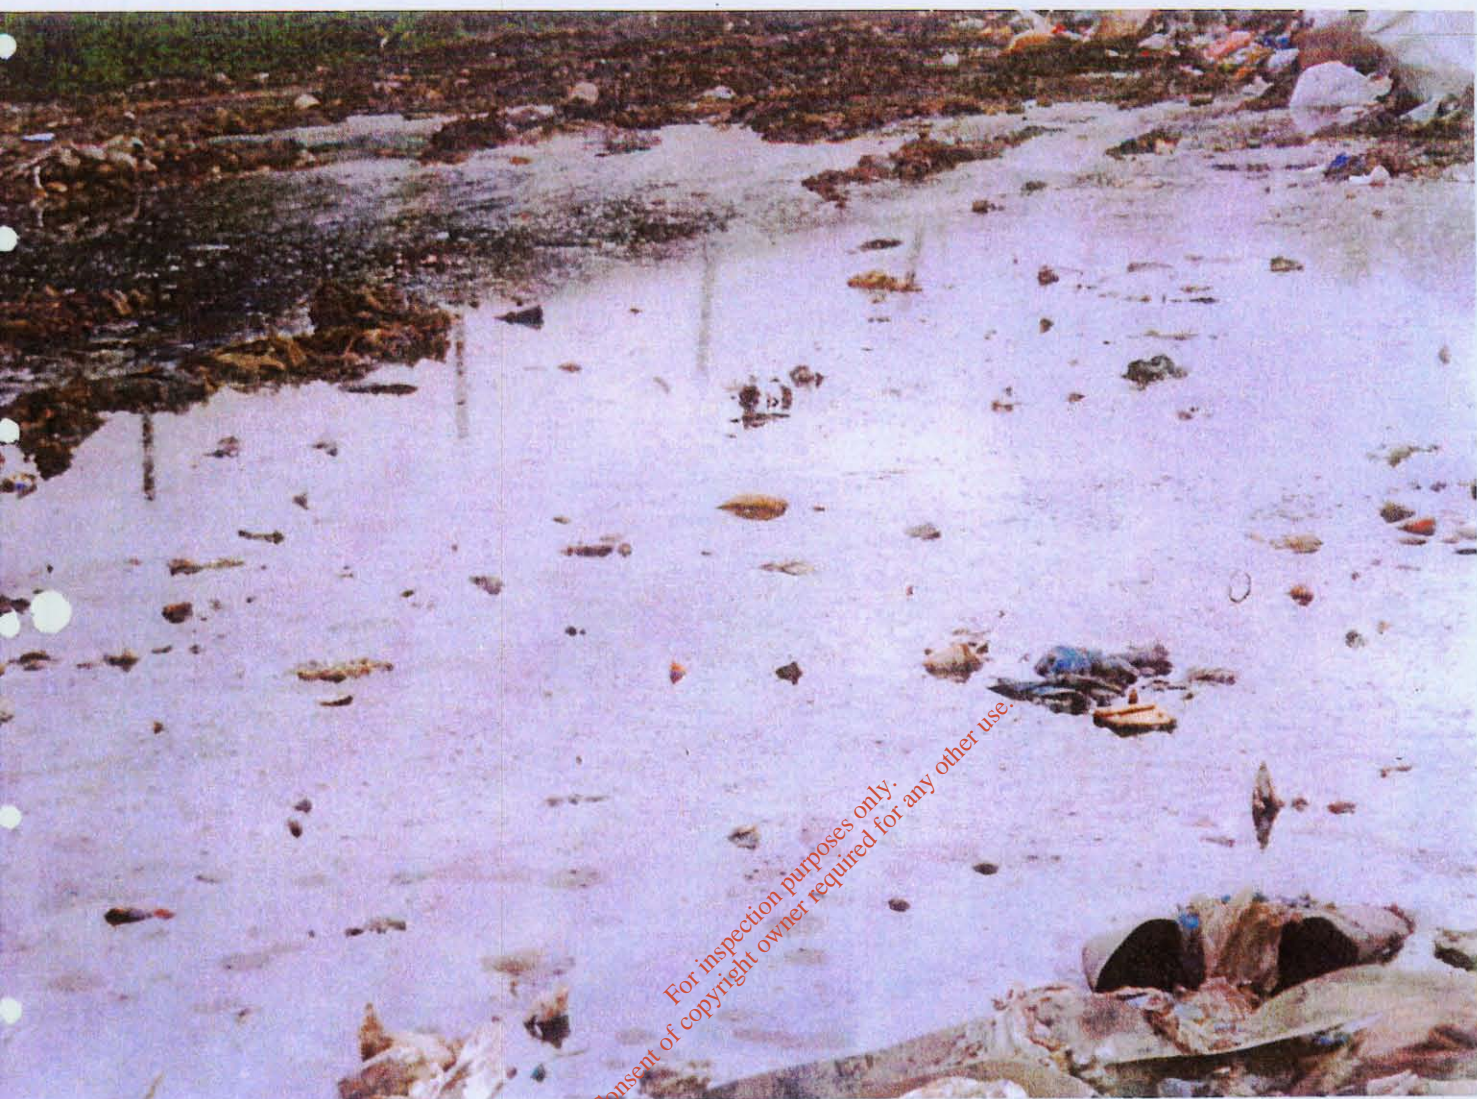
SURFACE WATER BUBBLING
WITH GAS, CELL & FURTHER
INVESTIGATION IS NEEDED TO ESTABLISH
THE CAUSE OF THIS PROBLEM

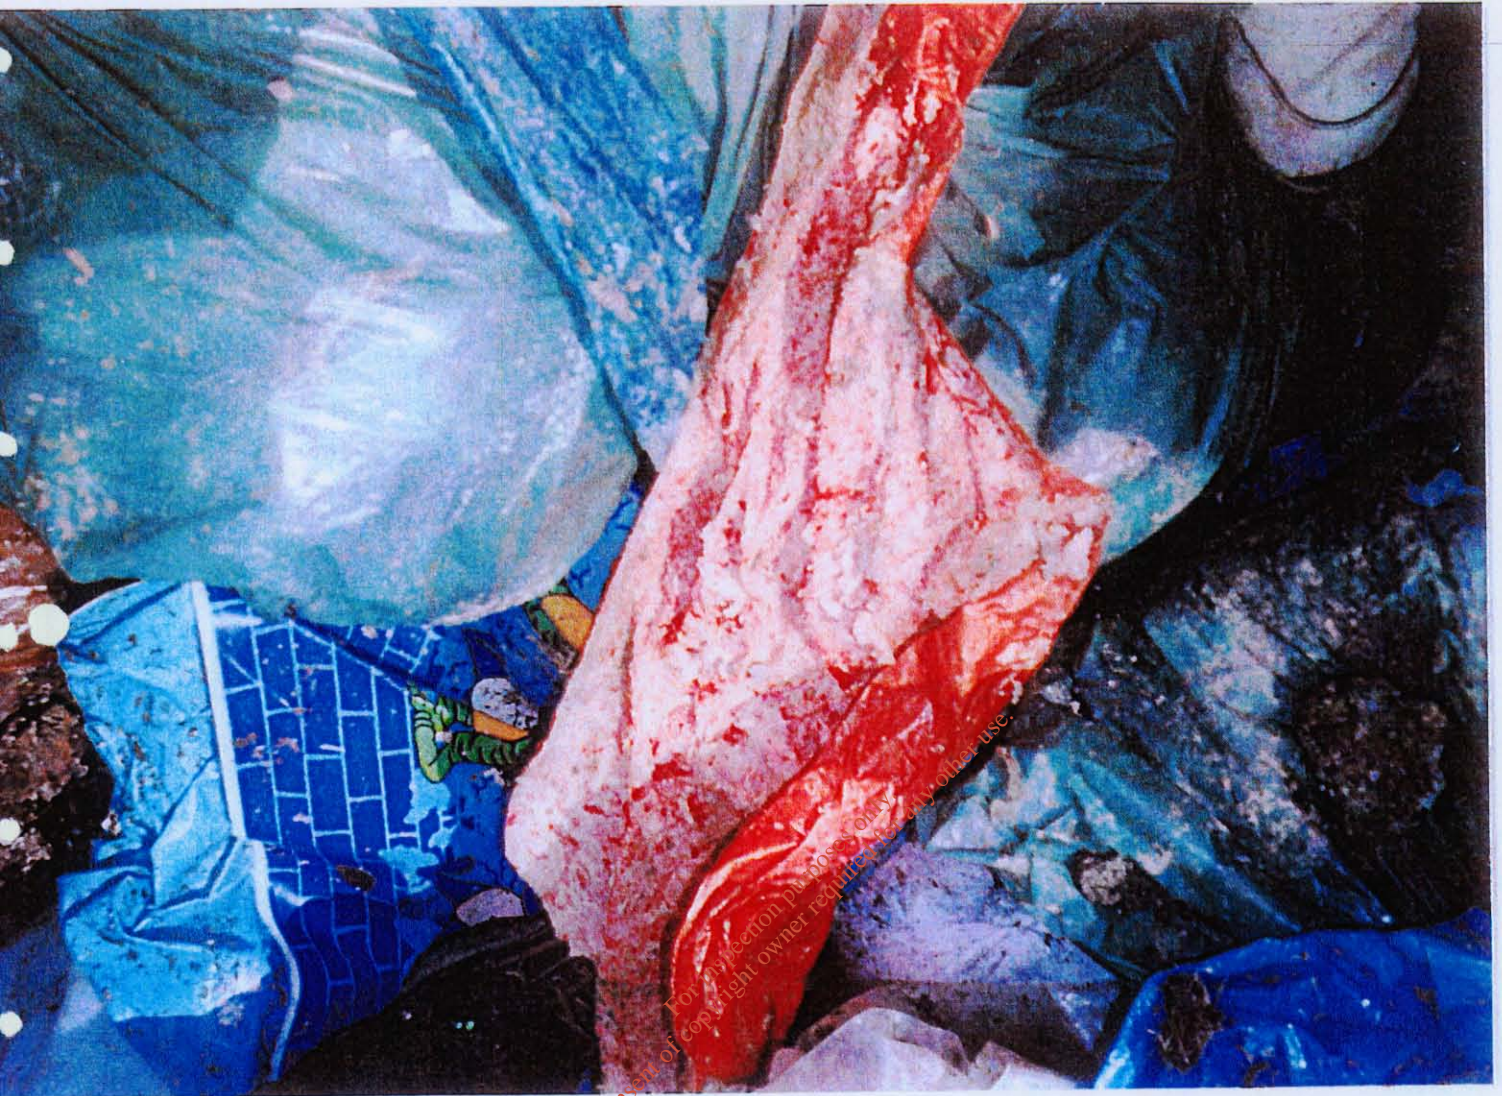
RED PLASTIC BAG CONTAINING MEAT
RESIDUE, BREACH OF CONDITION
5.1, LEFT UNCOVERED FOR
HOURS

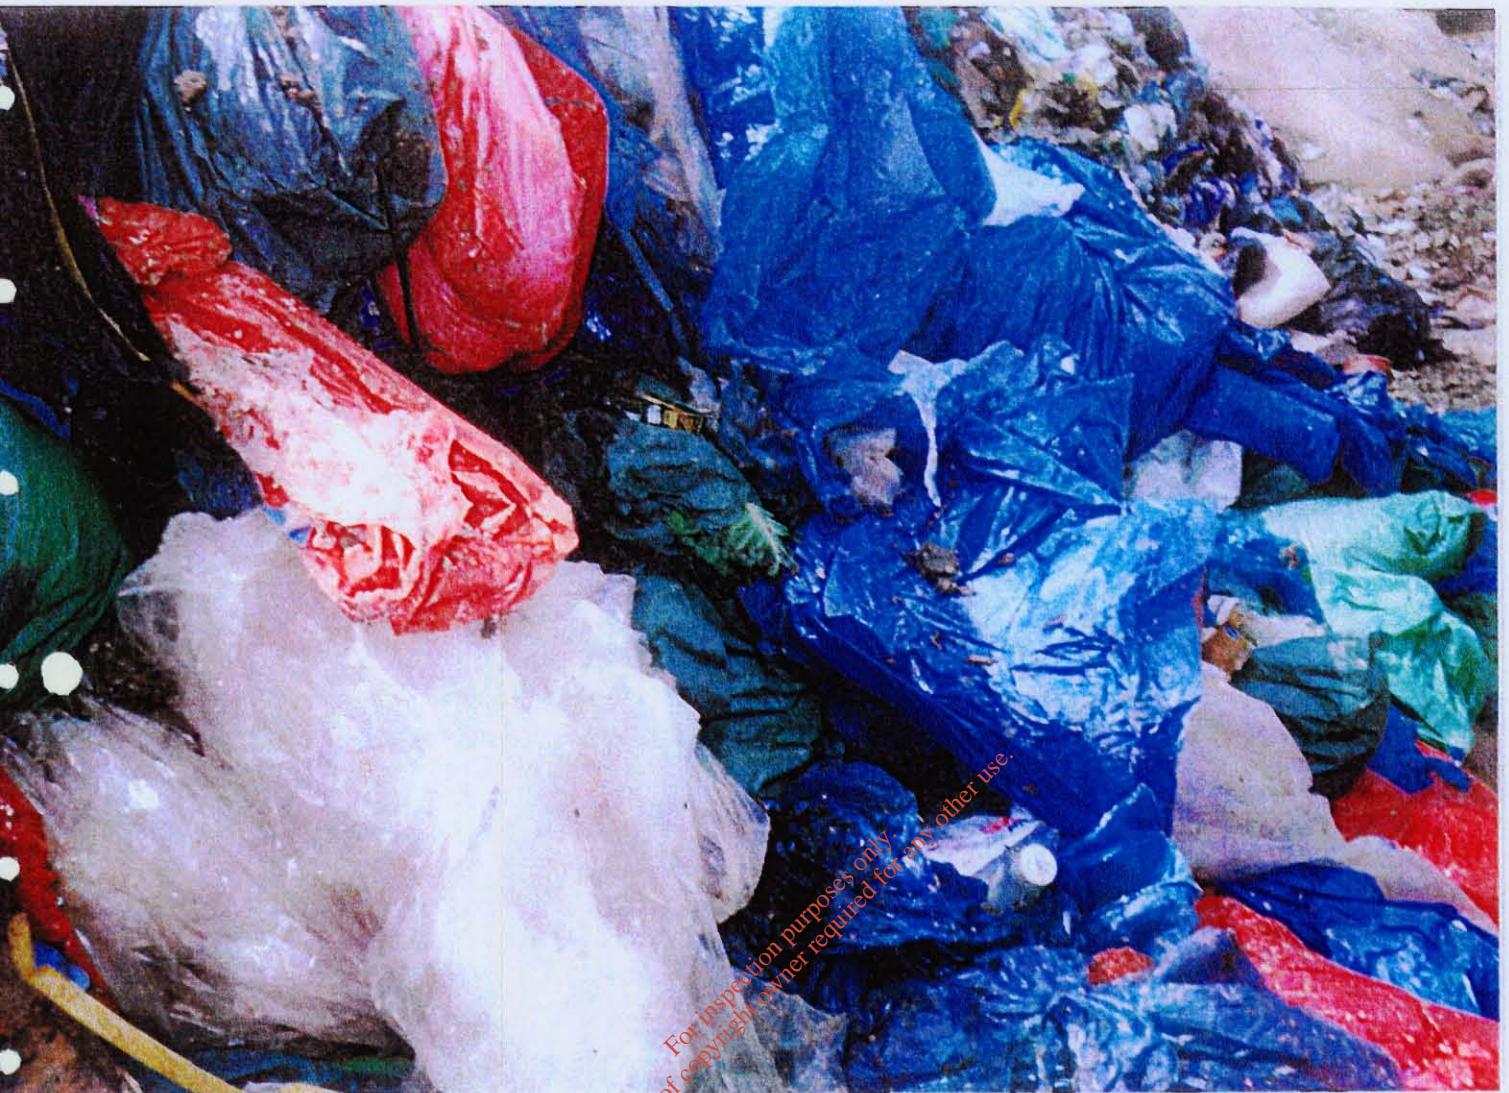
RED PLASTIC BAG CONTAINING MEAT
RESIDUE, BREACH OF CONDITION 5.1
LEFT UNCOVERED FOR HOURS

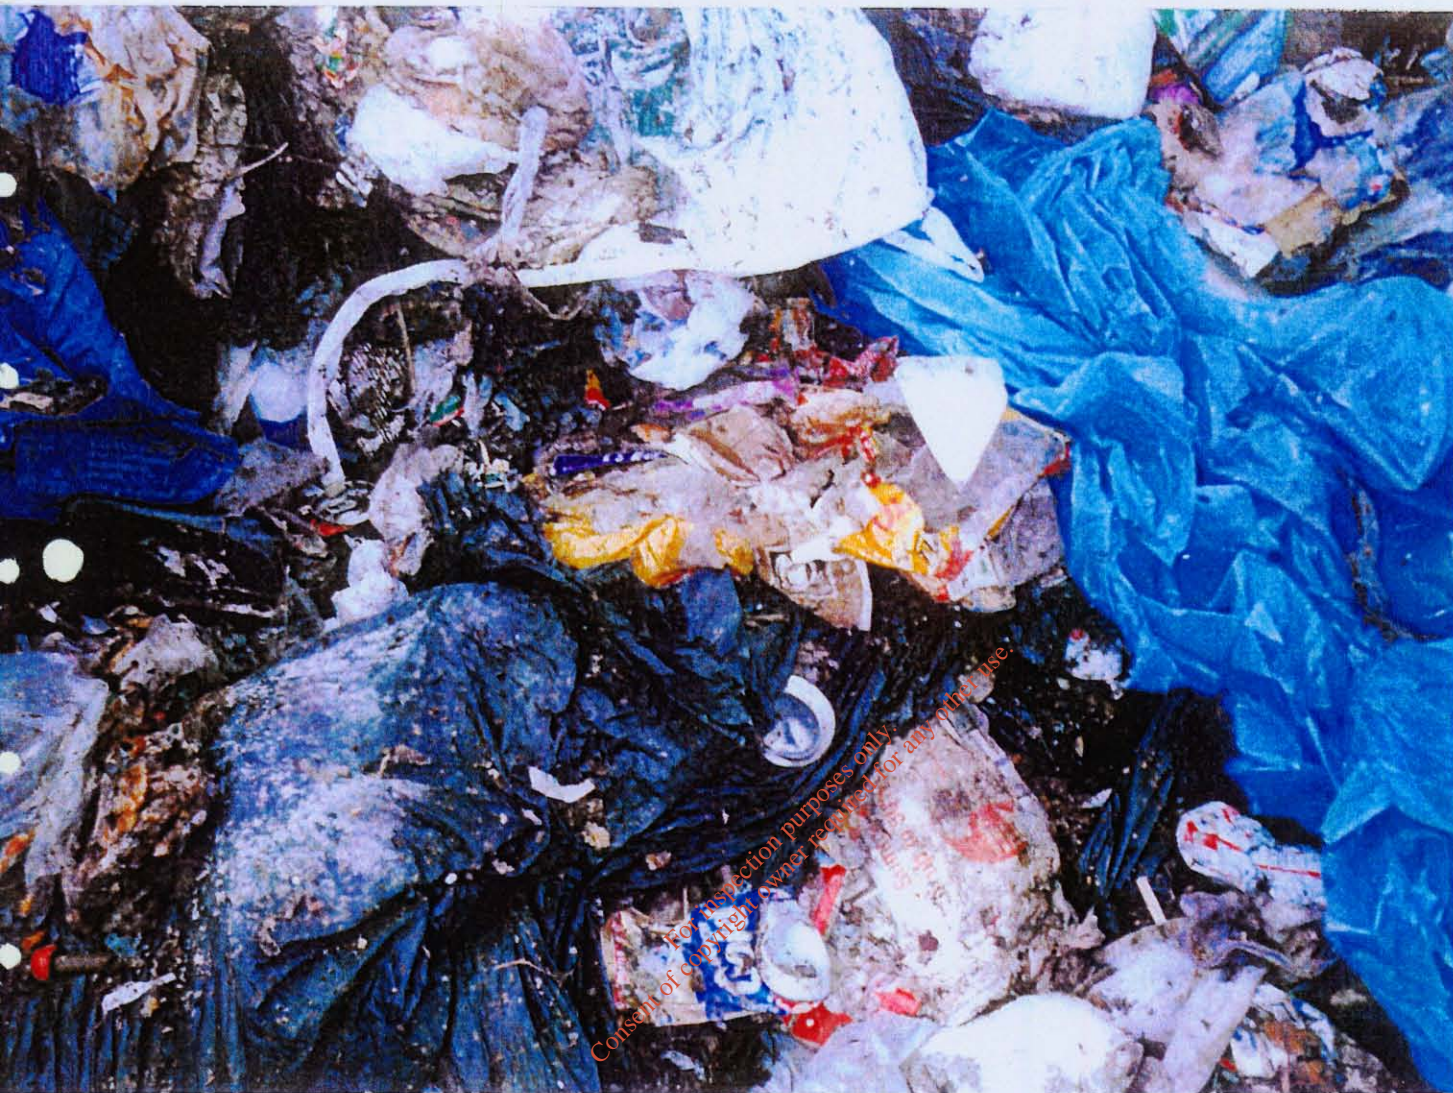
LARGE AMOUNTS OF BIODEGRADABLE
WASTE CONTRARY TO LANDFILL EU
LEGISLATION.

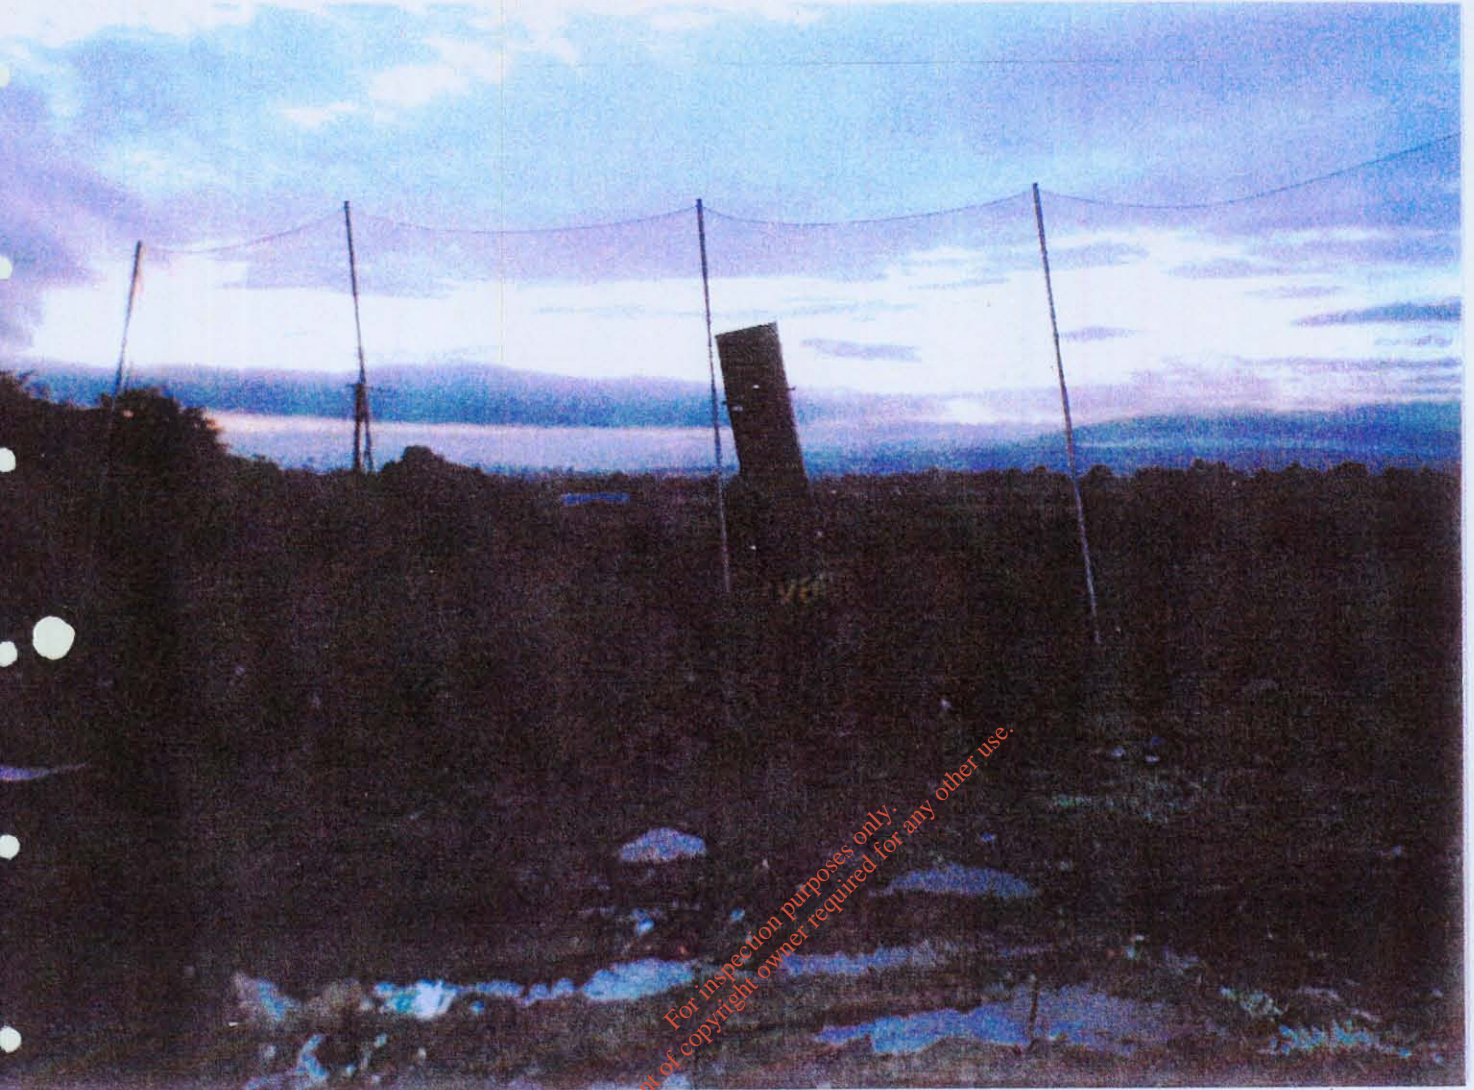
GAS BURN OFF BOILER NOT CONNECTED

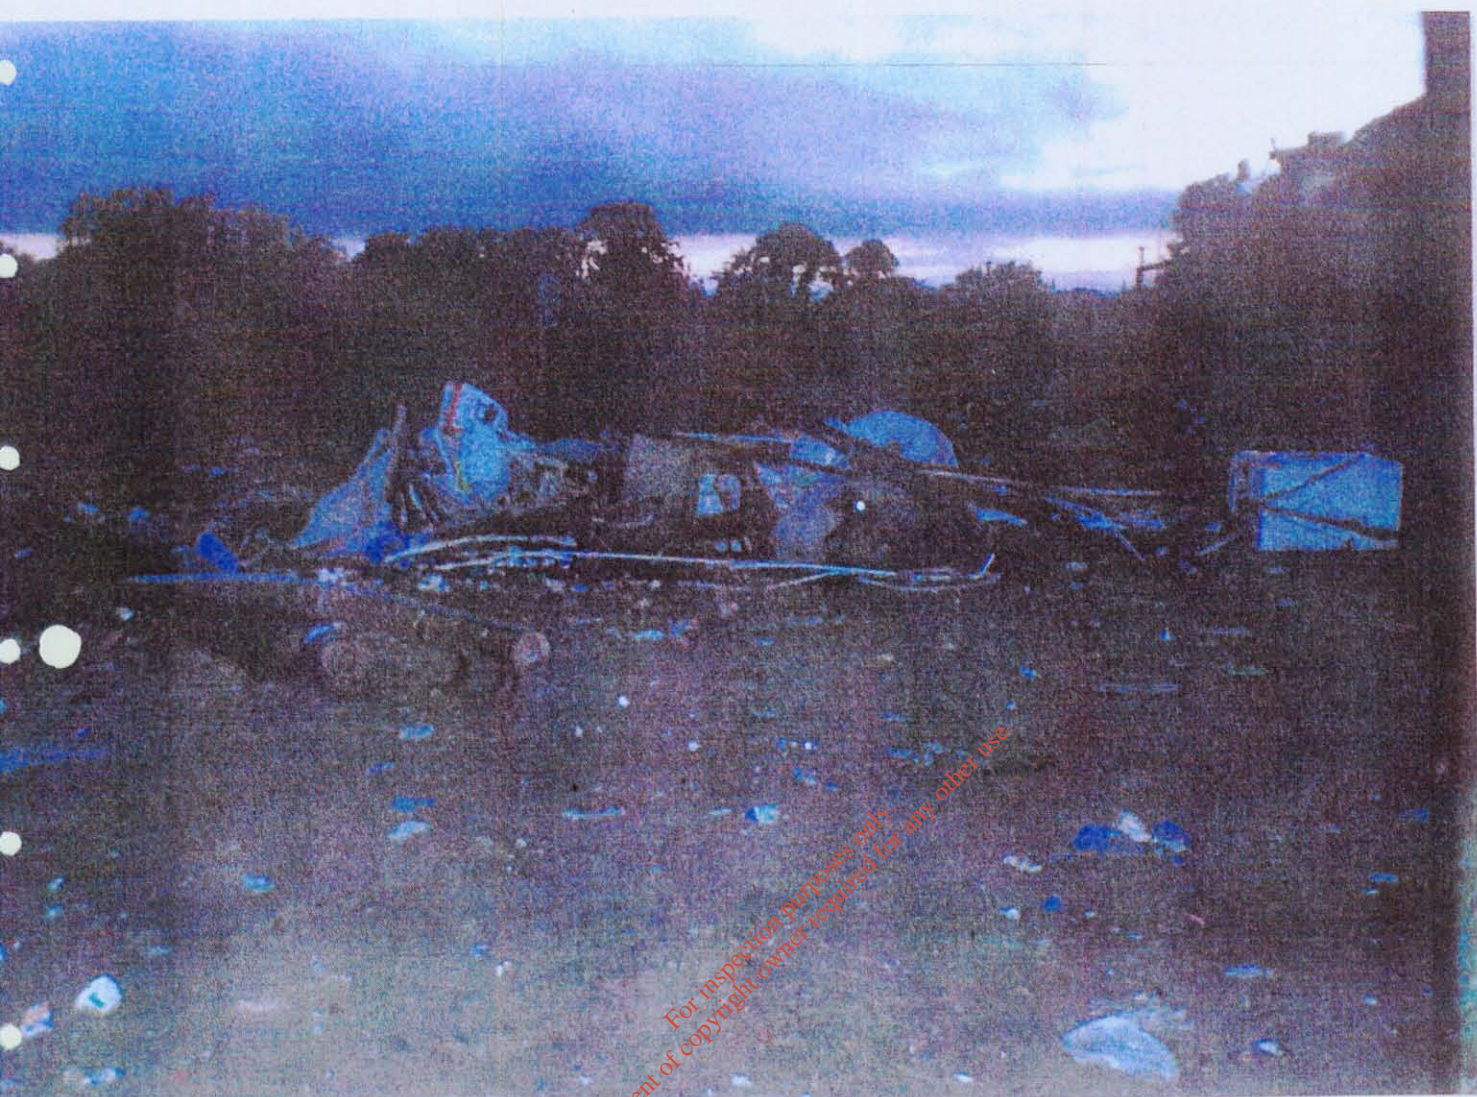
DISCARDED HOUSEHOLD APPLIANCES

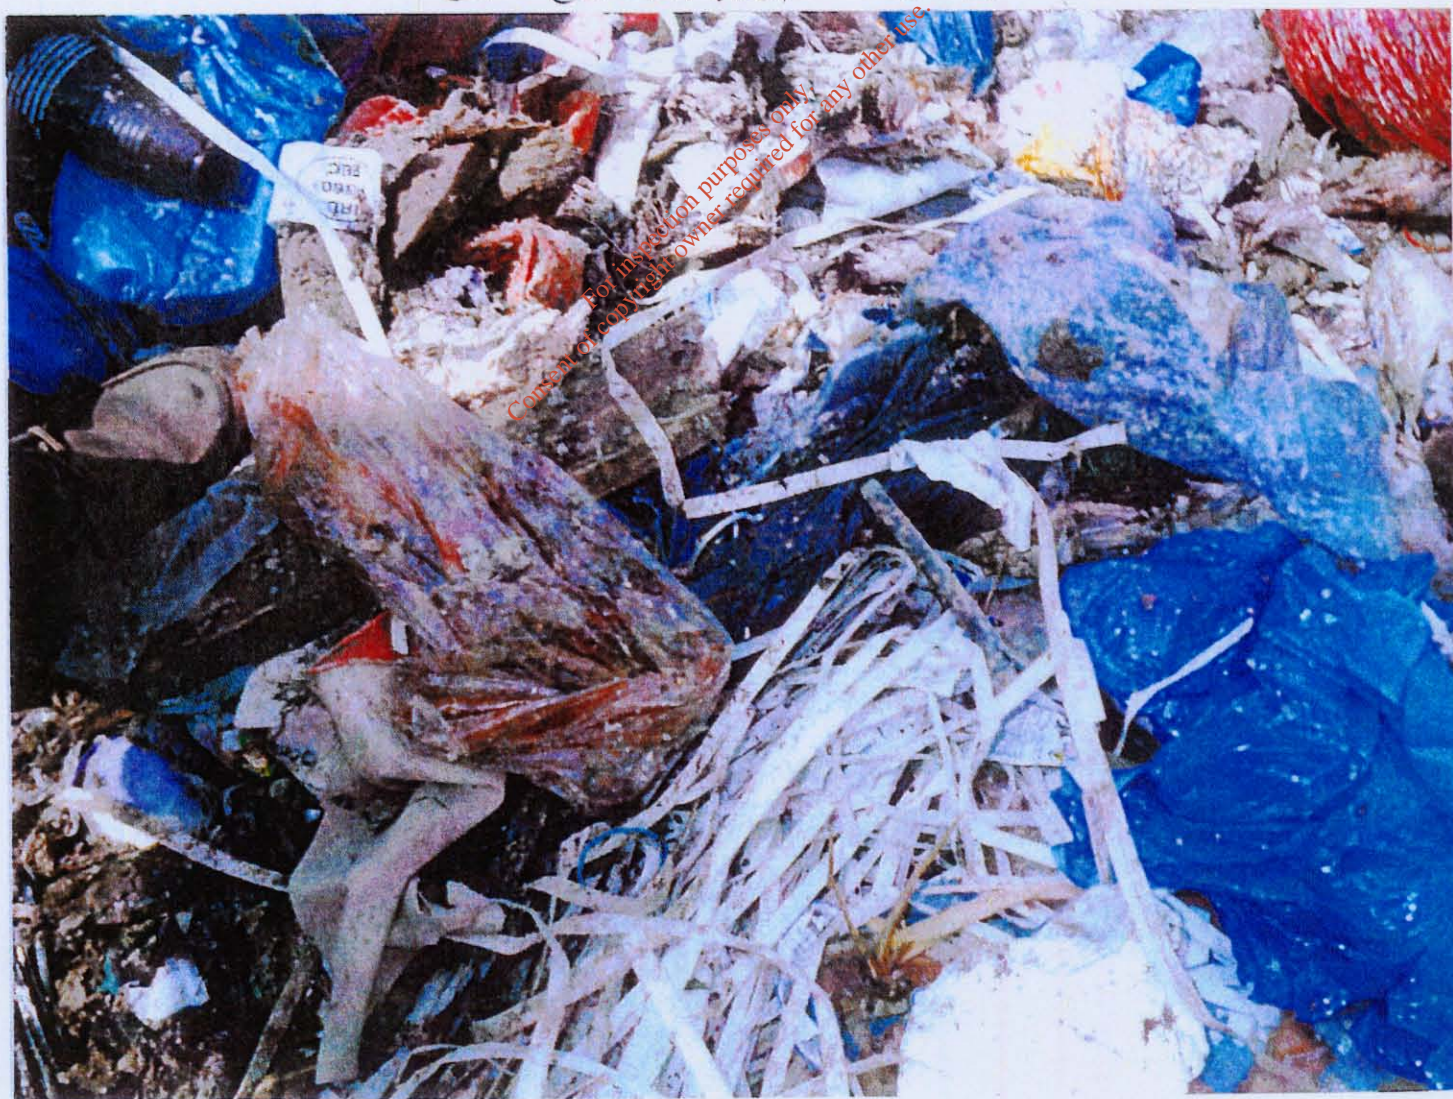
CLEAR PLASTIC FULL OF BLOOD
RESIDUE, BREACH
OF CONDITION 5.1.

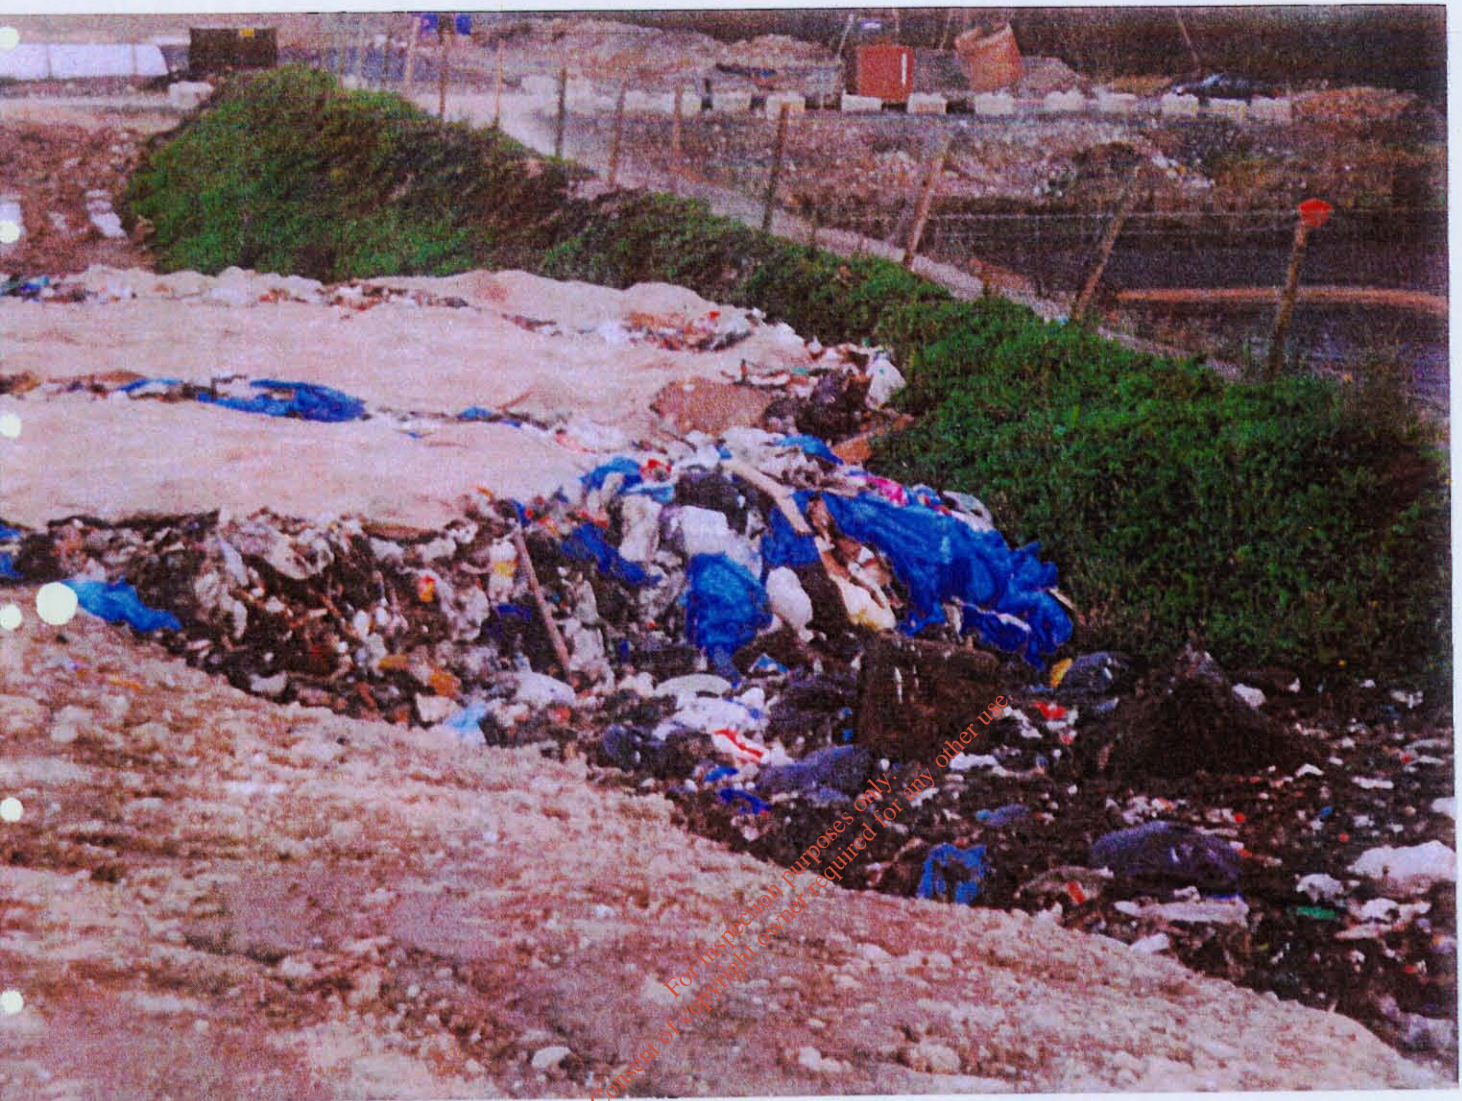
TIP FACE POOR COMPACTION LARGE AREAS UNCOVERED
