Environmental Protection Agency
 Office of Environmental Enforcement

14th December 2004

Shannon Vermicomposting make the following submission firstly on 78-2 application. Secondly on the overall none-compliance of 78-1 licence Ballaghveny Landfil site owned and run by North Tipperary County Council.

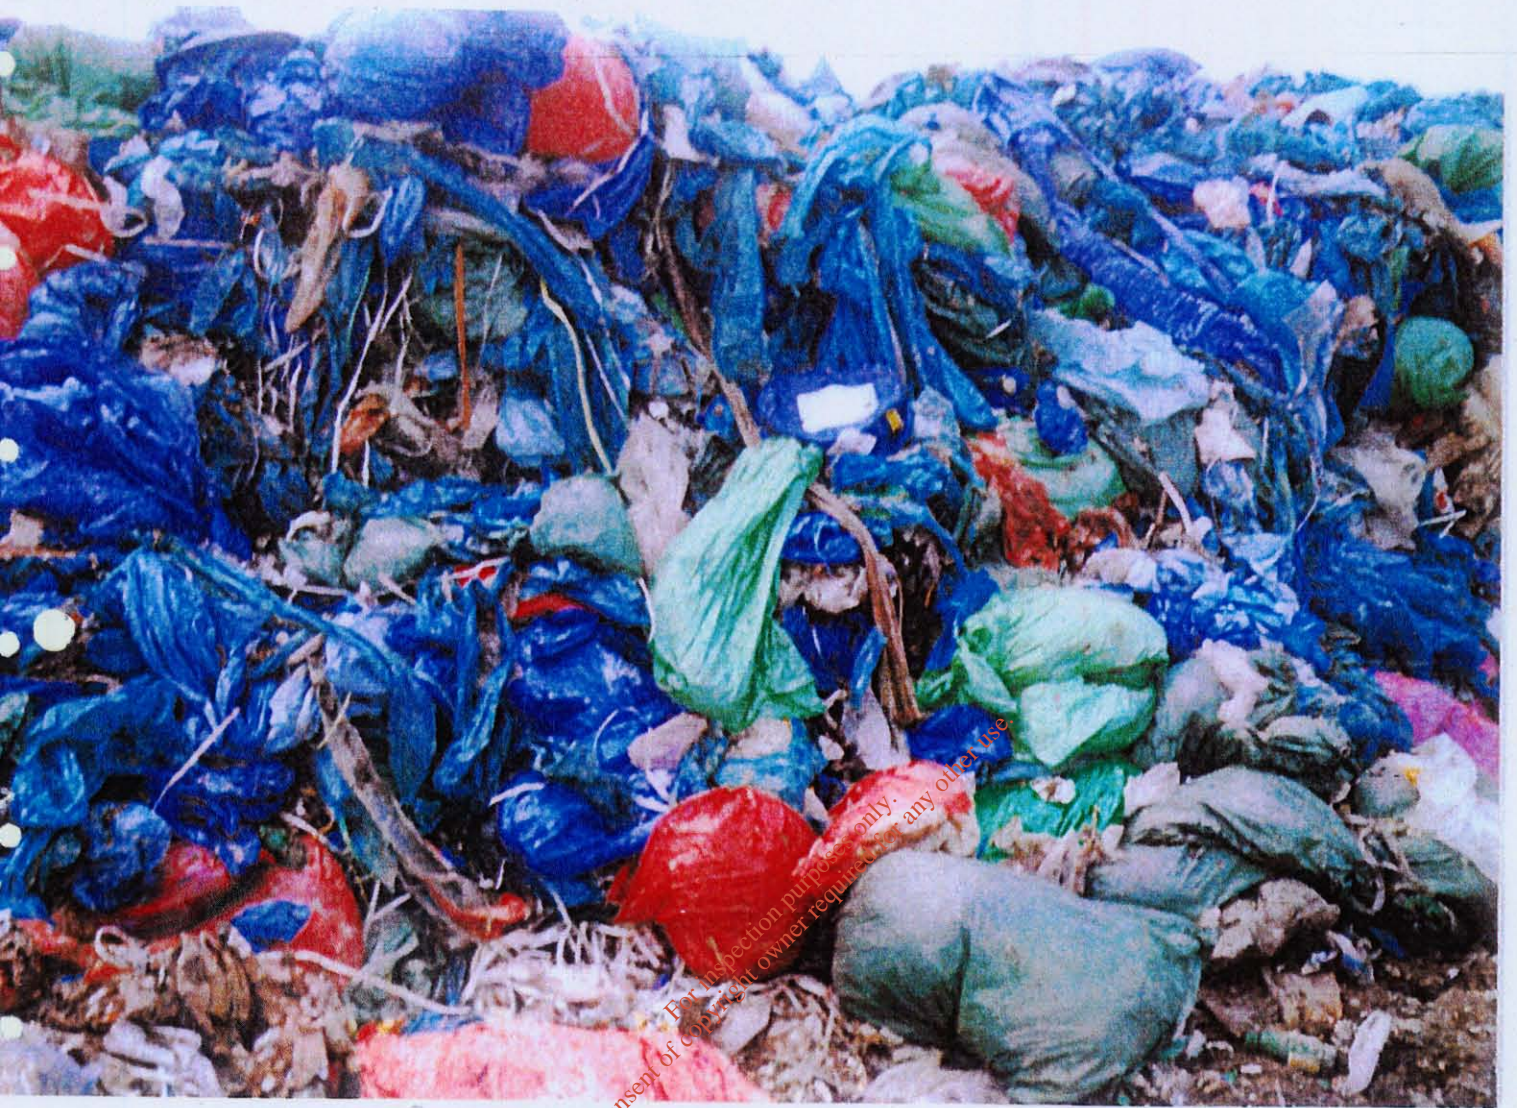
LARGE AREAS OF TIP HEAD
UNCOVERED LEFT IN THIS CONDITION
OVER THE WEEKEND, FLIES, BIRDS,
VERMIN, BREEDING AND FEEDING
GROWN, SEWAGE SLUDGE LEFT
UNCOVERED.

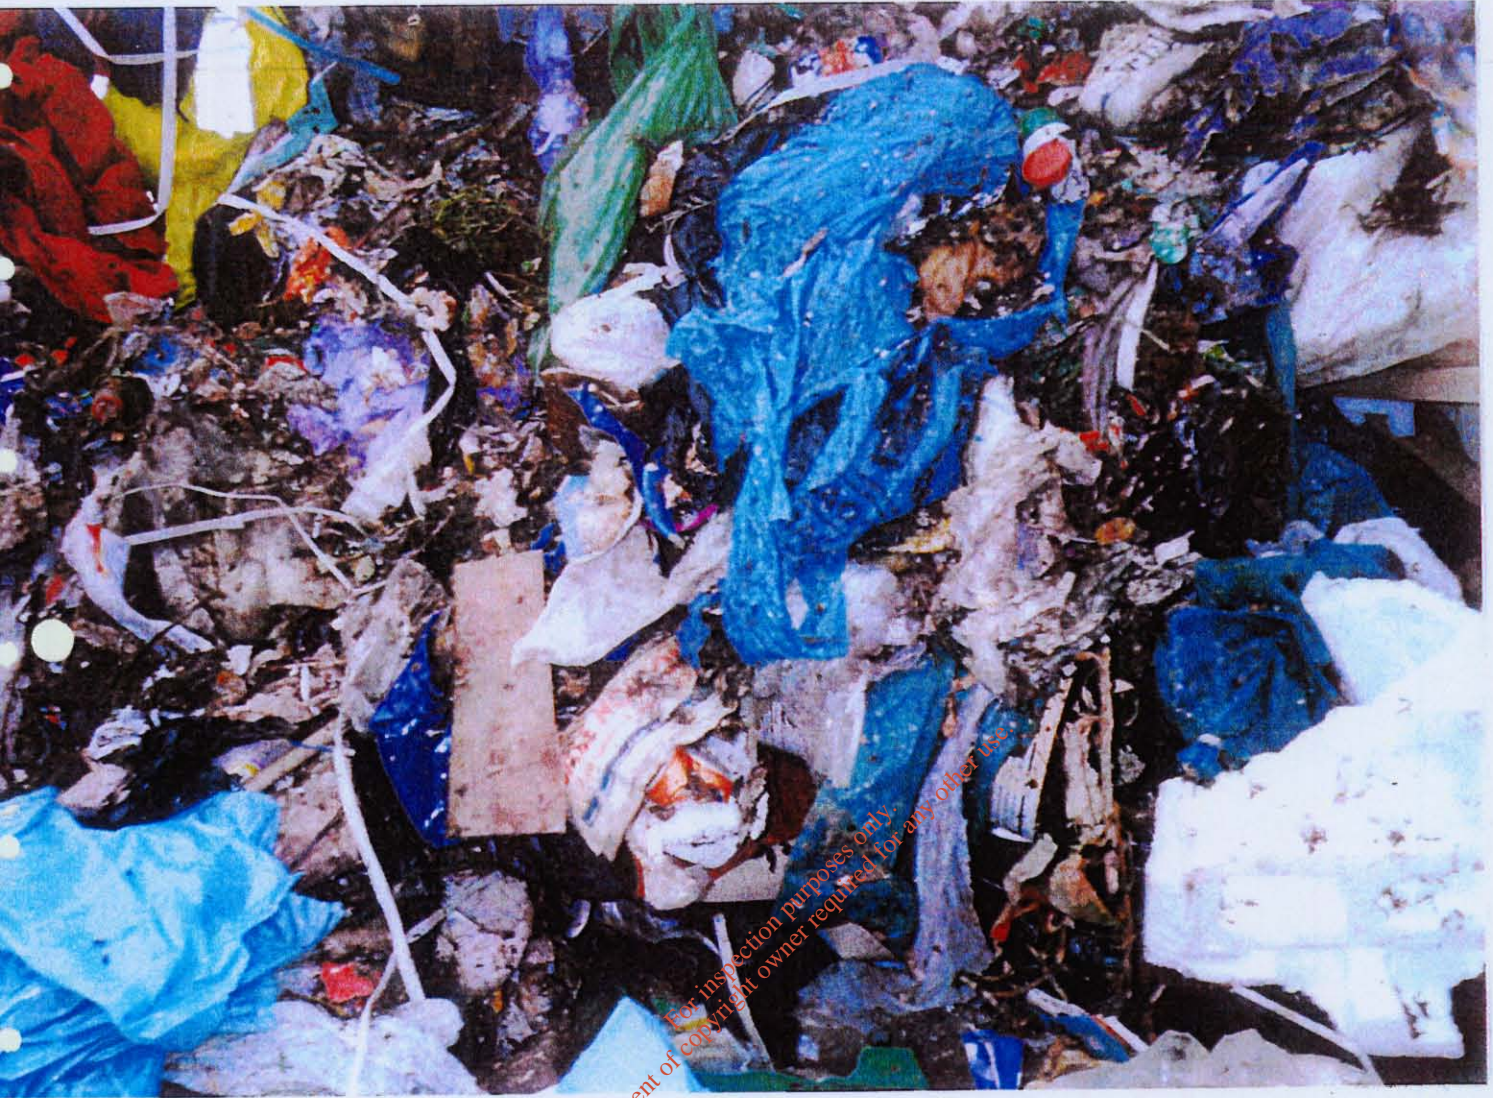
LARGE AMOUNTS OF BIODEGRADABLE MATERIAL LEFT EXPOSED FOR SEVERAL HOURS.

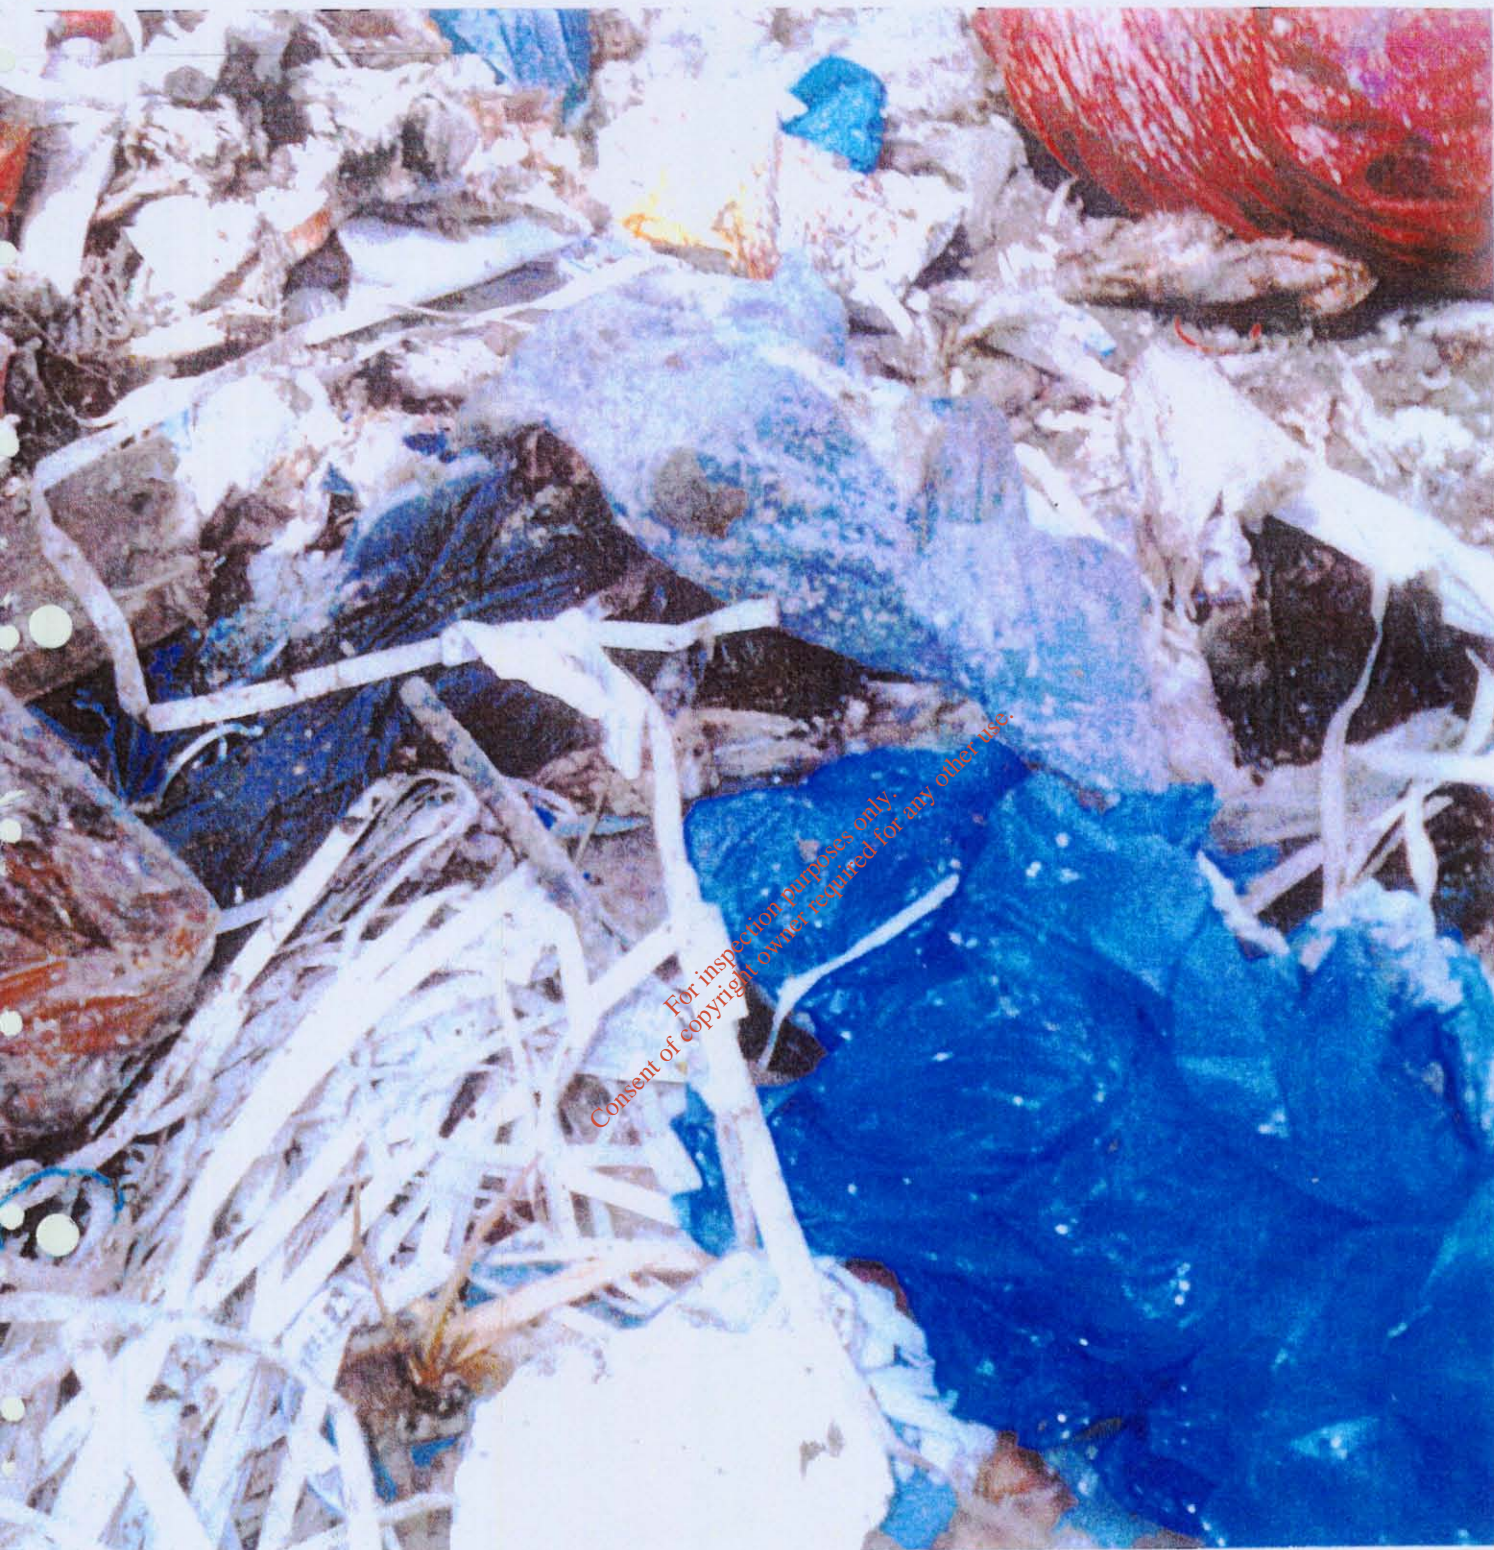
LARGE AMOUNTS OF BIODEGRADABLE
WASTE LEFT UNCOVERED.
