Attachment I.5 Ground and /or groundwater contamination
Schwarz Pharma Ltd revised IPCL Application

**Ground and /or groundwater
Locations**

Schwarz Pharma Ltd.

*HYDROGEOLOGICAL
INVESTIGATION OF THE SIFA
COMPLEX SHANNON FREE ZONE*

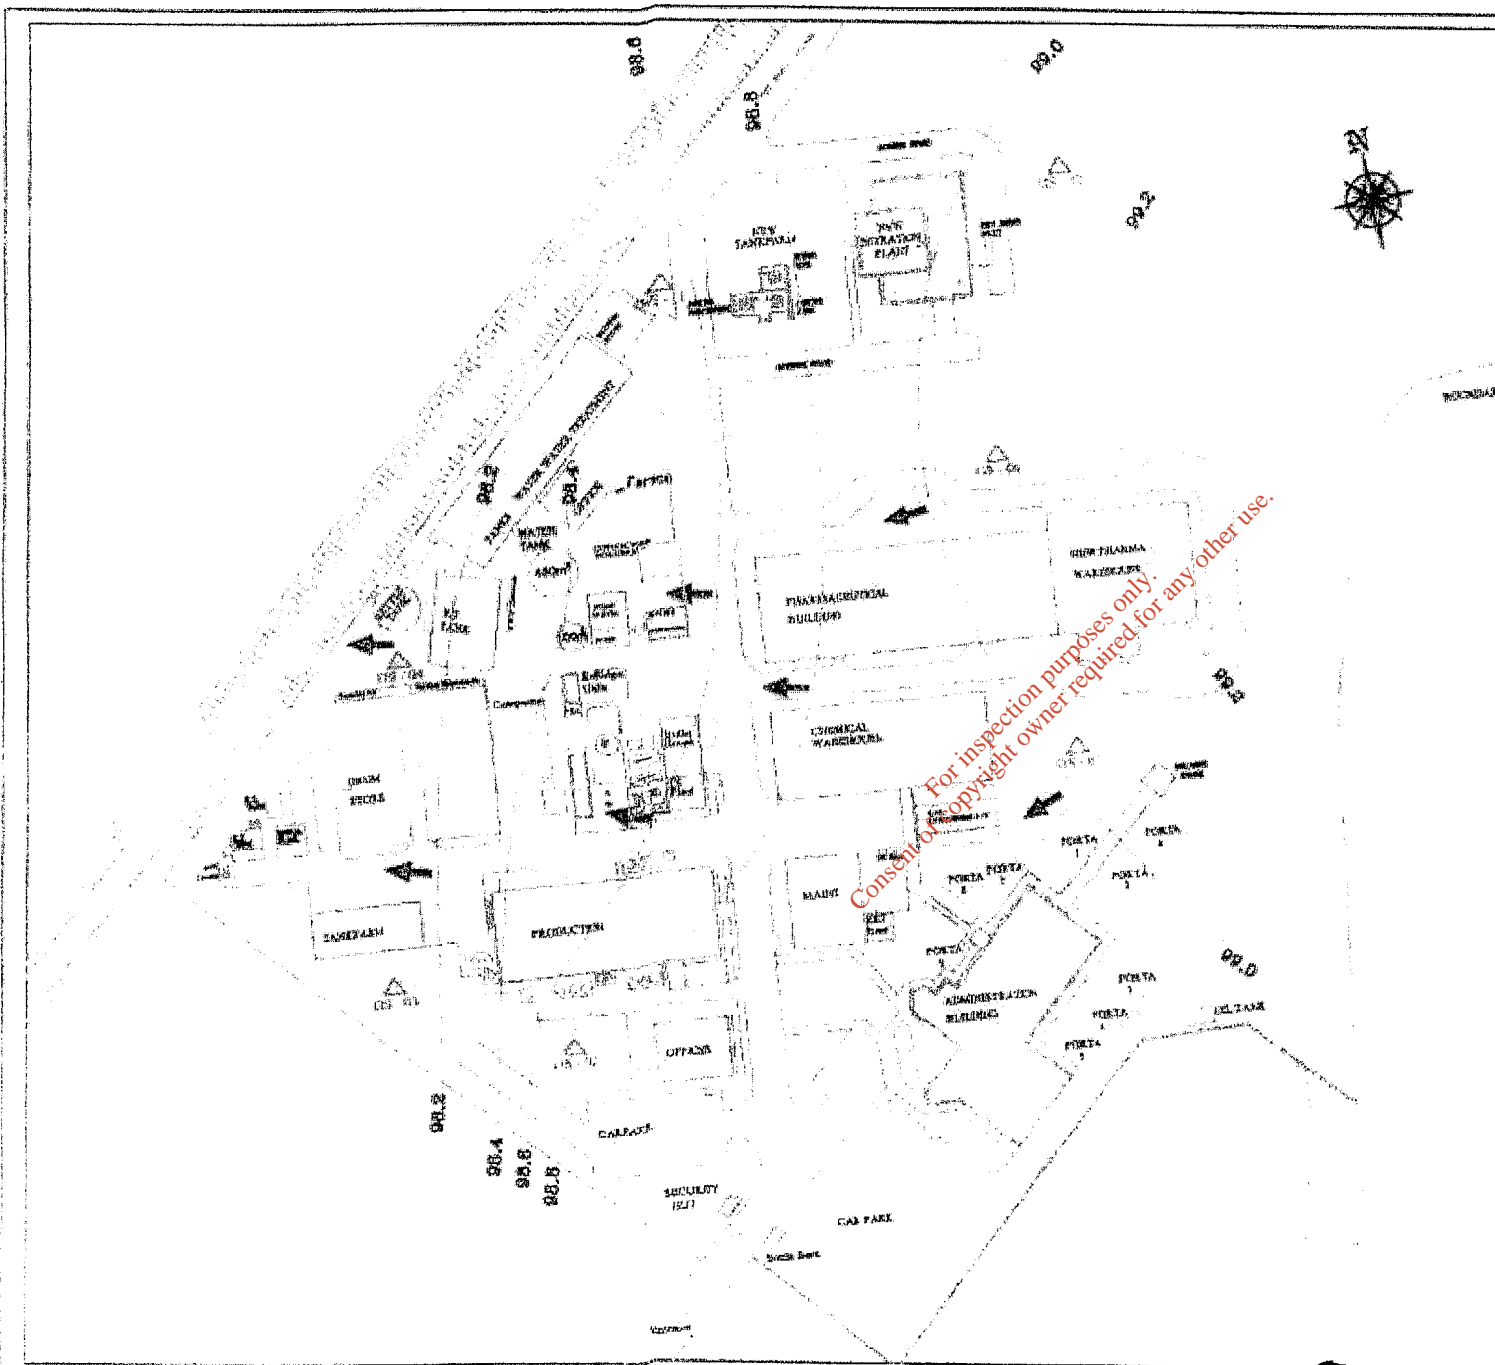
Piezometric Gradient

The resulting map shows a defined westerly gradient over the site, with the greatest gradients evident at the southerly end of the site (near car-park), where a clear tightening of the groundwater contours are evident.
