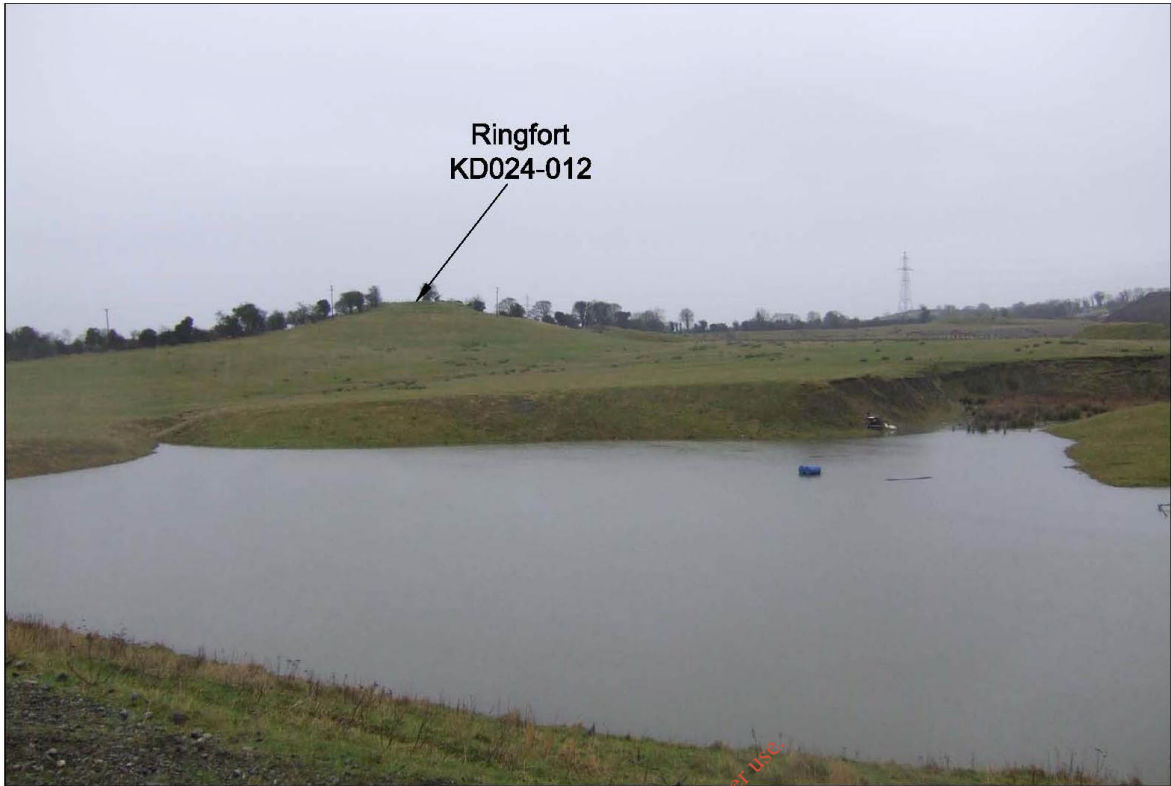
Plate 1 – Area of Land Interest with Ringfort (KD024-012) in Background Facing North

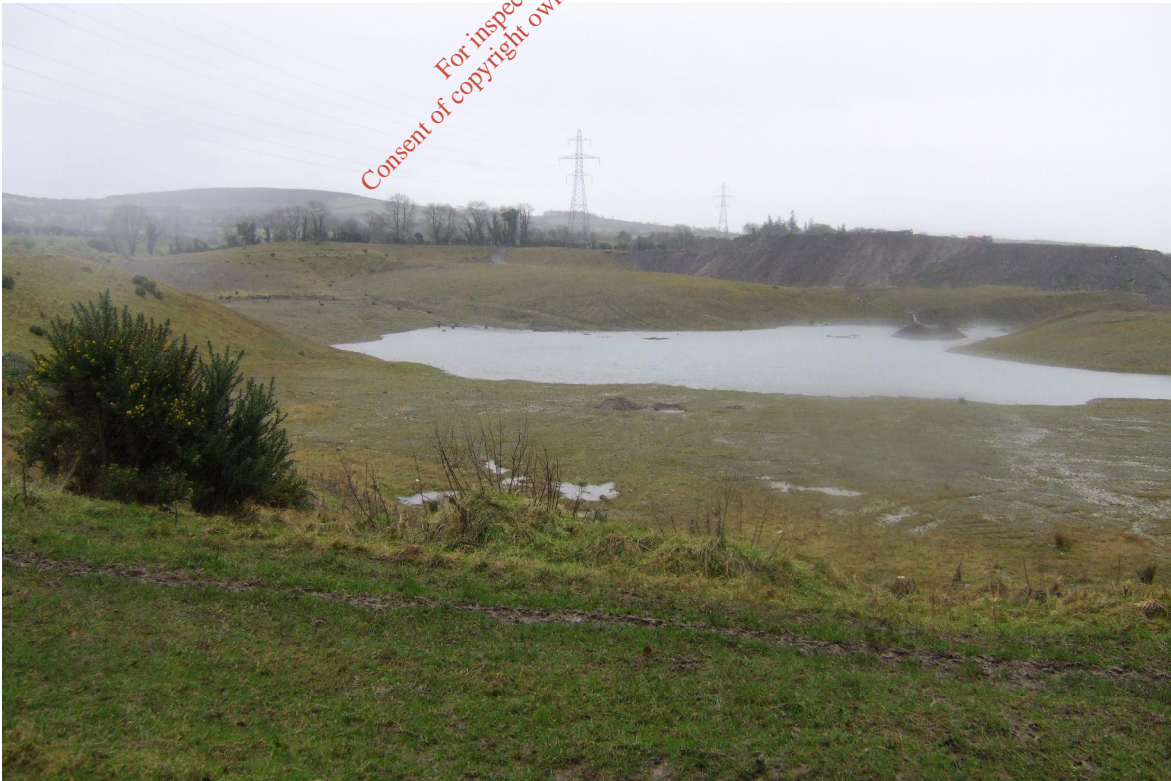
Plate 2 – Area of Land Interest Showing Quarried Area in Northeast

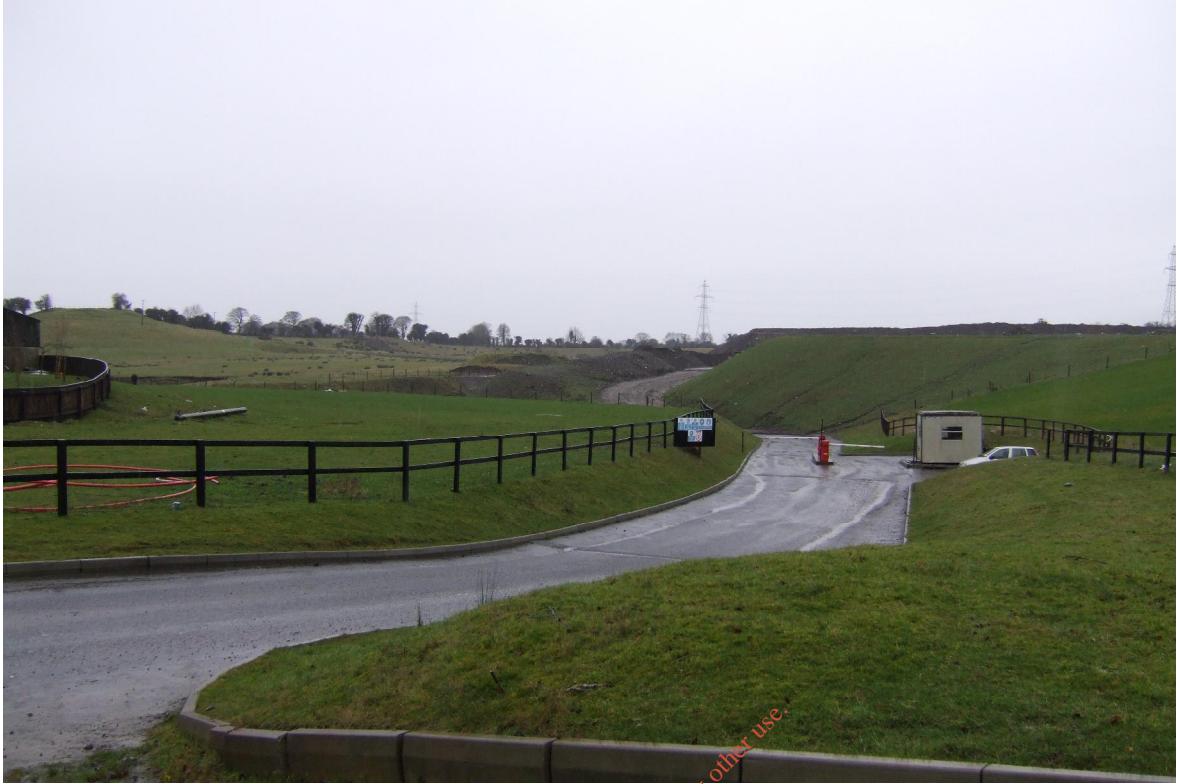
Plate 3 – Restoration of Lands Viewed from Site Entrance with Ringfort in Background

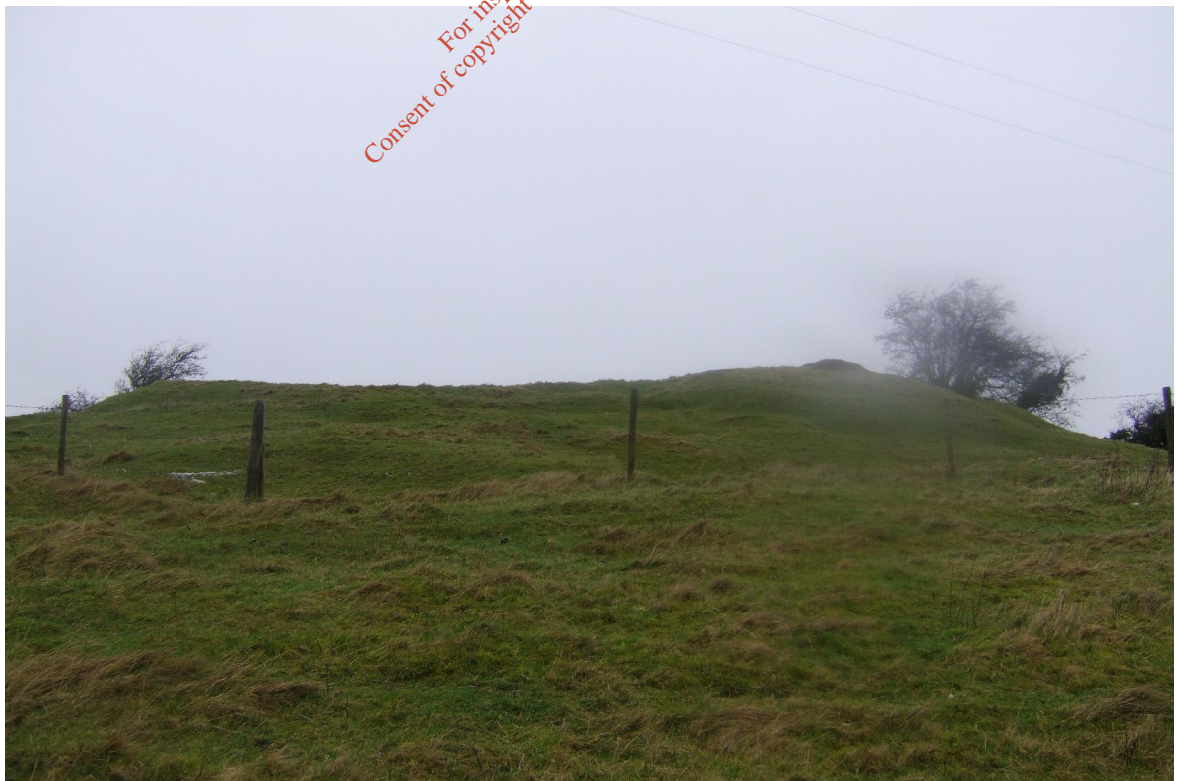
Plate 4 – Ringfort (KD024-012) with 5m Buffer Fence in Foreground, facing Southwest

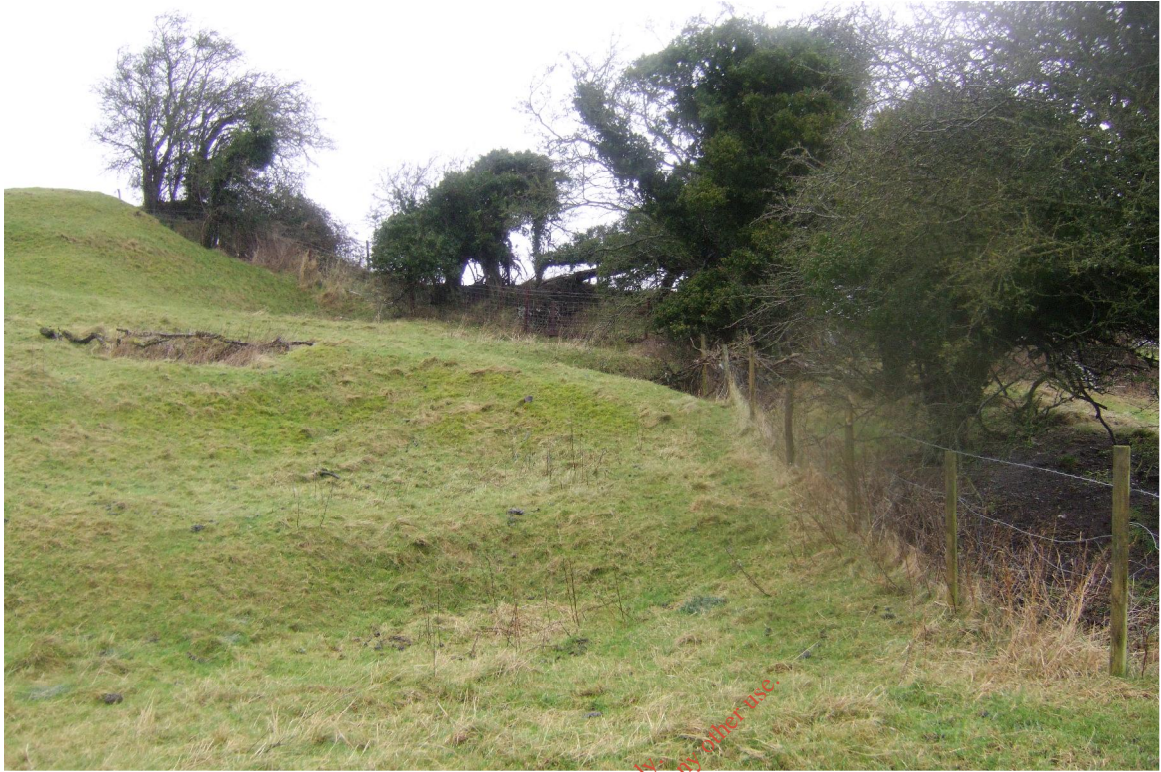
Plate 5 – Ringfort (KD024-012) Showing Disturbance to Bank in
Northwest Quadrant
