Geological and Hydrogeological Study of the Corranure Landfill,  
County Cavan

M. C. O'Sullivan & Co. Ltd.

<b>AUTHOR</b>	<b>CHECKED</b>	<b>JOB No.</b>	<b>DATE</b>
Dr. Davide Gallazzi PGeo	EuroGeol B.J.Murphy M.Sc. DIC MIEI	1229	25 <sup>th</sup> August 2003

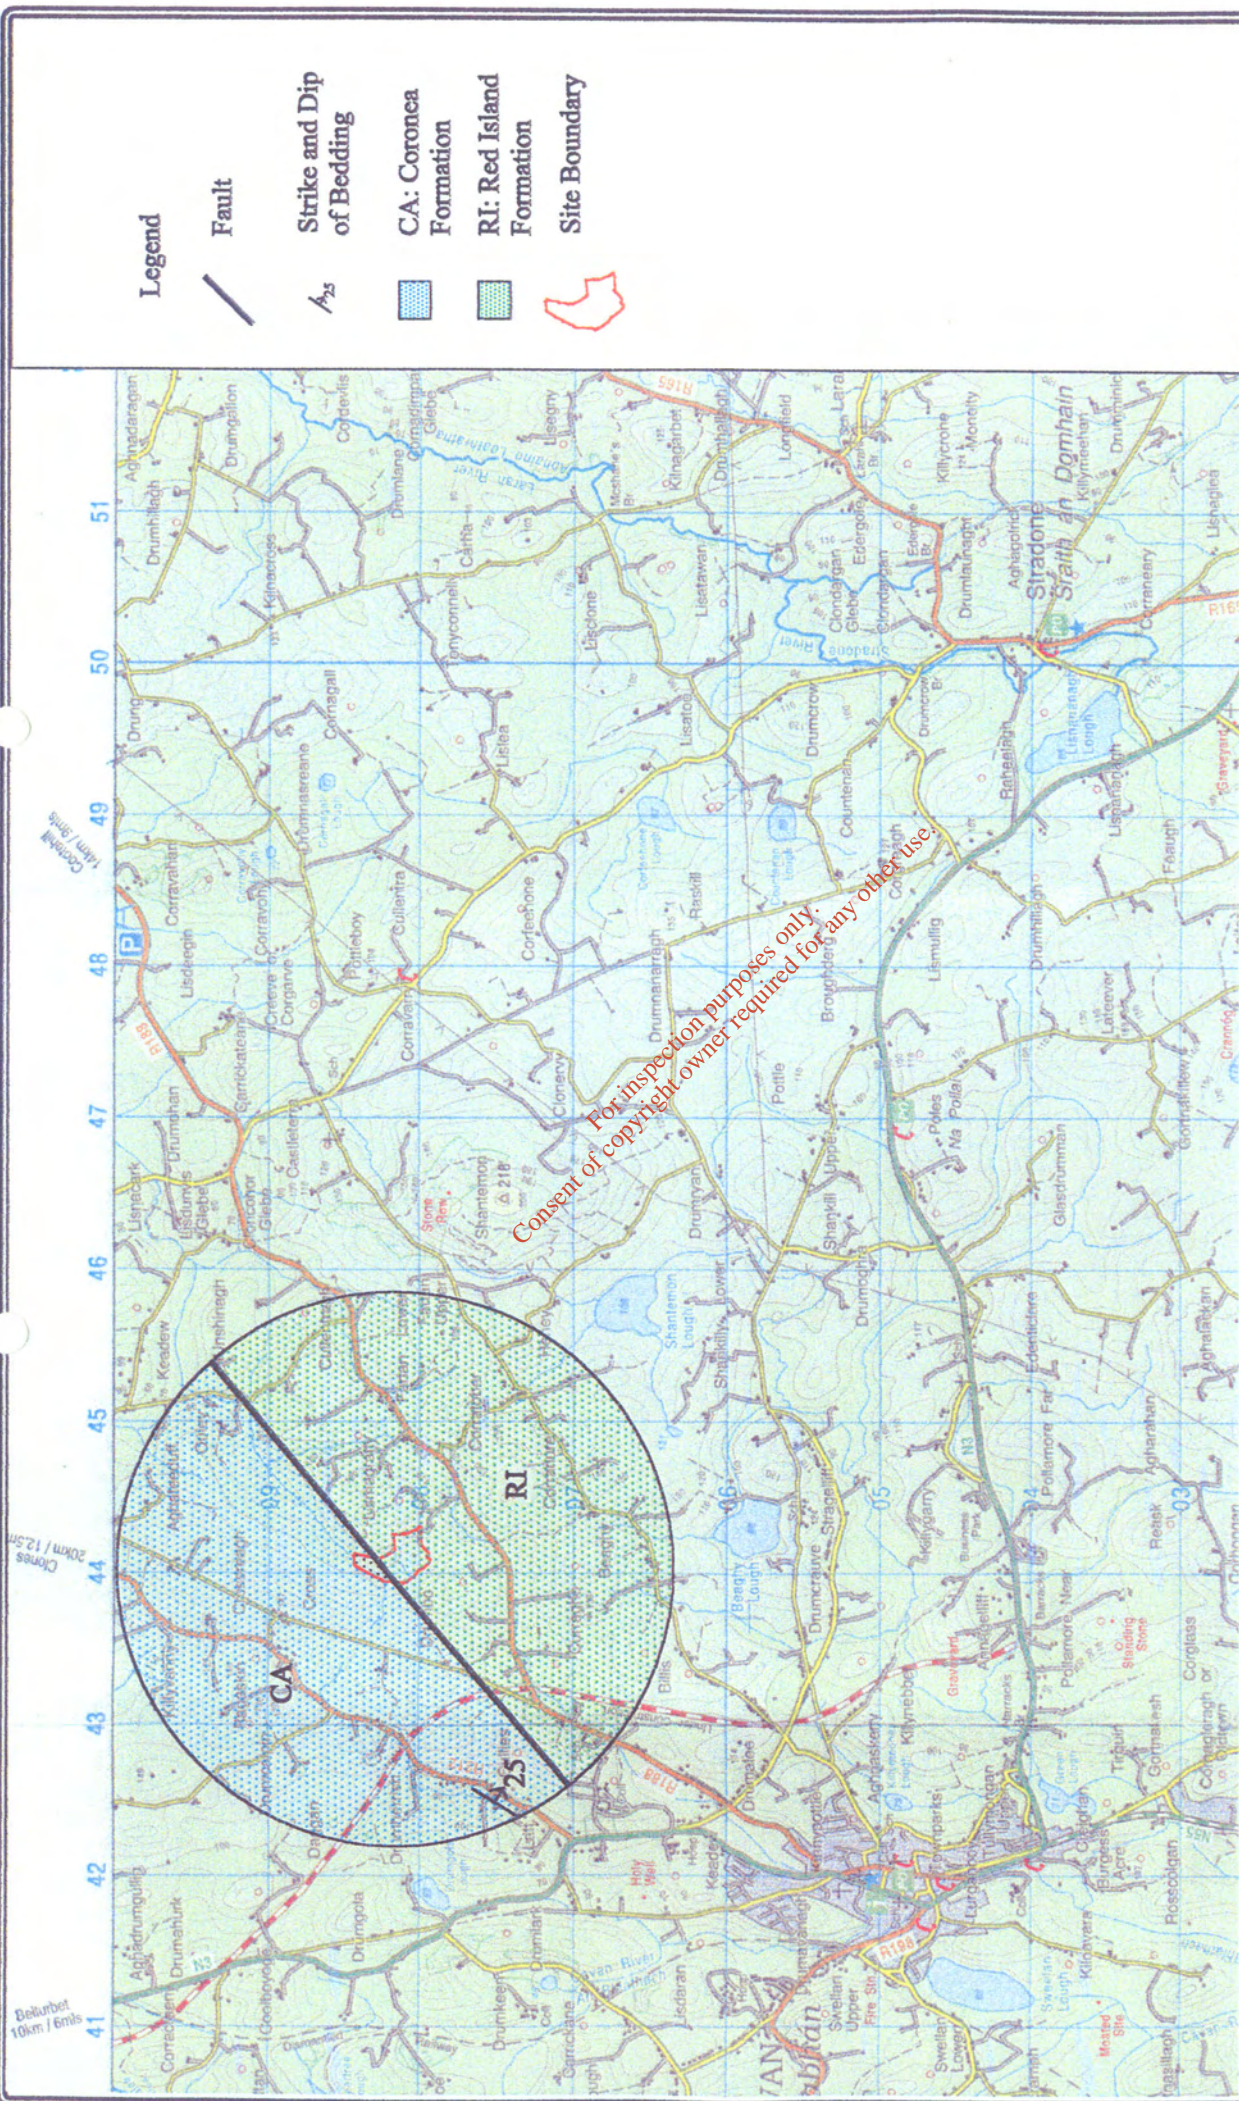
**Map 1 Site Location and Regional Geology**

The 1:100,000 map of the bedrock geology for the area (Map 1) and the accompanying booklet, published by the Geological Survey of Ireland (GSI) in 1997 indicate that the site is underlain by lithotypes belonging to the Longford – Down Inlier. This is made of a belt of rocks which extends from the coast of County Down to County Longford. Moreover the Longford – Down Inlier is part of greater belt-like structure, which extends into Scotland and into north-eastern America. All of these rocks were deposited on the submarine margin of the paleo-continent Laurentia, which laid on the north-western margin of the paleo-ocean Iapetus. This paleo-ocean disappeared as a consequence of continental drift around the end of the Silurian (ca. 410 Ma), with connected oceanic plate subduction, volcanic activity, continental collision and formation of mountains (Caledonian Orogeny). The zone of this collision is believed to extend, in Ireland, from County Louth to the Shannon Estuary.

The GSI map shows that the site is crossed with a NE-SW trend by a section of the Caticketeane Fault, which separates Tract 2 (on the western side) from Tract 3 (on the eastern side). Tract 2 is represented by the green greywackes, red shales and minor spilitic lavas of the Coronea Formation. Shales and argillites are particularly abundant in the lower part of the Formation, where they can reach a thickness of 30 m with a lateral continuity of several hundred metres. Features found in the lava indicate that the same has been erupted underwater at depths greater than 4,000 m. This geological formation has an estimated thickness between 1,600 m and 2,300 m.

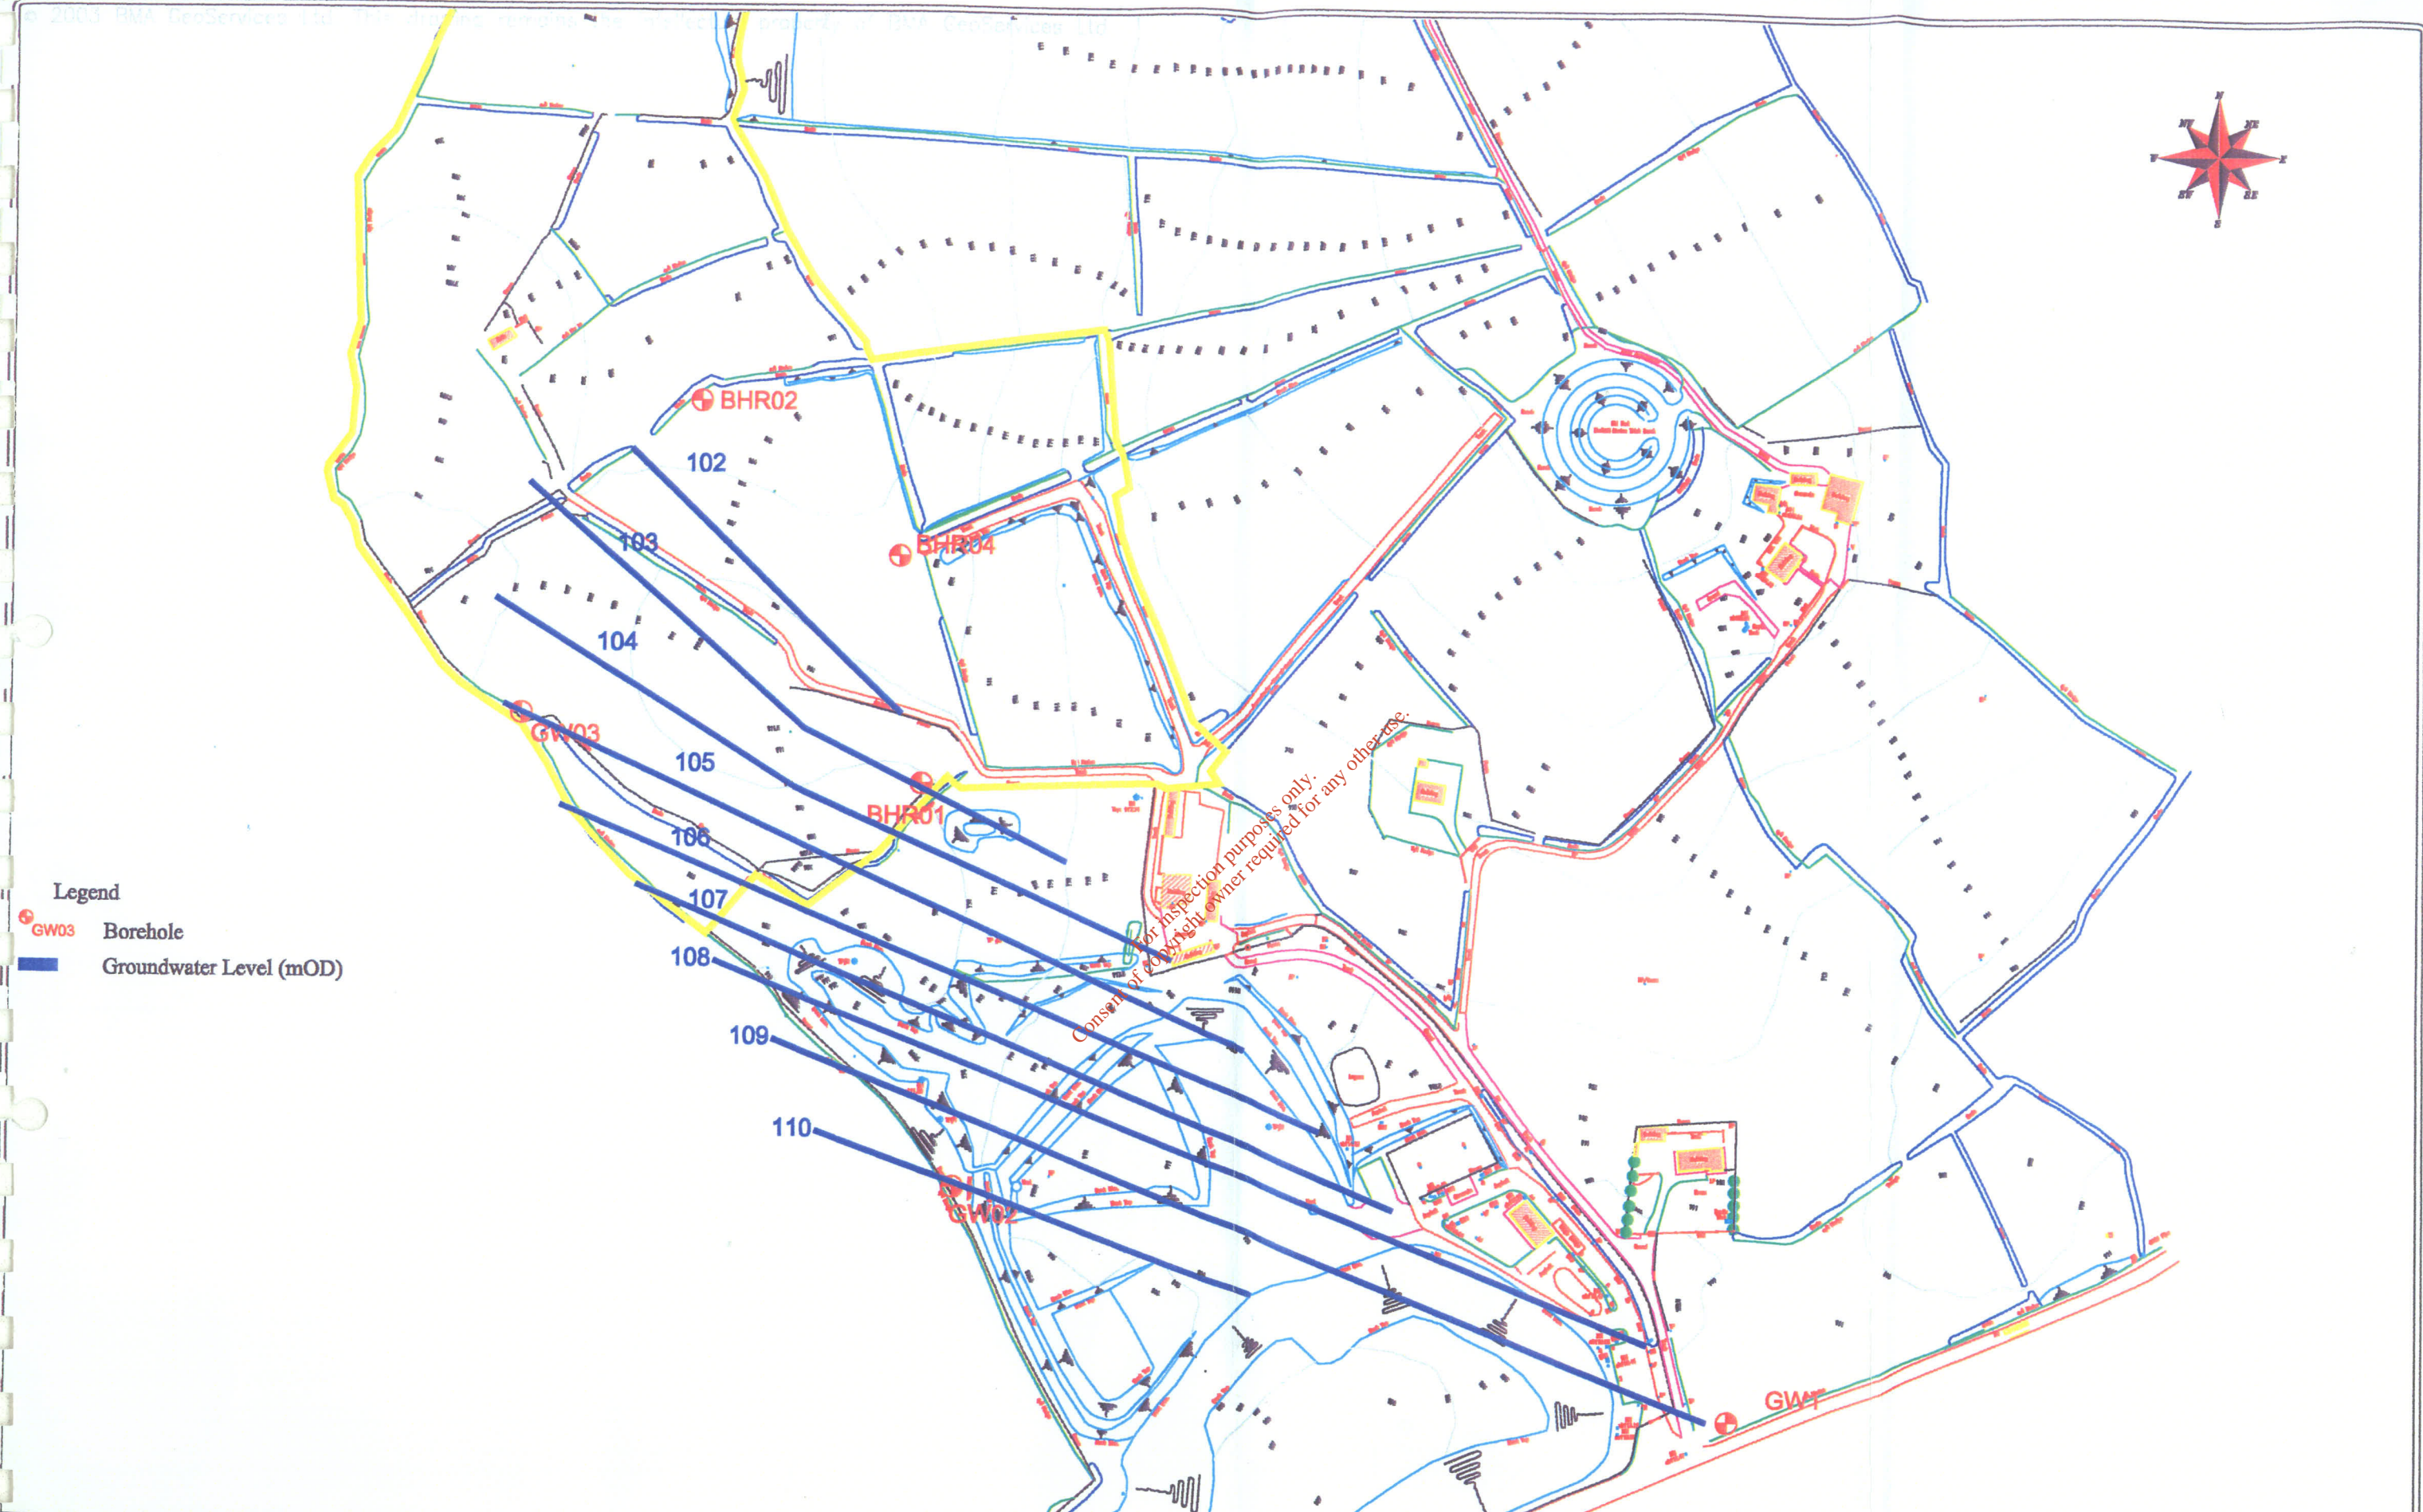
**MAP 3**  
**Piezometric Surface in Bedrock**

The elevation of depth to water measured on the field the 25<sup>th</sup> July 2003 show that the water level in all the monitoring wells has risen significantly above the bedrock elevation, so suggesting a semi-artesian nature of the bedrock aquifer.

Groundwater level in the bedrock varies between 101.05 mOD and 110.48 mOD. The direction of groundwater flow appears to be toward north with a gradient of 0.06 (Map 3).

The reconstruction of the piezometric surface for groundwater in bedrock indicates a flow northward, with a gradient of 0.06.
