**LANDFILL GAS LEAKAGE SURVEY AT CORRANURE LANDFILL, LISMAGRATTY &
CORRANURE TOWNLANDS, COOTEHILL ROAD, CAVAN, CO. CAVAN**

PERFORMED BY ODOUR MONITORING IRELAND ON BEHALF OF CAVAN COUNTY COUNCIL

PREPARED BY:	Dr. John Casey
ATTENTION:	Ms. Sinead Fox
WASTE LICENCE NUMBER:	Waste licence W077-01
DATE:	08 th February 2008
REPORT NUMBER:	2008A50(1)
DOCUMENT VERSION:	Document Ver. 001
REVIEWERS:	Dr. Brian Sheridan

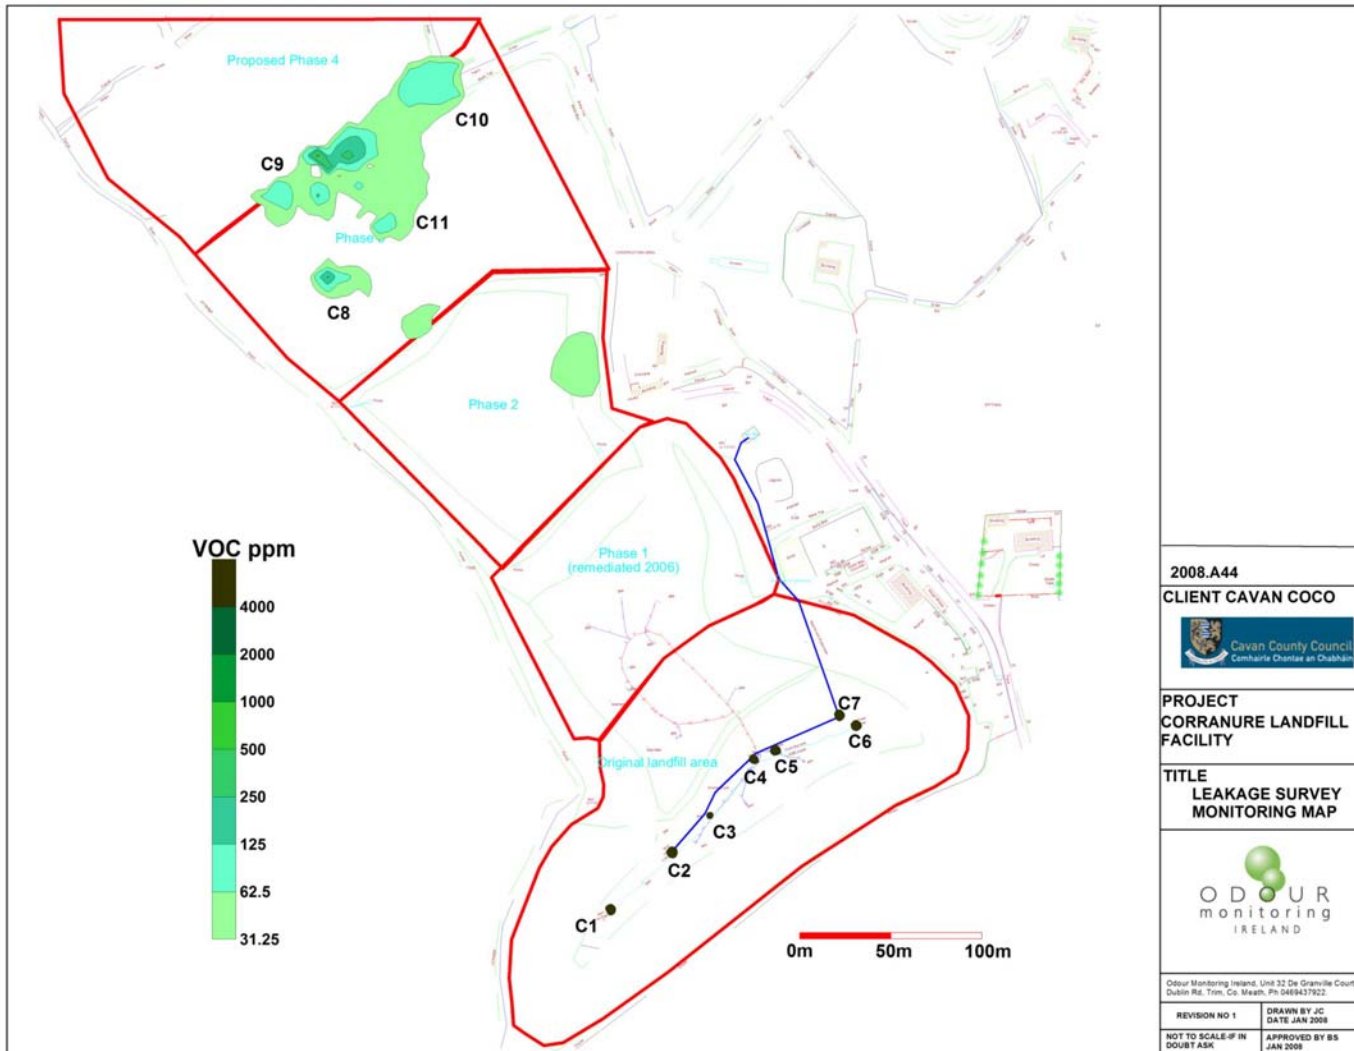
Figure 6.1. Landfill gas leakage monitoring within the operating landfill facility (colour scale area indicating TVOC gas colour scale).

Figure 6.1 and Table 3.1 illustrates the results obtained for the capping leakage survey. A total of 11 individual leakage zones were identified. Each leakage zone is discussed separately in this manner in order to allow for the development of remediation strategies to mitigate the individual leakage areas.

Location ID	Easting (m)	Northing (m)	Max Range VOC conc. (ppm)	Identification and Mitigation
C1	244274	307633	32 to 9999+	Leachate chamber (L/G13) should be sealed. Gas abstraction should be applied. All emission points should be appropriately sealed to prevent the flux of landfill gas to atmosphere while careful consideration should be given to the influx of Oxygen in to the cap in this area.
C2	244307	307664	32 to 9999+	Leachate chamber (L/G11) should be sealed. Gas abstraction should be applied. All emission points should be appropriately sealed to prevent the flux of landfill gas to atmosphere while careful consideration should be given to the influx of Oxygen in to the cap in this area.
C3	244329	307685	32 to 4000+	Vertical well chamber (L/G14) should be sealed. Improved gas abstraction should be performed upon vertical wells in the vicinity of this area. Vertical wellheads should be appropriately sealed to prevent the flux of landfill gas to atmosphere while careful consideration should be given to the influx of Oxygen in to the cap in this area.

C4	244352	307716	32 to 9999	Leachate chamber (L/G04) should be sealed. Gas abstraction should be applied. All emission points should be appropriately sealed to prevent the flux of landfill gas to atmosphere while careful consideration should be given to the influx of Oxygen in to the cap in this area.
C5	244365	307720	32 to 4000+	Vertical well chamber (L/G05) should be sealed. Improved gas abstraction should be performed upon vertical wells in the vicinity of this area. Vertical wellheads should be appropriately sealed to prevent the flux of landfill gas to atmosphere while careful consideration should be given to the influx of Oxygen in to the cap in this area.
C6	244409	307734	32 to 9999+	Leachate chamber (L/G07) should be sealed. Gas abstraction should be applied. All emission points should be appropriately sealed to prevent the flux of landfill gas to atmosphere while careful consideration should be given to the influx of Oxygen in to the cap in this area.

C7	244400	307740	32 to 4000+	Vertical well chamber (L/G06) should be sealed. Improved gas abstraction should be performed upon vertical wells in the vicinity of this area. Vertical wellheads should be appropriately sealed to prevent the flux of landfill gas to atmosphere while careful consideration should be given to the influx of Oxygen in to the cap in this area.
C8	244119	307980	32 to 390	Waste exposed on flanked area. Low permeability clay (10^{-9} minimum) should be tracked into the area. Flanked areas should be constructed to minimise landfill gas leakage and allow access for track machinery.
C9	244130	308047	32 1142	Waste exposed on flanked area. Low permeability clay (10^{-9} minimum) should be tracked into the area. Flanked areas should be constructed to minimise landfill gas leakage and allow access for track machinery.
C10	244175	308085	32 to 162	Waste exposed on flanked area. Low permeability clay (10^{-9} minimum) should be tracked into the area. Flanked areas should be constructed to minimise landfill gas leakage and allow access for track machinery.

C11	244157	308014	32 to 125	Weak flux of landfill gas from active area.

Eleven sources of landfill gas leakage were identified (see *Figures 6.1 and Table 3.1*) within the landfill.

Leakage locations C1, C2, C4 and C6 appear to be present as a result of insufficient sealing of leachate chambers. These pipes go directly into the waste body. The leachate chambers should be sealed properly with gaskets similar to those used upon the vertical wells. Sealing these pipes will be easily achieved and should reduce leakage markedly. It should be noted that slight abstraction should be applied when sealing has occurred.

Leakage locations C3, C5 and C7 appear to be present as a result of insufficient abstraction from the vertical wells. Leakage was recorded emanating from the chambers, which house the vertical wells. Vacuum pressure should be checked to ensure the negative pressure is being applied to the vertical wells. Further sealing of the area around the vertical well should be carried out also, to reduce leakage. It should be noted that leakage from locations C1 to C7 was very localised and should be very easily remediated without delay.

Leakage locations C8, C9 and C10 appeared to be a result of insufficient cover on flanked areas where waste fill was exposed. If flanked areas are not constructed properly and waste is exposed landfill gas will migrate outwards in the path of least resistance. All flanked areas should be constructed properly to eliminate this sort of leakage. It should be noted that the capping material was extremely logged with moisture on the date of the survey. High moisture in the capping material will reduce the overall amount of leakage recorded.
