ASSESSMENT OF FILLED SUBSOILS FOR WASTE LICENCE APPLICATION AT NAUL, COUNTY MEATH

**ASSESSMENT OF FILLED SUBSOILS FOR WASTE LICENCE APPLICATION
AT
NAUL, COUNTY MEATH**

FINAL REPORT

Report Title: Assessment of filled subsoils for Waste Licence Application at Naul, County Meath

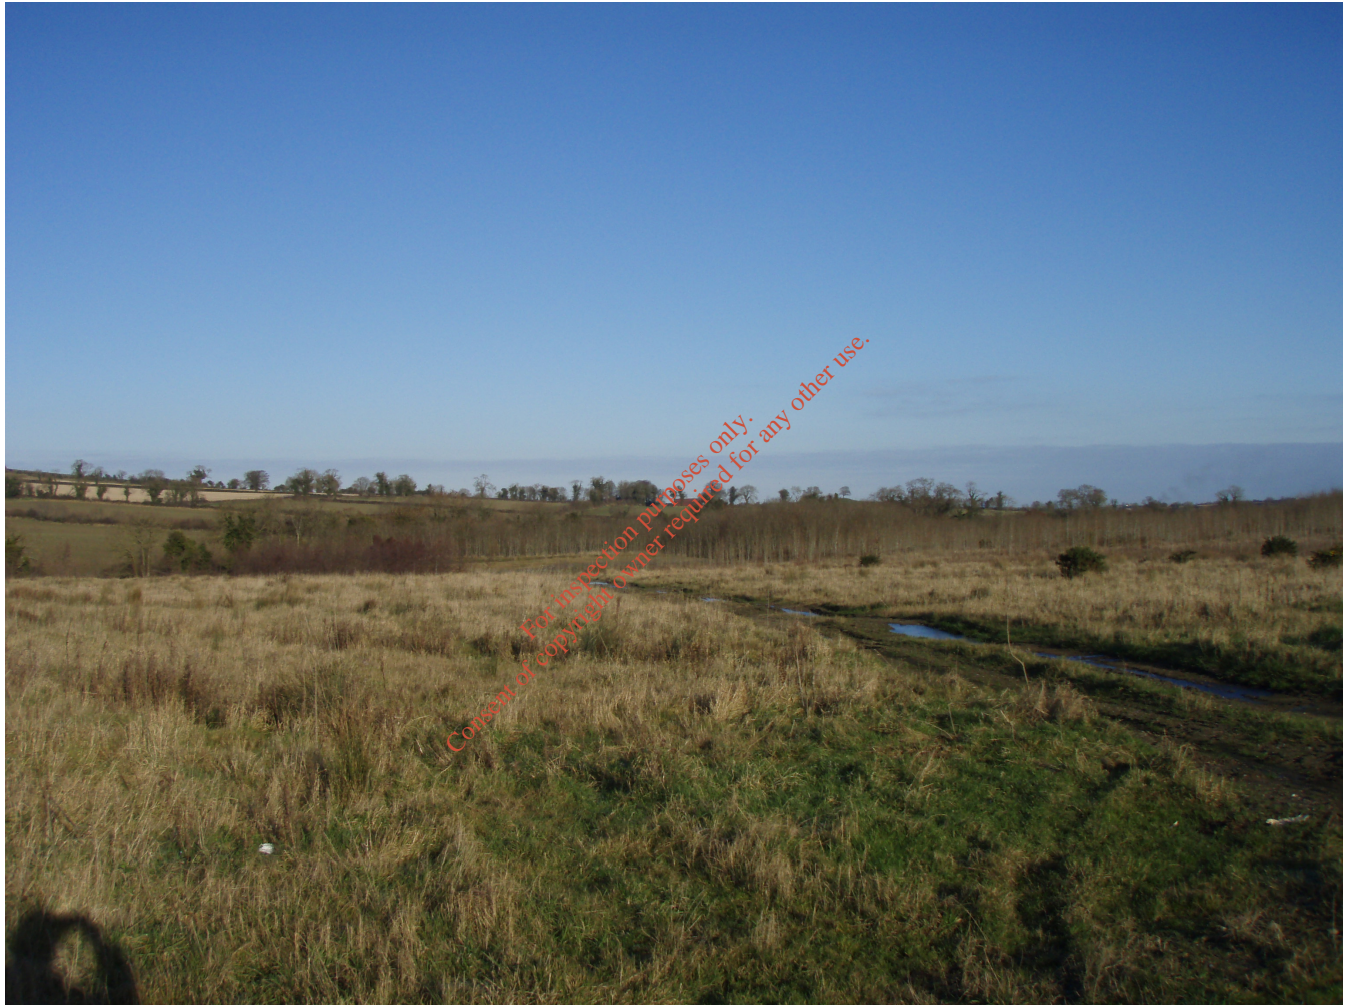
Plate 1 View across the failed forestry area, from its southwestern corner. The trees have failed completely in this western area, but did take along the easternmost boundary, as seen in the distance.

The fact that the topsoil is unevenly and thinly spread across the site itself is the foremost reason for the poor quality of the land in the northeastern extreme of the site at Naul: this factor alone would probably prohibit grass productivity on the site and would mean that more vigorous weeds would flourish in the area (it is notable that this has already occurred in the forestry area). From this, further reclamation of the site is recommended, in order to improve drainage across the site, to maintain a deeper and more consistent topsoil cover, and to better merge the relatively low area into the landscape with the higher, ridge area infilled and reclaimed to the immediate west of the forestry parcel.

It is therefore recommended that further well drained subsoil and topsoil be imported across the site. The land should be graded and built up to a similar height as the ground in the reclaimed field to the west, in order to merge with existing ground contours. The subsoil and topsoil material should be well aerated and well drained and the final topsoil cap should be at least 0.3m deep. Fertiliser should be applied to enhance the soil. This can be inorganic (*e.g.* N-P-K blend) or organic (slurry), and the topsoil should also be tested before application to ensure the maintenance of an appropriate nutrient balance in the ground.

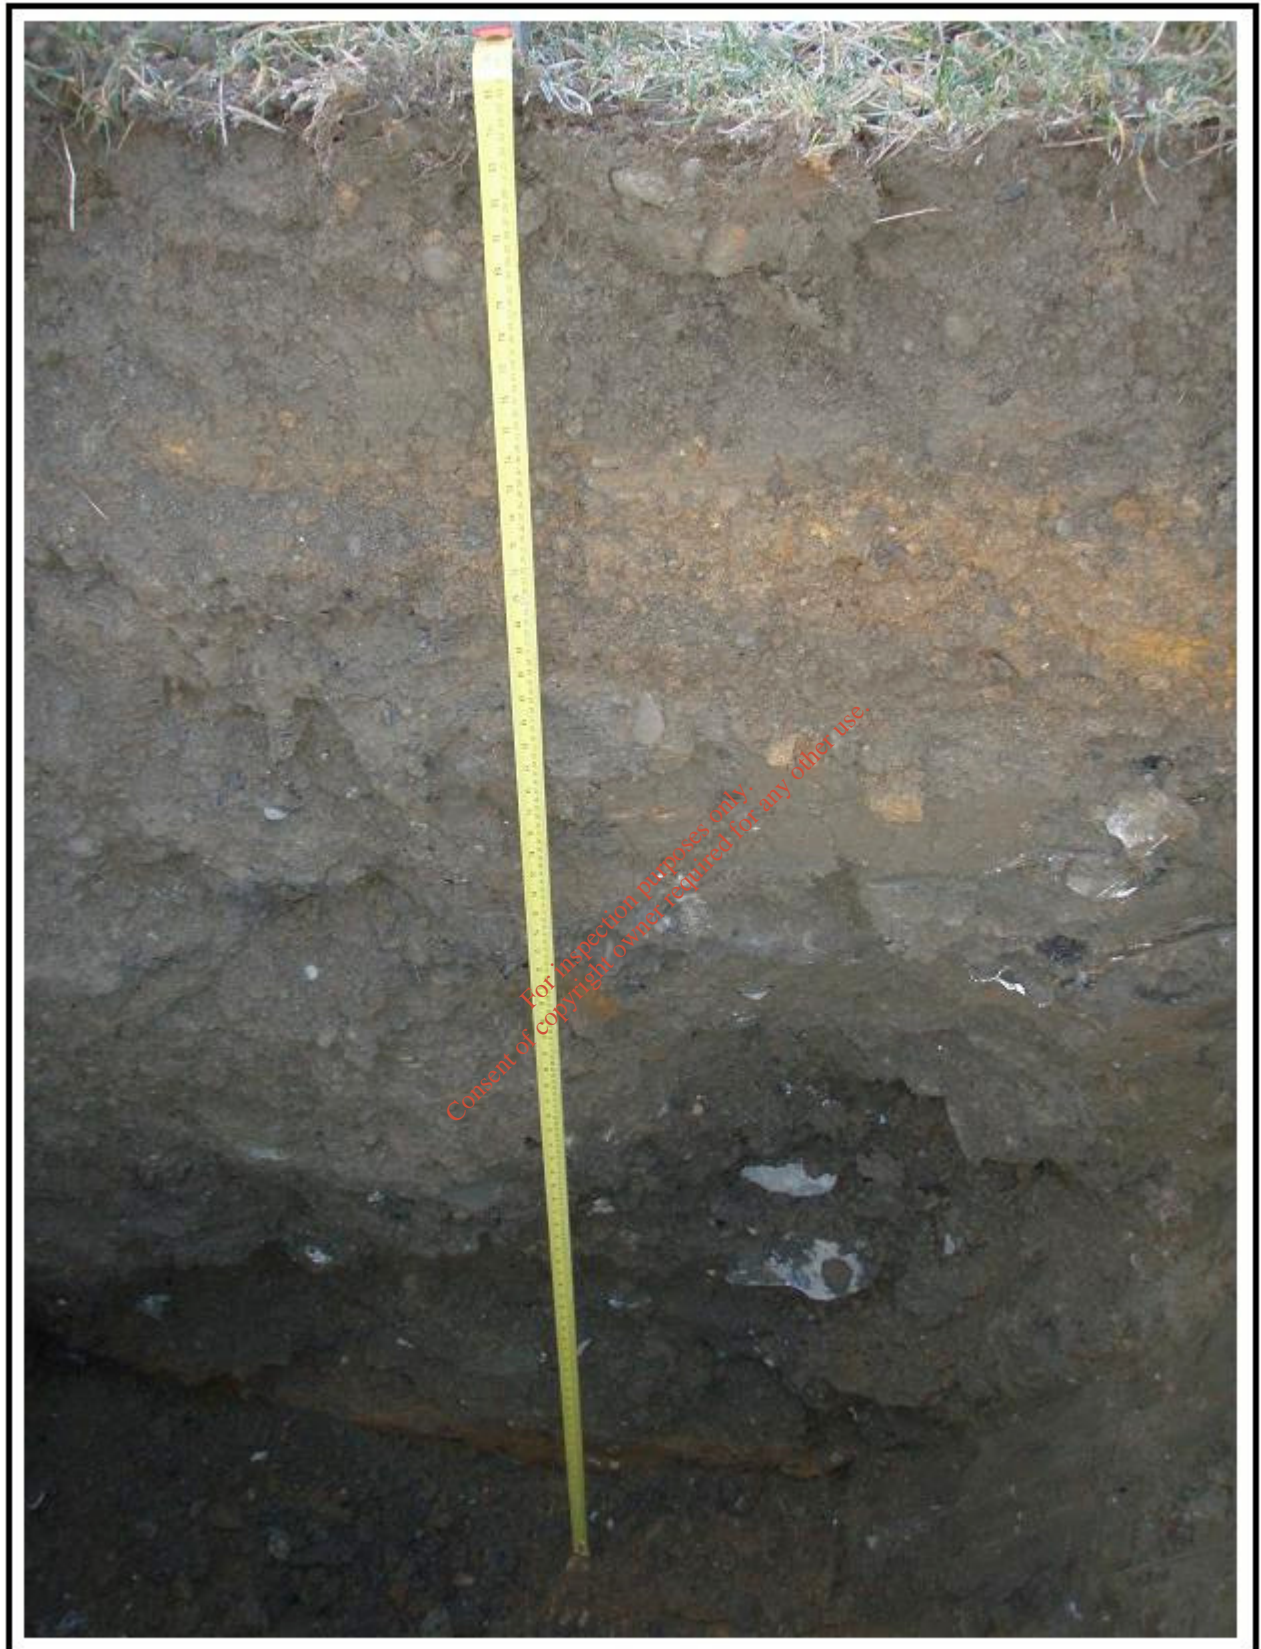
Plate A1: Profile of deep topsoil overlying subsoil in trial hole no. 1. See the absence of waste material from the profile and the well aerated nature of the material, with no groundwater seepages throughout the profile.

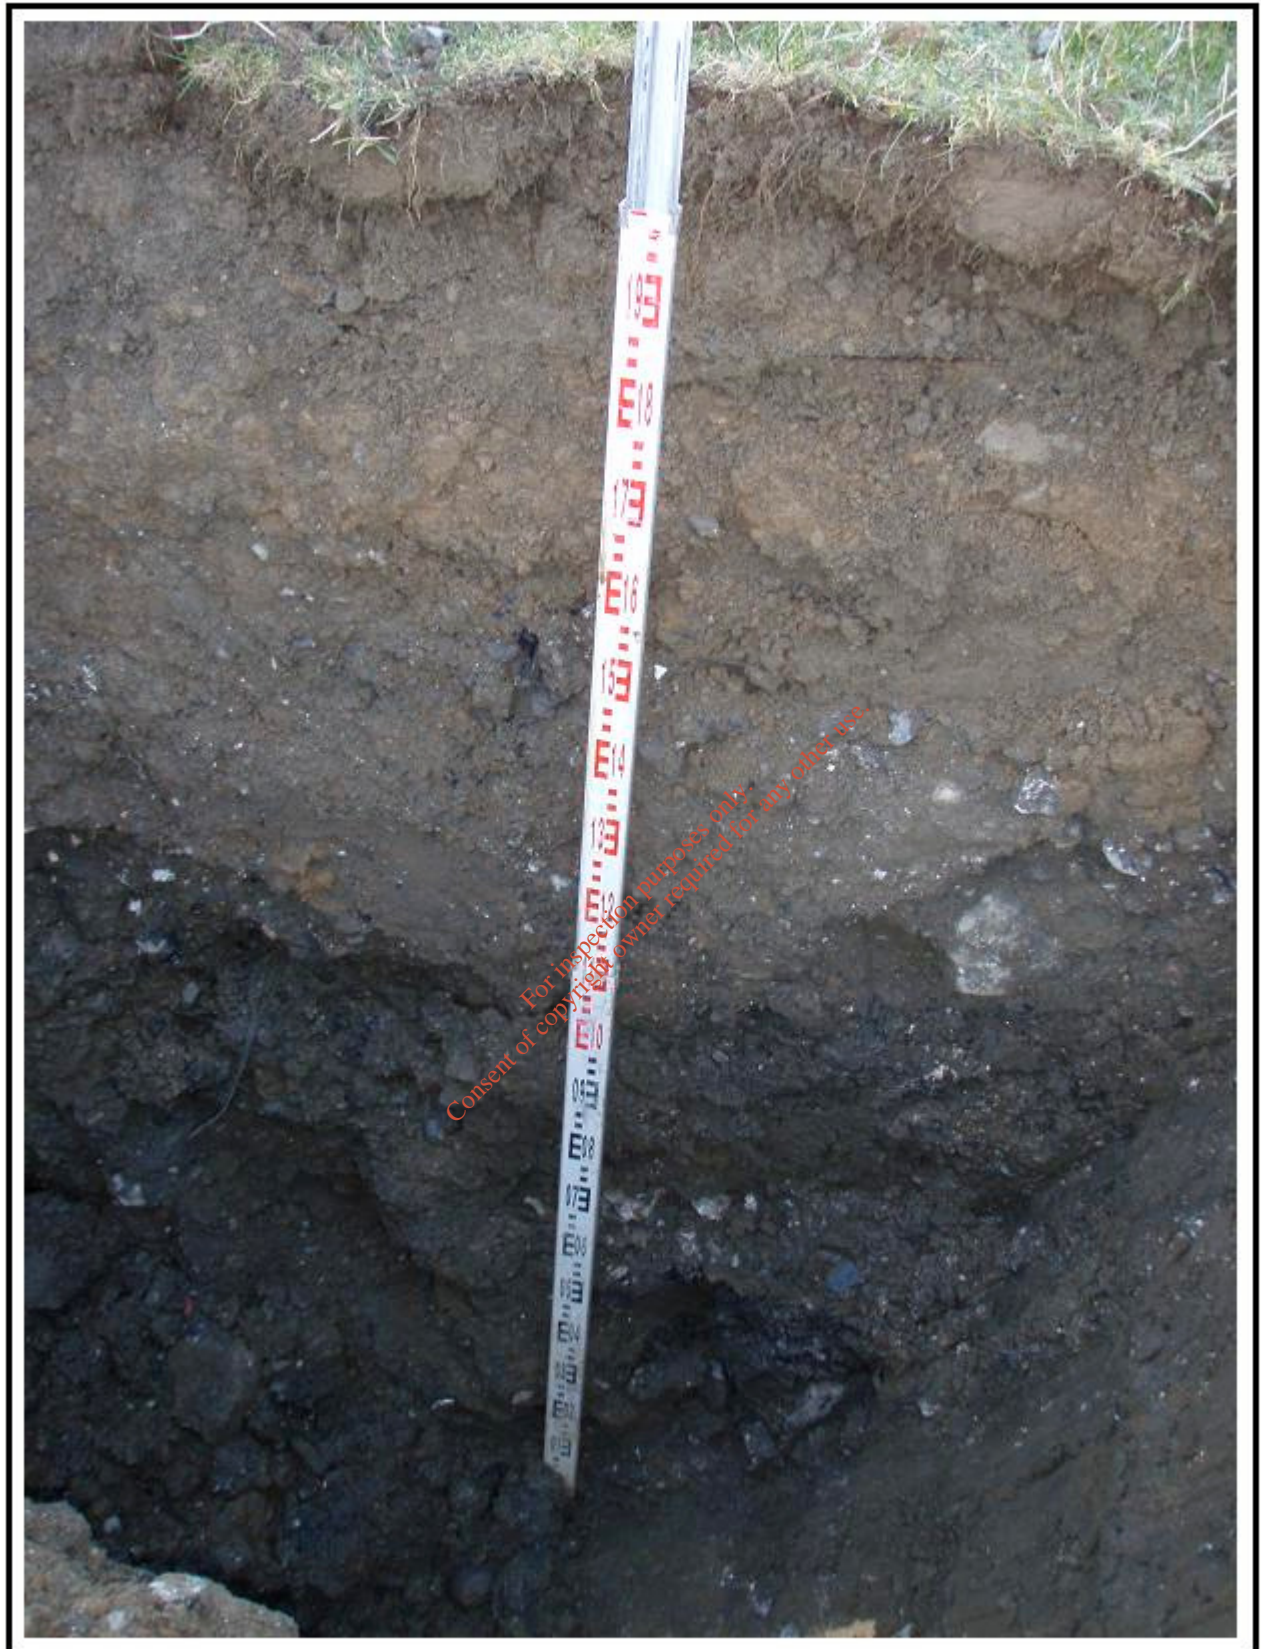
Plate A2: Profile of topsoil overlying subsoil in trial hole no. 2. See the general absence of waste material from the profile and the well aerated nature of the material, with one slight groundwater seepage at 1.05m depth.

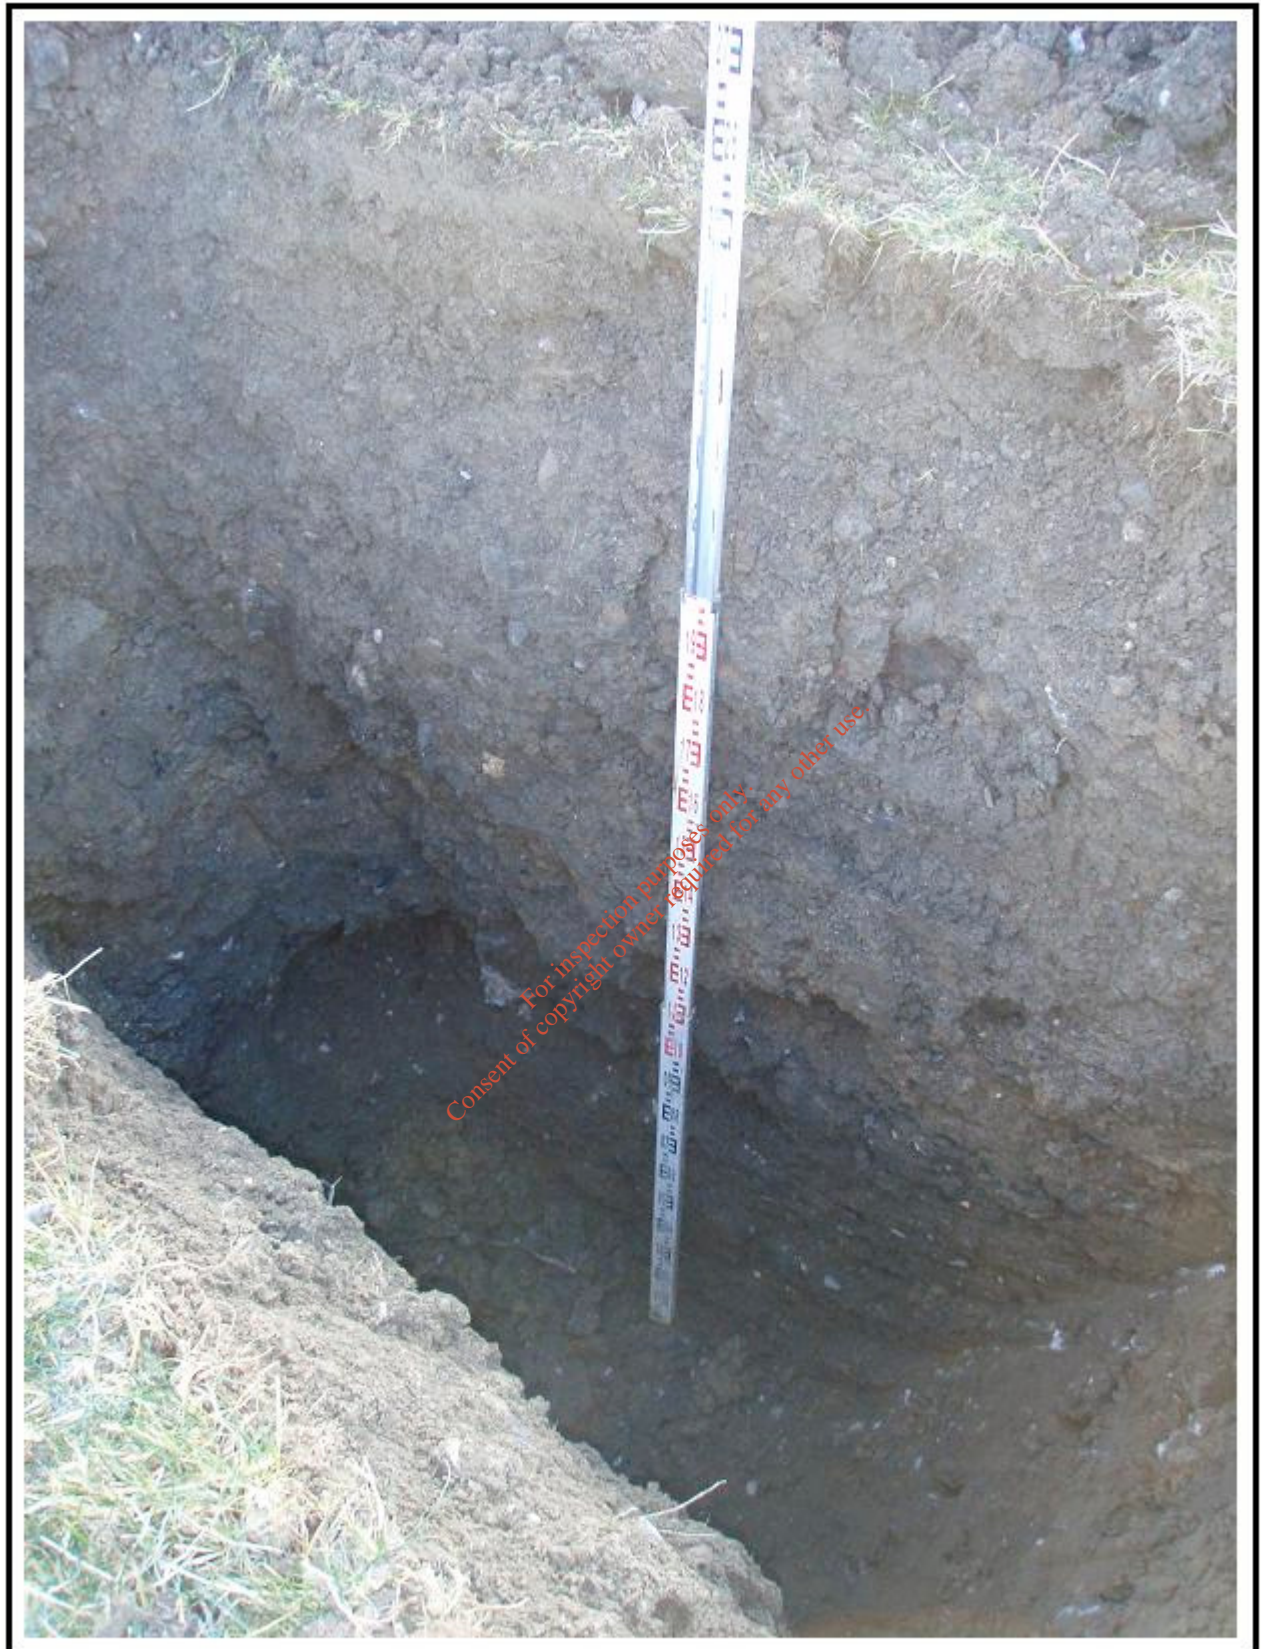
Plate A3: Profile of shallow soil overlying subsoil in trial hole no. 3. See the occasional pieces of concrete in the basal area of the profile and the well aerated nature of the material, with no groundwater seepages recorded to 2.5m depth.

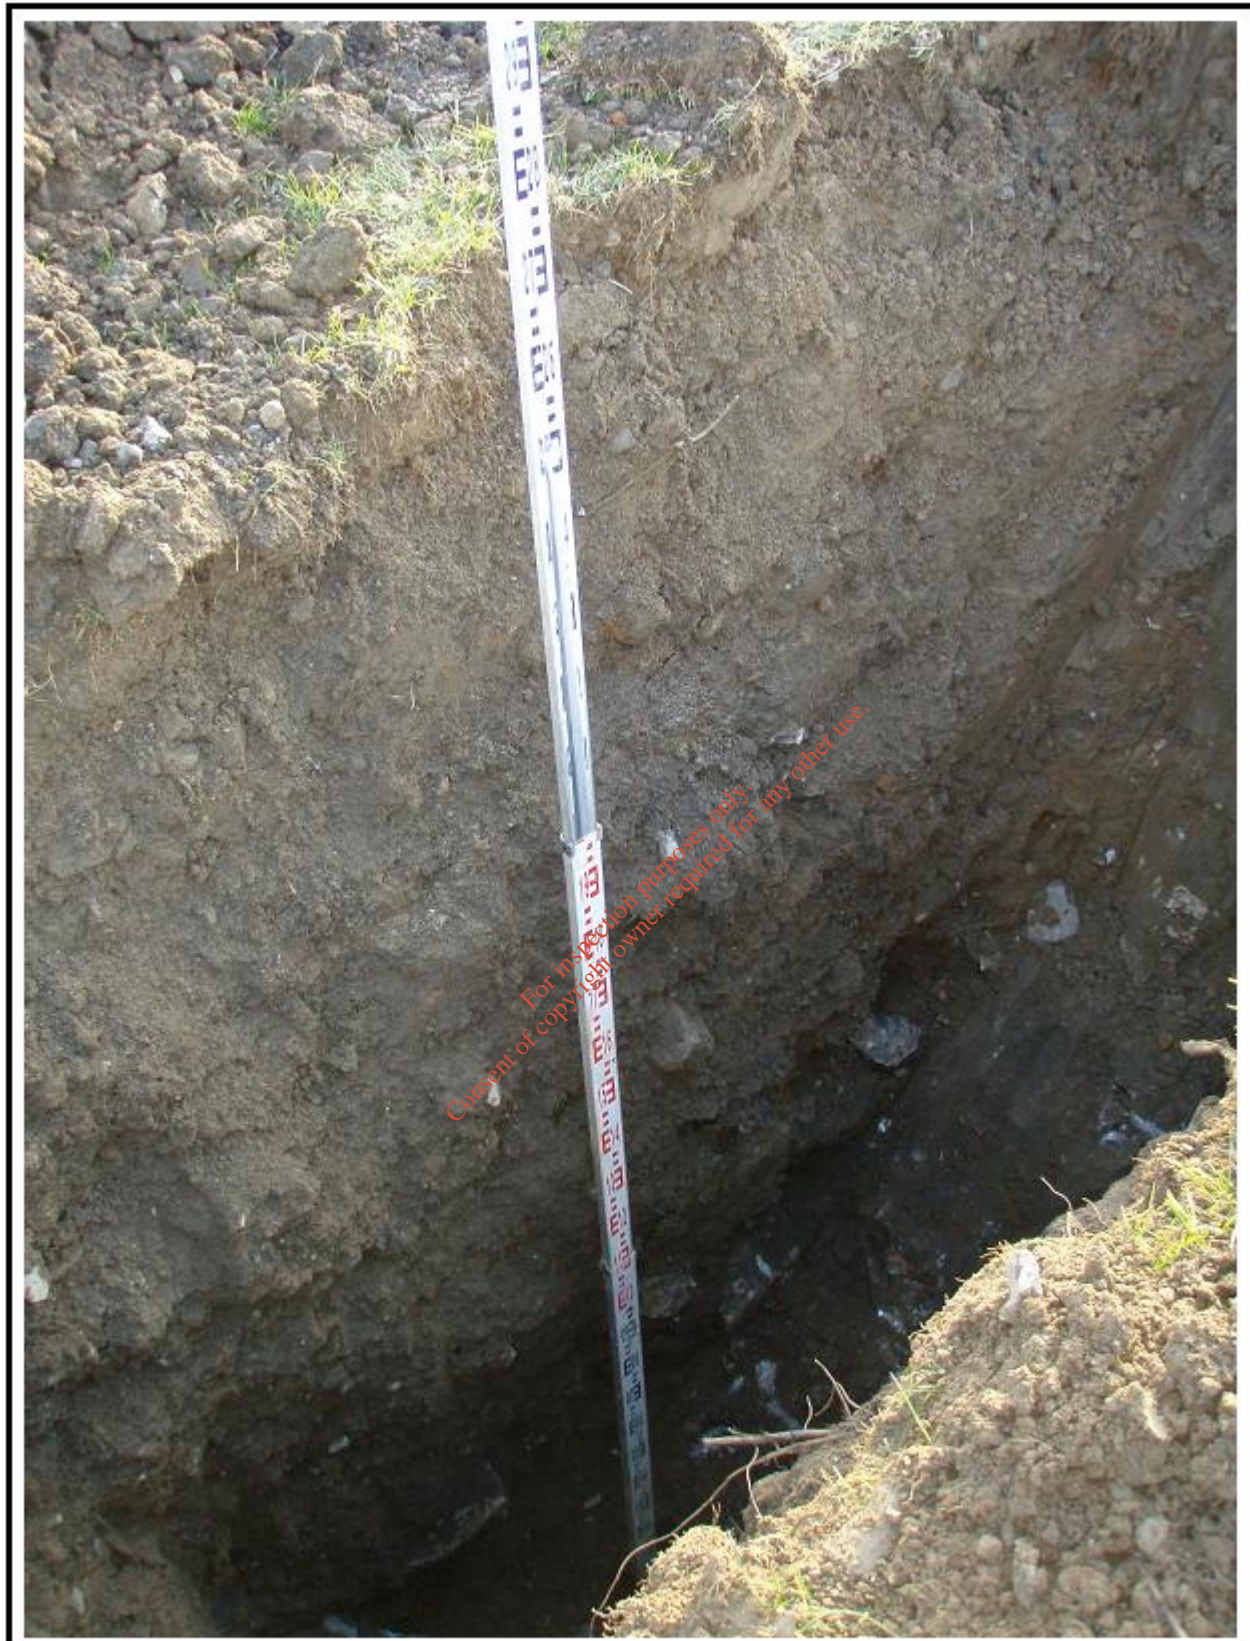
Plate A4: Profile of deep topsoil overlying subsoil in trial hole no. 4. See the concrete piece in the basal area of the profile and the well aerated nature of the material, with no groundwater seepages recorded to 2.5m depth.

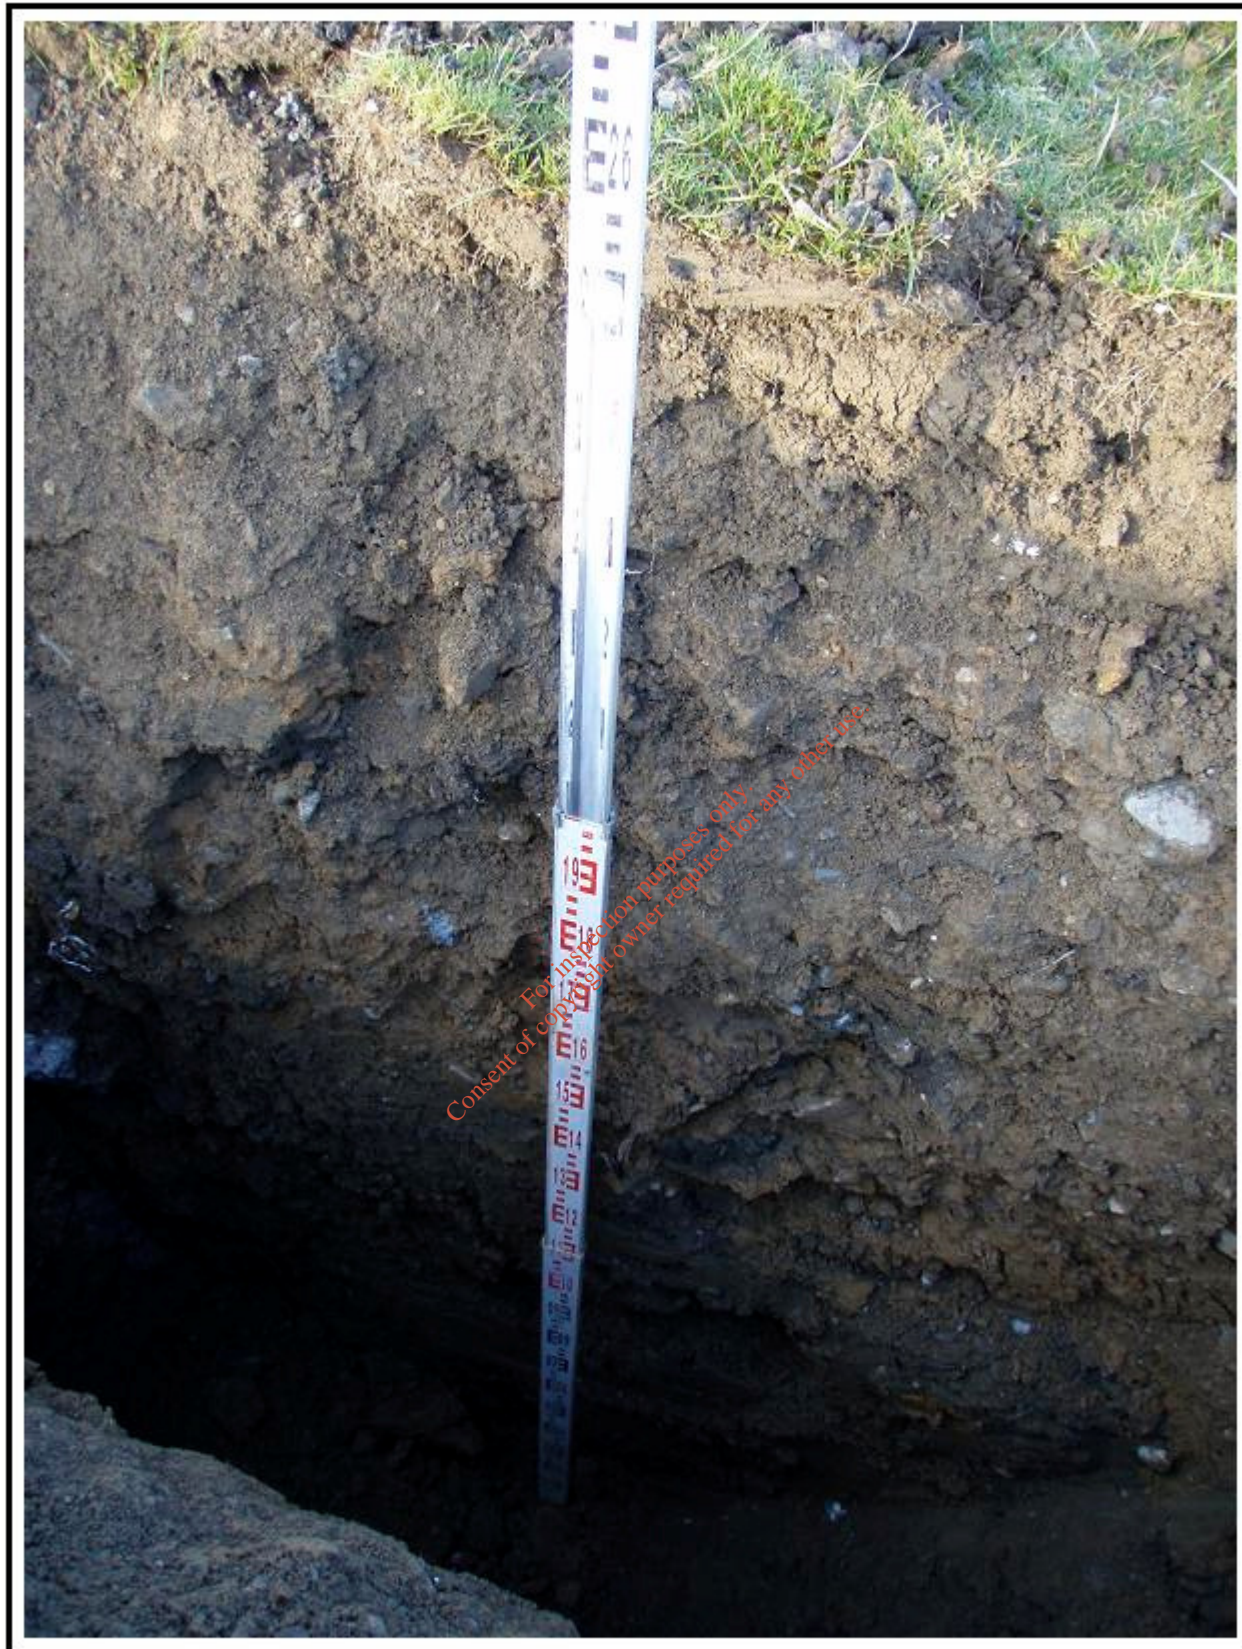
Plate A5: Profile of shallow topsoil overlying subsoil in trial hole no. 5. See the occasional concrete pieces and fragments of steel within the profile and the well aerated nature of the material, with no groundwater seepages recorded to 2.47m depth.

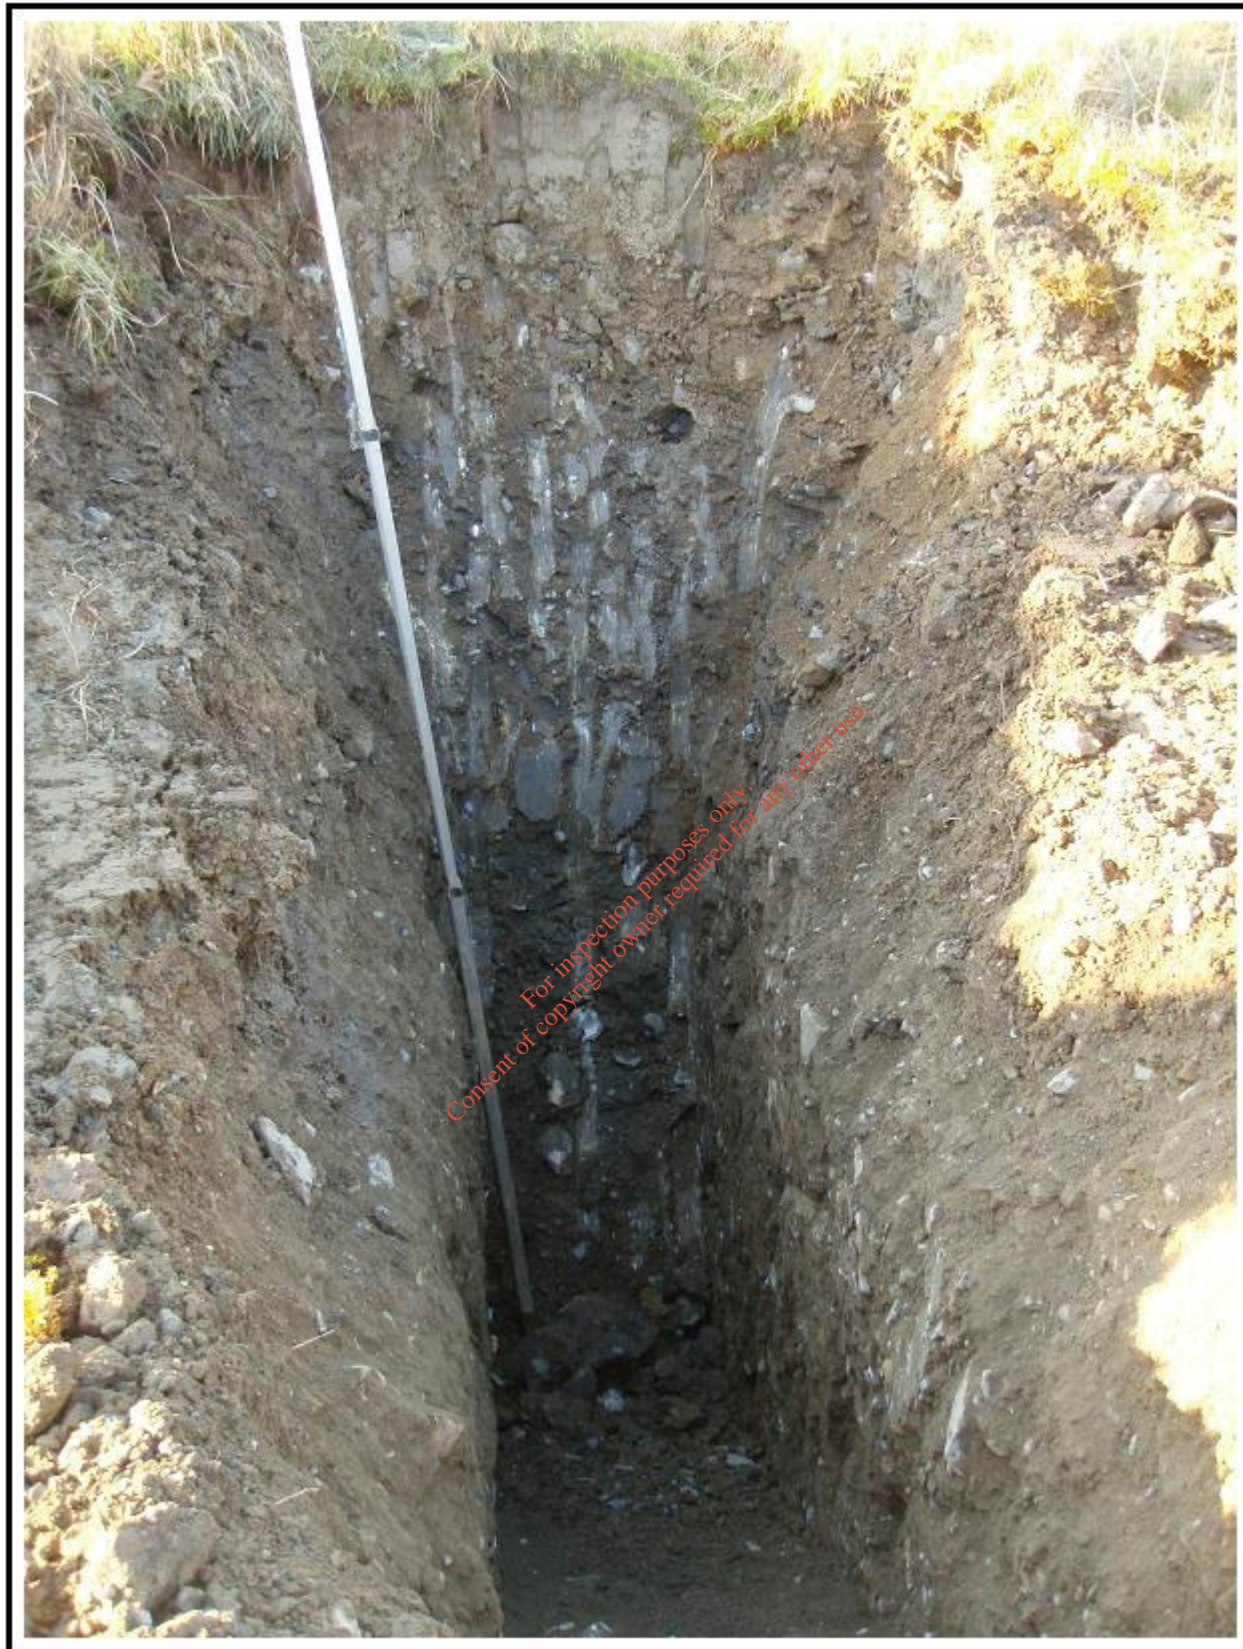
Plate A6: Profile of shallow topsoil overlying subsoil in trial hole no. 6. Surprisingly, given the low elevation, this hole was dry. See the complete absence of waste material in the clean *in situ* subsoil, with no groundwater seepages recorded to 2.8m depth.

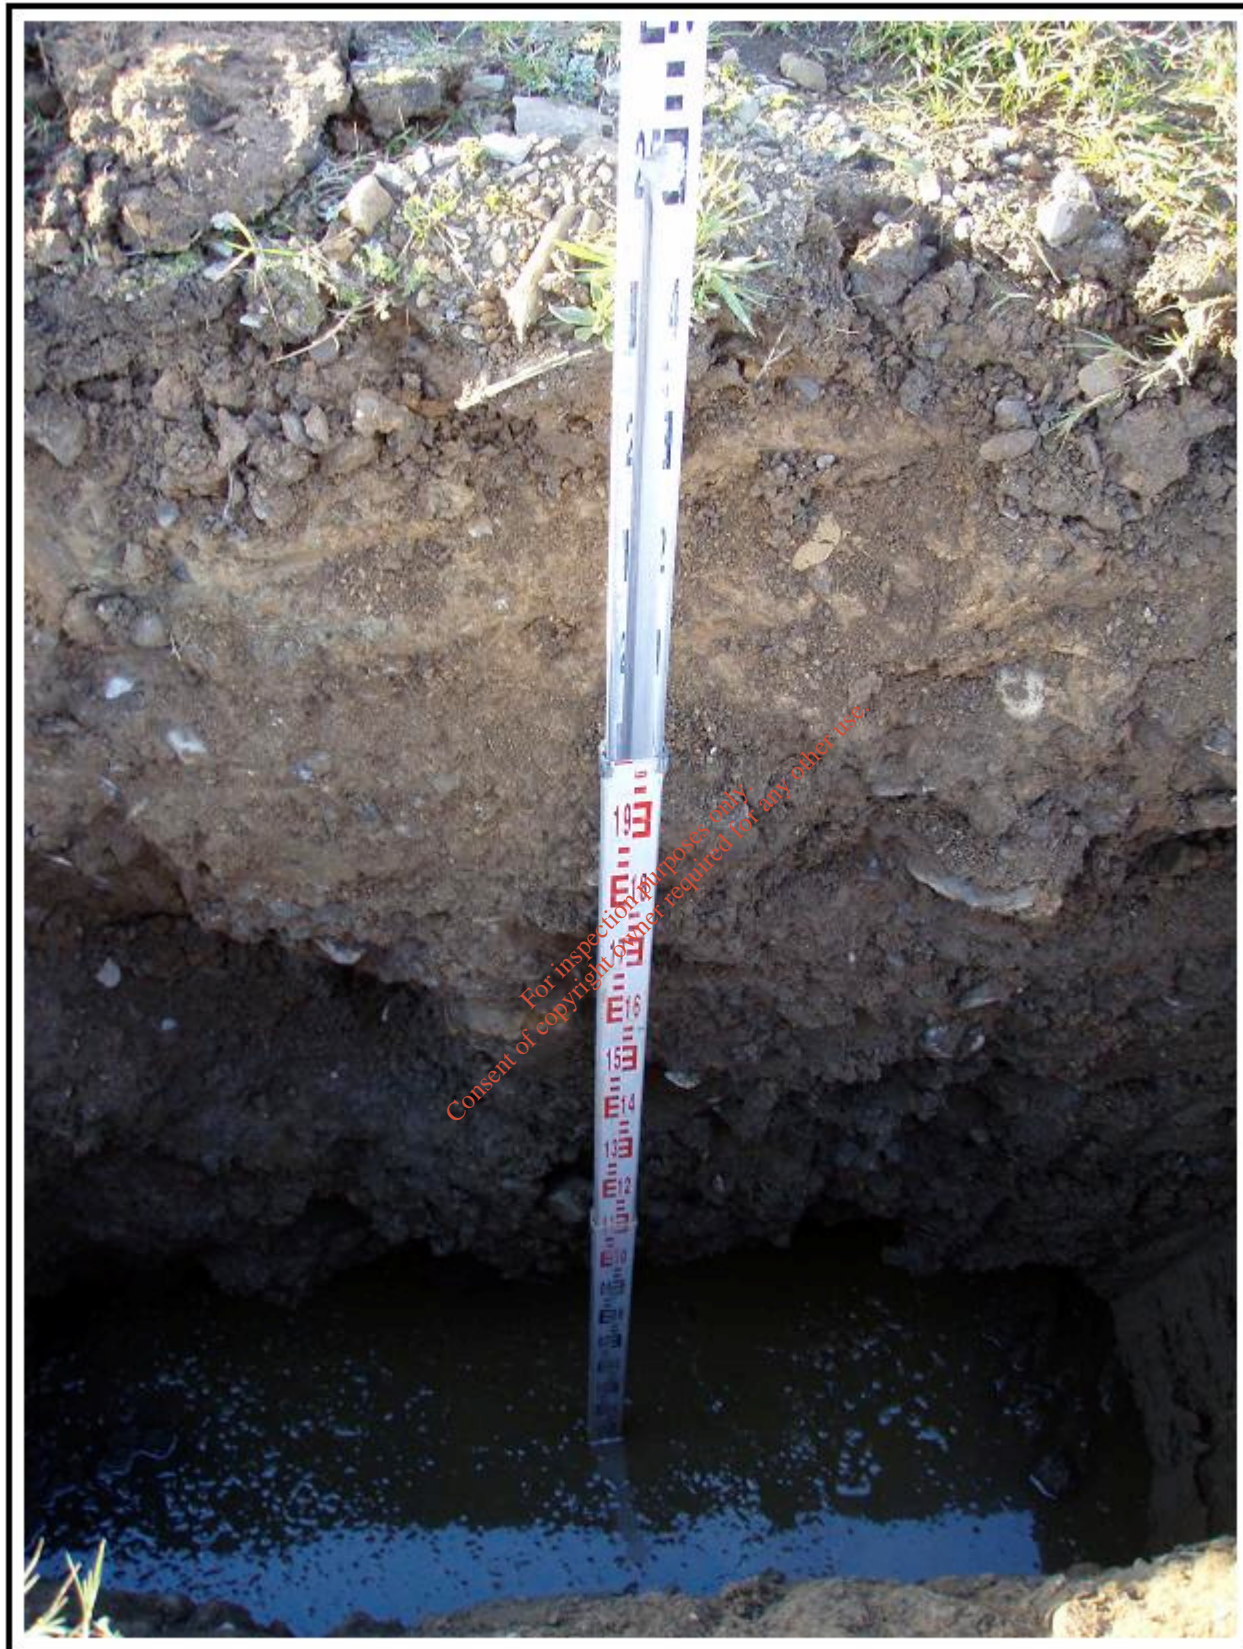
Plate A7: Profile of shallow topsoil overlying subsoil in trial hole no. 7. The water table seeps into this hole and rests at 2.04m depth below surface. See the complete absence of waste material and the preponderance of 'clean' imported subsoil here.

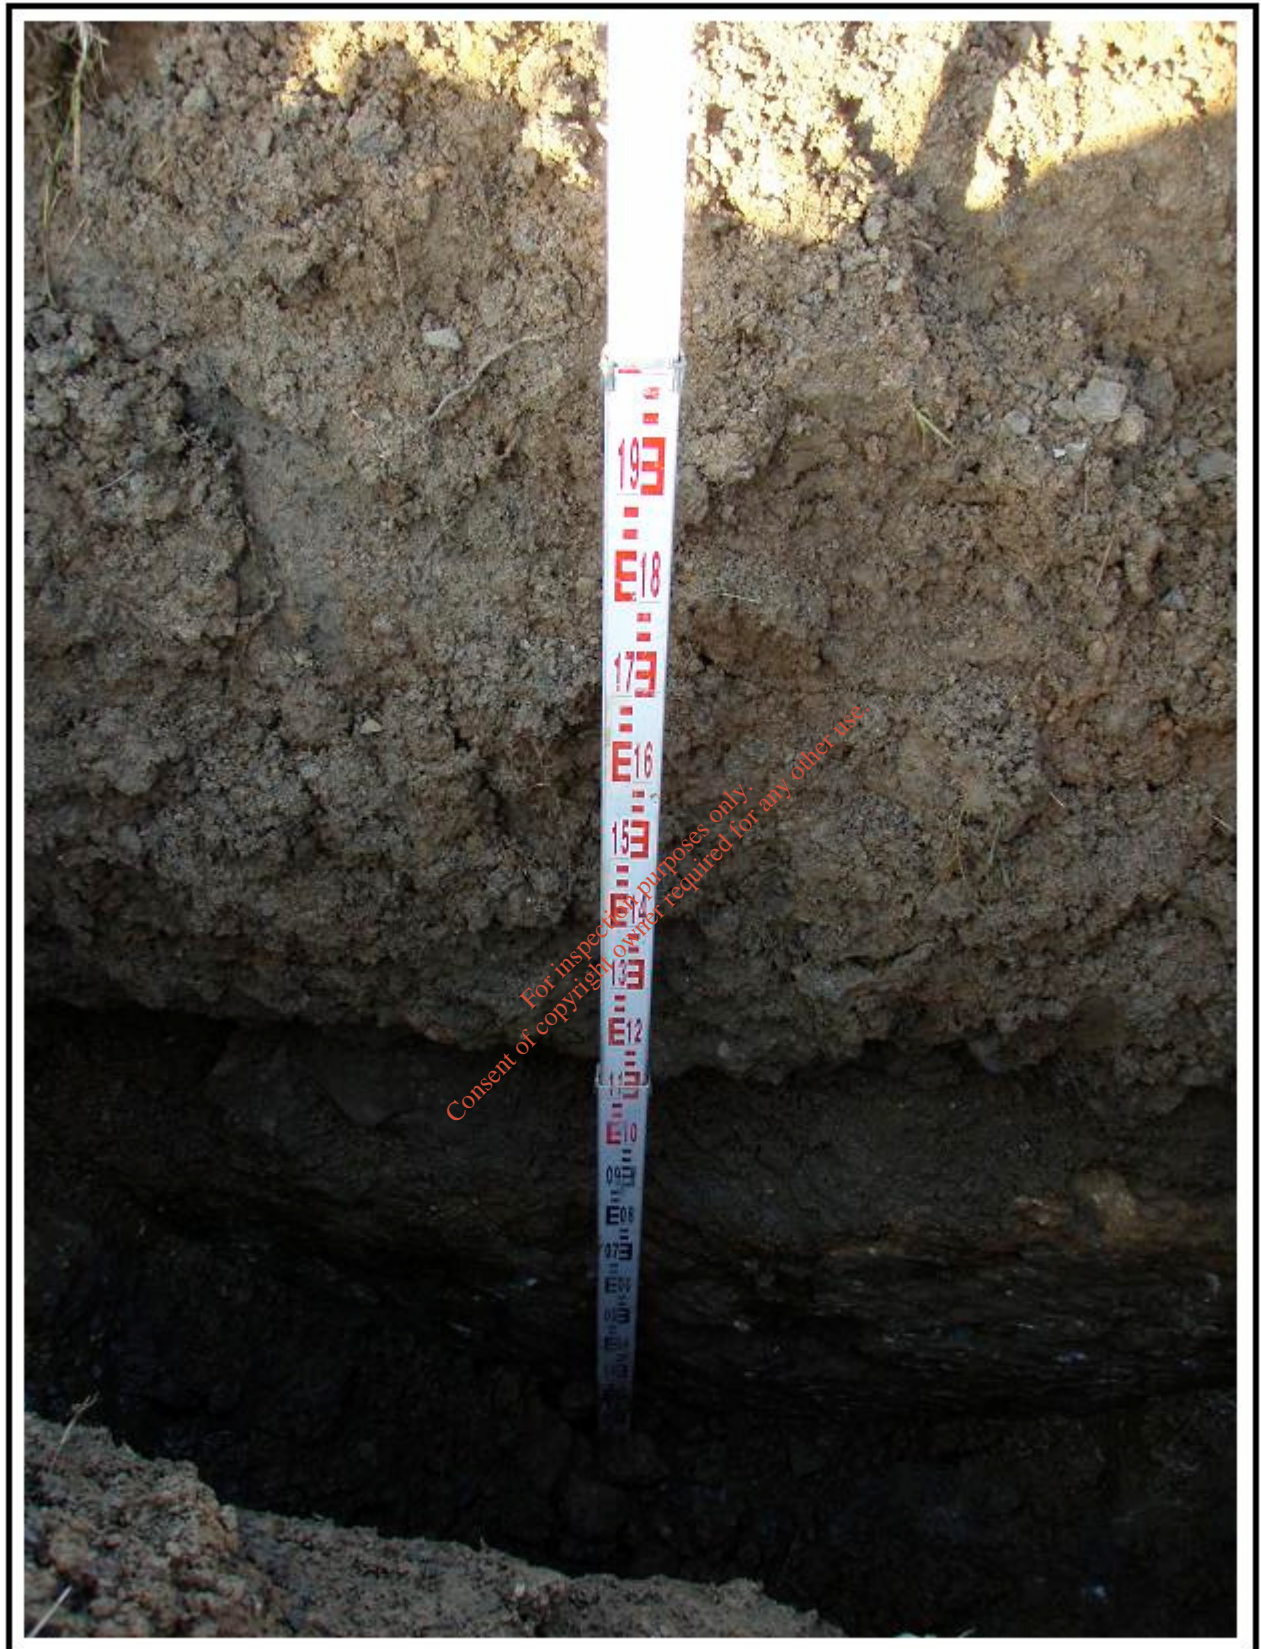
Plate A8: Profile of deep topsoil overlying 2 no. subsoil units in trial hole no. 8. Though initially dry, some groundwater seeps into this hole at depths below 1.0m below surface. See again the complete absence of waste material in the imported, uppermost subsoil units, and the *in situ* subsoil underneath.

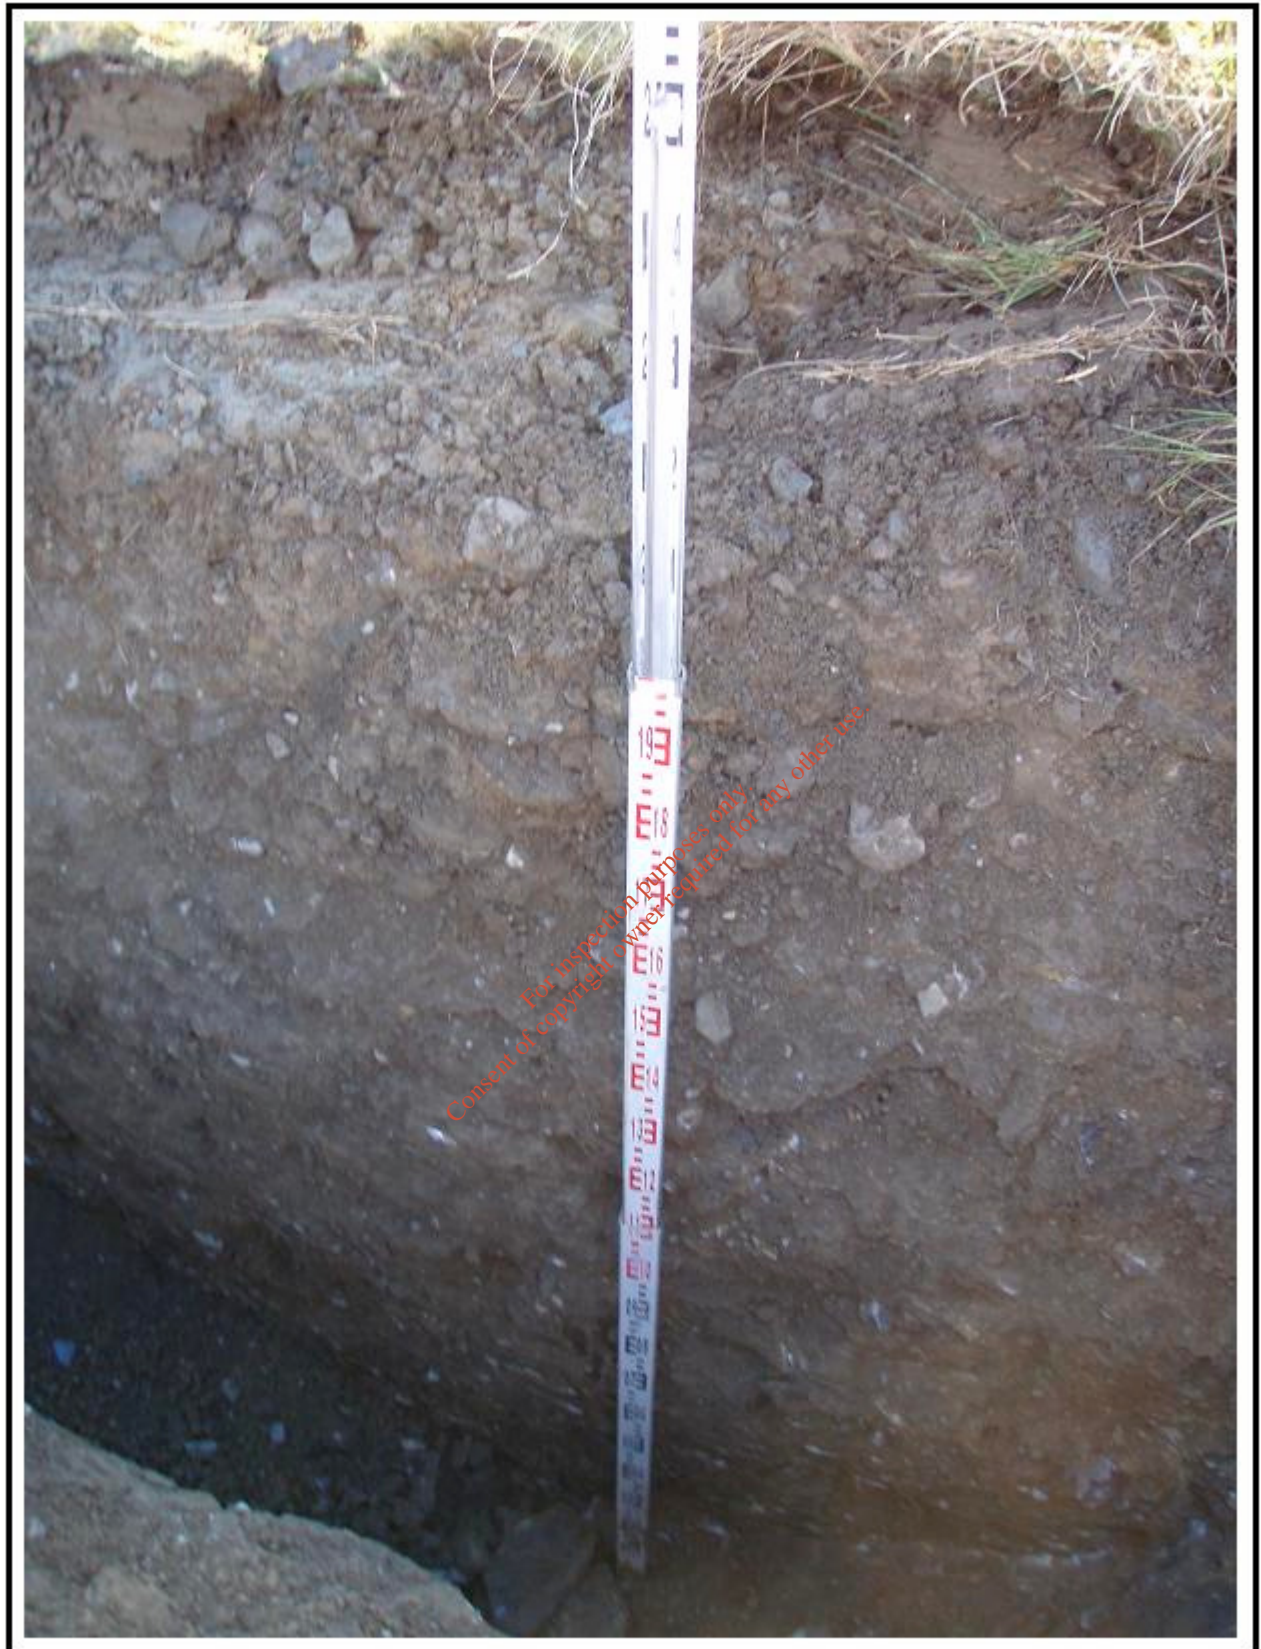
Plate A9: Profile of relatively shallow topsoil overlying overconsolidated, very stiff to hard subsoil in trial hole no. 9. See again the complete absence of waste material in the clean *in situ* subsoil here also. The topsoil is of very poor quality and may actually comprise mostly CLAY subsoil. The hole was dry to 2.2m depth.

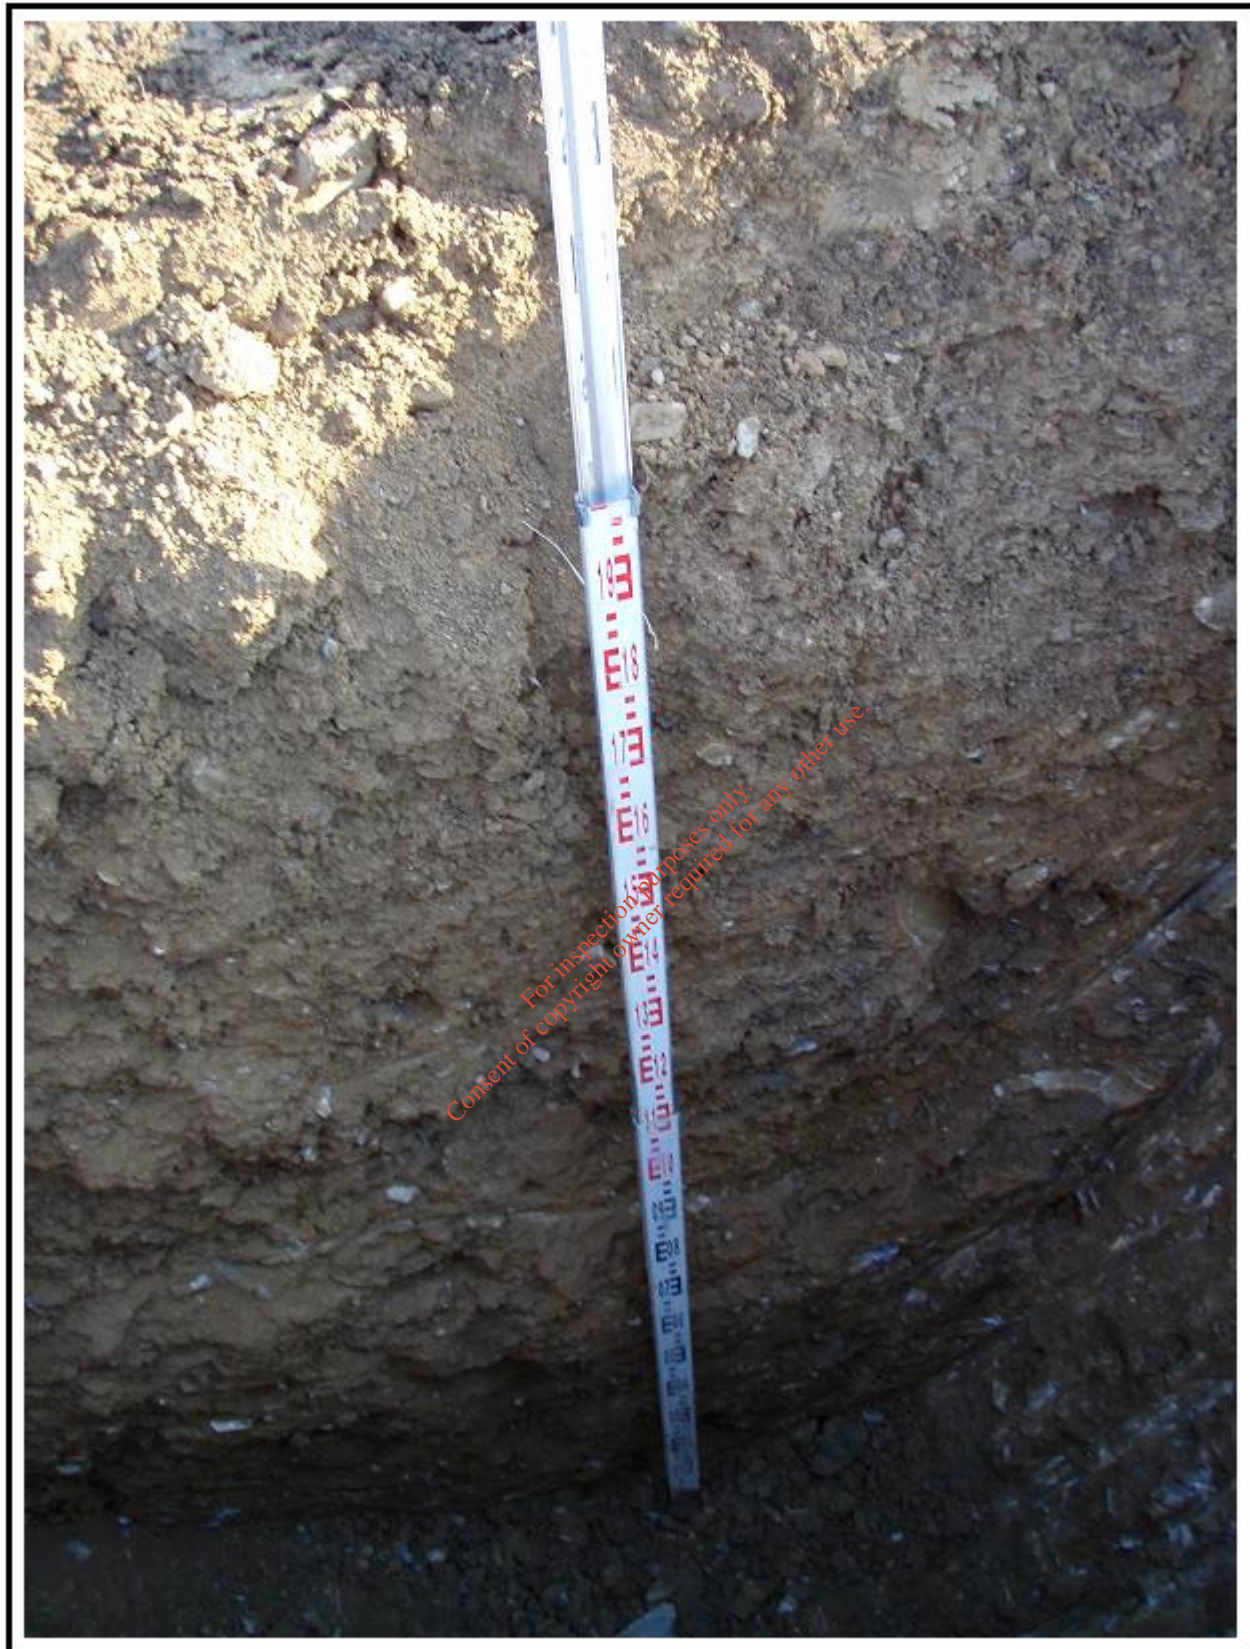
Plate A10: Profile of relatively shallow topsoil overlying overconsolidated, very stiff to hard subsoil in trial hole no. 10. See again the complete absence of waste material in this *in situ* subsoil material. The topsoil is of slightly better quality here and the subsoil is slightly more aerated. The hole was dry to 2.25m depth.
