ASSESSMENT OF FILLED SUBSOILS FOR WASTE LICENCE APPLICATION AT NAUL, COUNTY MEATH

**ASSESSMENT OF FILLED SUBSOILS FOR WASTE LICENCE APPLICATION
AT
NAUL, COUNTY MEATH**

FINAL REPORT

Report Title: Assessment of filled subsoils for Waste Licence Application at Naul, County Meath

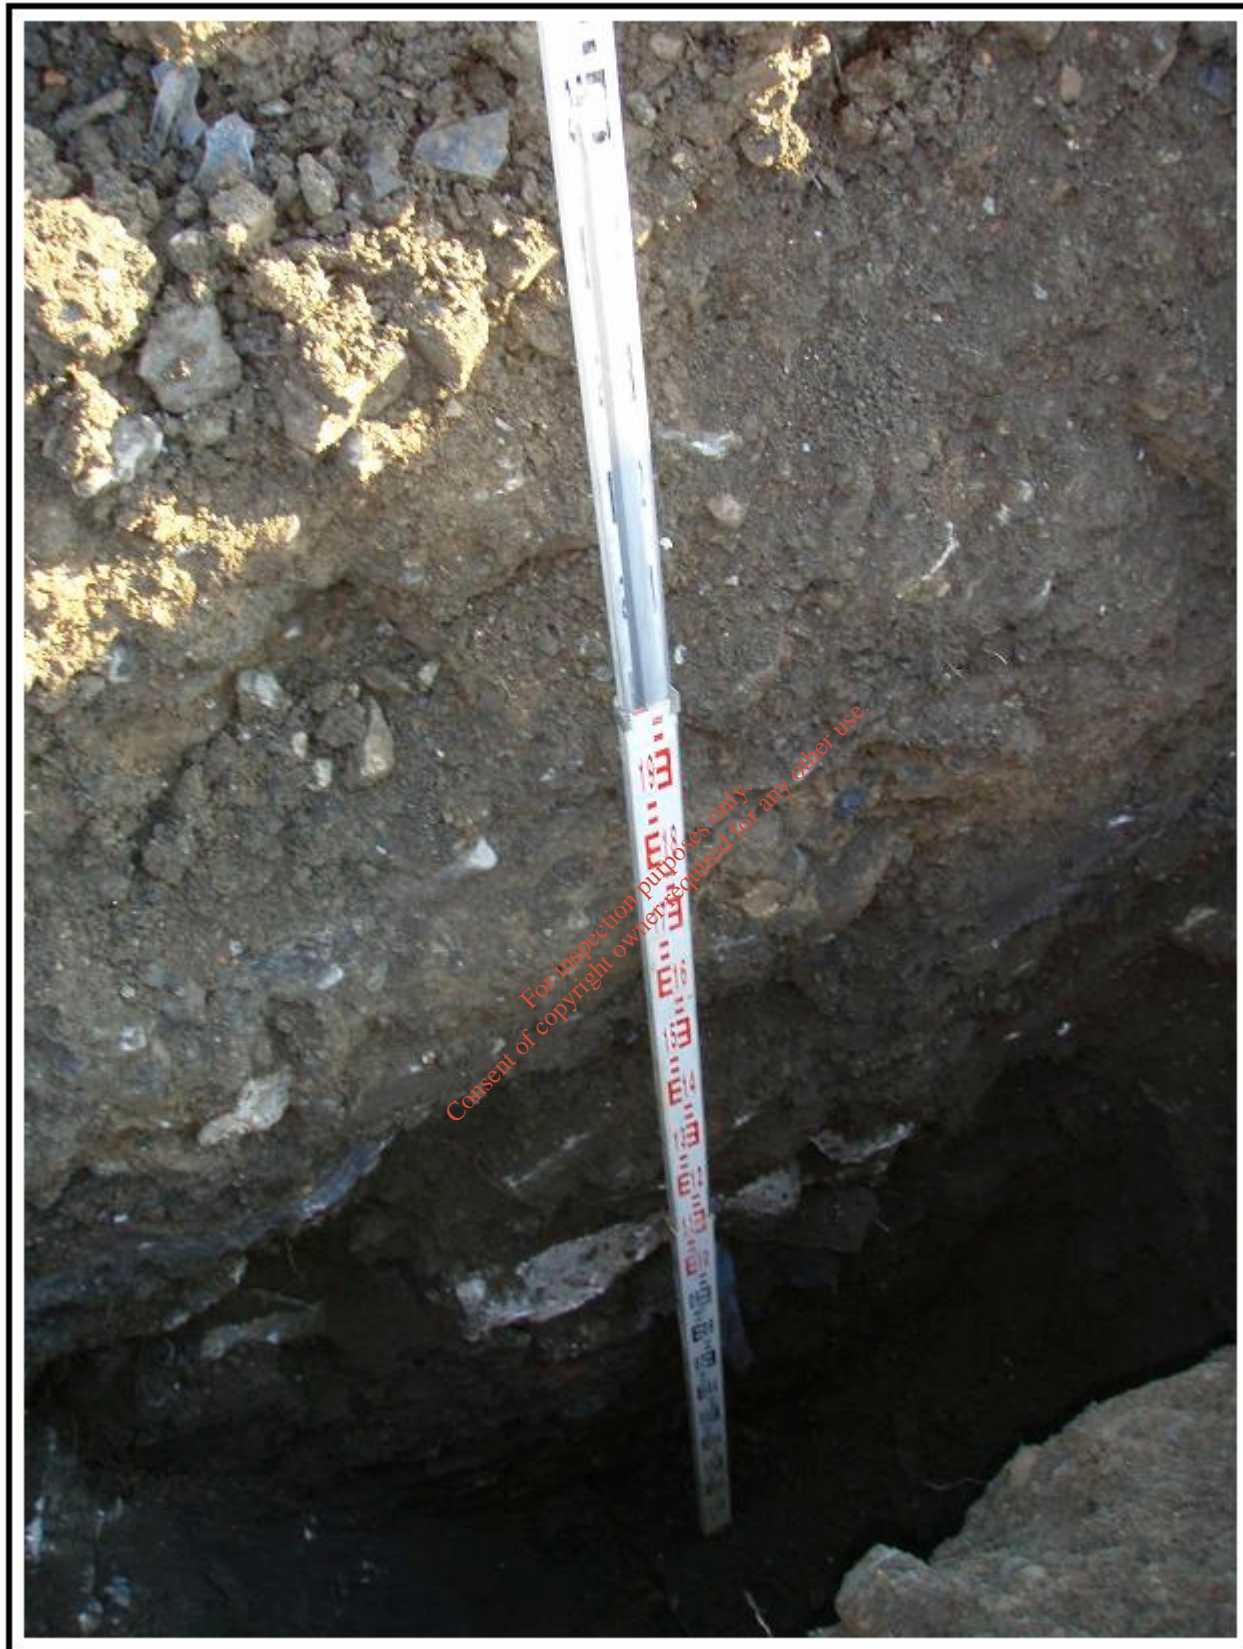
Plate A11: Profile of overconsolidated subsoil with alternating layers of very soft to stiff material in trial hole no. 11. Here some buried pieces of concrete are seen at depth. No topsoil has been emplaced above this material as of yet, and the ground is bare.

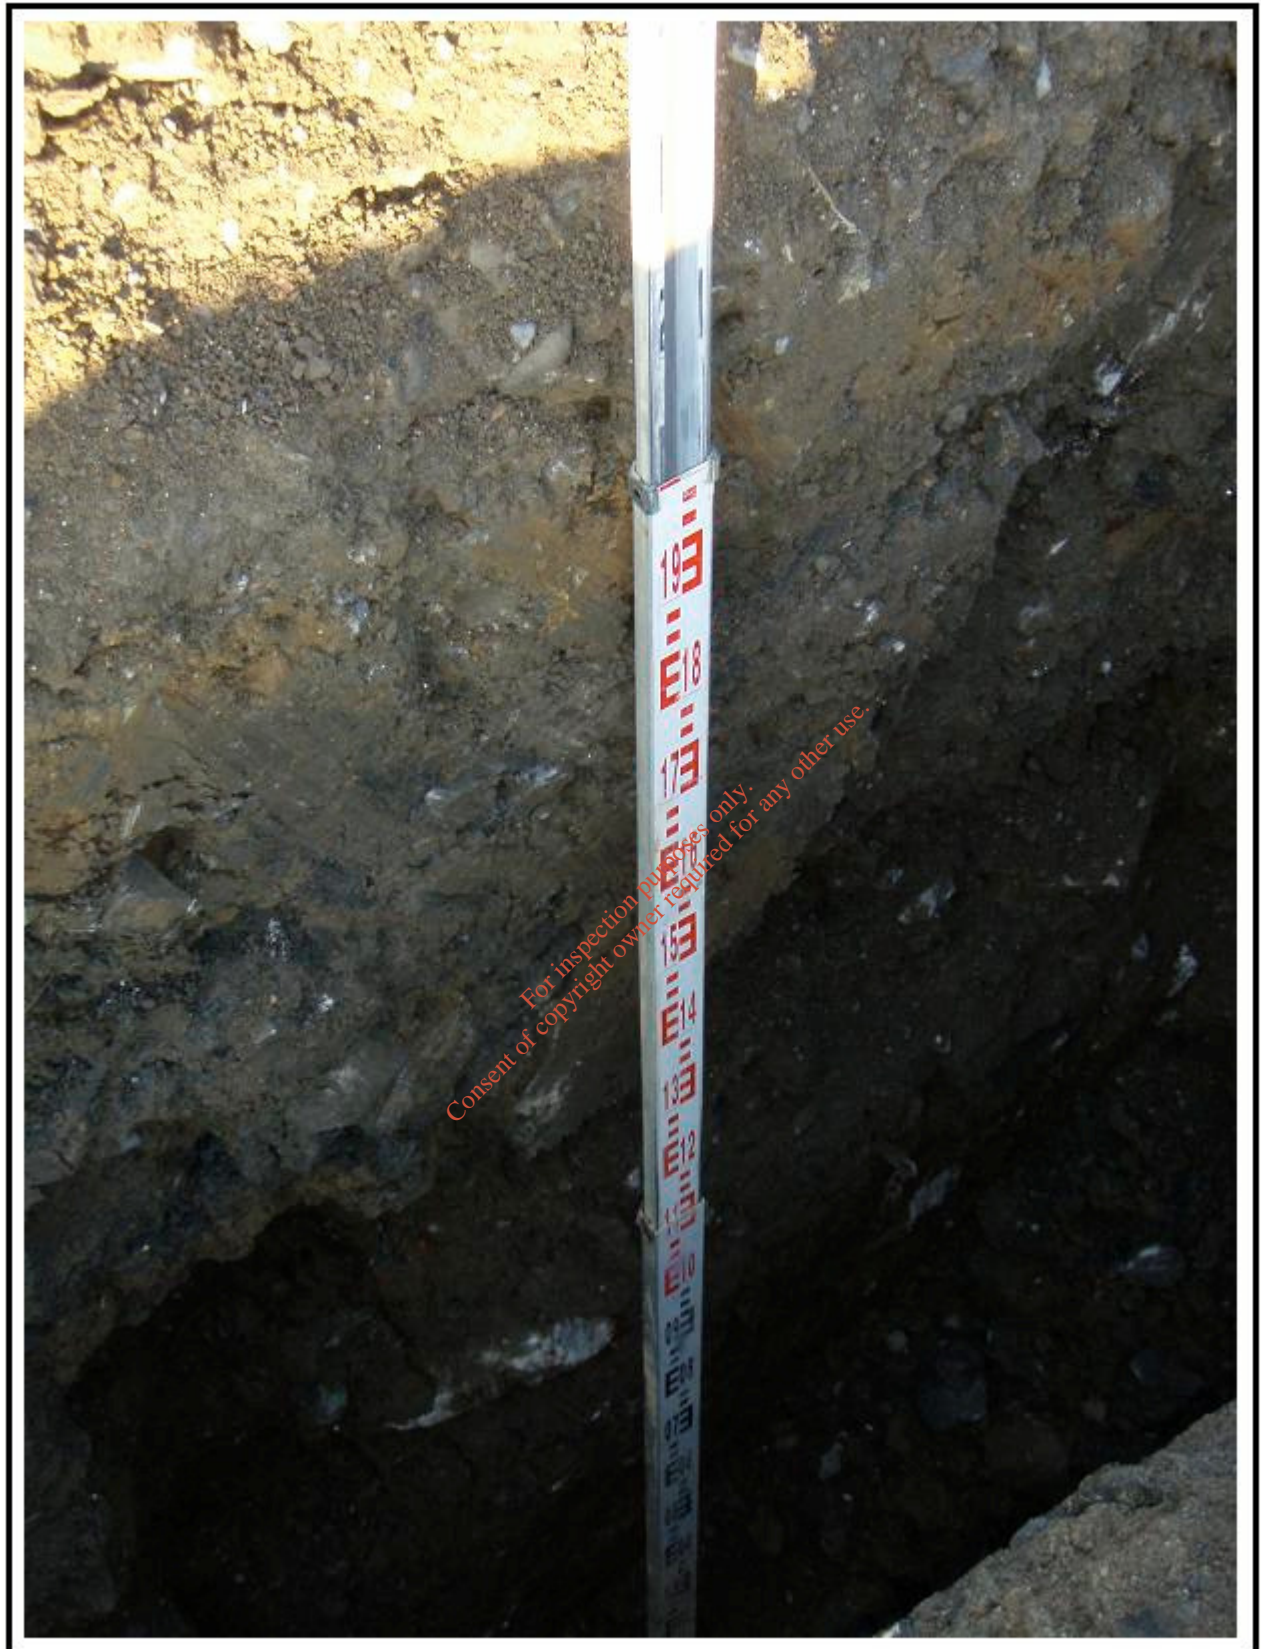
Plate A12: Profile of overconsolidated subsoil with alternating layers of very soft to stiff material in trial hole no. 12. Here also some buried pieces of concrete are seen at depth. No topsoil has been emplaced above this material as of yet, and the ground is bare.

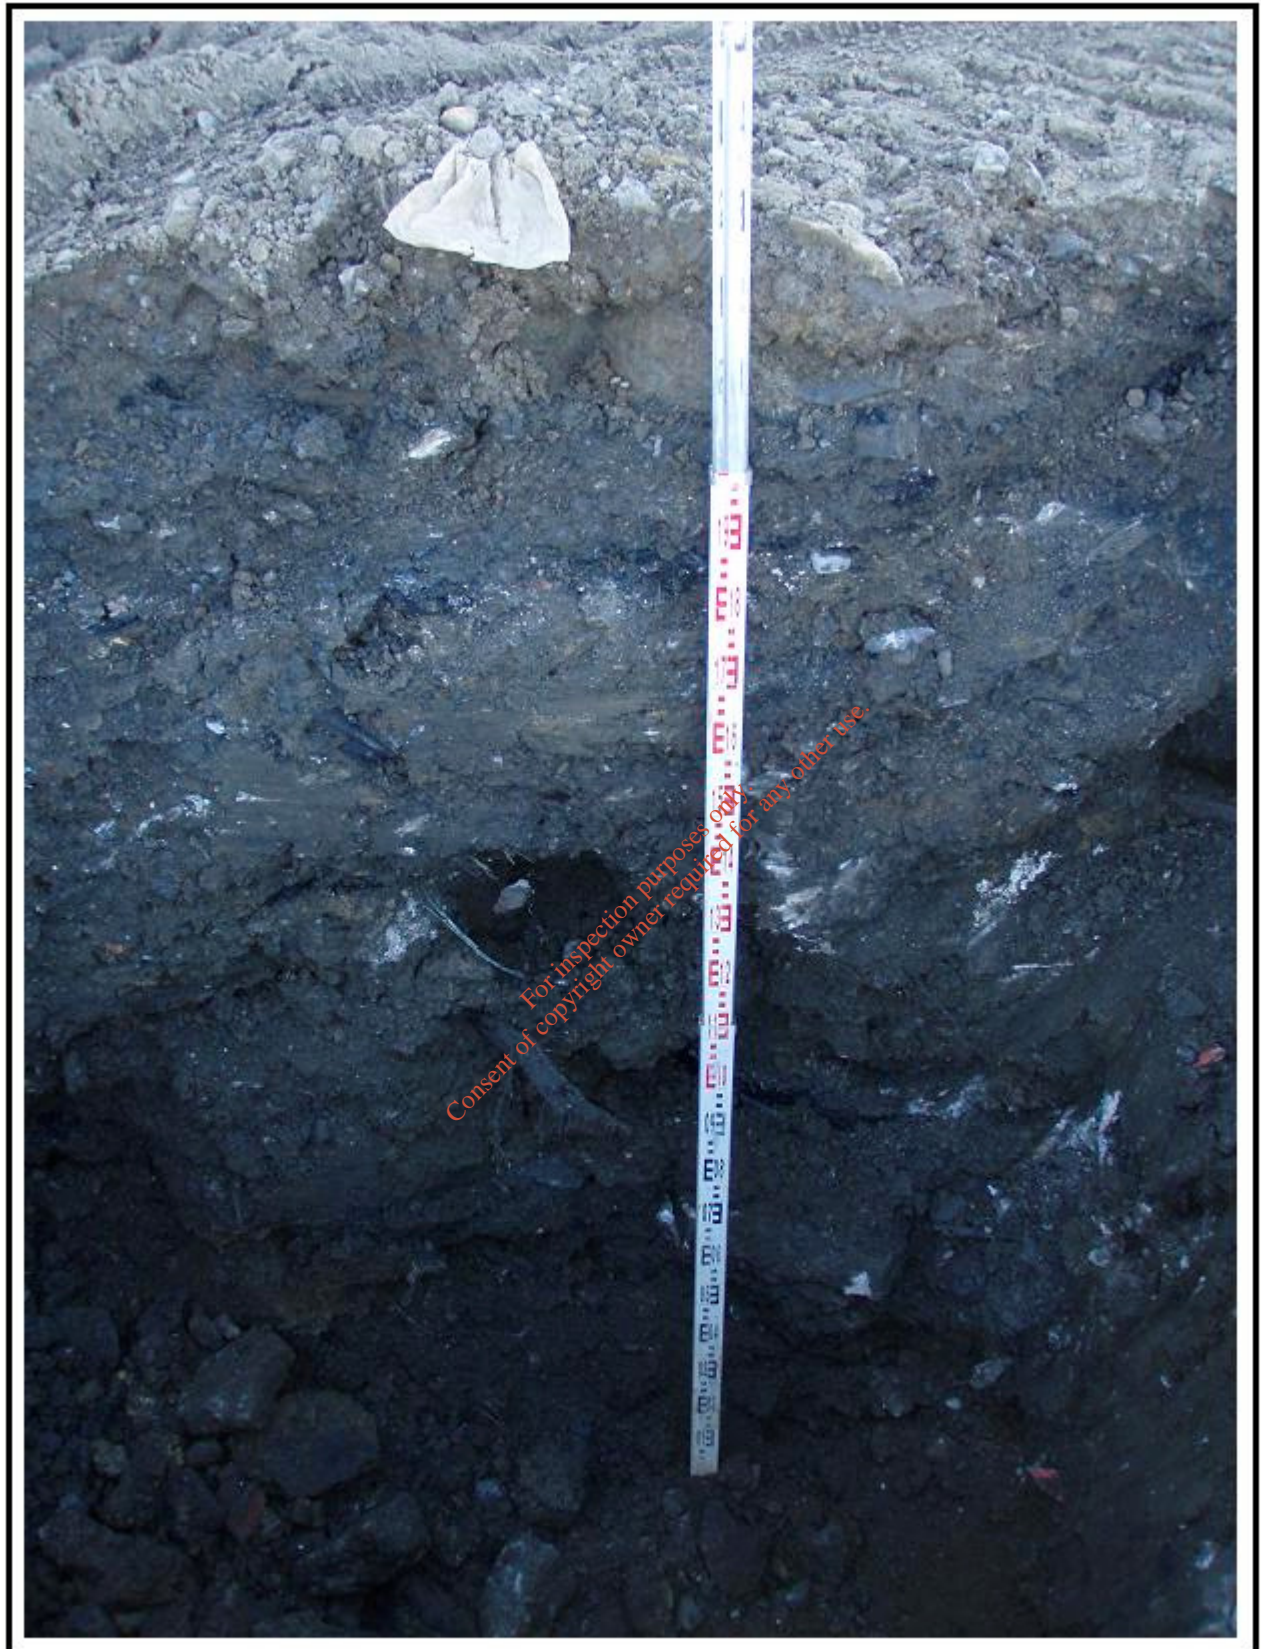
Plate A13: Profile of overconsolidated subsoil with alternating layers of very soft to stiff material in trial hole no. 13. Buried pieces of concrete, wire, branches and cloth also occur. No topsoil has been emplaced above this material as of yet either, and the ground is bare.

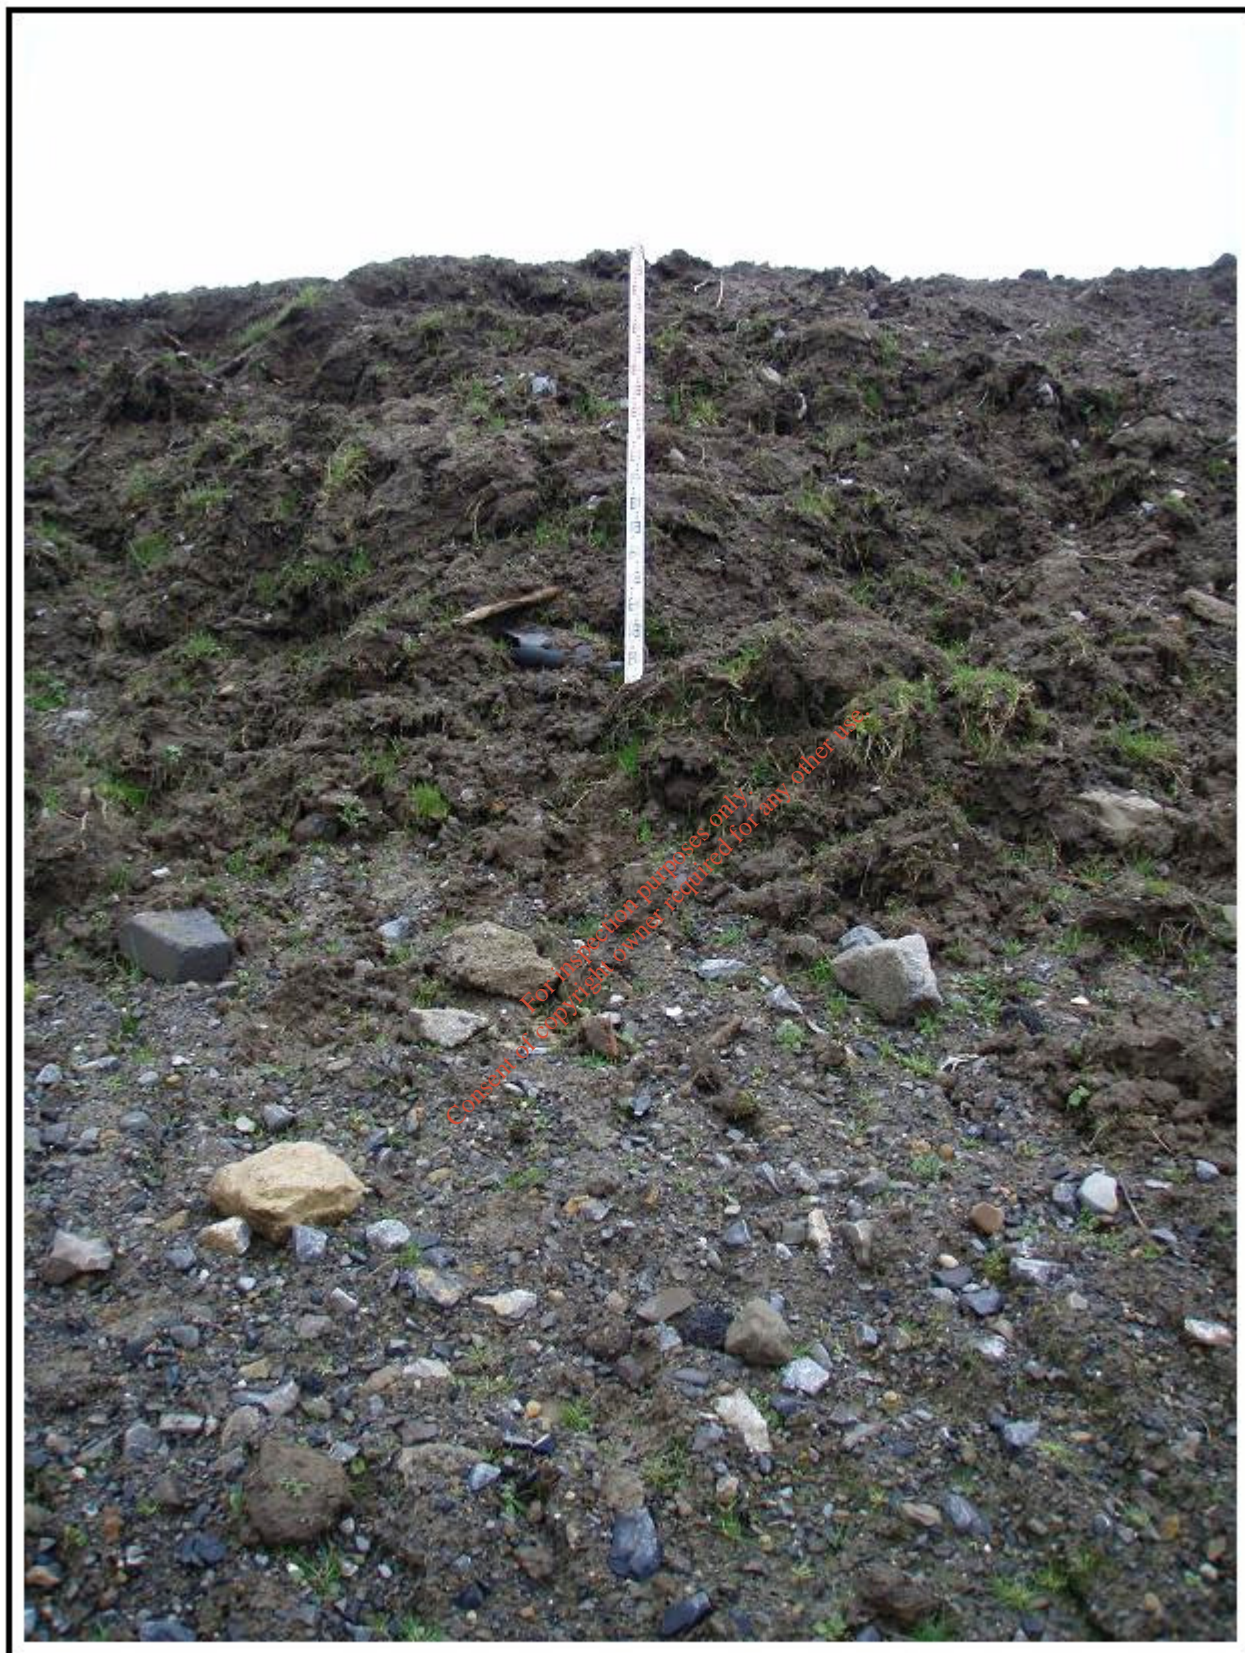
Plate A14: Profile of recently-lain topsoil overlying overconsolidated subsoil at the side of the main eastern fill area. This material is very clean with only one small portion of waste material (plastic pipe) seen.

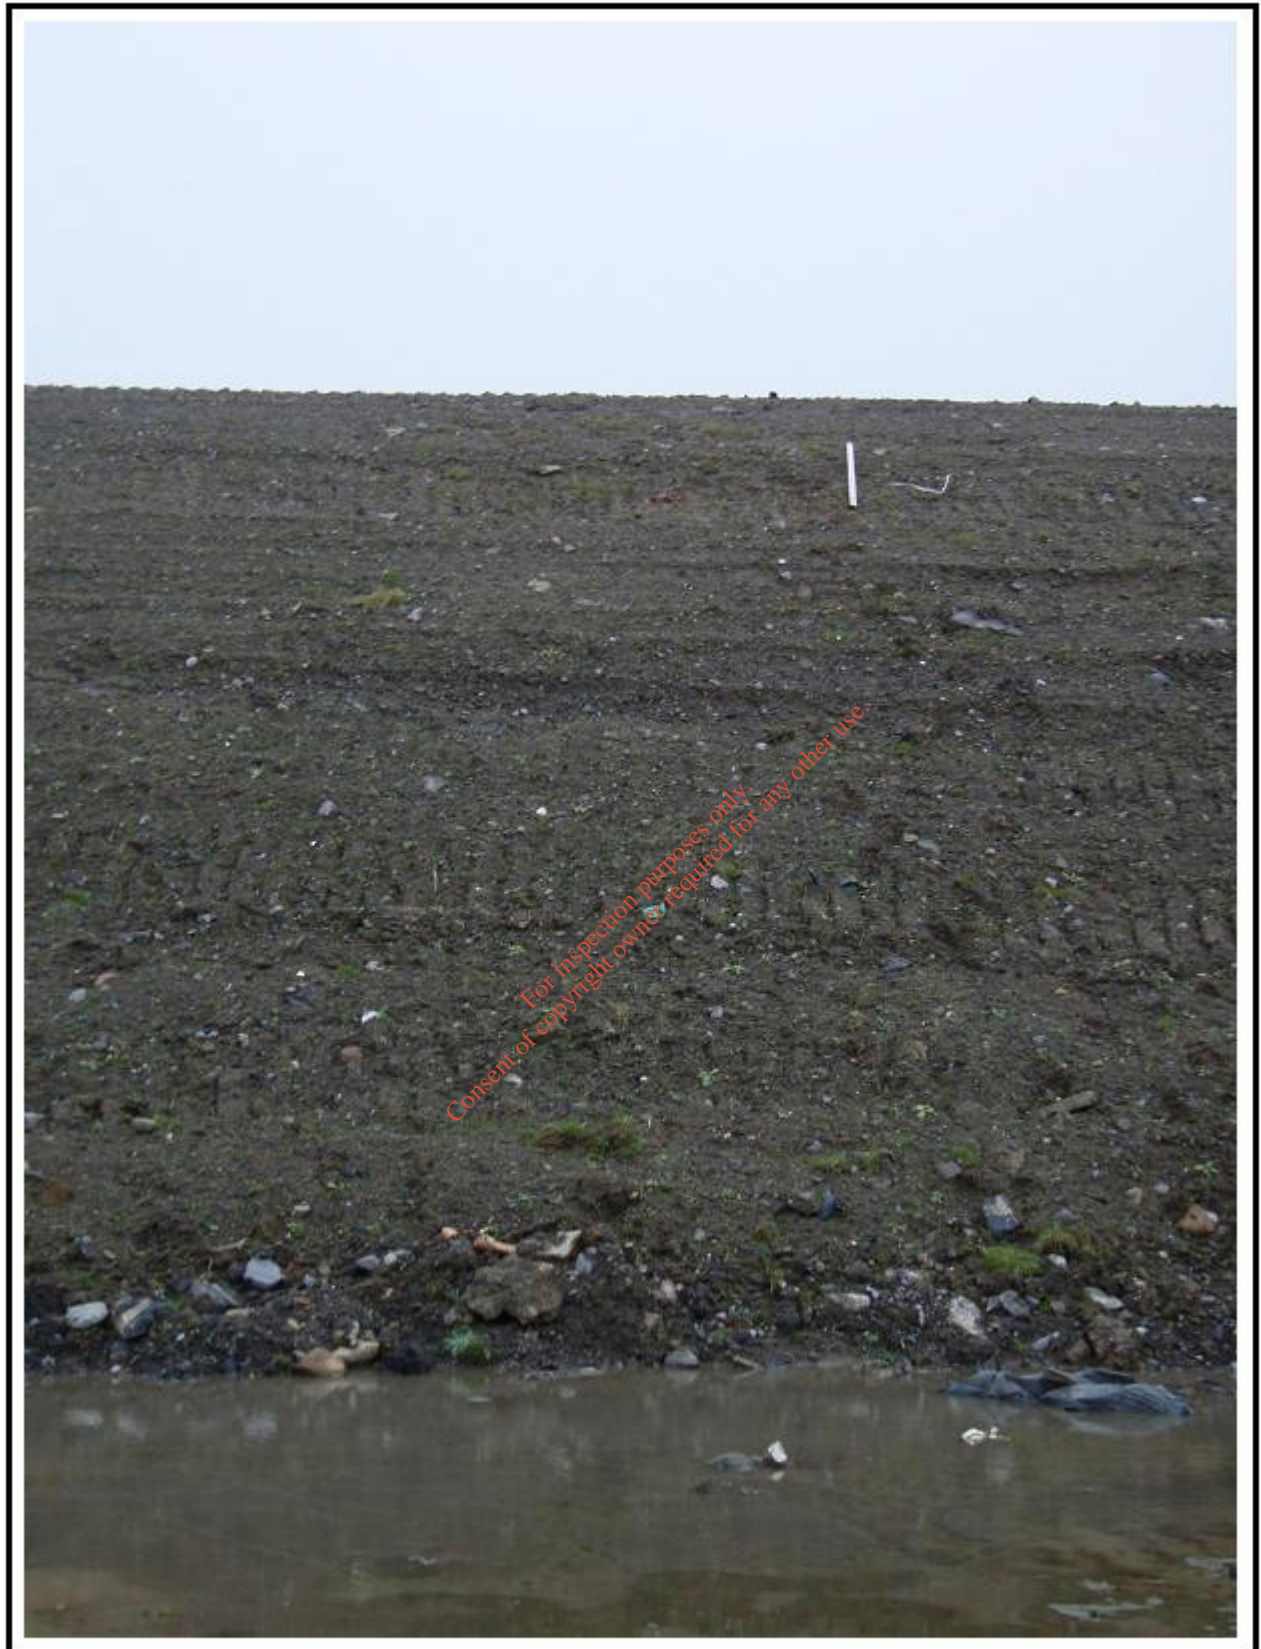
Plate A15: Profile of relatively shallow, recently-lain topsoil overlying overconsolidated subsoil at the northern side of the main eastern fill area. This material is very clean also.

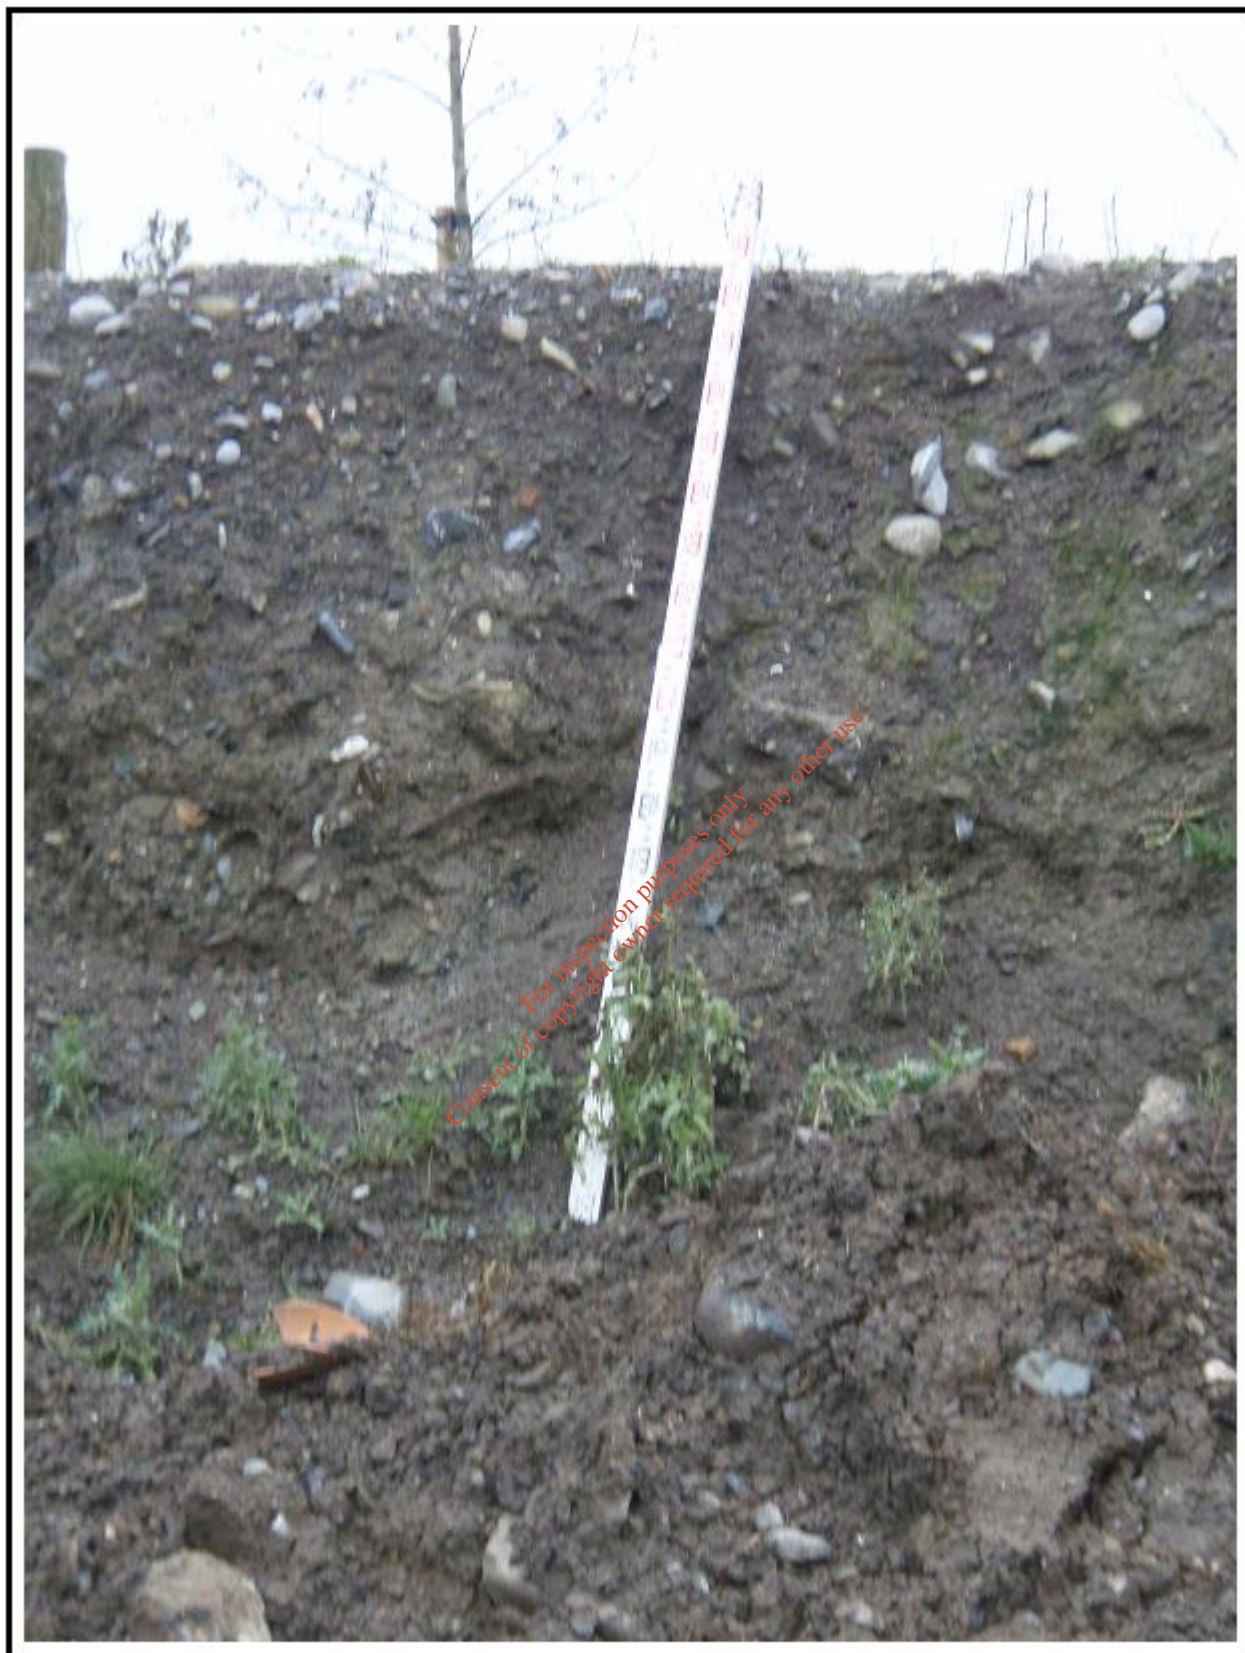
Plate A16: Profile of relatively shallow exposure into subsoil at the eastern extreme of the fill area. This material is also very clean.

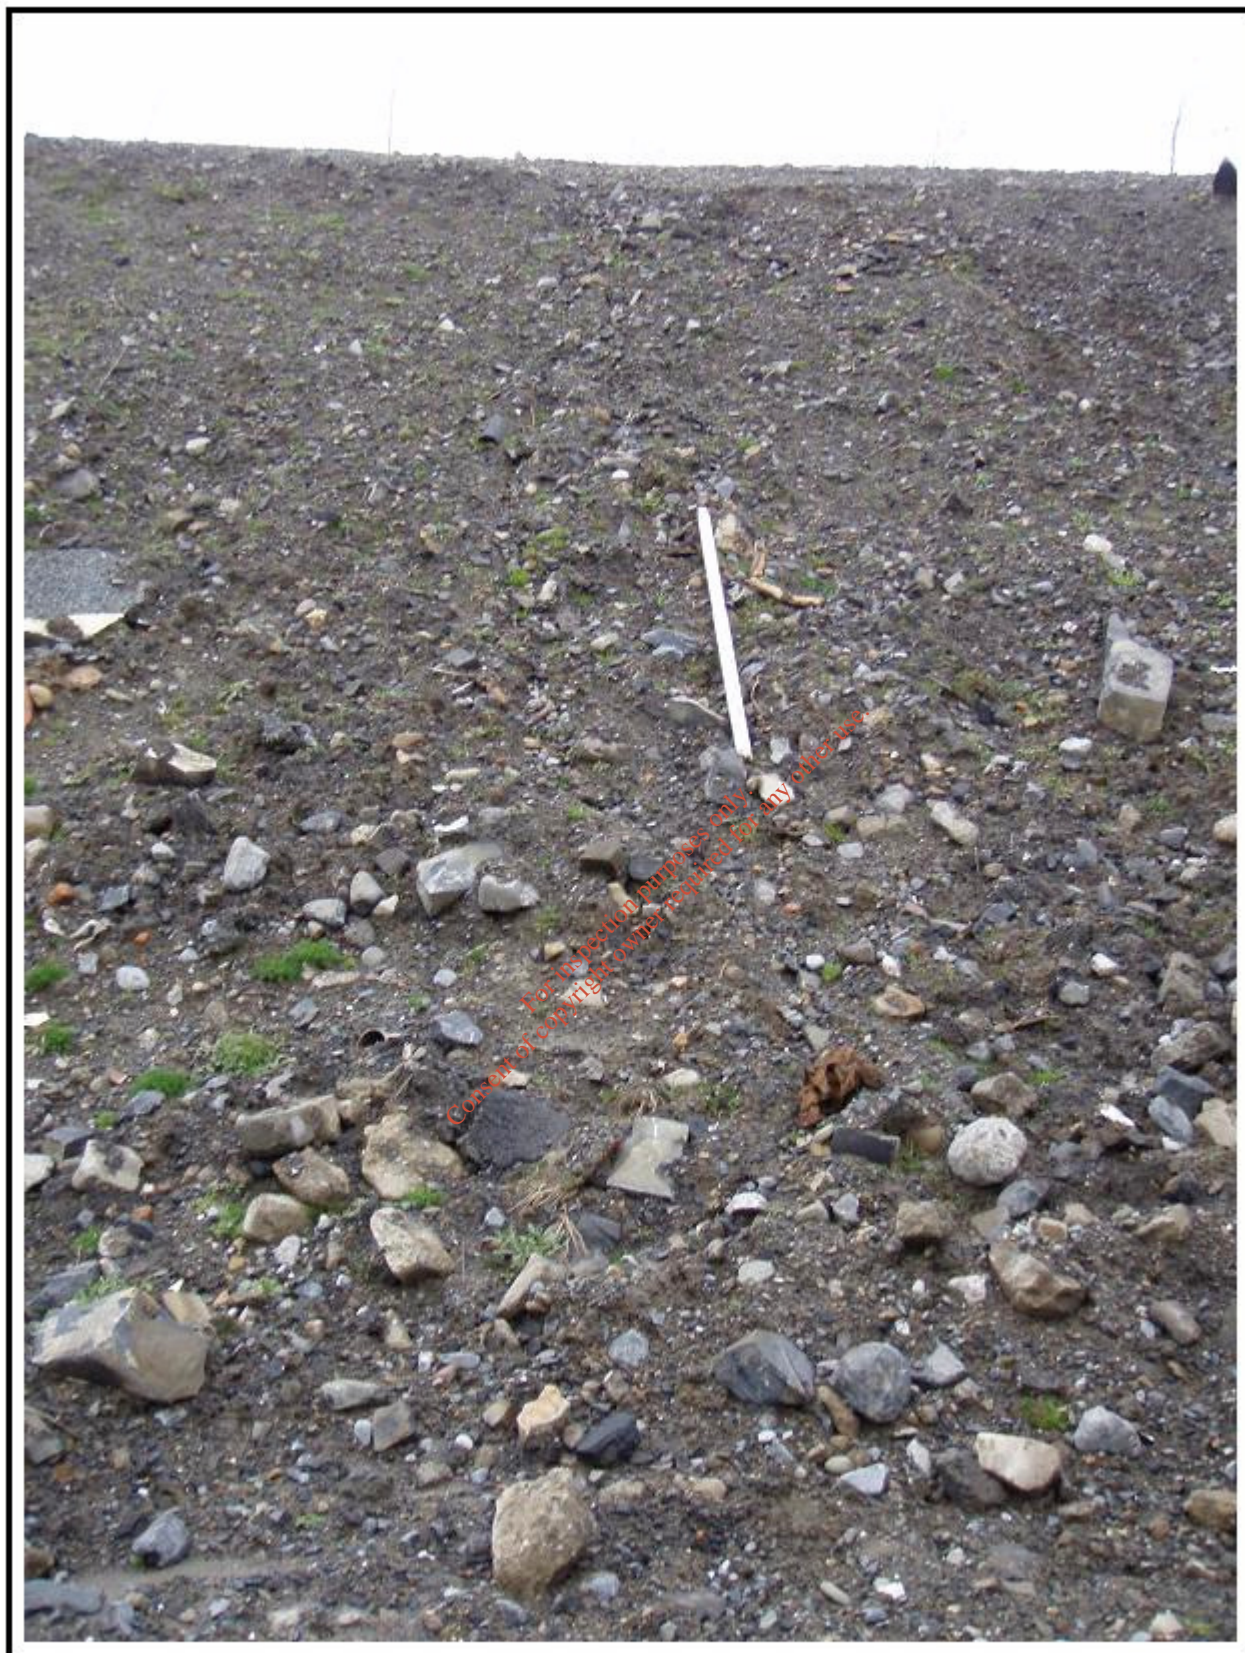
Plate A17: Profile of exposure into subsoil at the northeastern extreme of the main pit area. This material is clean, and gets more gravelly and 'bouldery' at the base.

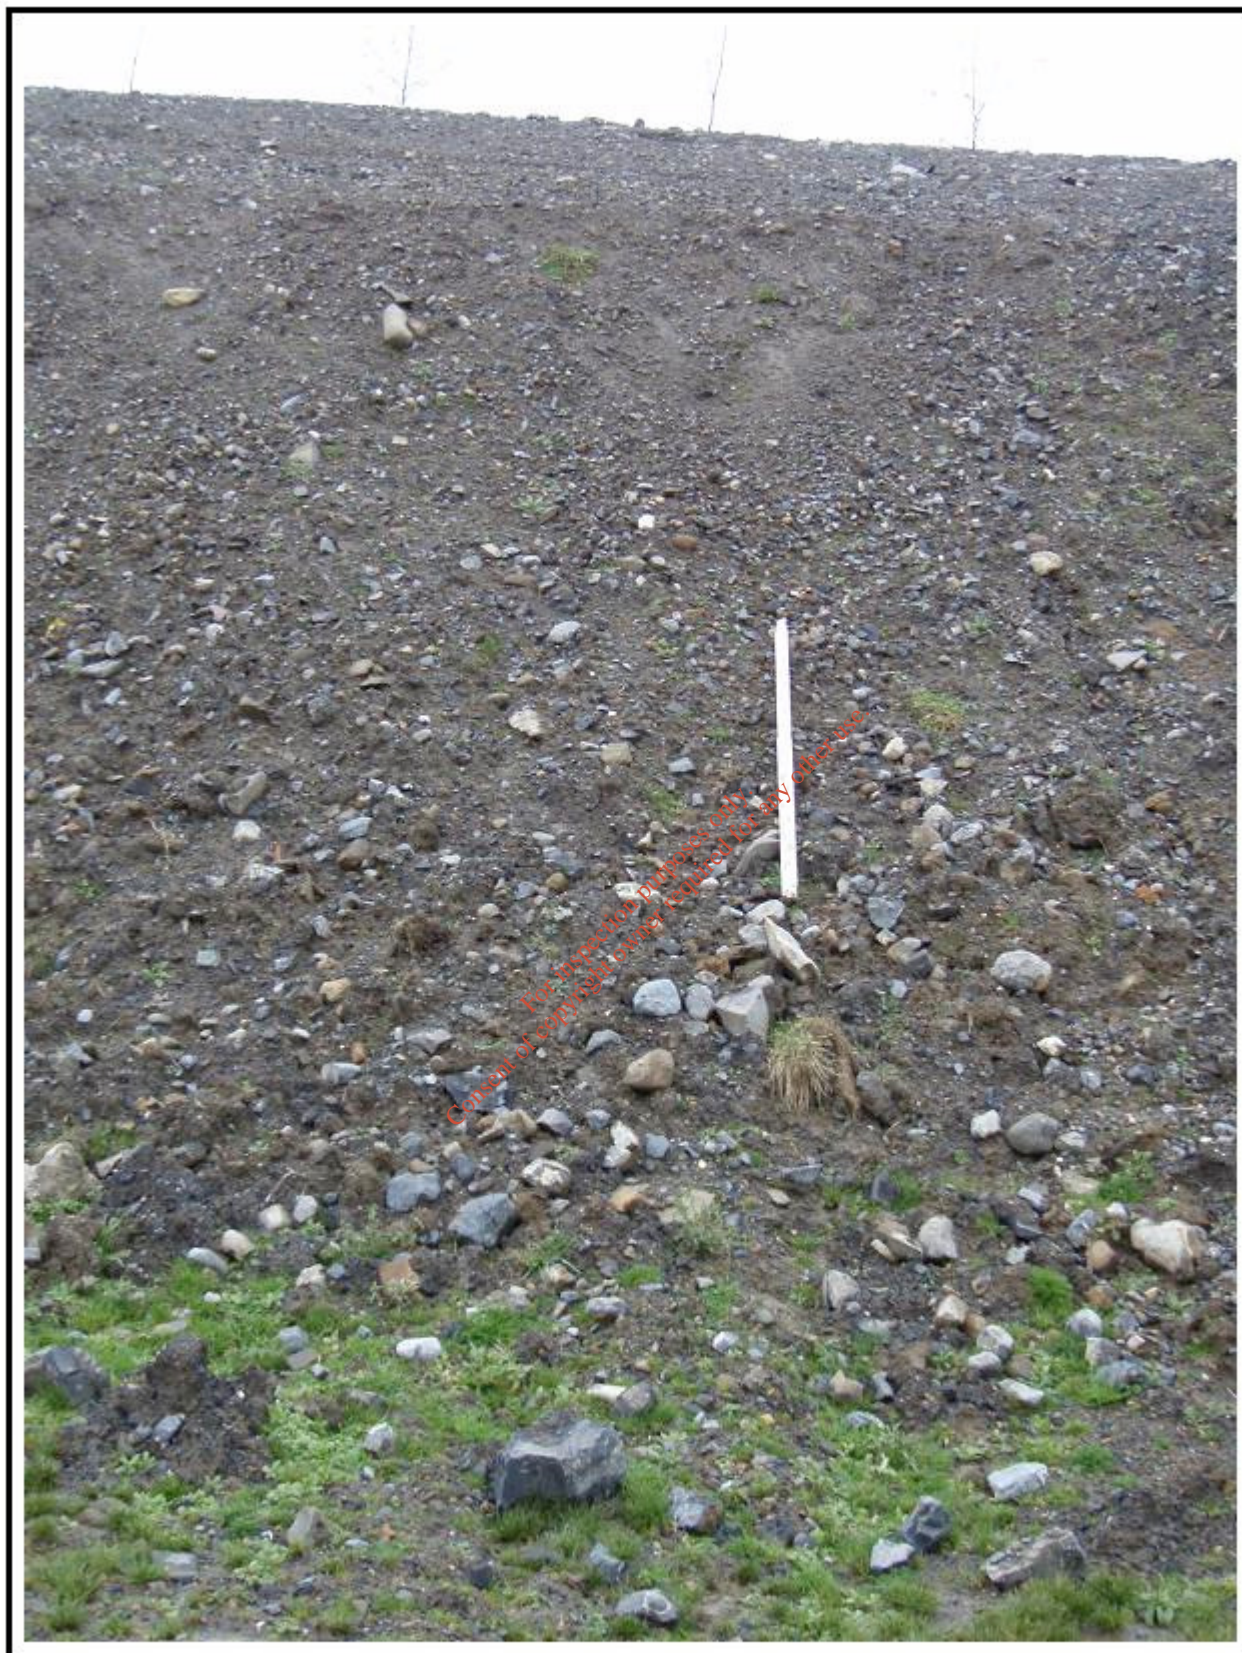
Plate A18: Profile of exposure into subsoil at the northwestern extreme of the main pit area. This material is clean, and again gets more gravelly and 'bouldery' at the base.
