SRAHMORE PEAT DEPOSITION SITE

STABILITY ASSESSMENT

December 2007

**PROJECT:** **Strahmore Peat Deposition Site  
Co. Mayo  
Stability Assessment**

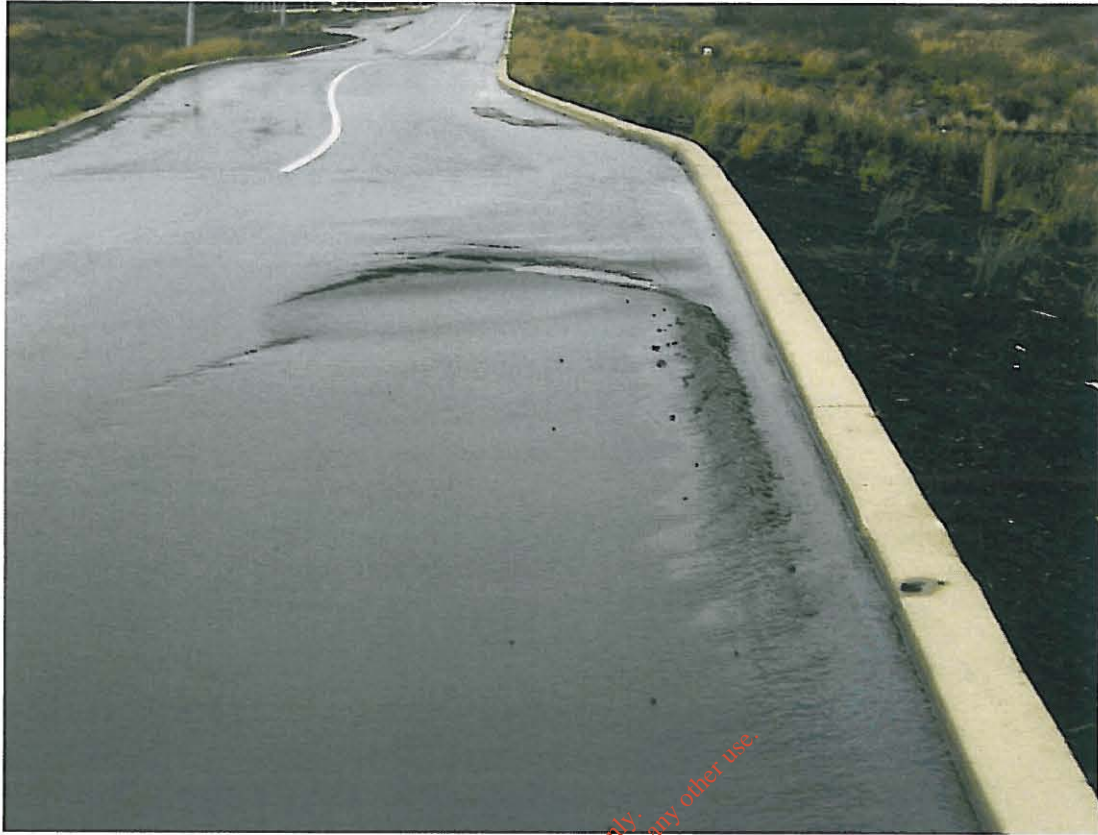
Cracks and localised wheel ruts are evidence of damage to the wearing coarse were present particularly on the east side of the road.

Localised cracks and rutting Haul Road

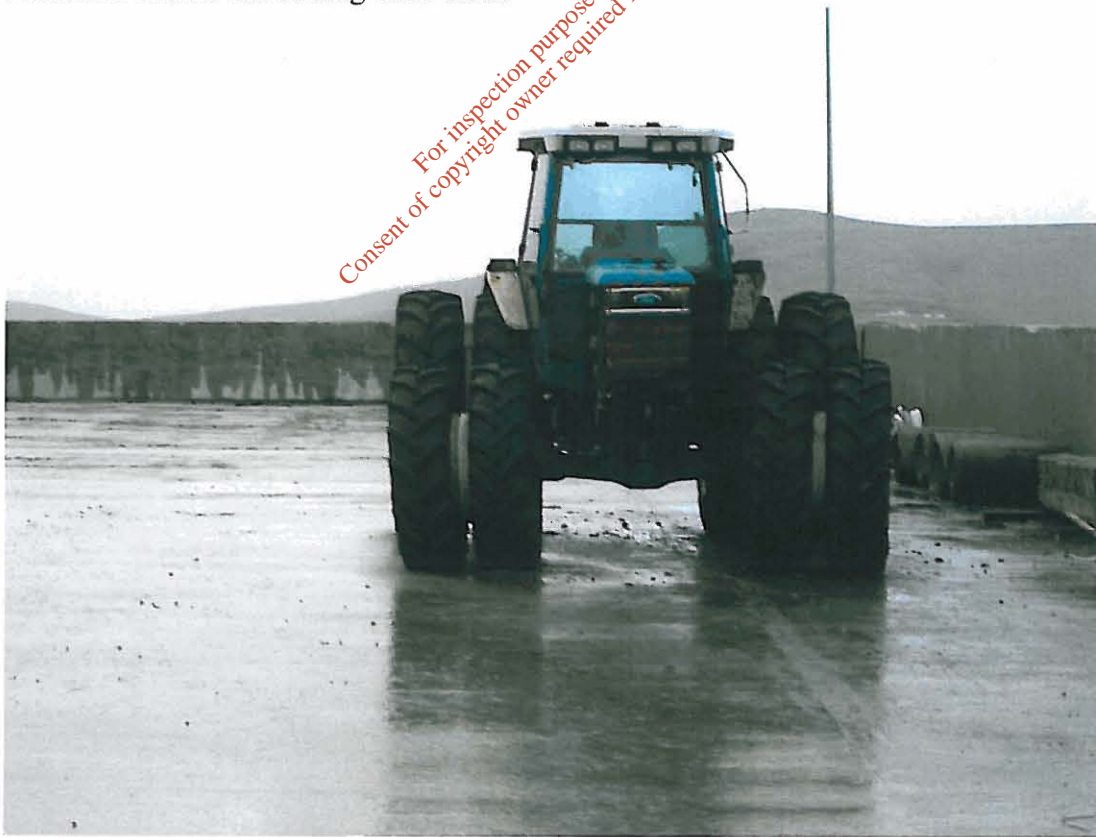
Haku Tractor Peat Deposition Area

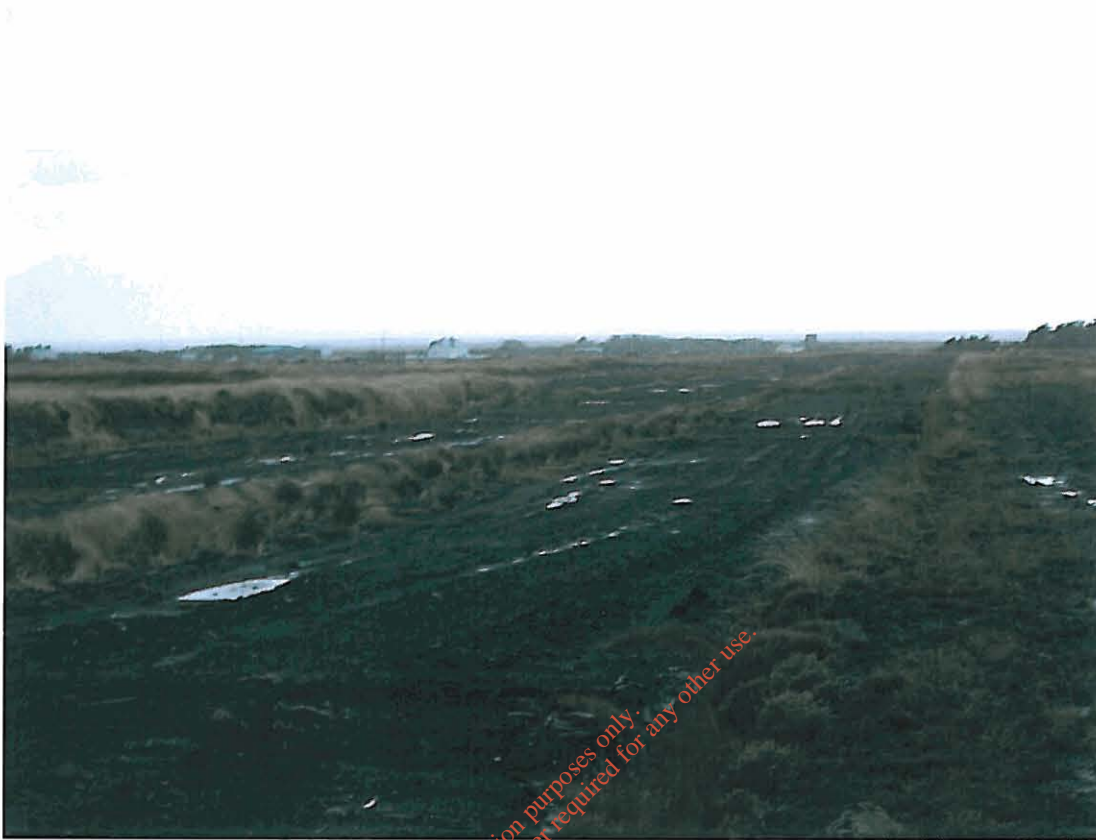
Bay 1 Empty

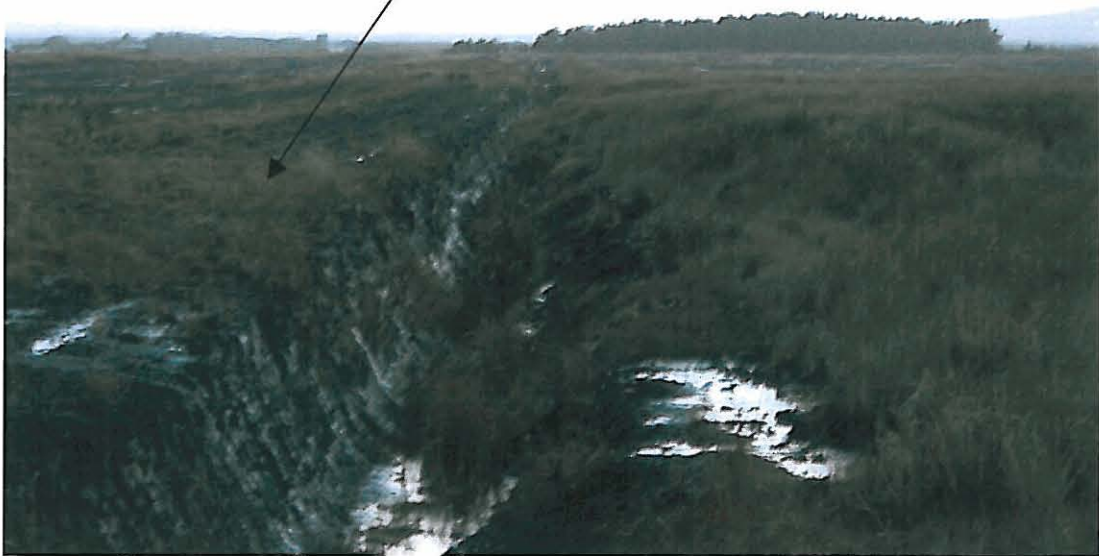
Bay 2 North End partly filled with peat in 2005

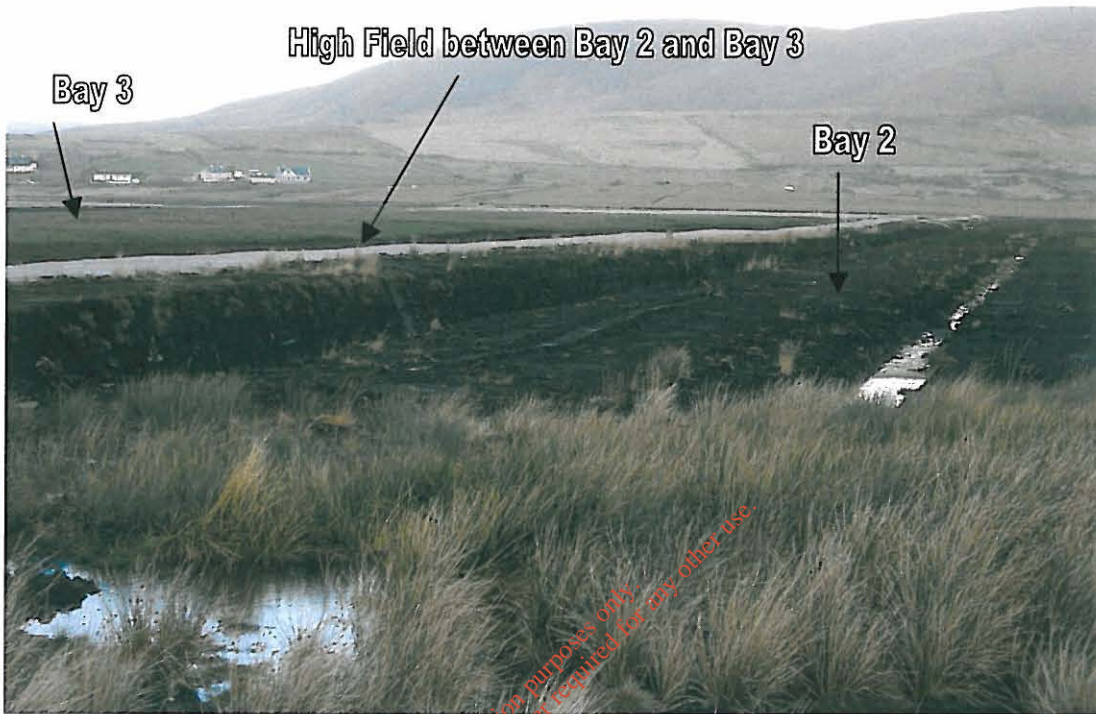
Southern end of Bay 2 empty

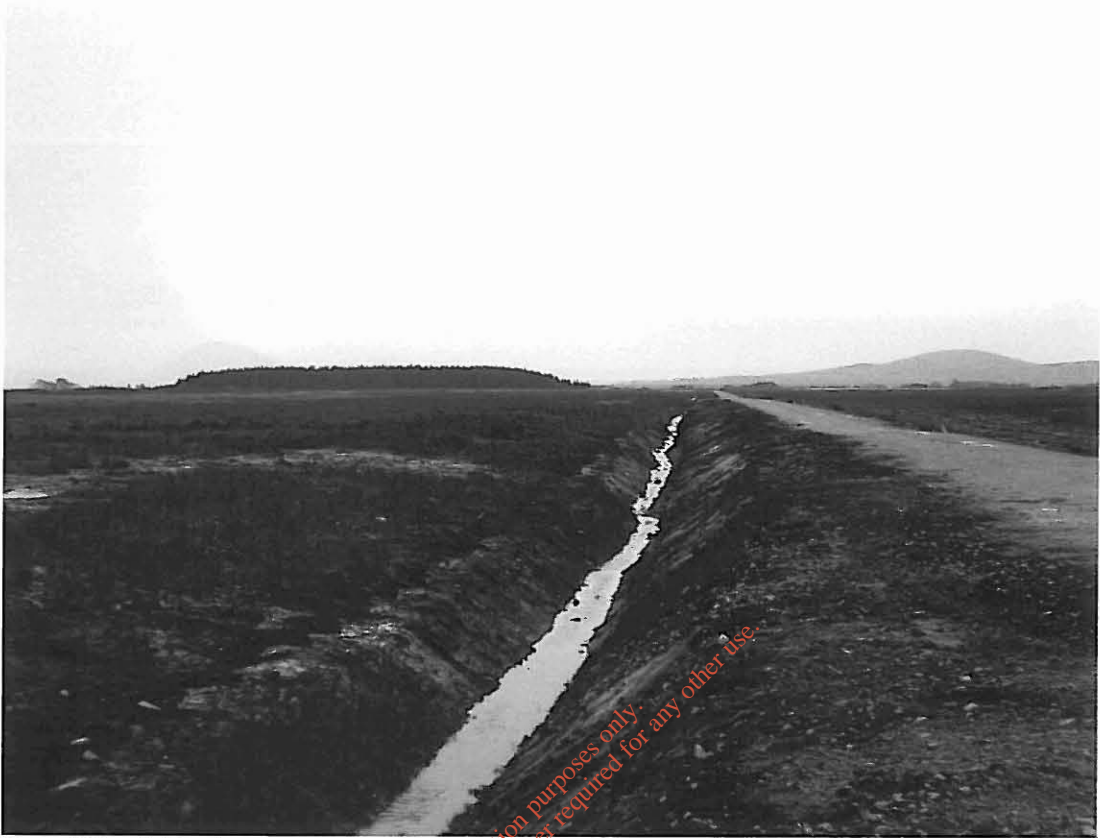
deposited peat, which are linked to deep edge drains at the base of each high field. V-Ditch drains are present on the north and south of each bay. The drains are open and functioning well in each Bay

Bay 4 North Drain

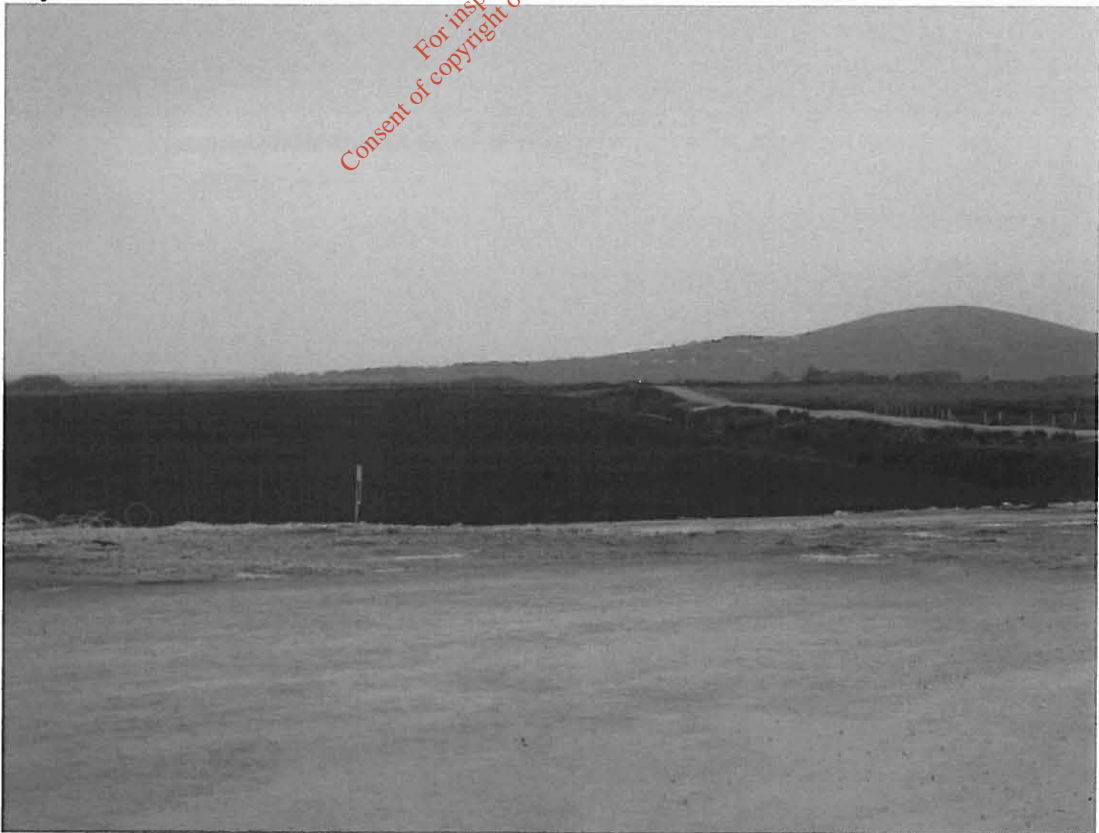
Bay 5 Heavily vegetated

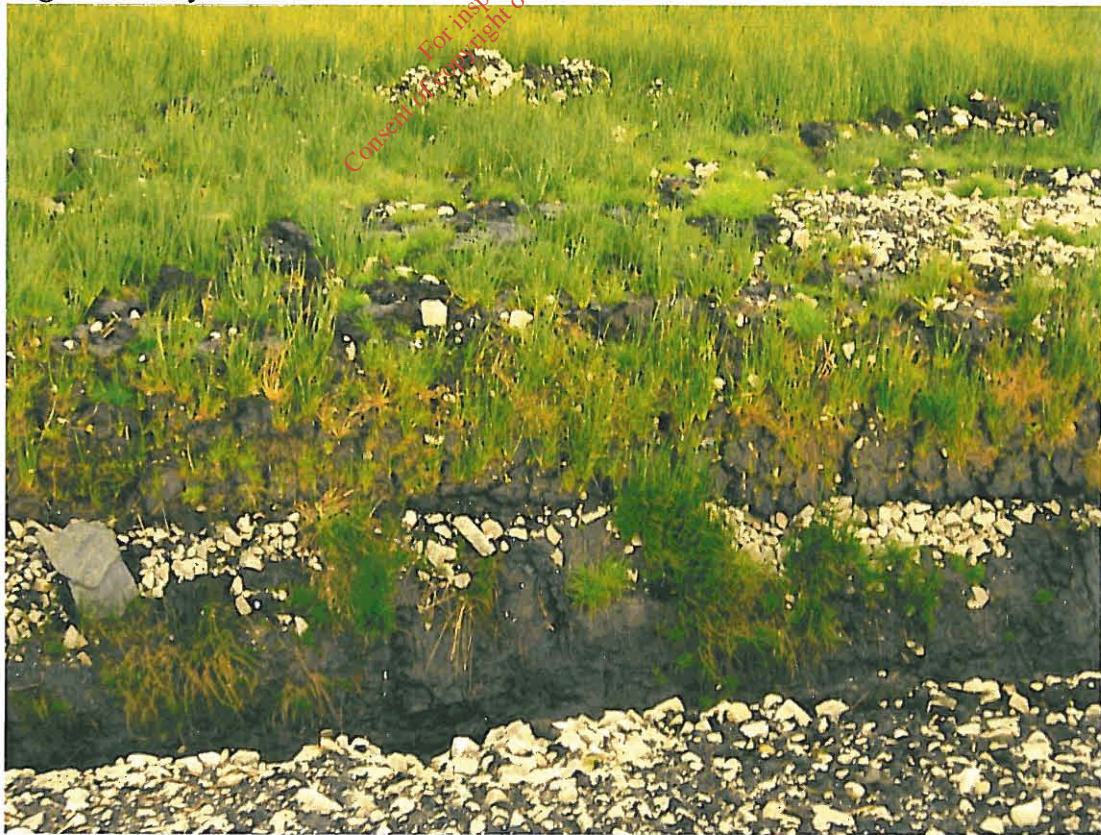
The Peat placed in Bays 2,3,4 and 5 is at it's maximum thickness, about 1.5m thick, in the centre of each of the bays thinning towards it's margins. The deposited peat is not loading the internal high fields. The upper surface of the peat is dry, firm with numerous desiccation cracks. The peat is densely covered by rushes, which have colonised the imported peat. V-ditch drains have been excavated in the

The peat within each bay is contained by the high fields and there was no evidence of any movement or slumping of the deposited peat

Condition of deposited Peat

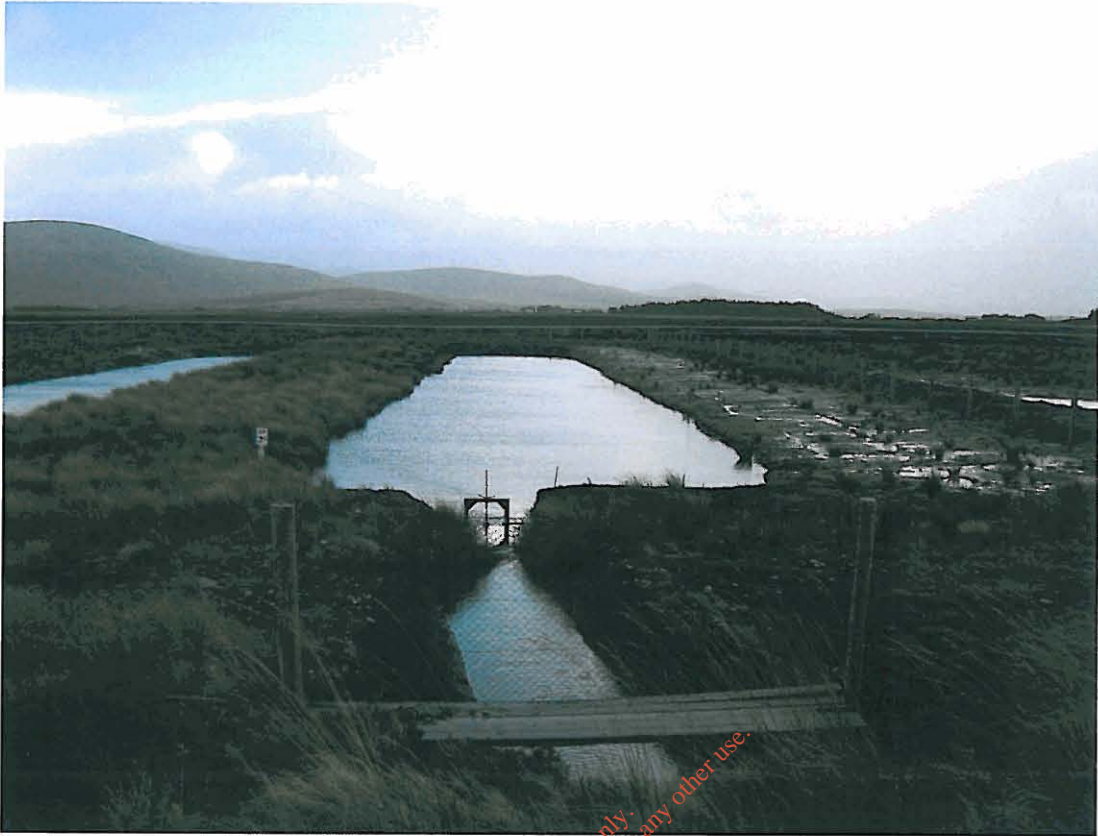
Settlement Ponds North Eastern End Bay 6

Two pairs of rectangular settlement ponds are present in Bay 6 and North East of Bay 6. The exposed side walls of the ponds are in good condition and no indication of distress in the peat was noted

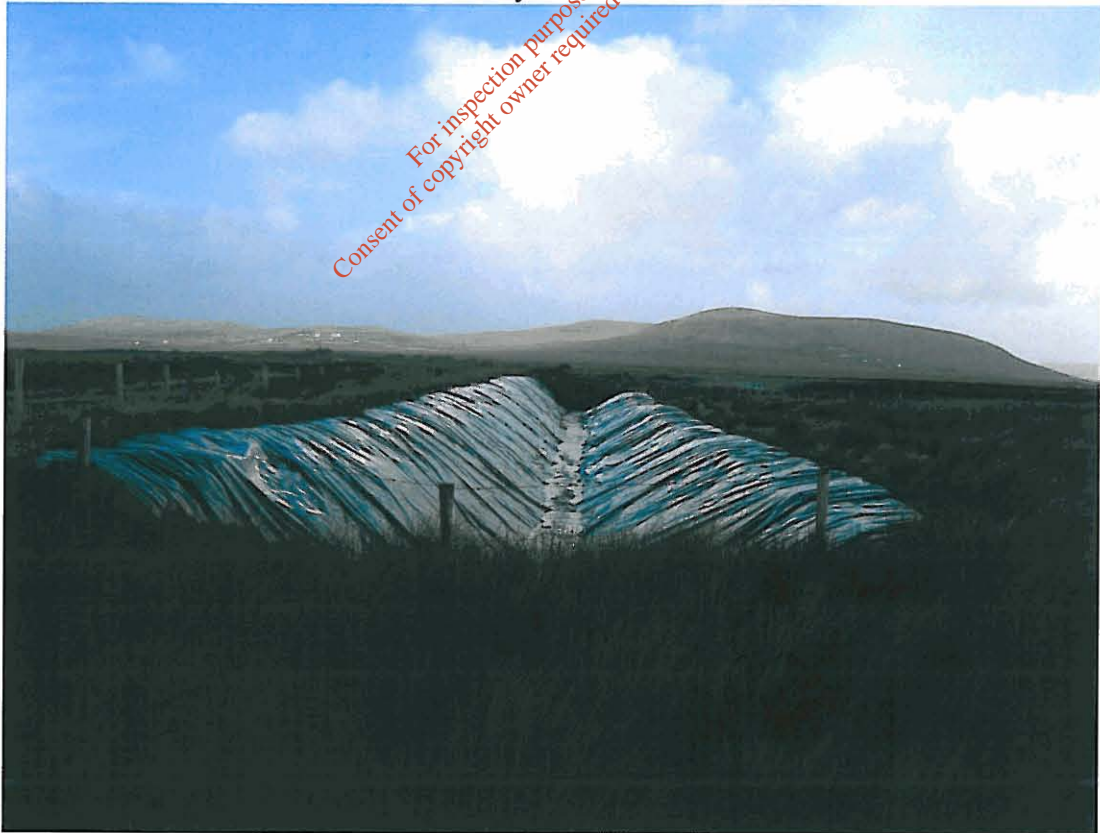
South Western Swale

This is a deep wide drain lined with plastic sheeting at the south-western end of the Bays. No bulges or cracks in the plastic liner were observed and no tension cracks were present at the crests of the Swale.
