### PAVEMENT ASSESSMENT SURVEY

ON 1.9 KM SECTION OF THE L6042,  
FROM THE JUNCTION  
WITH THE L2023 SOUTHEASTWARDS TO  
WALSHESTOWN, CO. KILDARE

October 2009

09 5071 50022

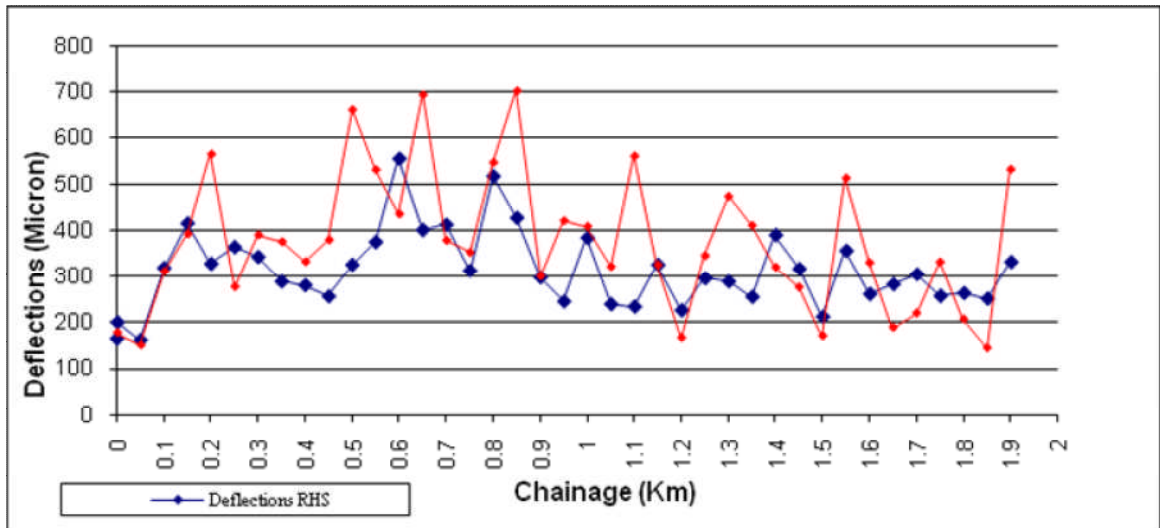
Figure 1 Measured deflections

The deflection results from the FWD survey are provided on Figure 1. The estimated surface moduli values are shown on Figure 2. A material's resilient modulus is an estimate of its modulus of elasticity (E). While the modulus of elasticity is stress per unit strain, resilient modulus is the equivalent modulus for rapidly applied loads, similar to those experienced by road pavements under moving vehicles. Typical resilient modulus values in MPa would be as follows:

Results for deflection and Surface Modulus of the section of pavement extending from CH 50 to CH 400 confirm this road to be in generally poor condition. It displays an average Surface Modulus of 507 MPa which indicates that this pavement cannot continue to perform under projected future traffic loadings, including under baseline and added loads from the two 'approved' developments. This area requires an asphalt overlay of 40 to 50 mm depending on traffic scenarios.

Results for deflection and Surface Modulus of the section of pavement extending from CH 400 to CH 850 show it is also in poor condition. It displays an average Surface Modulus of only 412 MPa which indicates that this pavement cannot continue to perform under projected future traffic loadings including under baseline and added loads from the two 'approved' developments. This area requires significant asphalt overlay of between 40 to 90 mm depending on traffic scenarios.

Results for deflection and Surface Modulus of the section of pavement extending from CH 850 to CH 1900 and is in fair to poor condition. While there are areas that exhibit reasonable results, there are also areas showing high deflections under load. When analysed in its entirety this section displays an average Surface Modulus of 625 MPa which indicates that this pavement cannot continue to perform under projected future traffic loadings including under baseline and added loads from the two 'approved' developments. The projected asphalt overlay deficiencies range from 40 to 80 mm depending on traffic scenarios.

To upgrade the subject 1.9 km section of the L6042 to sustain the predicted traffic volumes as anticipated in Scenario 3 (i.e. 2.37 msa), the following actions are recommended for each zone:

Zone	Action required
1	No action required
2	Repair localised distressed areas, as required and overlay with 50mm Wearing Course.
3	Repair localised distressed areas, as required and overlay with 90mm of Asphalt, comprising 40mm Wearing Course over 50mm Base Course.
4	Repair localised distressed areas, as required and overlay with 80mm of Asphalt, comprising 40mm Wearing Course over 40mm Base Course.

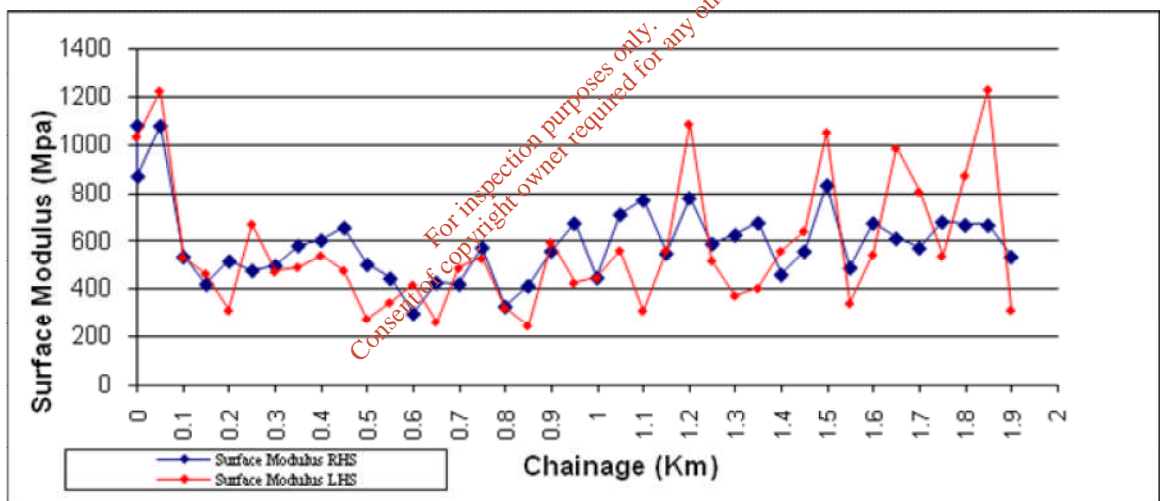
Figure 2 Surface modulus

The pavement Surface Modulus is the overall combined stiffness of the road and can be used to provide an assessment of future life. It is calculated by taking the applied stress under the FWD applied load and dividing it by the measured maximum deflection under the centre of the load.

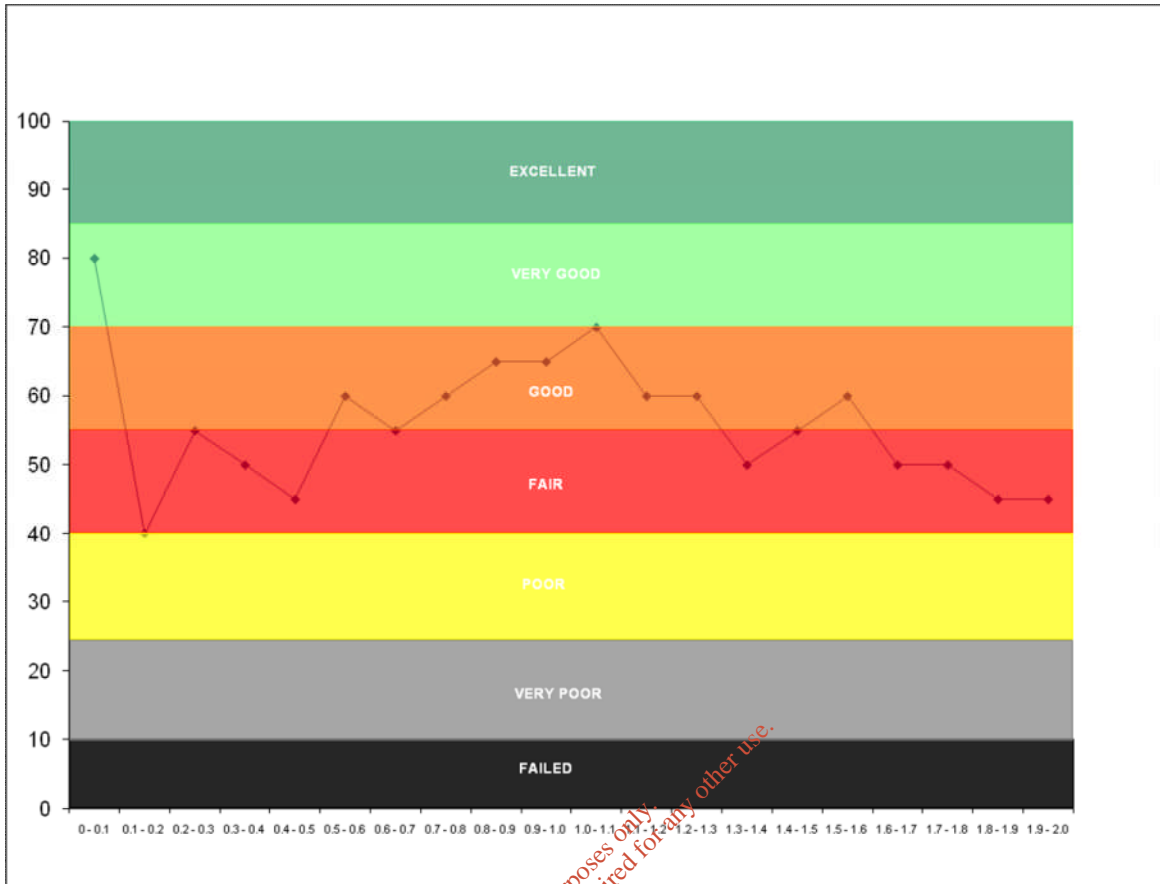
**Figure 3 Visual Condition Survey observations**

Based on a visual condition survey, the majority of the pavement section had Pavement Condition Index (PCI) values in the 40 to 60 range indicating a predominant Fair to Poor condition overall. The Falling Weight Deflectometer (FWD) of structural capacity survey indicated the minimum overlay requirements for the Scenario 2 condition ranged from 50 to 80 mm. For the Scenario 3 traffic, the minimum overlay requirements increase to 50 to 90 mm.

PCI values less than about 50 indicate a pavement in poor condition requiring maintenance and/or remedial works to restore serviceability. A graphical representation of observations from the VCS is contained in Figure 3 following the text of this report. The majority of the pavement section had PCI values in the 40 to 60 indicating a predominant Fair to Poor condition overall. Because the VCS and the FWD survey assess different aspects of the pavement, there will not be complete correlation with the two results. However, the VCS results assist in establishing optimum rehabilitation strategies.

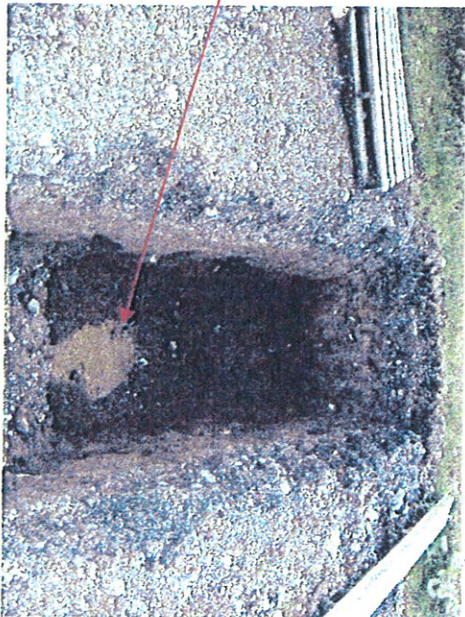
Trial Hole & Existing Building

It was noted that the soil structure in the trial hole for the first 0 – 0.8 / 1.0m of subsoil was very compact and most likely have been compacted over time by use of heavy traffic over time while the quarry was in operation.

In addition as per the recommendations in Section 5.0 of the Site Characterisation Form it is advised that the subsoil be loosened to a minimum depth of 1.5m and that the percolation area is fenced off to prevent heavy traffic from causing any damage by compression to the area.

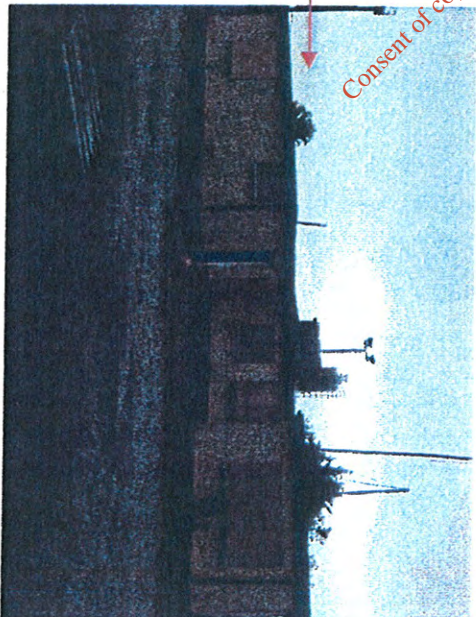
During the assessment the existing septic tank on site was inspected and found not to meet the EPA Guidelines and therefore it is considered unsuitable for continued use and will need to be replaced with a new system.

Existing Office building served by an existing septic tank

With no water in the trial hole and good soakage recorded in the percolation tests the site is suitable for an on-site sewage system subject to good practice. The existing septic tank is considered unsuitable and should be replaced. Taking into consideration the surface waters it is recommended to install an Advanced Treatment System discharging the effluent to a constructed subsurface polishing filter. The base of the trenches should be positioned between 0.8/1.0m. The system must be installed in accordance with the EPA Waste Water Manual for Domestic Houses.
