# **Annual Environmental Report 2009.**

**Licence Register No.** PO 406-02

**Licensee:** Bailieboro Foods Limited and  
Bailie Foods Ireland Limited.

**Location of Activity:** Lear, Bailieborough, Co. Cavan

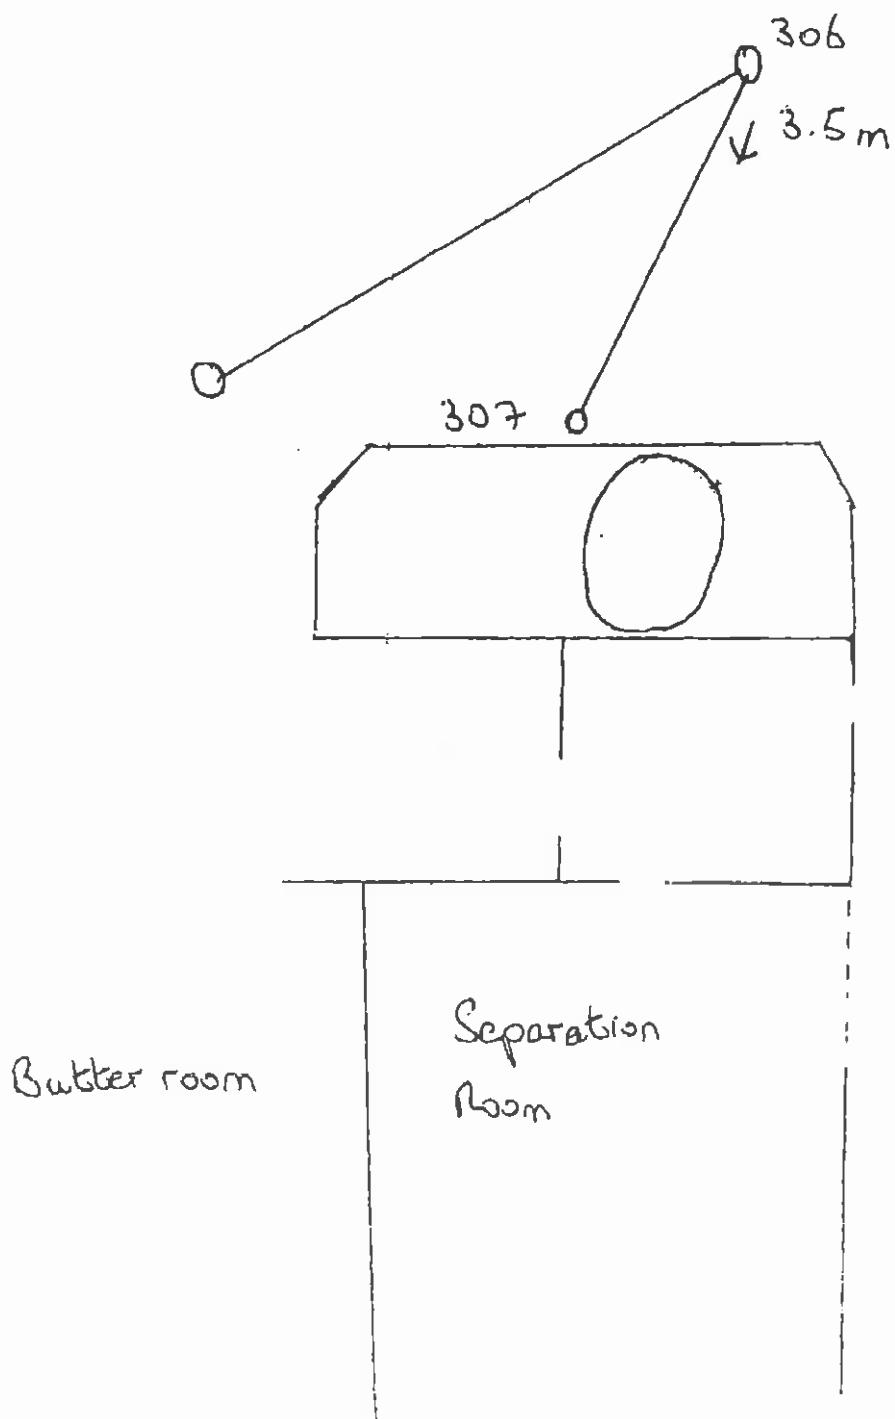
Inspection of the Effluent Lines in Creamery showed - effluent line 306 to 307 is damaged (3.5metres from 306 -307) as shown on page 1 of diagrams. Not damaged enough to stop effluent line working but should be repaired.

Effluent line is Damaged

Damage Starts 3.5 meters From Manhole  
306 Towards 307

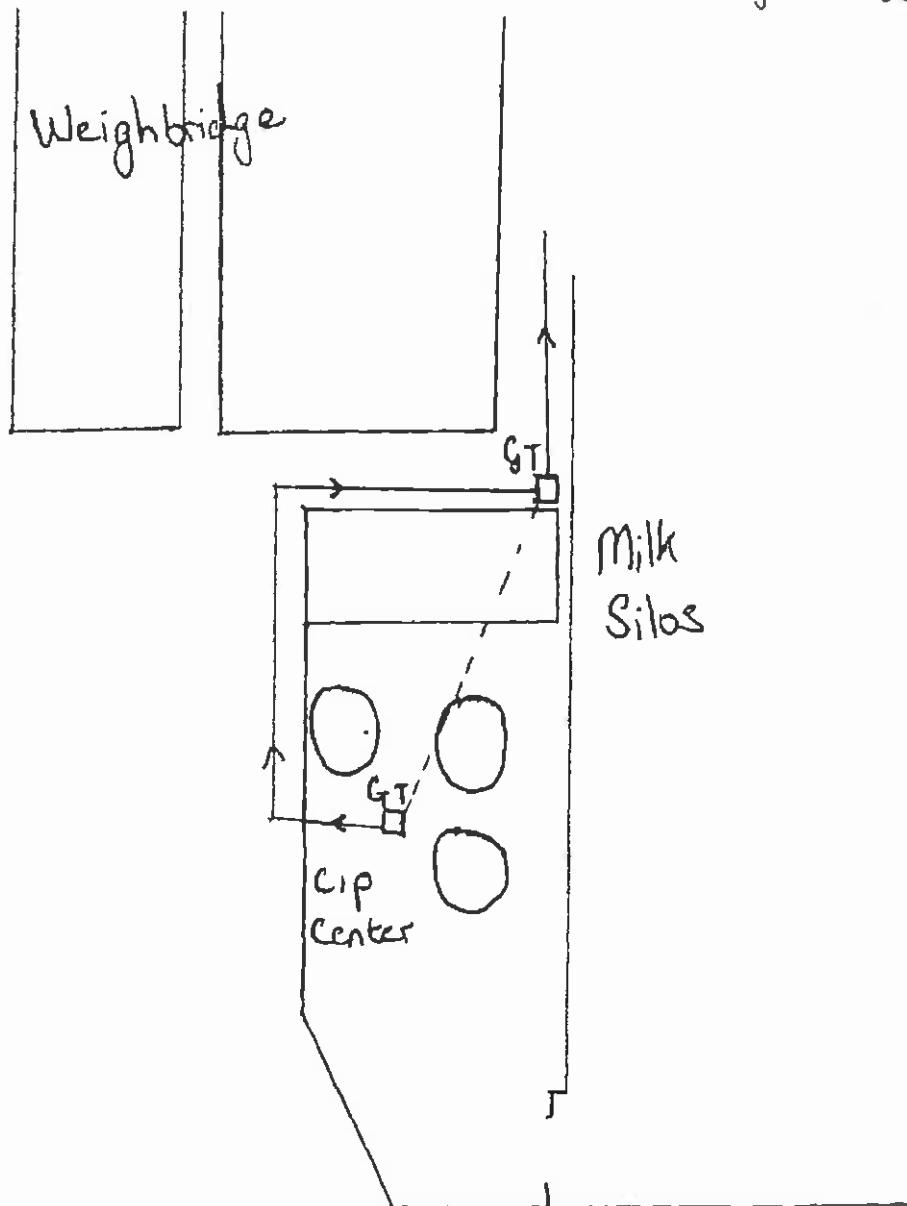
Effluent line from Cip Centre goes a different direction as shown on page 2 of diagrams. All other Effluent Lines in Creamery are in good condition.

This Shows the  
Direction of the  
Effluent line from  
CIP Center, GT - GT  
-- This line doesn't  
exist

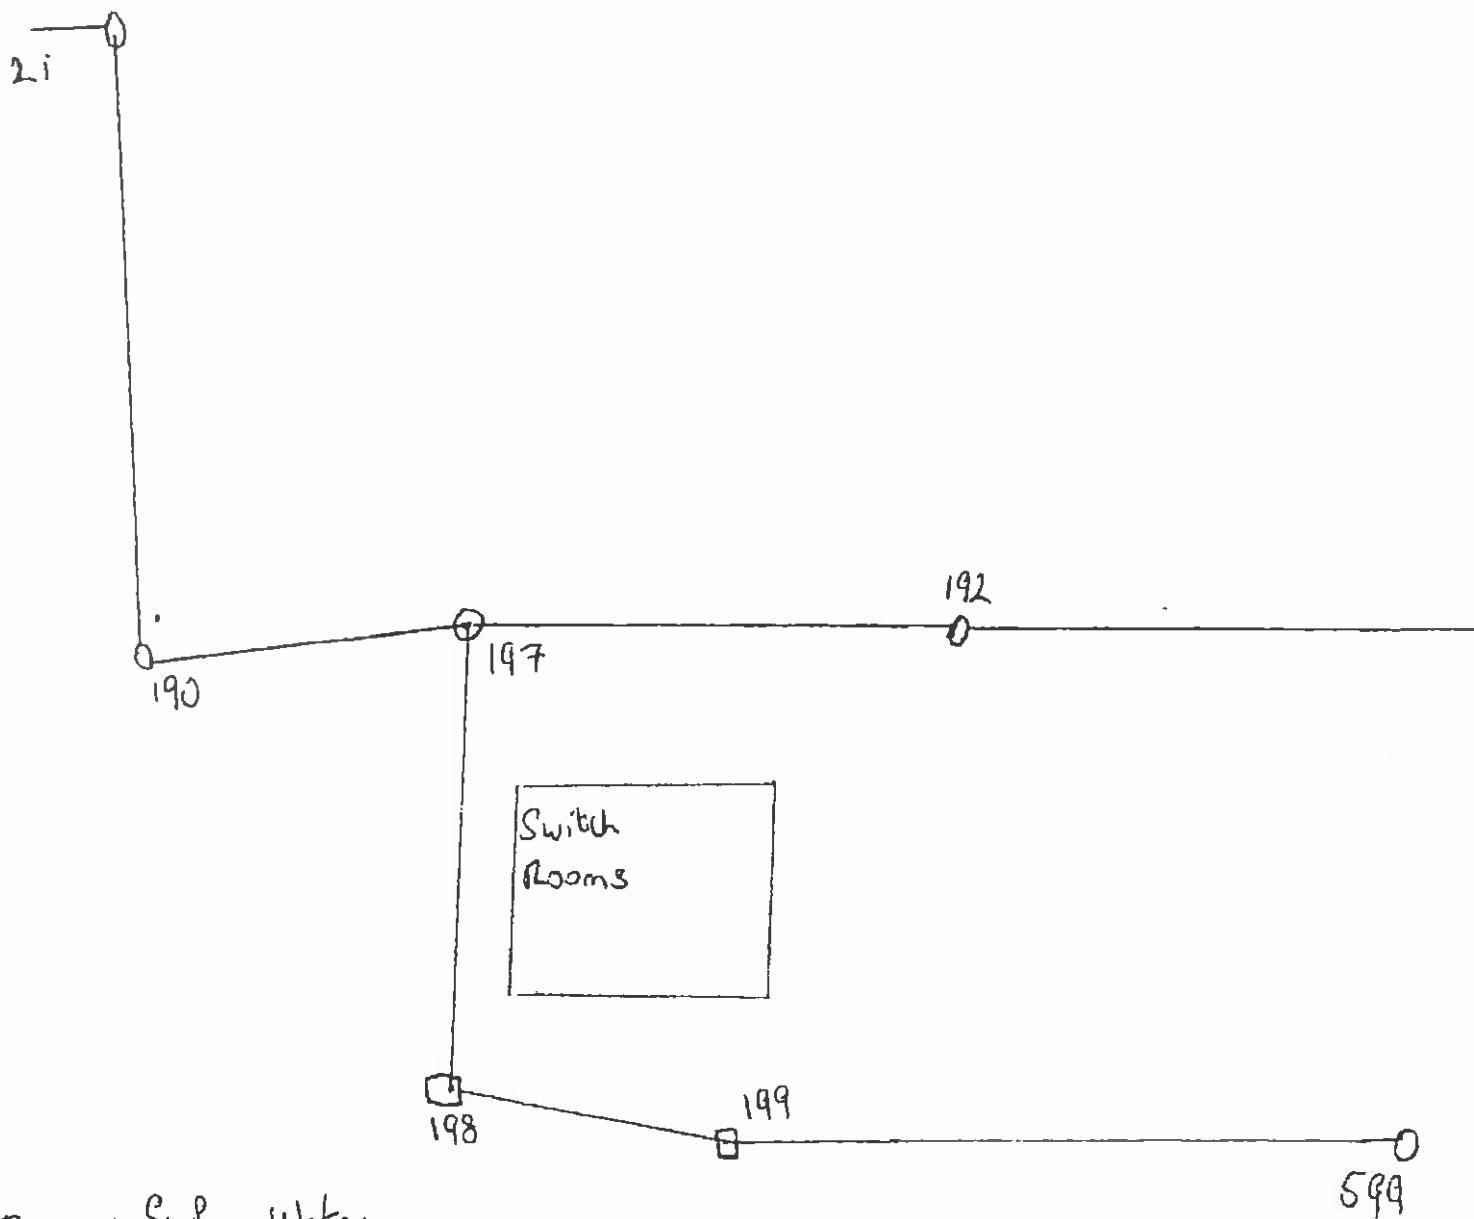
### Creamery Surface Water

All Surface Water Lines were in poor condition - full of silt and stones (all lines had to be jetted. Lines were only working to 50%capacity. Lines now flowing at 100% but need to be cleaned more frequently due to the high volume of water passing through, shown on page 3 of diagrams. Area of note: road gully is tarmaced over as shown on page 4. Pages 5,6 and 7 are manholes numbered as they were not numbered previously.

This Surface Water line was full of Stones and grit

This line Should be Cleaned At least Every 2 Years

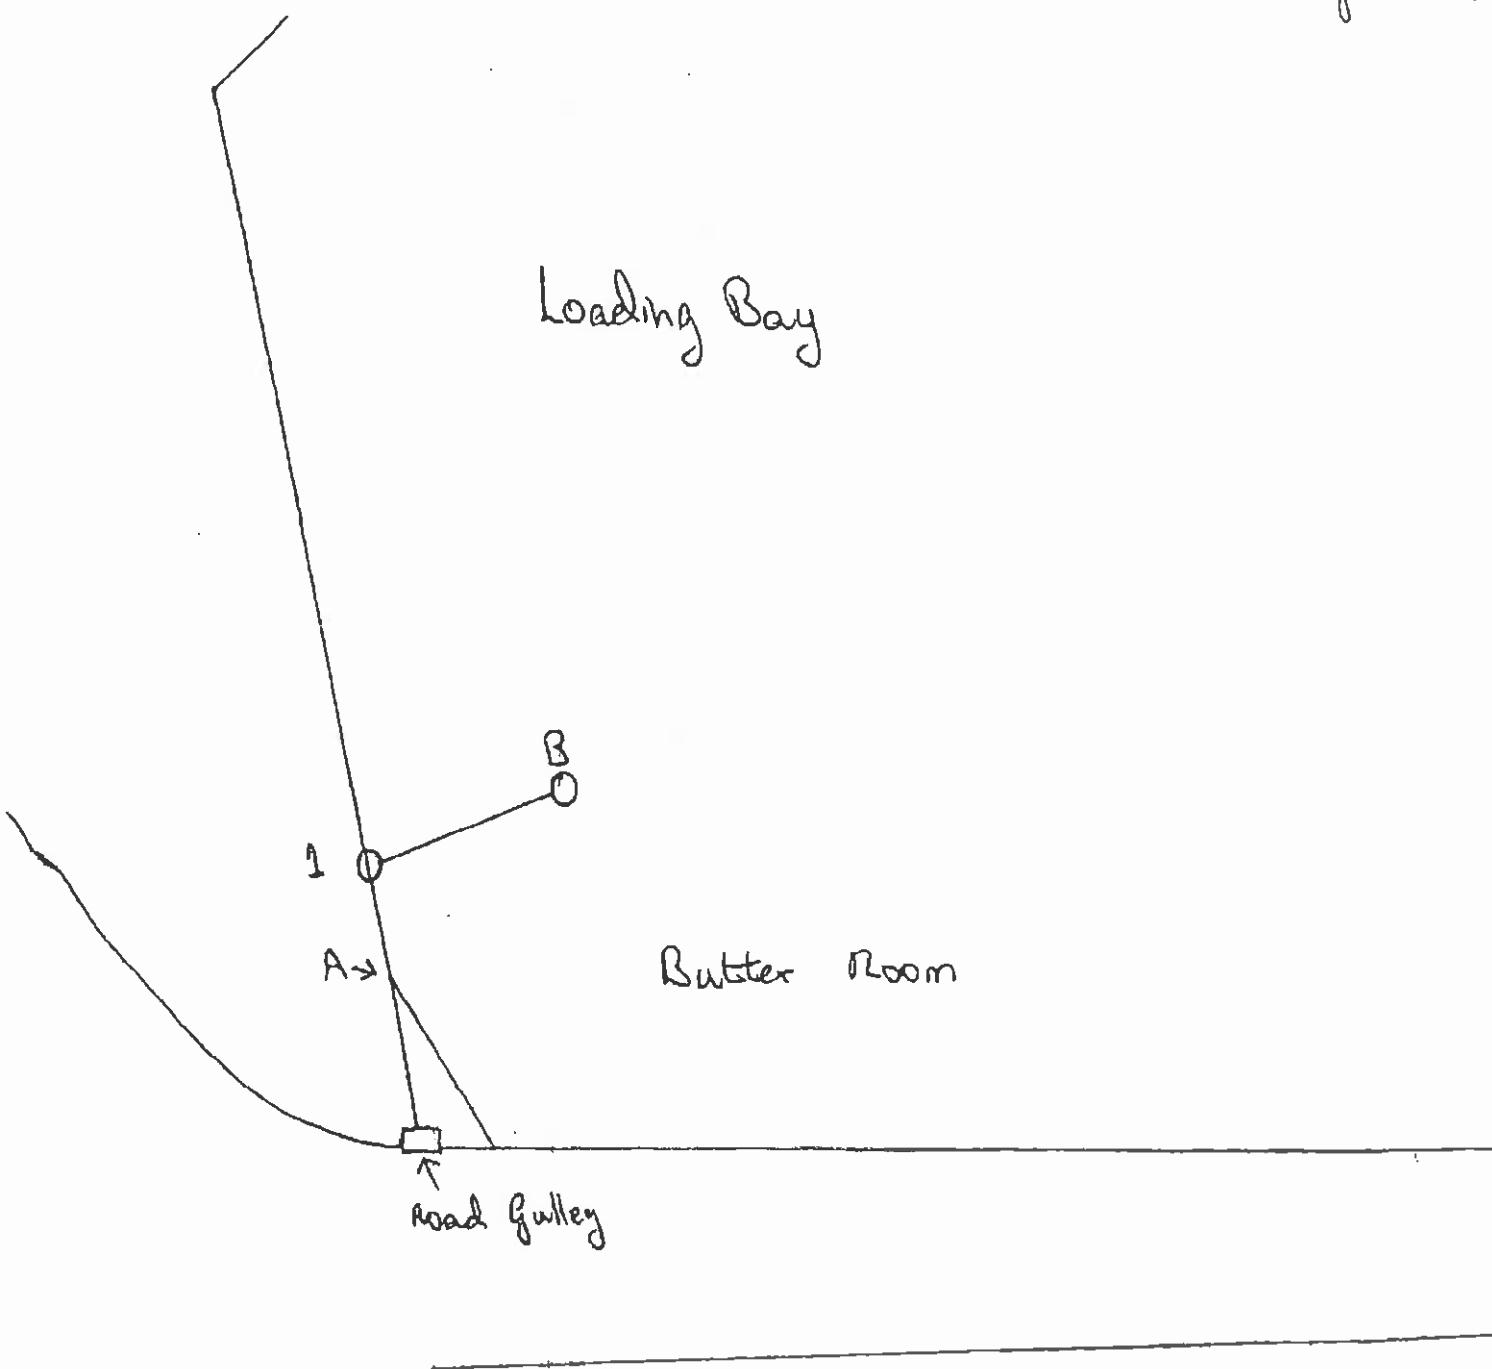
Creamery Surface Water

Road Gully is Tared over

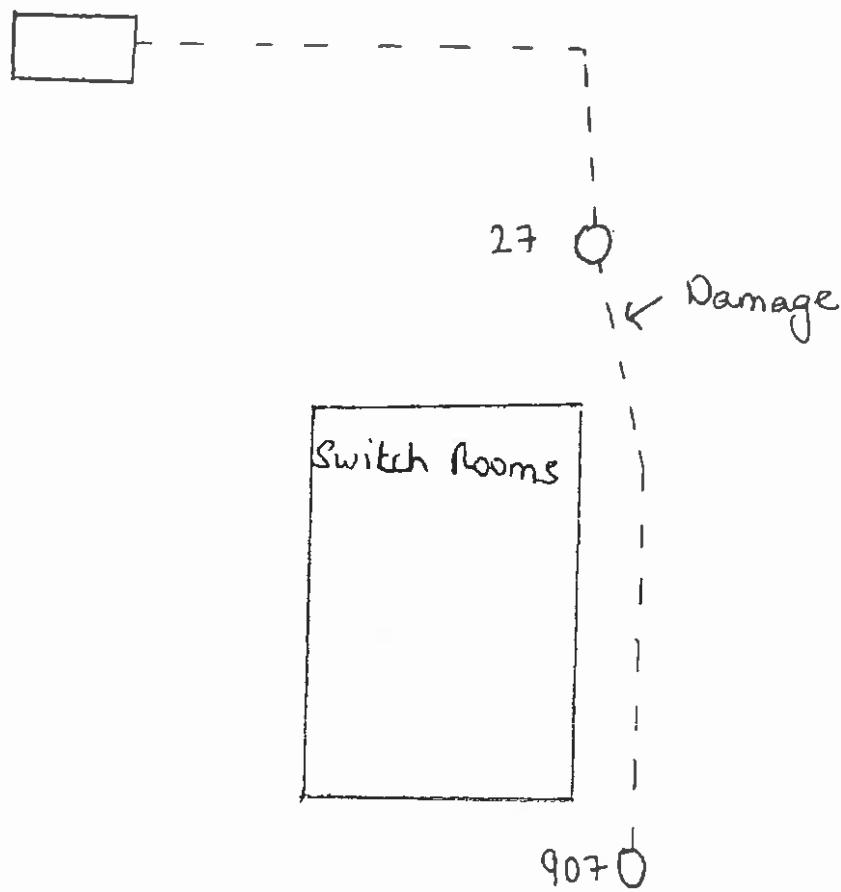
Sewer line is damaged 2.3metres from manhole 27 towards manhole 907 as shown on page 8 of diagrams. All other sewer lines are in perfect working order.

Sewer line is Damaged 2.3 meters

from Manhole 27 - Towards

Manhole 907

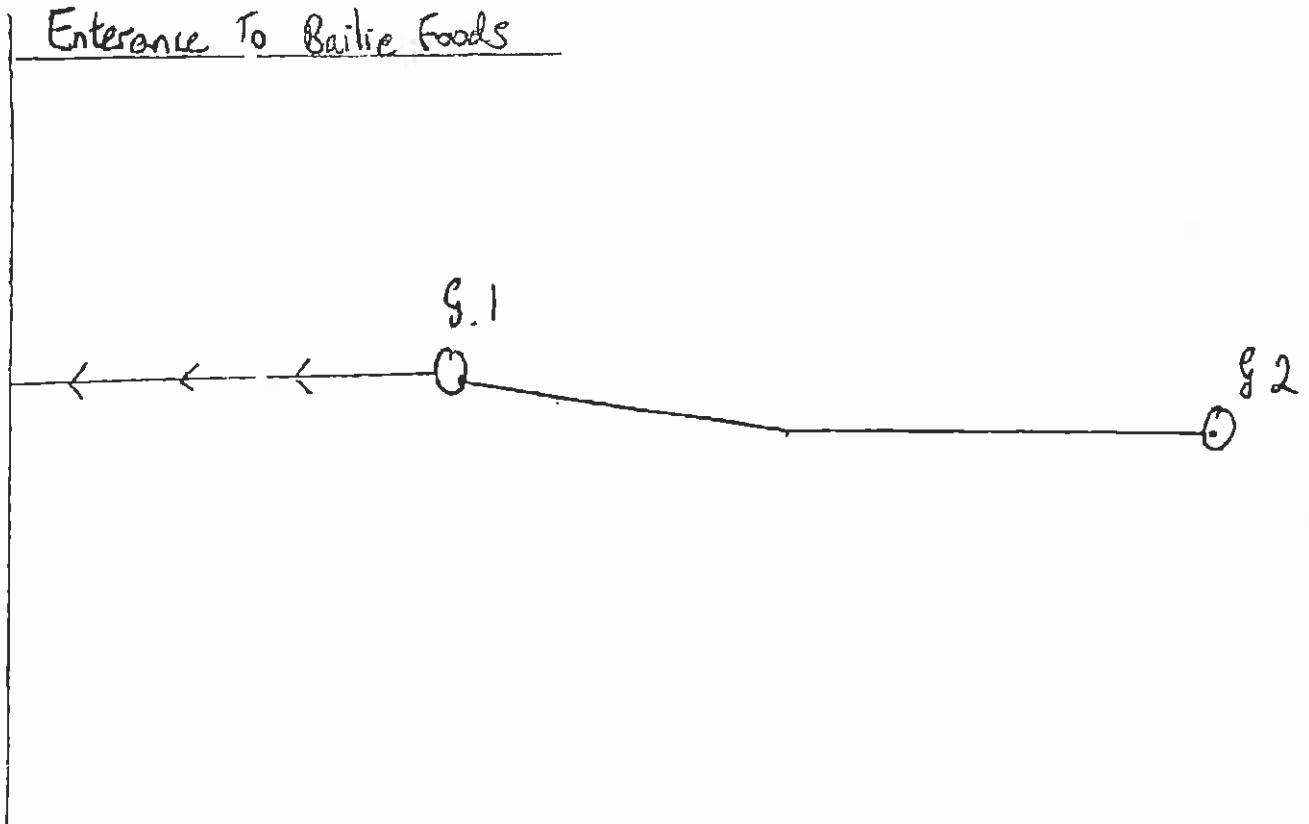
The surface water line at entrance to Bailie Foods ie manhole G1 to the river is collapsed as shown on page 9 is in need of repair. Manhole G17 to manhole19 is damaged as shown on page 10. All other surface water lines are in good working order.

Ground Water - g1 to River is Collapsed

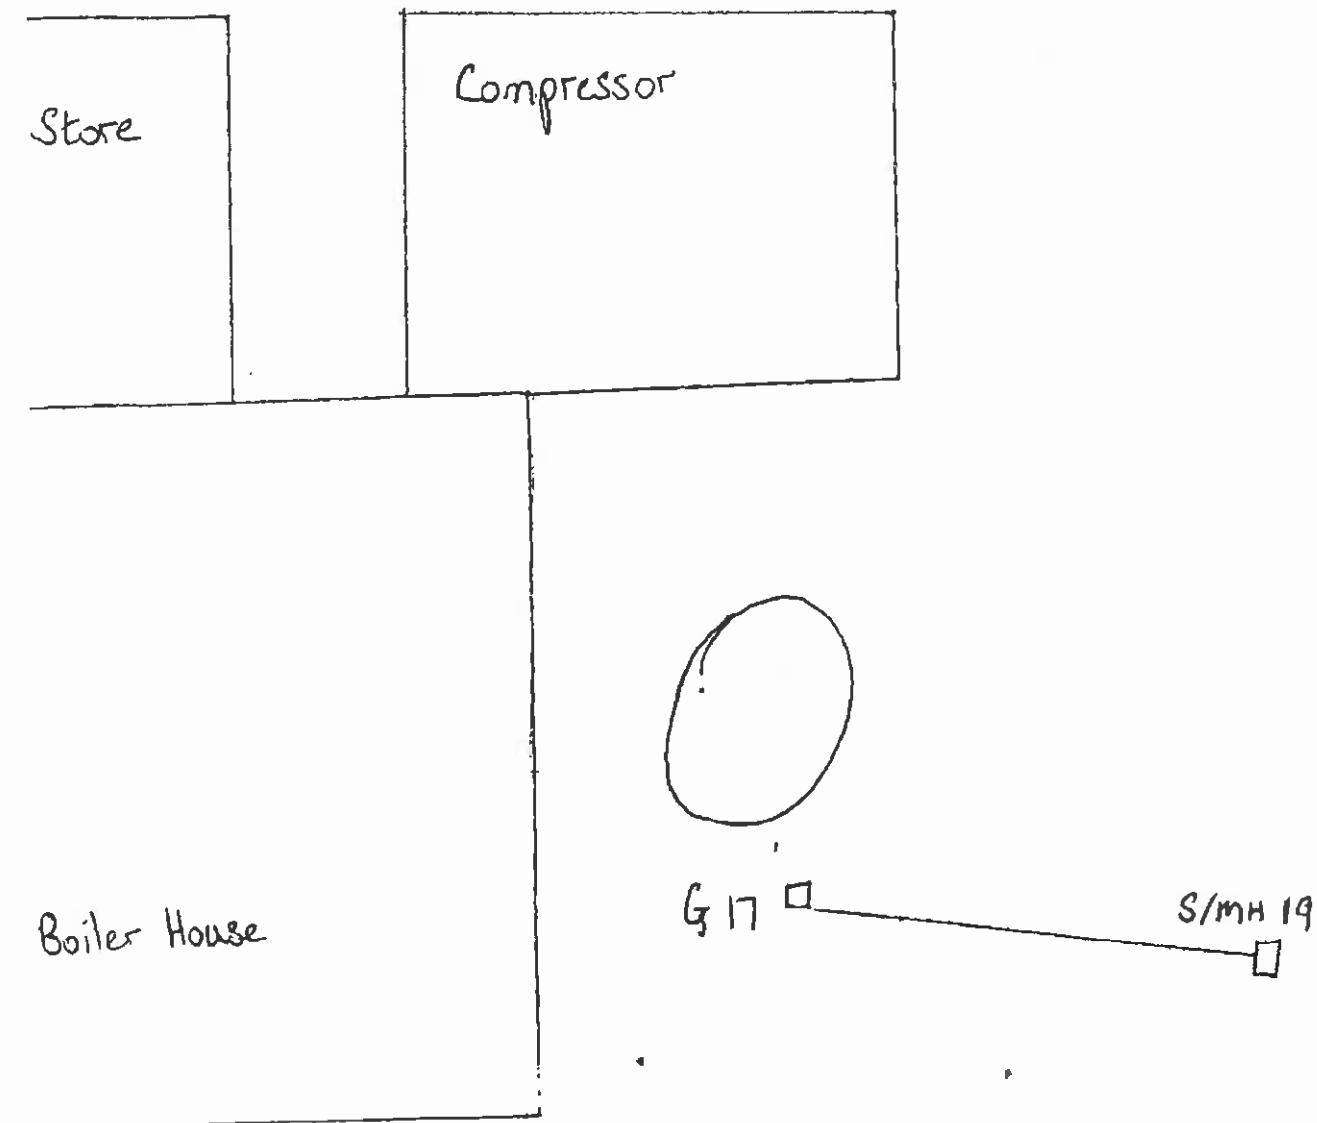
G 17 to 19 Is Badly Damaged

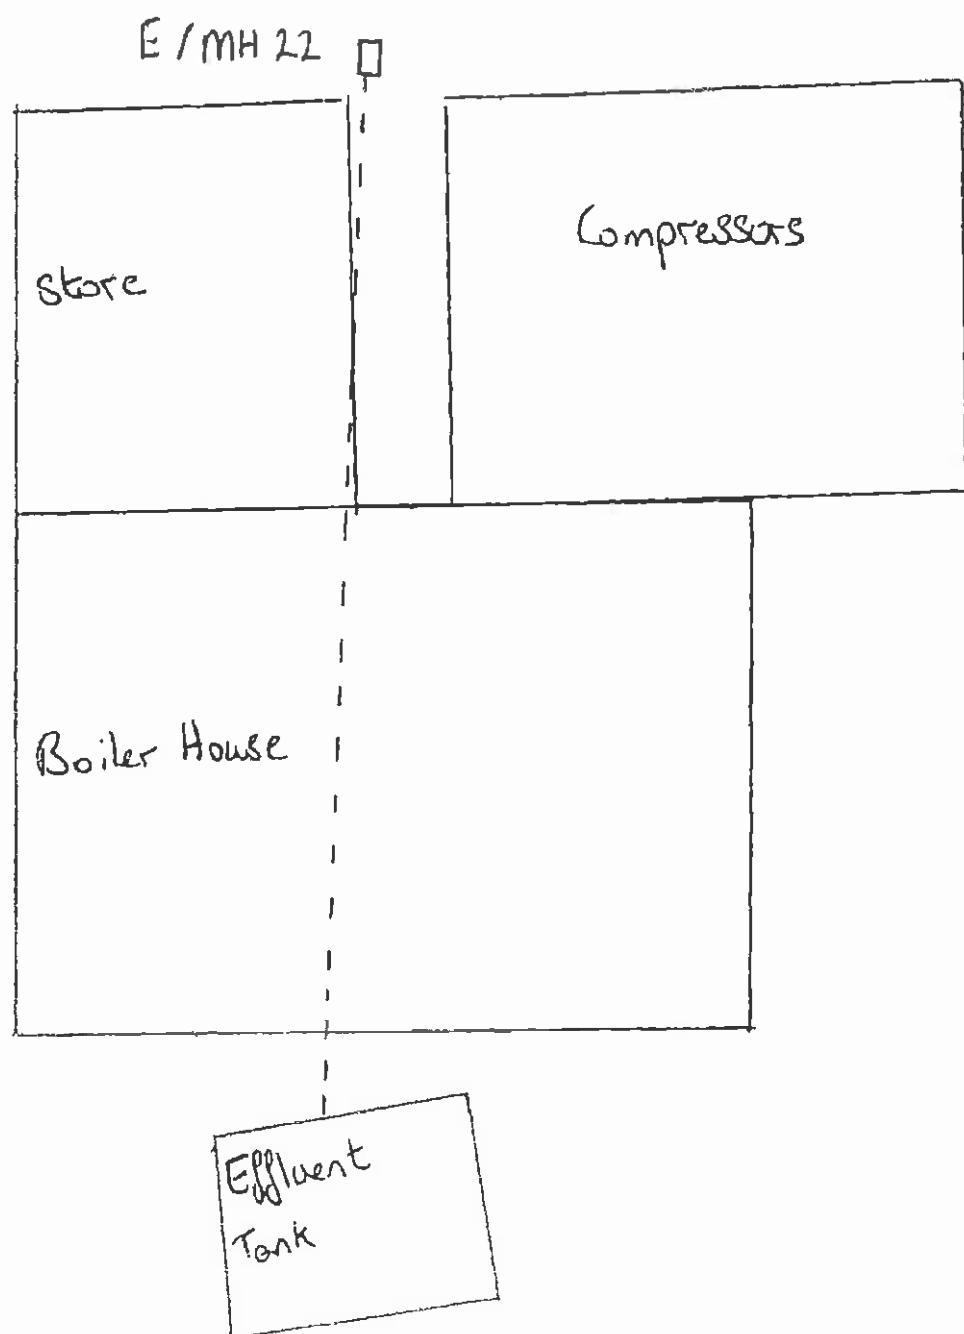
Effluent line from Manhole 22 → Effluent Tank Could Not be Surveyed  
Because of Constant Flow of Effluent

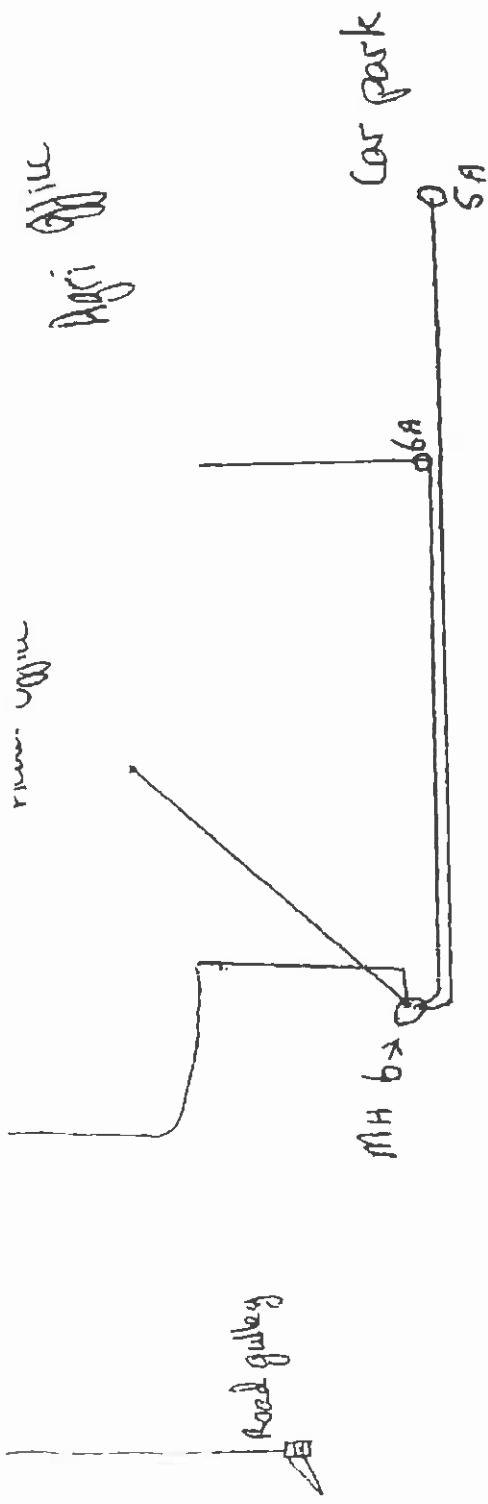
c Buildings flows to MH 6 At Entrance  
 Monhade regularly floods because the  
 outlets pipe from MH 6 is clogged  
 The road gully is covered with tar-mack  
 we could get into the road gully we  
 see how bad the damage is.
