ARTICLE 14 RESPONSE

Details of Waste Water Treatment Plant

SITE SUITABILITY REPORT

SITE CHARACTERISATION FOR AN ON-SITE WASTEWATER TREATMENT SYSTEM

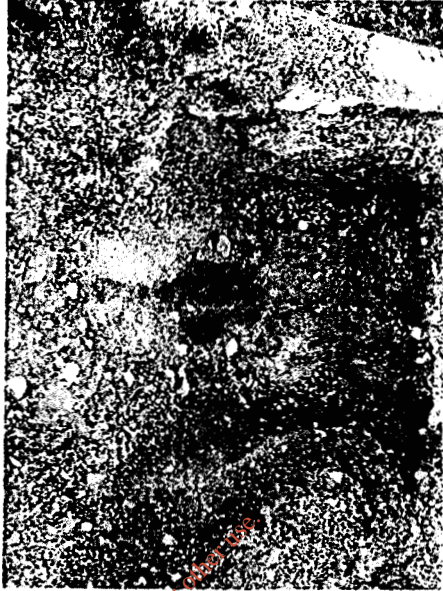
T - test Holes

Small puddle
in base of trail
hole after
night of heavy
rainfall.

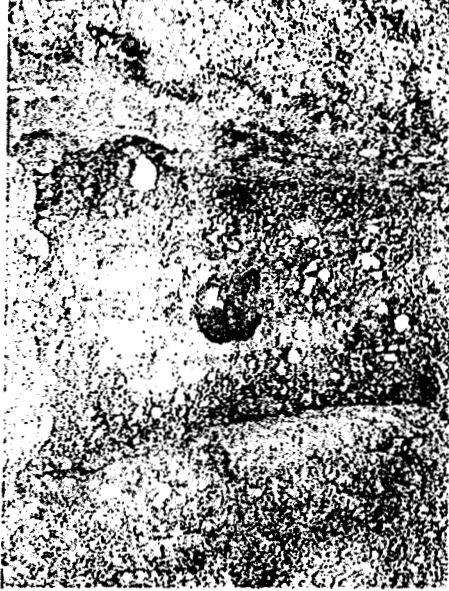
<i>Ground Condition</i>	Very firm mainly hardcore / gravel based surface
<i>Comments on above information incorporation desk study information:</i>	
Surface waters are a target. Fast flowing stream passes front of the site.	
Limited usage of an on-site system will reduce risk.	
Existing septic tank old, single chamber and considered unsuitable - will need to be replaced

Existing Office
building
served by an
existing septic
tank

There is an existing septic tank on the site beside where the tests have been carried out. However it is a single chamber tank and old and considered unsuitable for use. Taking into consideration the proximity of the stream and the aquifer it is recommended to install an advanced treatment system to provide added protection. Having encountered very compact / dense sub soils it is advised that when constructing a subsurface polishing filter that soil loosening is also carried out to a depth of 1.5m and that the whole percolation area is fenced off to prevent heavy transport from damaging it by compressing the ground. The system must be installed in accordance with the EPA Waste water Manuals. Please see cover letter attached.

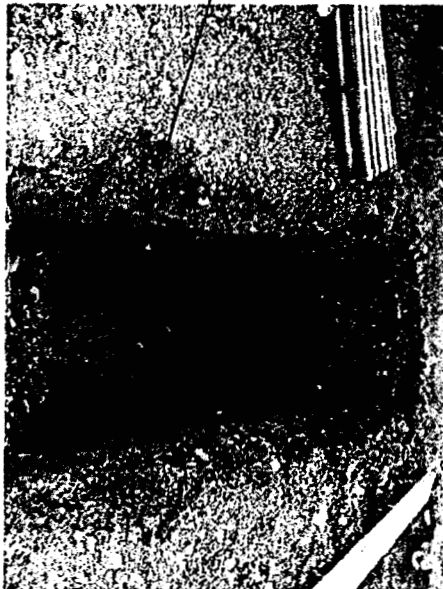
Trial Hole & Existing Building

Evaluation: Groundwater is not a target. The compactness of the subsoils will affect soakage. Area has hardcore surface and has had heavy machinery around it over the years which appears to be reflected in the first 0 - 0.8m where very compact soils were encountered.

In addition as per the recommendations in Section 5.0 of the Site Characterisation Form it is advised that the subsoil be loosened to a minimum depth of 1.5m and that the percolation area is fenced off to prevent heavy traffic from causing any damage by compression to the area.
