## OFFICE OF CLIMATE, LICENSING & RESOURCE USE

### INSPECTOR'S REPORT ON A CERTIFICATE OF AUTHORISATION APPLICATION

TO:	DIRECTORS	
FROM:	Caroline Connell	- Environmental Licensing Programme
DATE:	8 <sup>th</sup> June 2011	
RE:	<p>Application for a Certificate of Authorisation from:  <b>Cork County Council</b>, Inniscarra, Co. Cork,  for a historic unlicensed waste disposal landfill facility at:  Newmarket, Co. Cork.  Certificate of Authorisation Register Number <b>H0001-01</b></p>

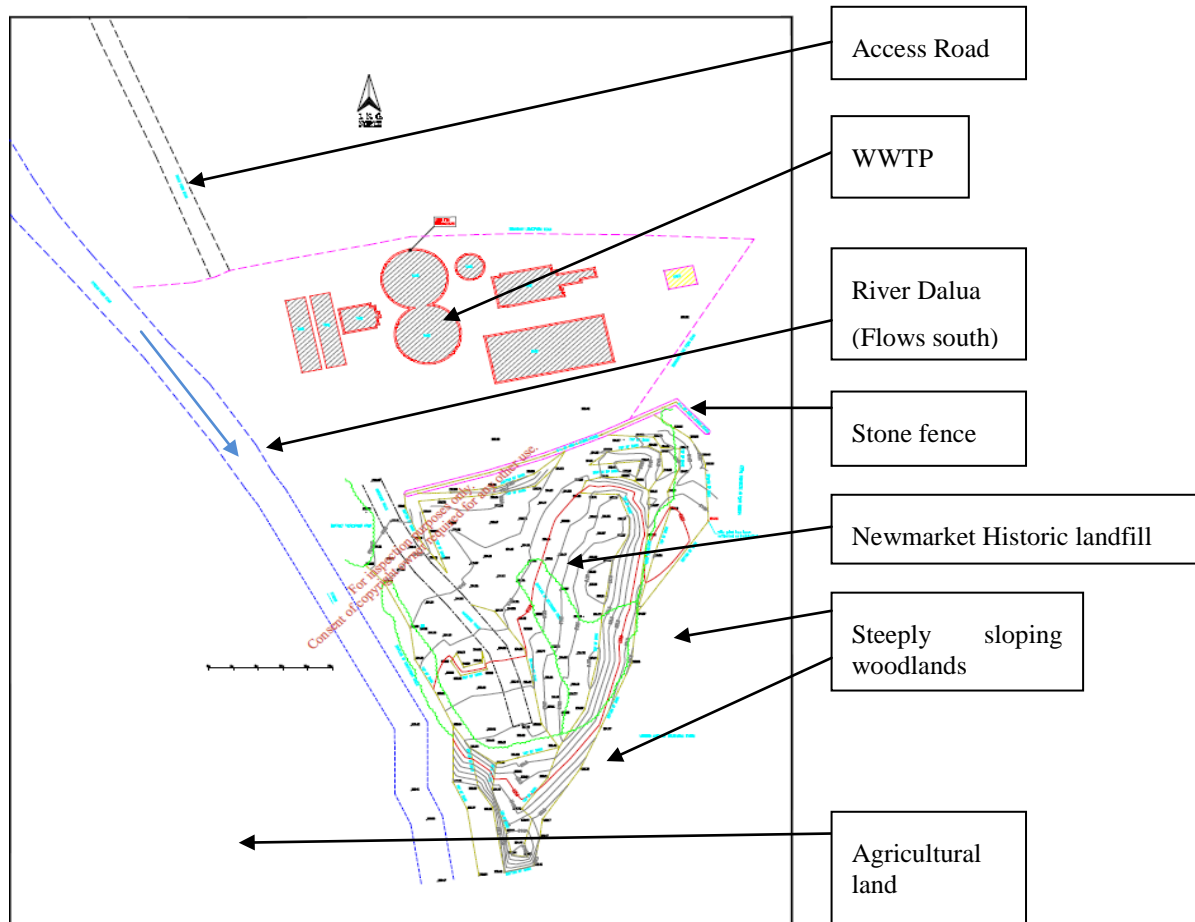
**Figure 2: Site Layout.**

- The northern extent of the landfill was defined by a hedgerow and a drainage ditch/stream which separates the site from the WWTP. This was confirmed as waste was encountered in TP-3/5/6 but was not found in TP-13/14.
- The eastern extent of the waste was established in TP-1. TP-8 and TP-9 confirmed that the waste extends approximately 3.5m to the west of the gravel access road.

- The southern extent of the landfill had to be defined visually as this area could not be accessed.
- The lateral extent of the waste shown in Figure 2 above below covers an area of approximately 2,300m<sup>2</sup>.
- It has been estimated that approximately 4,000m<sup>3</sup> of waste is deposited at the site.

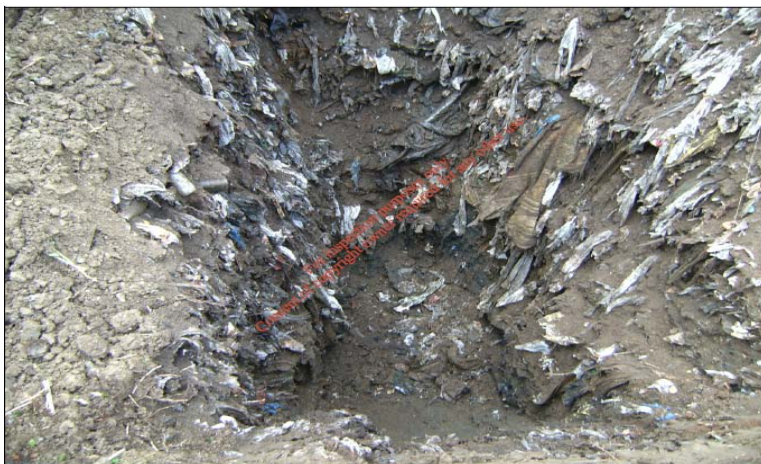
**Figure 3: Waste in TP-3.**

The waste encountered in the trial pits ranged from damp to dry with some wet zones at the base. The waste comprised a mix of plastic and glass bottles, occasional empty flattened steel drums, empty plastic drums, concrete pipes, steel, papers, tyres, tyre tubes, timber and trees, all of which were supported by a sandy matrix. The sandy clay may have been used as cover material when the site was operational; however, no discrete layers were noted. There was no evidence of any significant amounts of potentially hazardous waste, staining or odours. Leachate was not encountered. Figure 3 below illustrates the types of waste encountered.

Waste from TP- 2, TP-3, TP-4, TP-5 and TP-12 was tested, and with the exception of TP-2 and TP-12 the levels of all parameters tested were below the waste acceptance criteria (WAC) for inert waste set out in the Council Decision 2003/33/EC<sup>1</sup>.

The levels of Total Organic Carbon (TOC) in the sample from TP-2 were 76,000mg/kg, which is higher than the inert WAC of 30,000mg/kg for TOC. However the Council Decision has derogation, where the TOC levels above the threshold can be ignored if the Dissolved Organic Carbon (DOC) levels are less than 500mg/kg. The DOC for this sample was 36mg/kg and can therefore be characterised as inert. The TOC of a sample of underlying

In TP-12 sulphate, 1,500mg/kg, and Total Dissolved Solids (TDS), 5,300mg/kg, were both above their respective inert WAC of 1,000mg/kg and 4,000mg/kg. However the Council Decision states that where the sulphate level exceeds its threshold, the material can still be categorised as inert if the TDS value does not exceed 6,000mg/kg. In the case of TP-12 the TDS is below 6,000mg/kg.

Overall taking the above into consideration the waste has been characterised as inert.

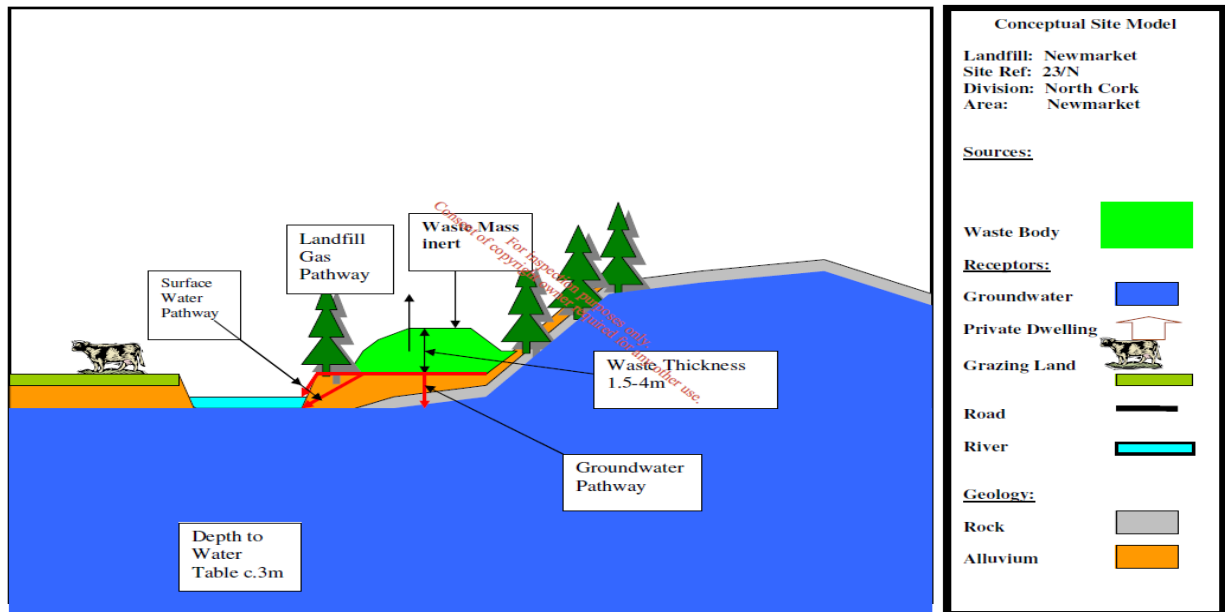
**Figure 4: Refined Conceptual Site Model (Tier 3).**

Rain falling on the waste body will infiltrate the waste and discharge along the base into the surrounding surface water streams or migrate vertically toward the subsoils (see Figure 4 on page 7). The natural subsoils beneath the waste have been reported to be of low permeability and appear to retard the movement of infiltrating rainfall. It is likely that most rainfall reaching the base of the waste will ultimately discharge laterally along the base of the waste into the surrounding surface water drainage system with a small amount reaching the water table and ultimately entering the adjacent Dalua River as shallow baseflow.

As identified in Figure 4 below potential receptors which may be impacted by the landfill include:

- Immediate surrounding land and groundwater
- Surface water
- Atmosphere
- Conservation areas

The Tier 3 Assessment involved a review of the Tier 1 conceptual site model (CSM – Figure 4 on page 7) after the Tier 2 Assessment was complete. In line with the COP, Cork County Council determined that a Quantitative Risk Assessment was not required to be undertaken due to the low risk rating determined by the Tier 2 Assessment.

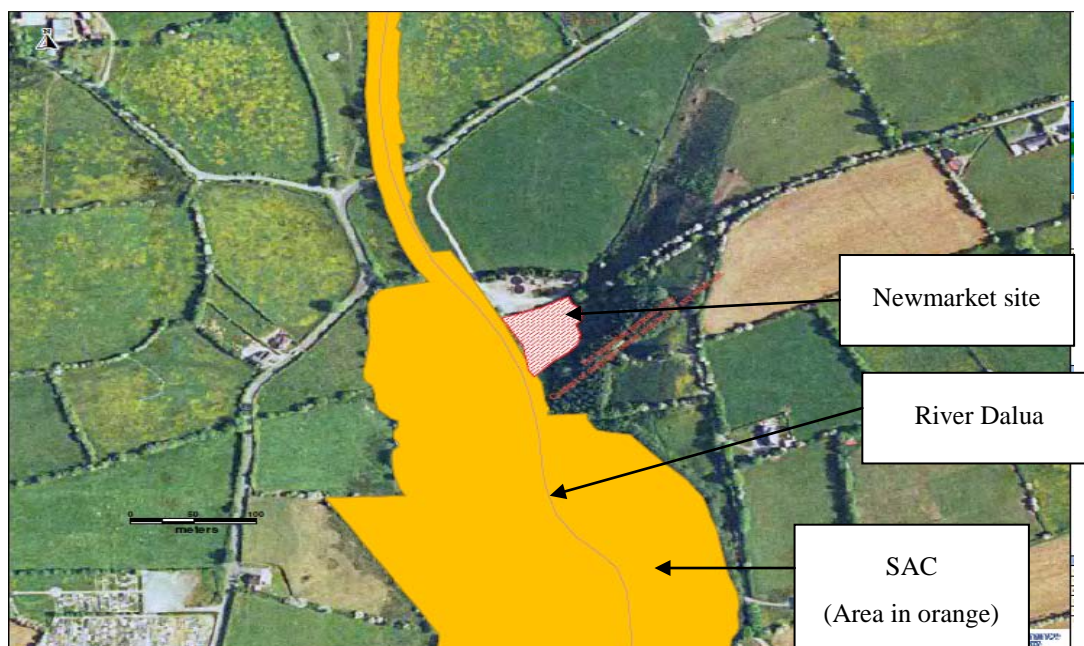
**Figure 5: Special Area of Conservation**

As shown in Figure 5 below the landfill site is adjacent to the Blackwater River Special Area of Conservation (SAC) (Site Code 002170).

Cork County Council have concluded that the landfill is not impacting on the groundwater or the surface water and that it is therefore not impacting on the SAC adjacent to the site.

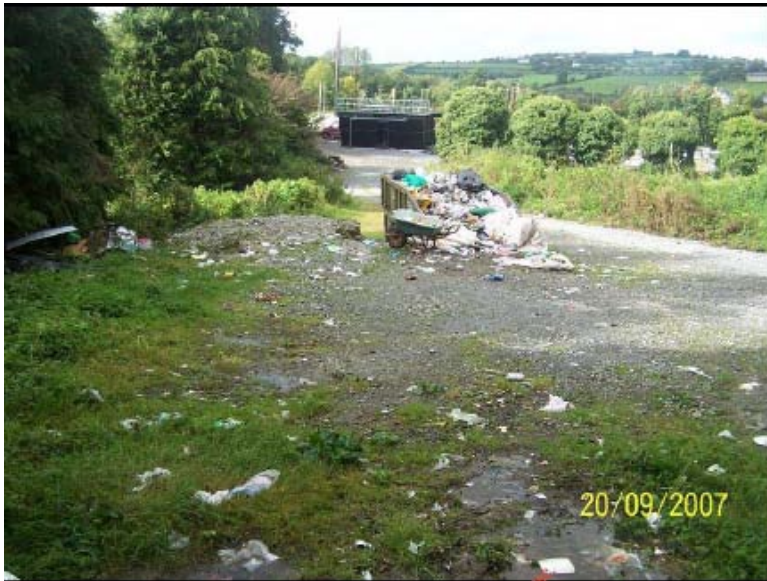
skip of waste remains near the access point to the site (see photos attached in Appendix 1). During the walkover survey no evidence was found of leachate or landfill gas. Odour was noted coming from the skip.

**Photo 1: Facing northwest towards the entrance to the site.**

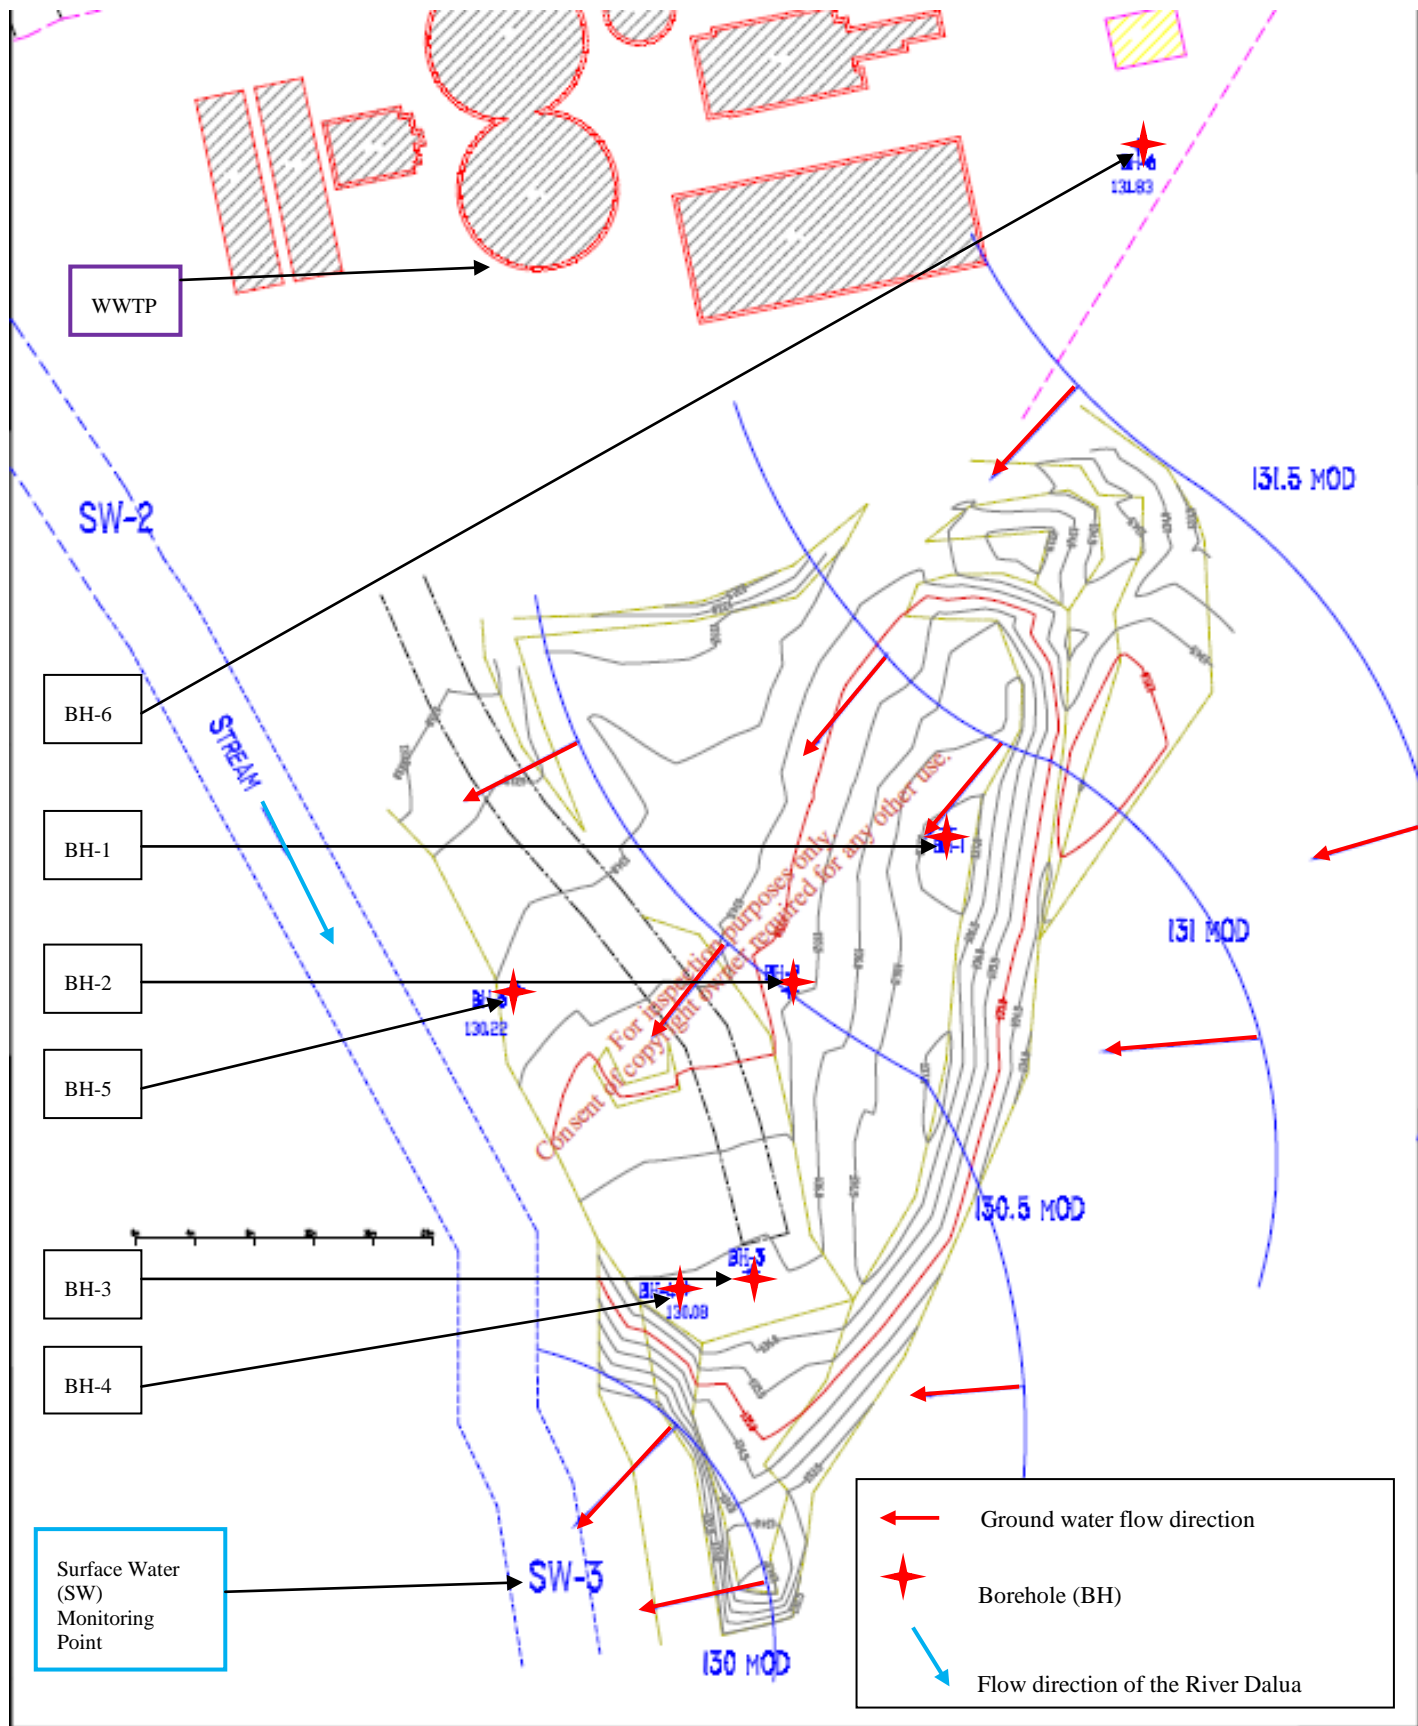
Figure 6: Groundwater flow direction 24 June 2007 and borehole locations.

Three wells BH-4, BH-5 and BH-6 (see Appendix 2) were installed to monitor groundwater levels and quality up and down the hydraulic gradient of the site. Based on the topography, the direction of groundwater flow was expected to be from the north east to the south west of the site towards the River Dalua. The groundwater flow regime is presented in Appendix 2. BH-4 was located in the most southerly accessible area of the site, which is downgradient of the majority of the waste body. BH-5 was installed in the west of the site where trial pits had not identified wastes and was therefore considered downgradient of the waste body. BH-6 was located in the north eastern corner of the site, outside of and upgradient of the waste body.

Borehole installations at the site confirmed the aquifer vulnerability rating with depth to bedrock levels recorded at one metre below ground level (mbgl) in BH-4, 1.1mbgl in BH-5 and 1.8mbgl in BH-6. The depth to the water table is approximately 3m as demonstrated in Figure 4 above. Groundwater samples were taken from BH-4, BH-5 and BH-6 on the 24 June 2008. Samples were analysed for a range of organic and inorganic parameters. All samples analysed were below their respective IGV Guideline limits except in the following cases:

- Ammonium was detected at a level of 2.05mg/l in BH-6, which is higher than the IGV of 0.15mg/l for ammonium. The contamination is not attributed to the landfill. Ammonium was not detected in the downgradient wells BH-4 and BH-5.
- Cyanide was detected in BH-4 and BH-6 at levels of 0.03mg/l which are higher than the IGV of 0.01mg/l for cyanide.
- Total Petroleum Hydrocarbons (TPH) were detected in BH-6 at a level of 0.038mg/l which is higher than the IGV of 0.01mg/l.
- The herbicide dichlobenil was detected at BH-6 at a level of 0.126µg/l which is higher than the IGV for individual pesticides. The total levels of pesticides detected at BH-6 was however only 0.126µg/l, which is lower than the IGV for total pesticides of 0.5µg/l.

The analytical data suggests that the waste material on site does not have an impact on the groundwater downgradient of the site. Ammonium, pesticides and TPH were detected at very low levels in the upgradient well BH-6. The only parameter that is higher than its respective IGV downgradient of the waste is cyanide. Cork County Council considers cyanide to be naturally occurring as the levels in the upgradient well exceed the IGV and cyanide was also detected in the surface water monitoring point upstream of the landfill site as outlined on page 9. The low level ammonia, hydrocarbon and pesticide contamination detected in the upgradient well may be linked to agricultural practices locally and possibly minor spills of fuel or oils in the vicinity of the WWTP plant. Cork County Council does not consider the levels detected to be associated with the presence of the landfill site.

Condition 3.4 of the recommended certificate of authorisation requires annual sampling, analysis and characterisation of groundwater from at least two available groundwater monitoring boreholes, one of which shall be downgradient of the closed landfill.

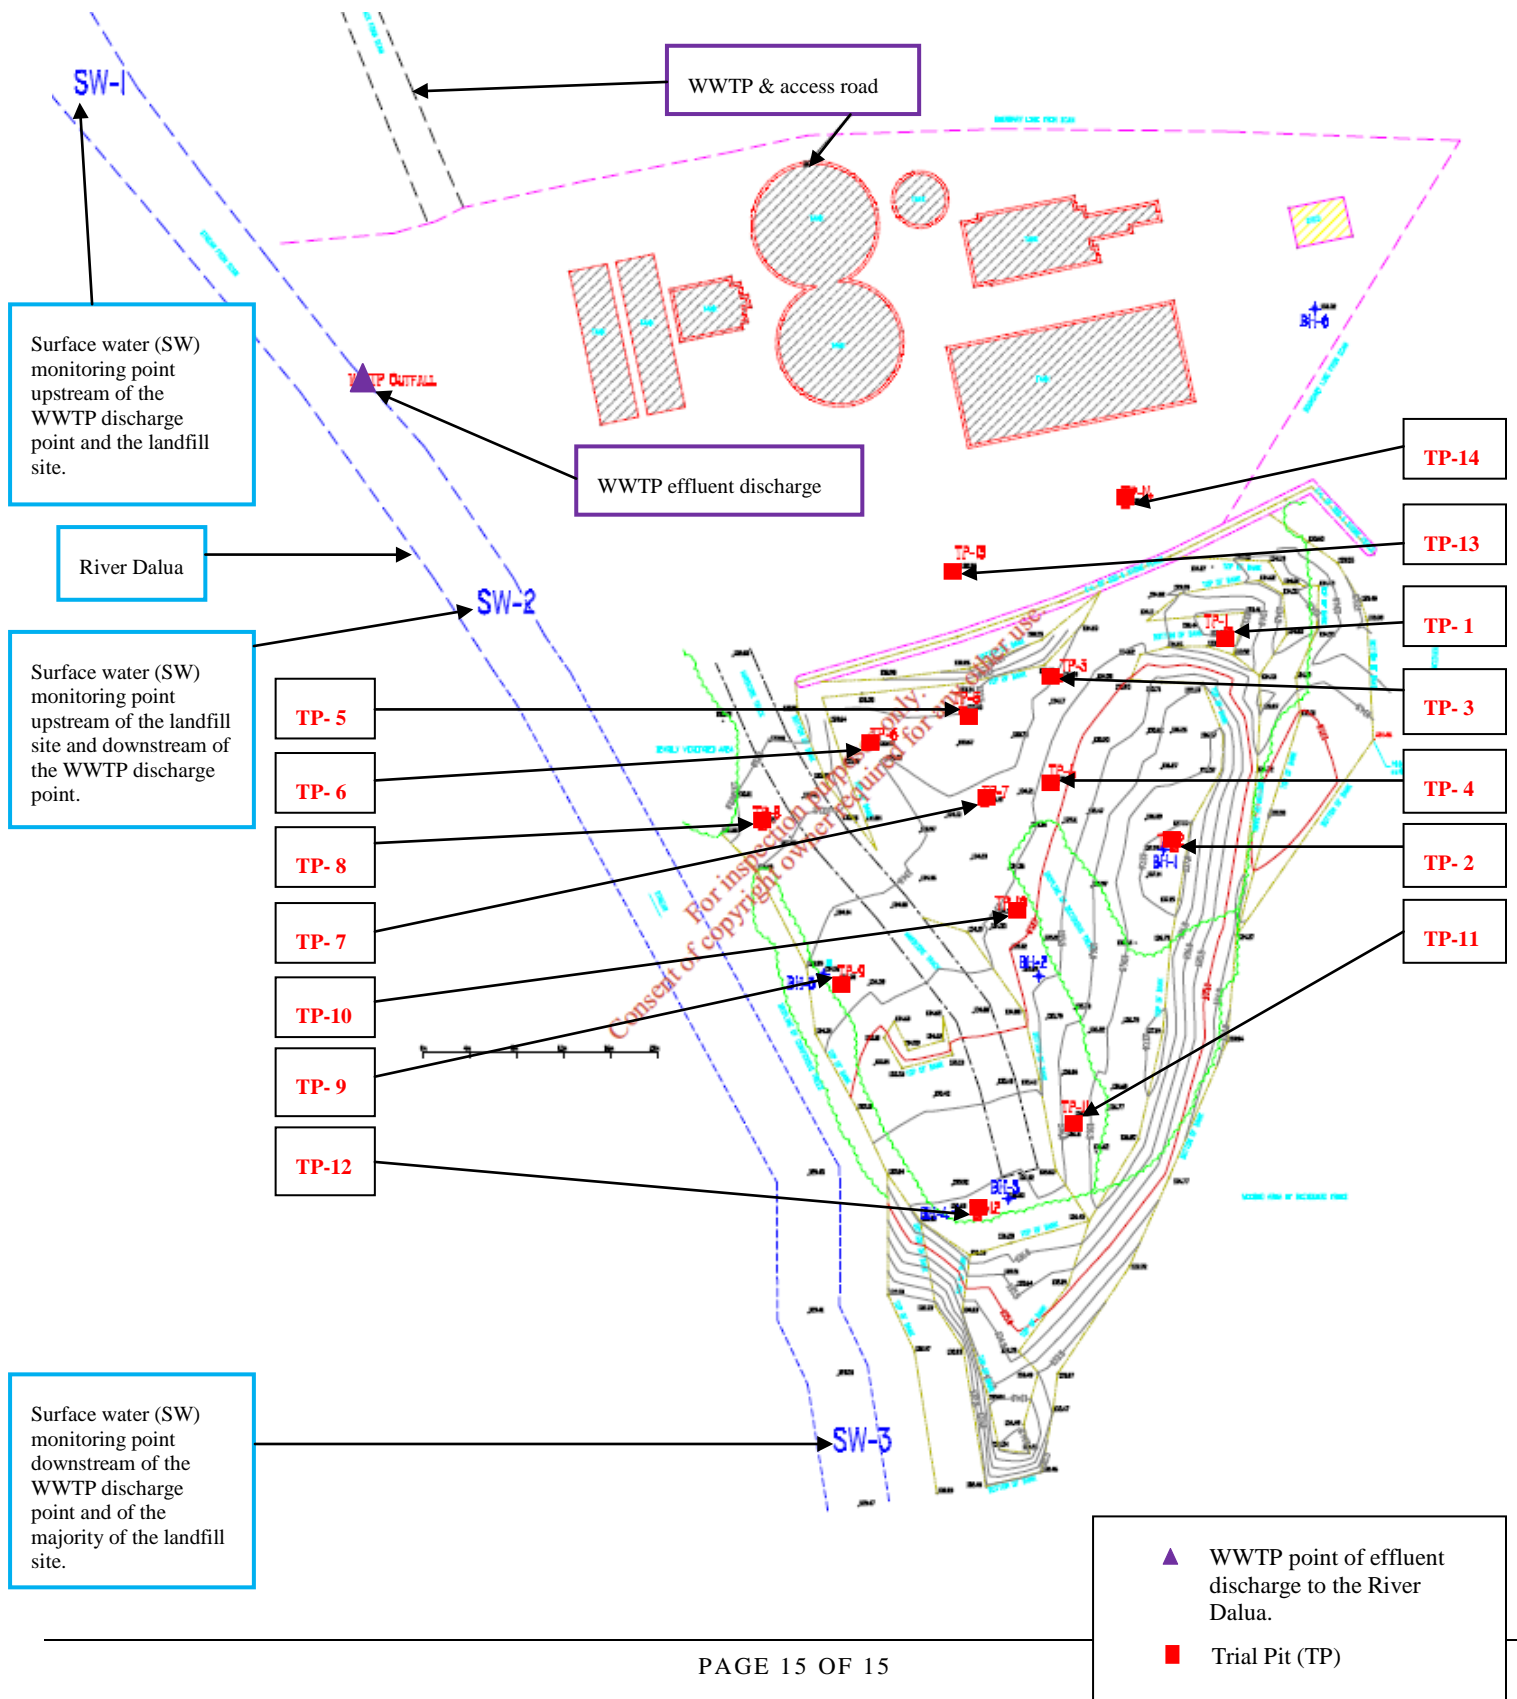
**Figure 7: Trial pit and surface water sampling point locations.**

Fourteen trial pits (TP) were excavated (see Appendix 3) in order to determine the lateral and vertical extent of the waste.

Surface water samples were taken in the river in three locations on 24 June 2008. SW-1 was an upstream sample location which was located north of the site and the WWTP. SW-2 was taken downstream of the WWTP discharge but upstream of the landfill and the drains that discharge to the river. SW-3 was taken downstream of the waste body and of all surface water discharges into the river from the landfill area. The location of the sampling points is shown in Appendix 3.

Samples collected from SW-1, SW-2 and SW-3 were analysed for a range of organic and inorganic parameters. Cork County Council assessed all monitoring results against the relevant standard outlined in the “*Parameters of Water Quality – Interpretation and Standards*” published by the EPA in 2001 and confirmed that all parameters analysed were below their respective standards, except for cyanide which was detected at levels greater than 0.01mg/l in all three samples taken. It is noted that 0.01mg/l is the environmental quality standard (EQS) specified for cyanide in the European Communities Environmental Objectives (Surface Waters) Regulations 2009. SW-1 had the highest levels of cyanide (0.06mg/l) while SW-2 and SW-3 had levels of 0.03mg/l. Cork County Council have concluded that due to the detection of cyanide in the upstream location and in the groundwater samples taken indicates that this parameter appears to be present naturally above the relevant guideline limit and is not due to the presence of the landfill site.

The water quality between all three samples was noted to be generally very consistent. Zinc fluctuated slightly; however, downstream levels were less than those found upstream of the landfill. Concentrations of ammonia, orthophosphate, cadmium, mercury and phenol reported could not be assessed in terms of compliance with the European Communities Environmental Objectives (Surface Waters) Regulations 2009. This is due to the fact that the limit of detection exceeds the respective thresholds under the Regulations. However as noted above, downstream concentrations are generally no greater than upstream.
