R&A Bailey
IPPC Licence No. P0807-01

Annual Environmental Report
2011

2011 Boiler Combustion Testing Report	29
ATTACHMENT 2	30
2011 Noise Report	30
ATTACHMENT 3	31
Bund Integrity Assessment Report 2011	31

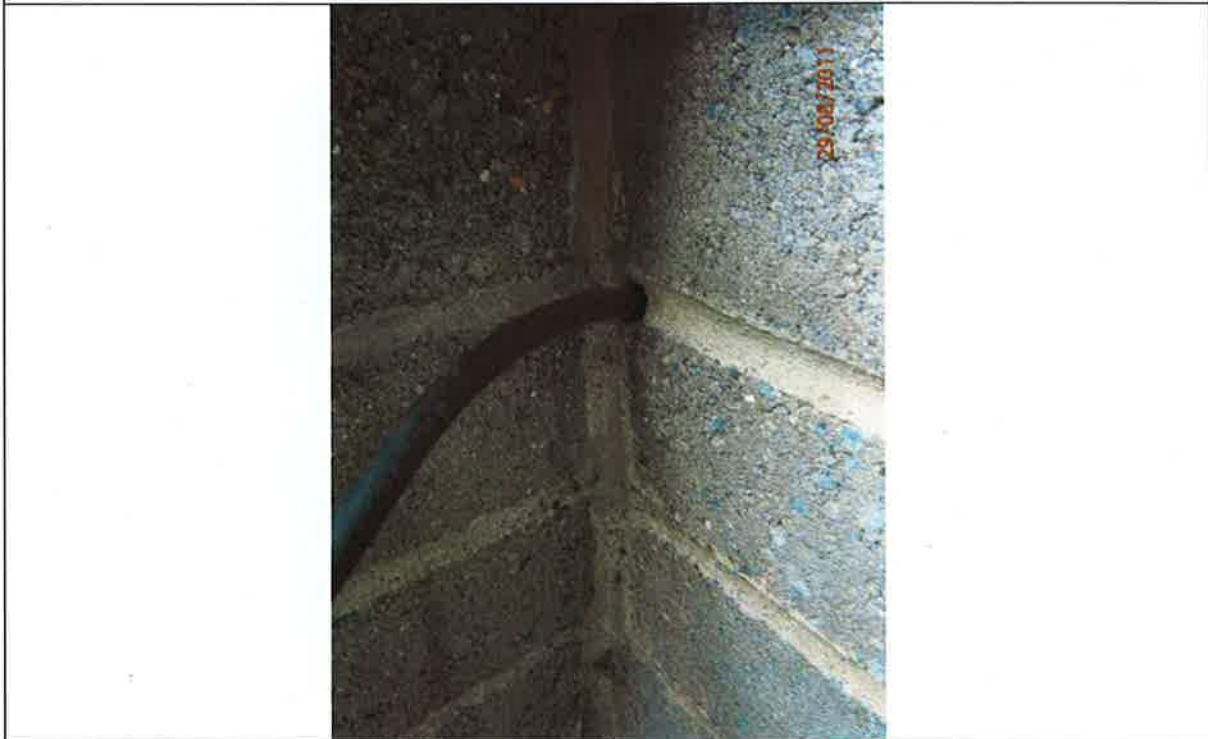
Figure 1.2: Bund 01 – Breach of bund wall by electrical cable

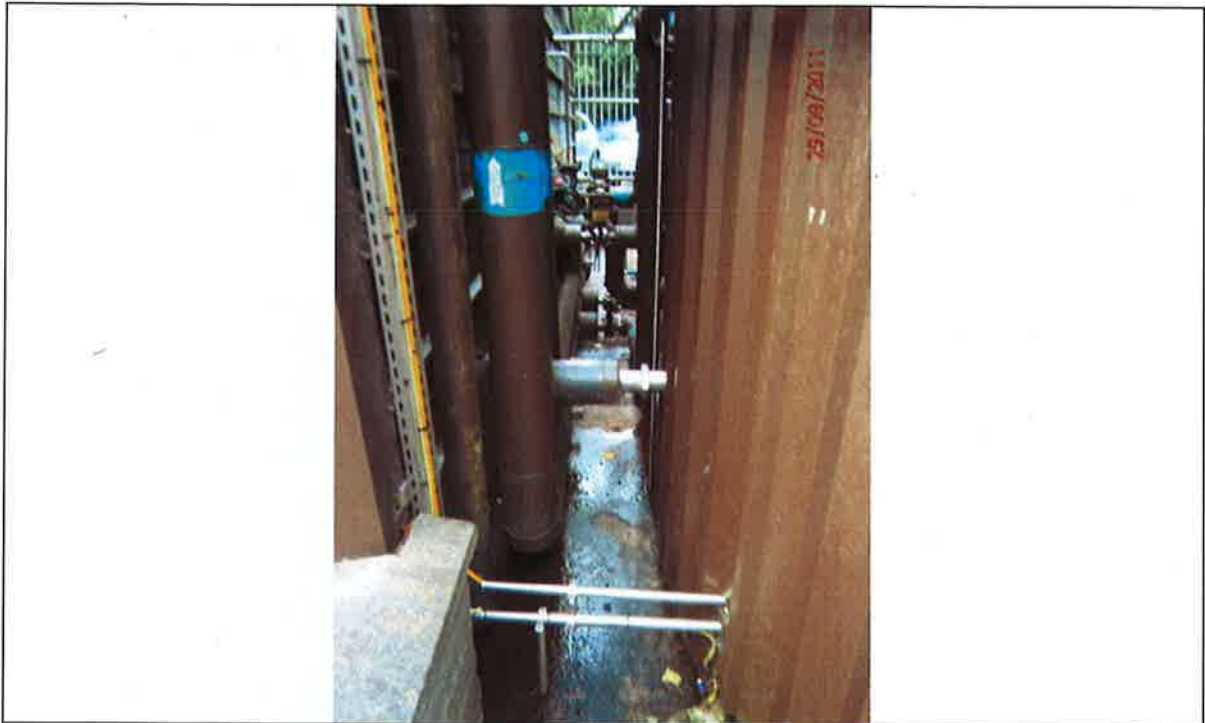
Figure 1.3: Bund 01 – Proximity of CBST1 to east side of bund, limited of access space around tank

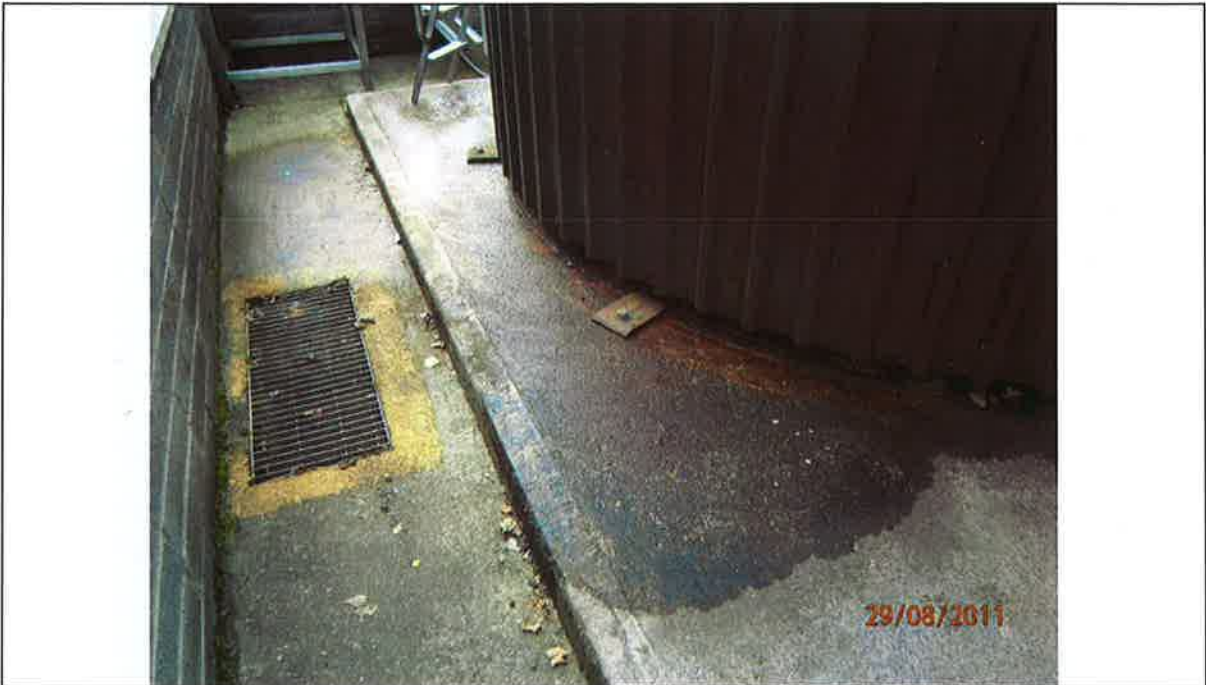
Figure 2.2: Bund 02 – Base of bund wet

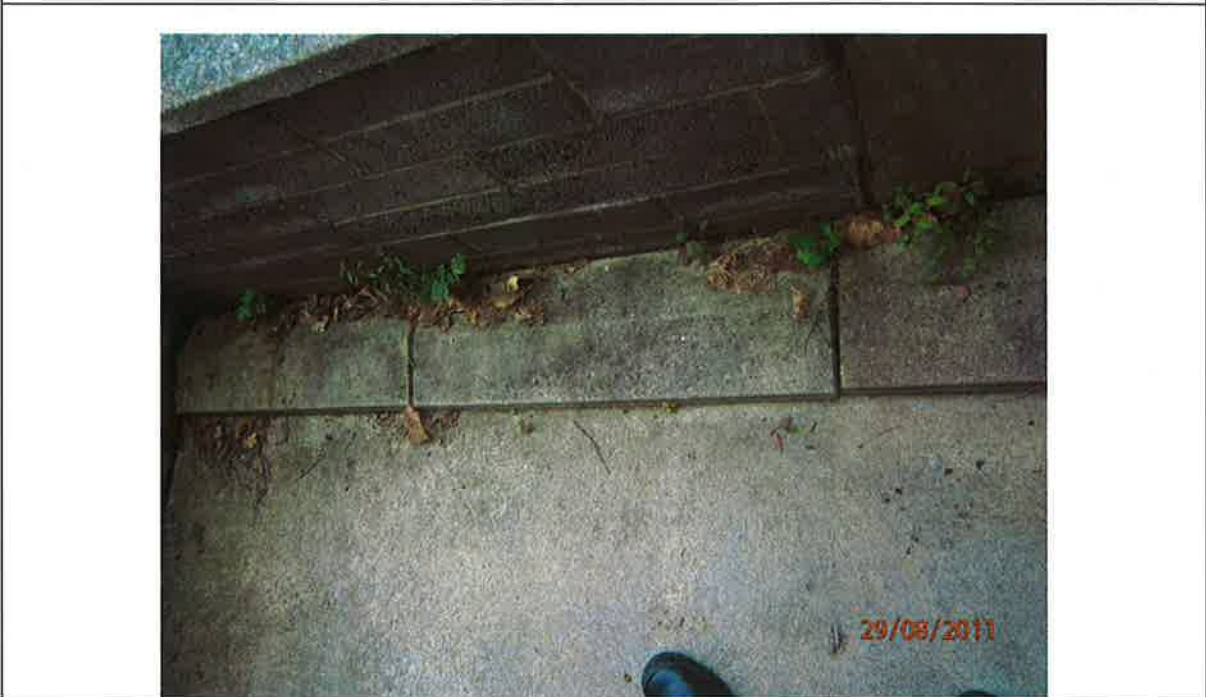
Figure 2.3: Bund 02 – Pillars stored in bund

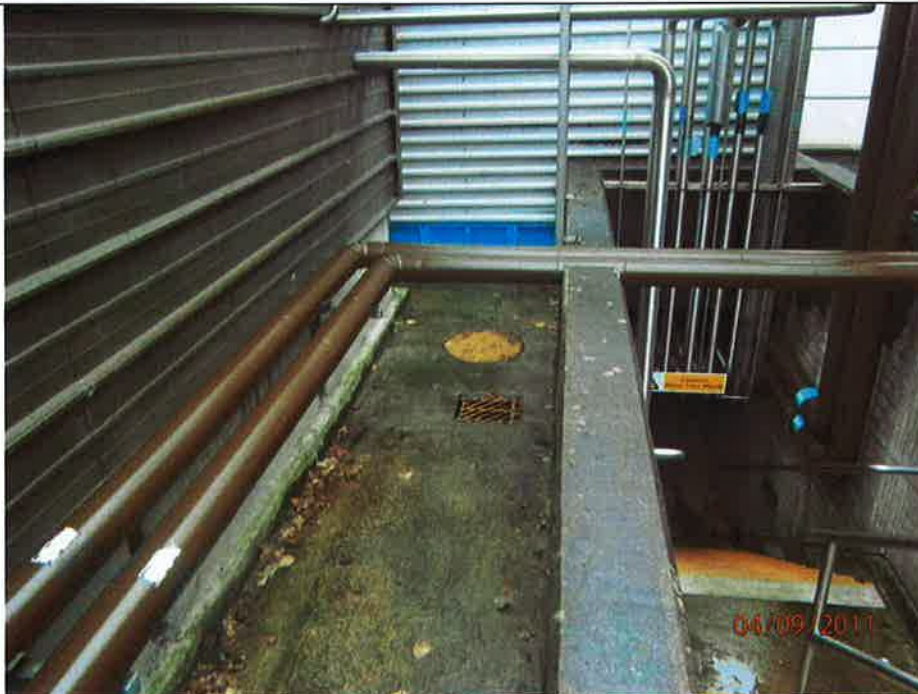
Figure 3.2: Bund 03 – Drain and piping between Bund 03 and ductway

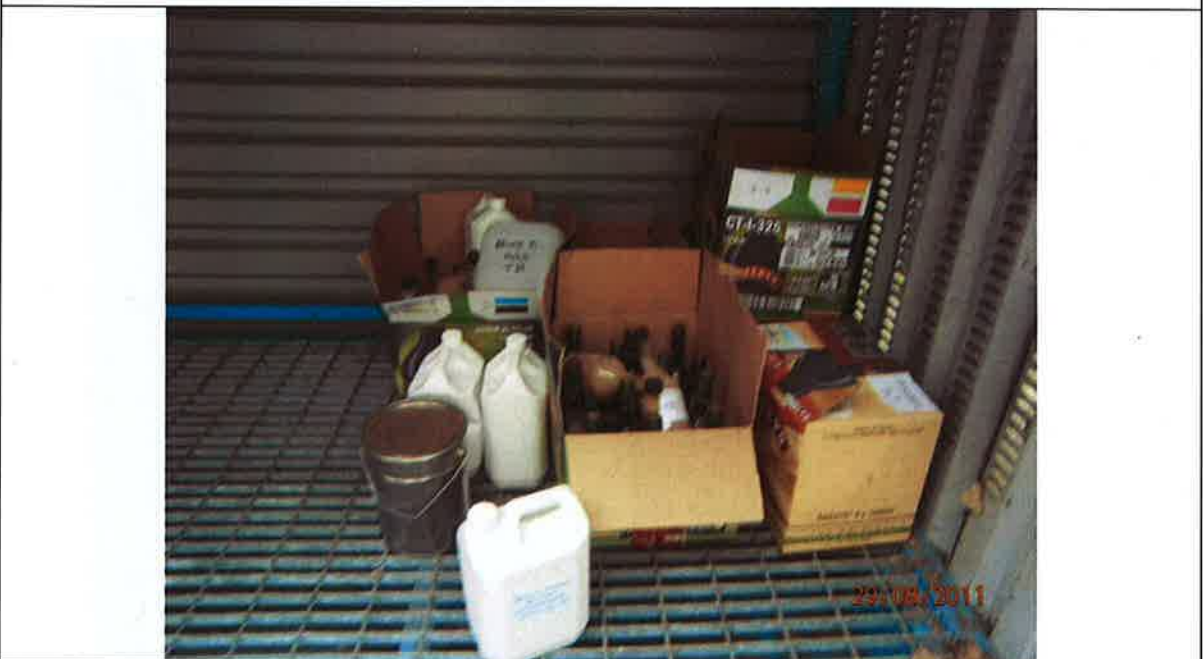
Figure 4.2: Housekeeping – Open boxes overfilled with bottles

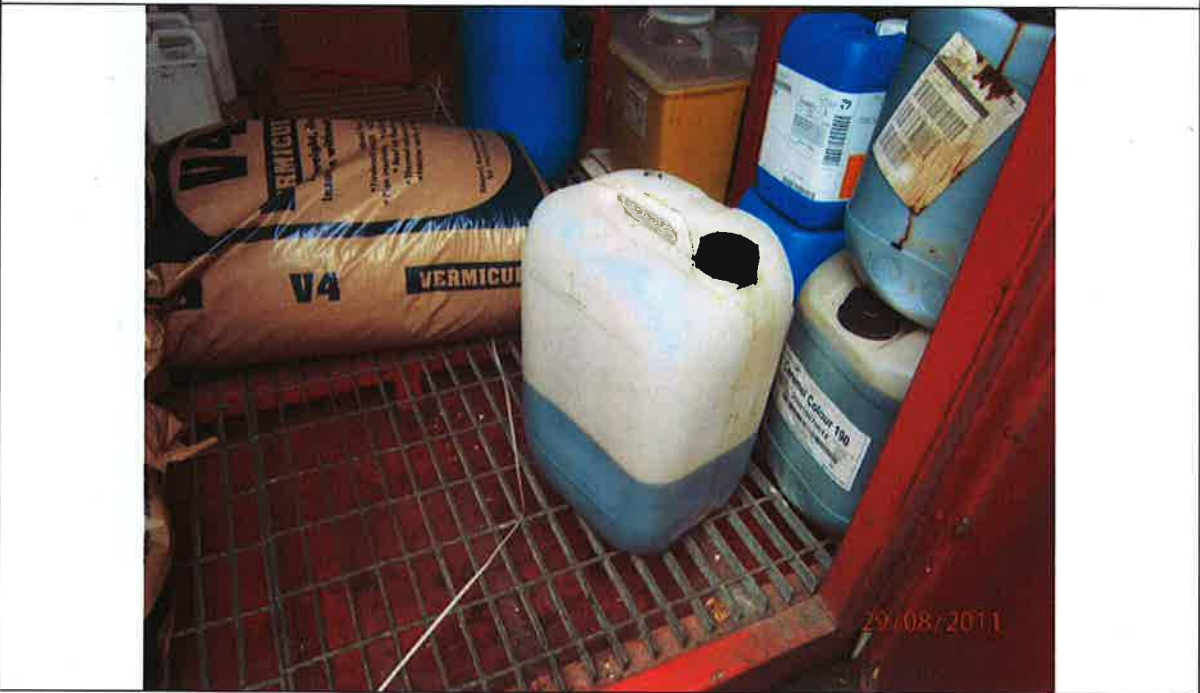
Figure 5.4: Bund 05 – Evidence of haphazard storage in bund container

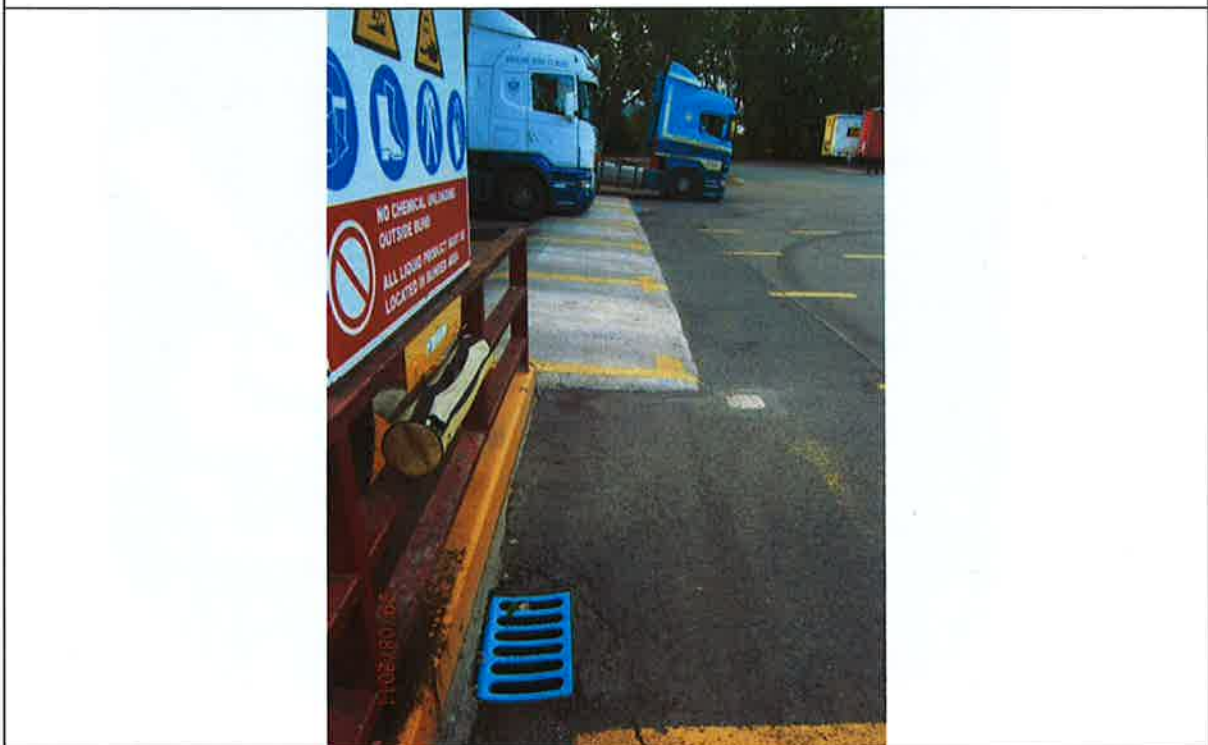
Fig. 6.2 Bund 06 – Surface water drains close to bund

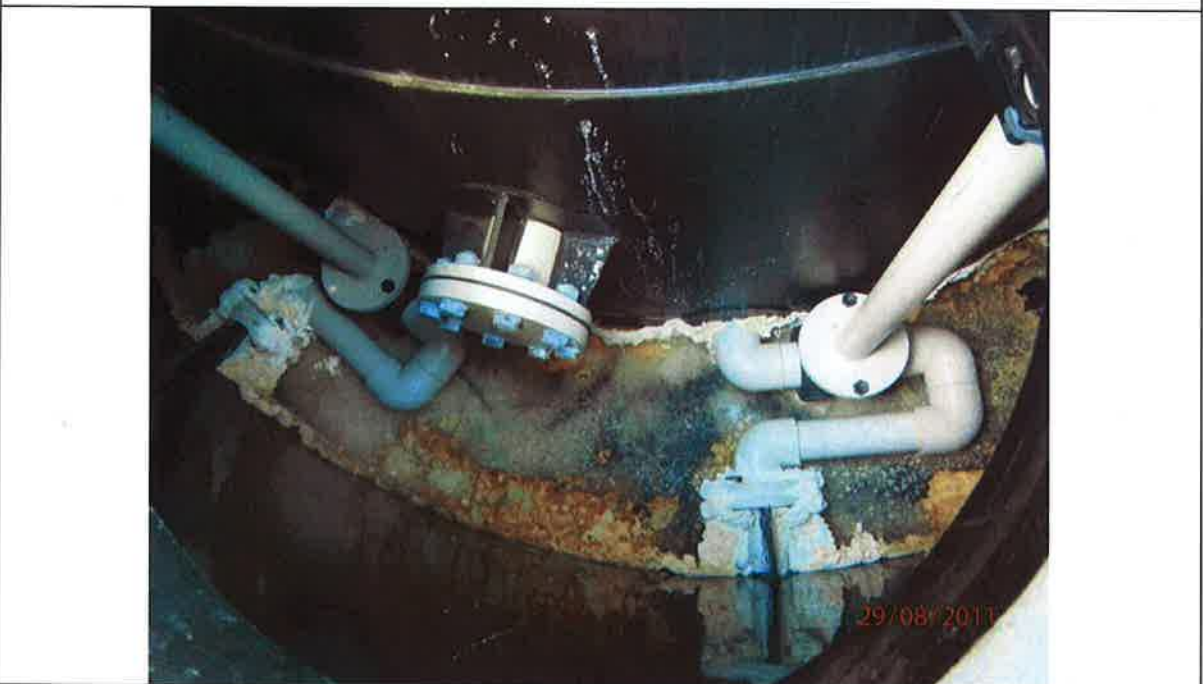
Fig. 7.2: Bund 07 – Liquid caustic retention

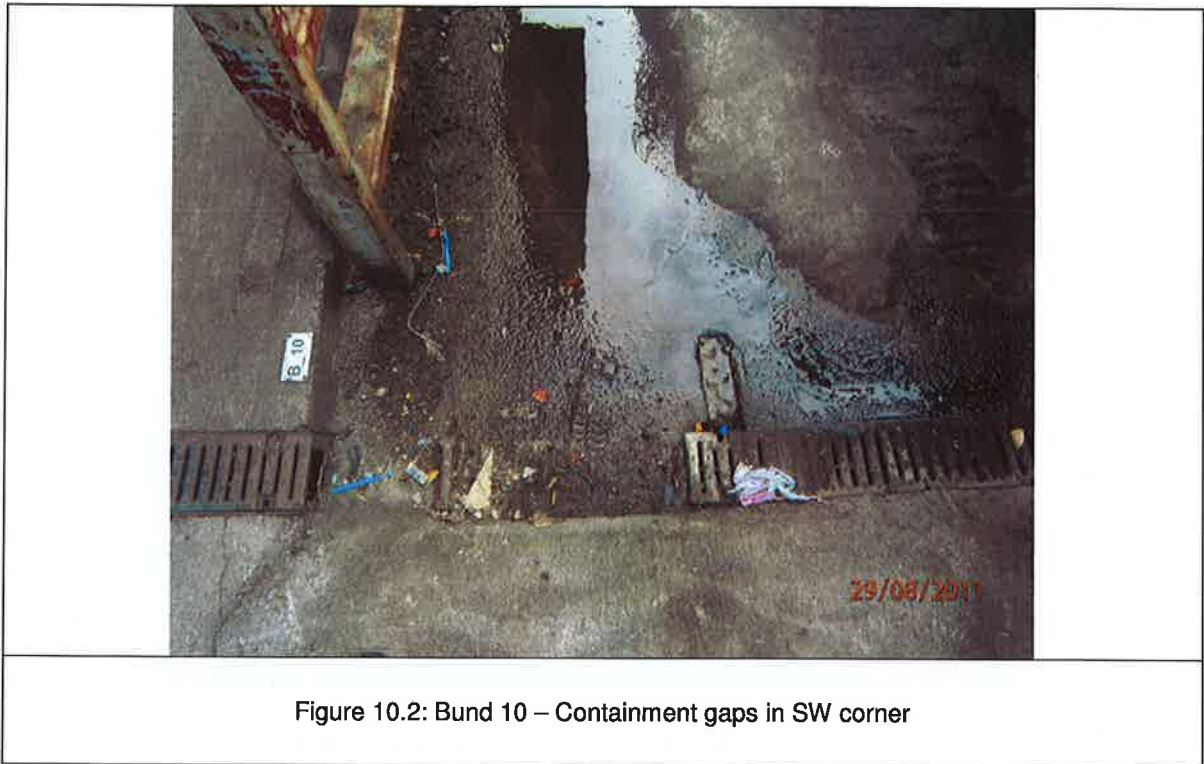
Figure 10.2: Bund 10 – Containment gaps in SW corner

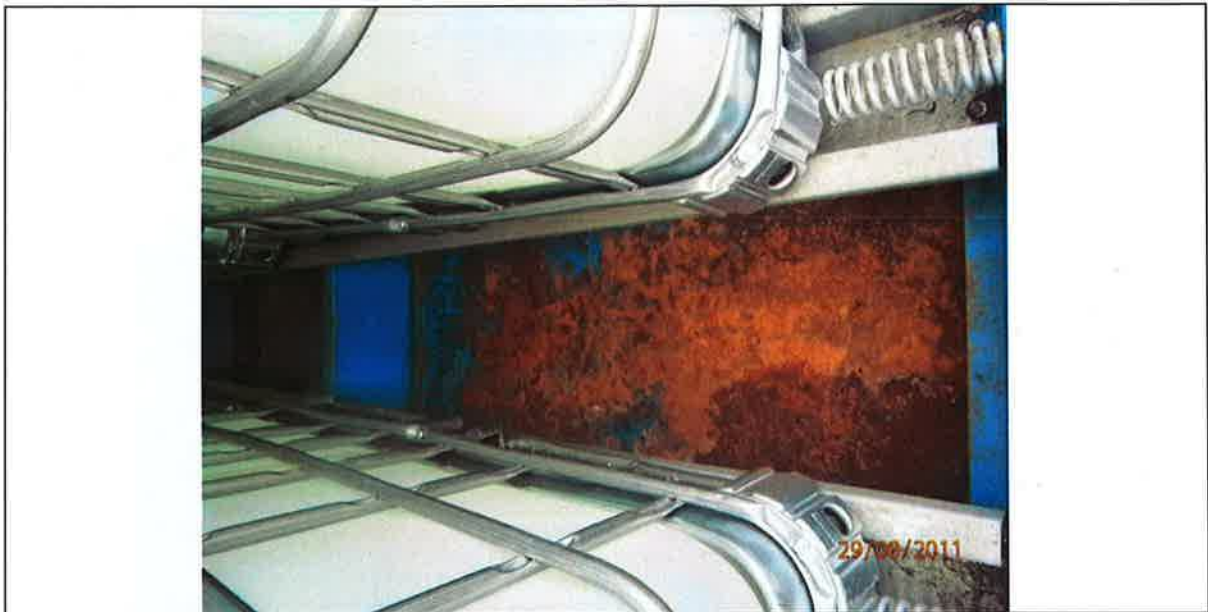
Fig. 14.2: Rusting at base of Bund 14

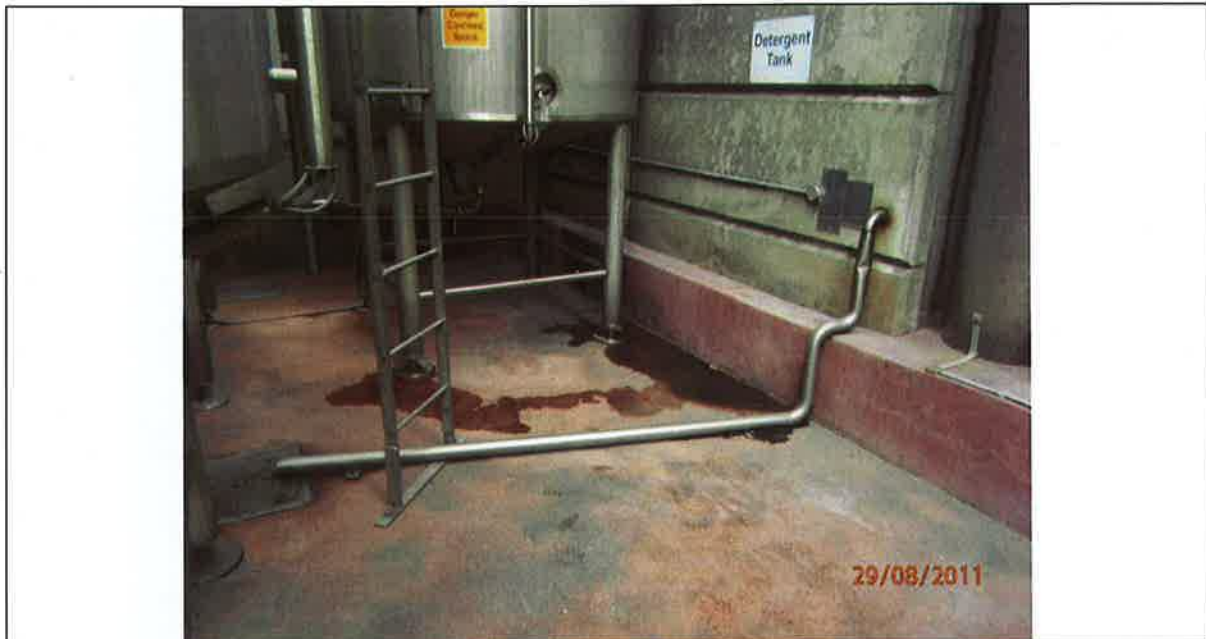
Fig. 17.2: Spill around detergent tank

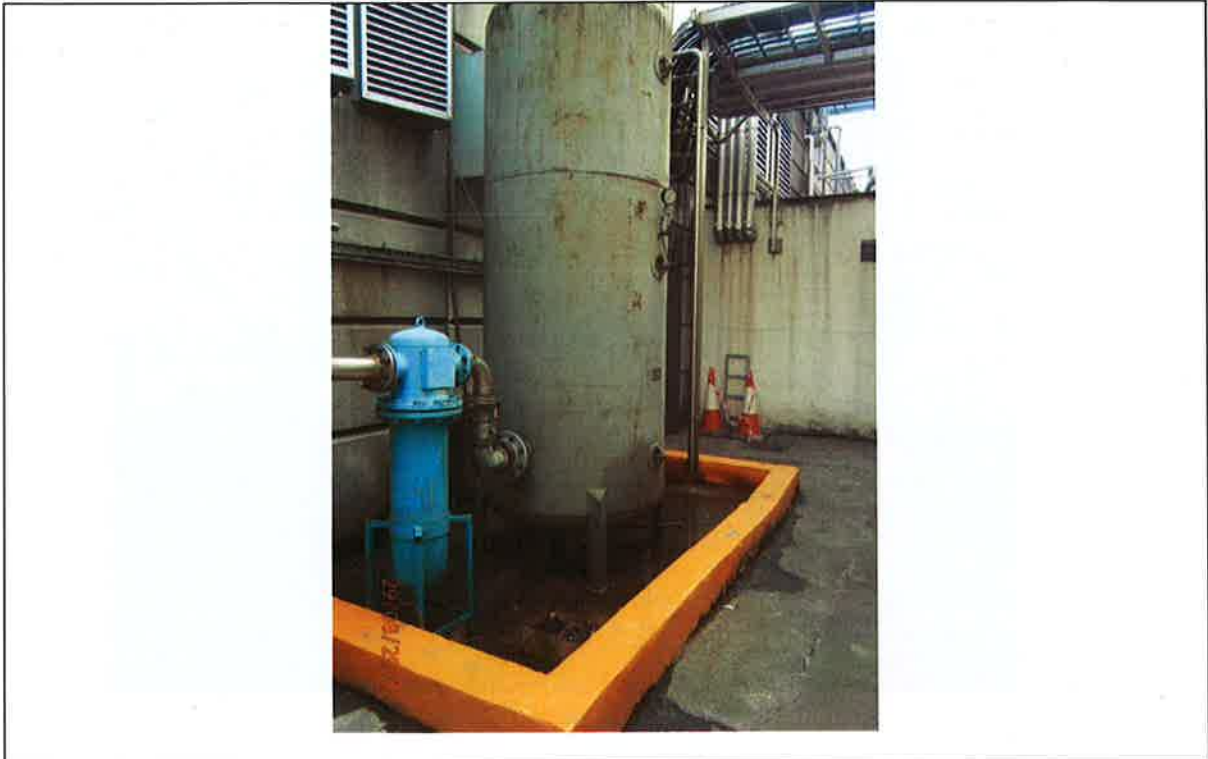
Fig. 20.1: Bund 20 (Note dampness on outside of bund wall)

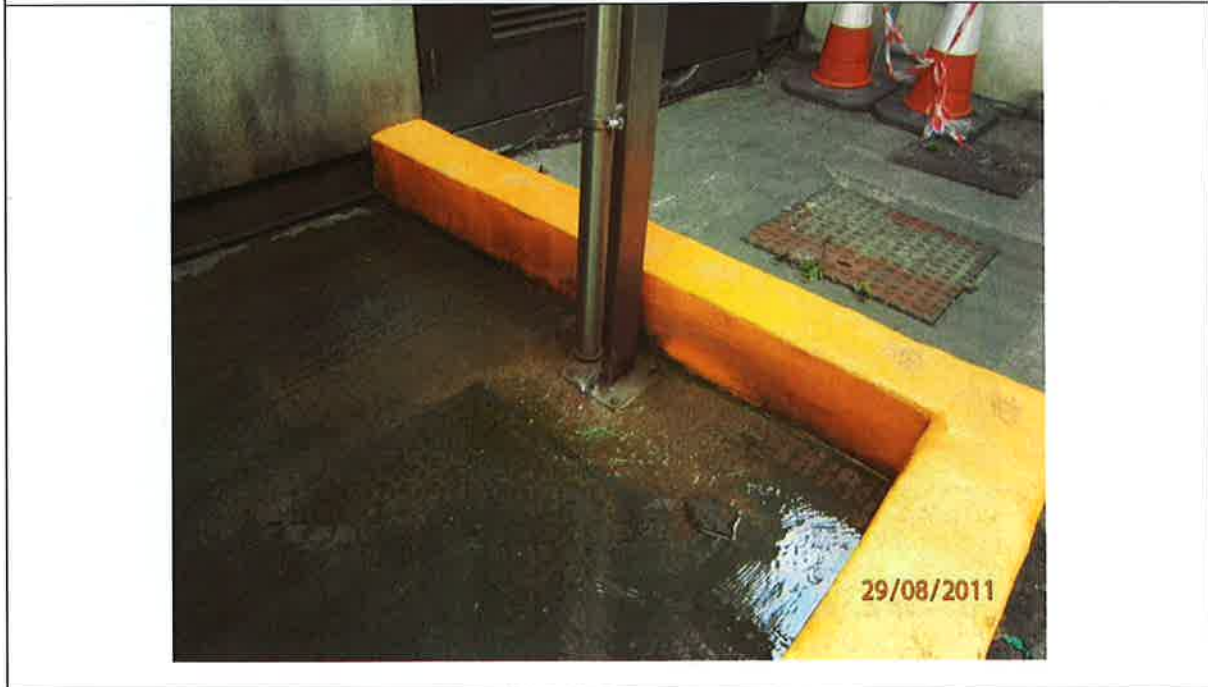
Fig. 20.2: Water draining into Bund 20 from Cooling Towers

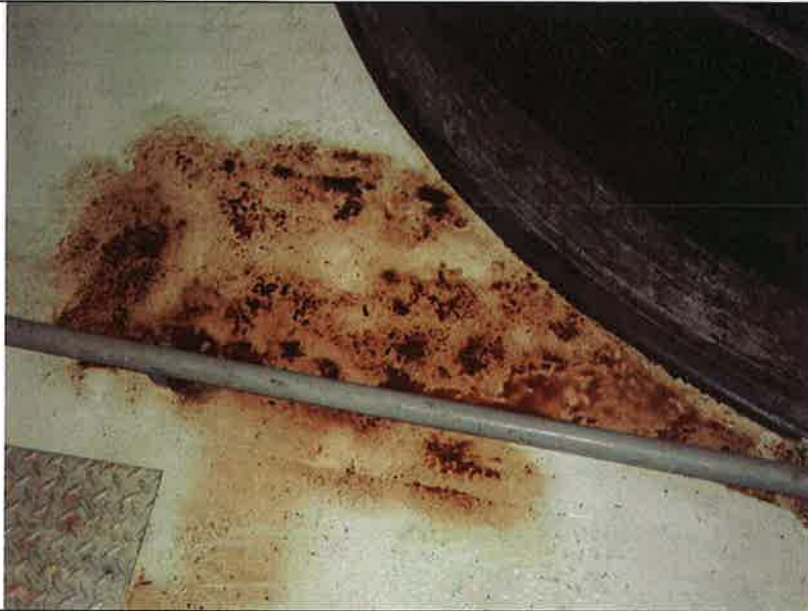
Fig. 26.3: Evidence of leak around the bund

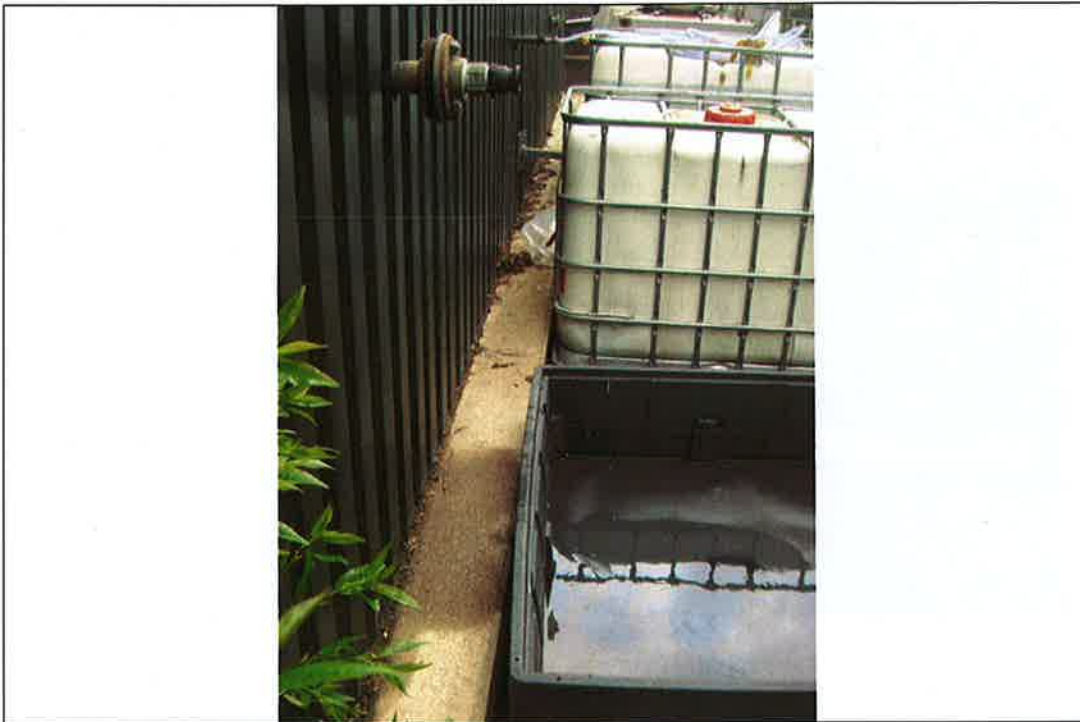
Fig. 27.2: Bund 27 – connection point for acid delivery does not extend over grey Chemstore container

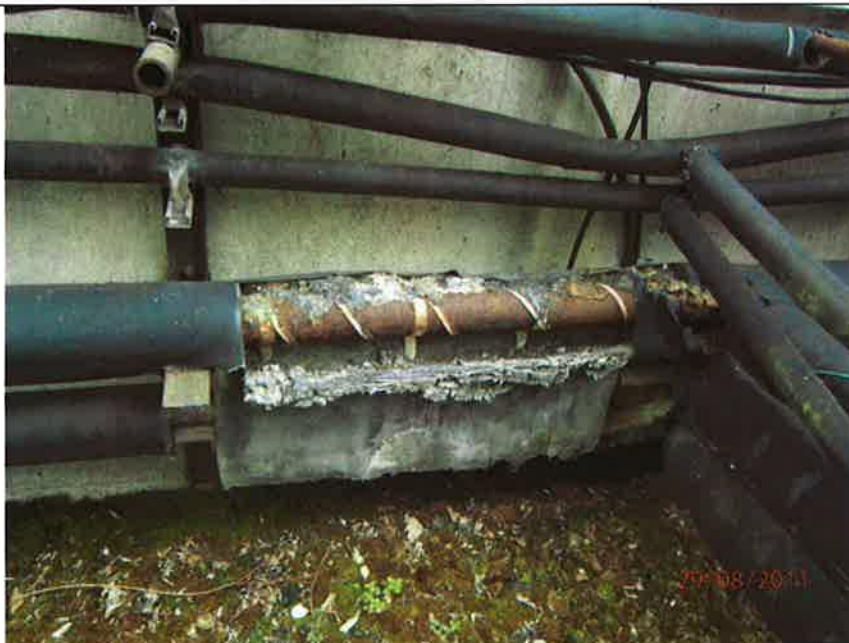
Fig 28.3: Bund 28 – Poor condition of pipework within bund

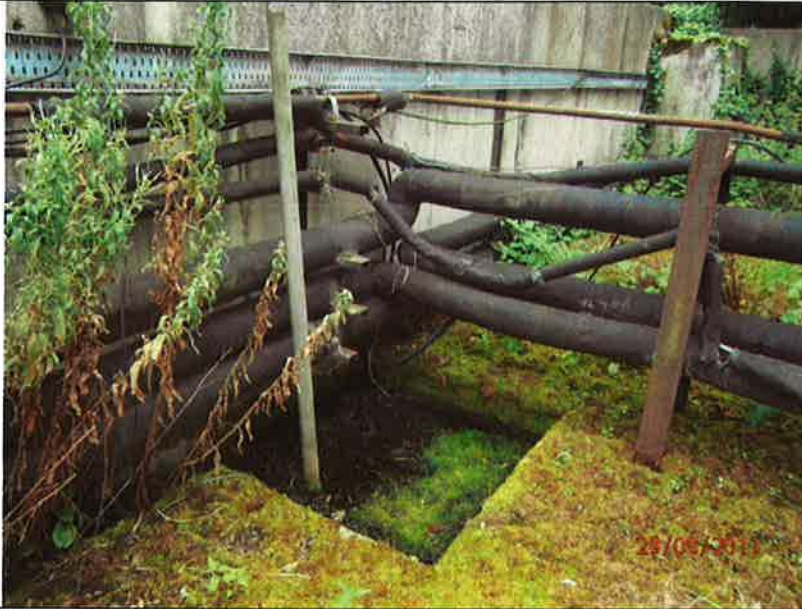
Fig 28.4: Bund 28 – Cabling off cable tray and within sump in bund. Poor condition of pipework also.

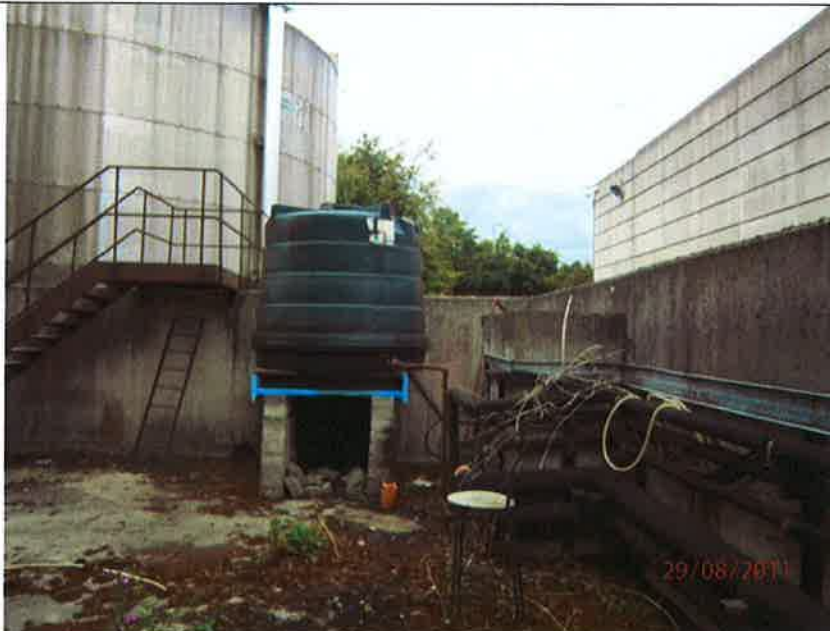
Fig 28.5: Bund 28 – Poor condition of piping associated with the disused diesel bunds; Diesel tank use for periodic testing of boilers

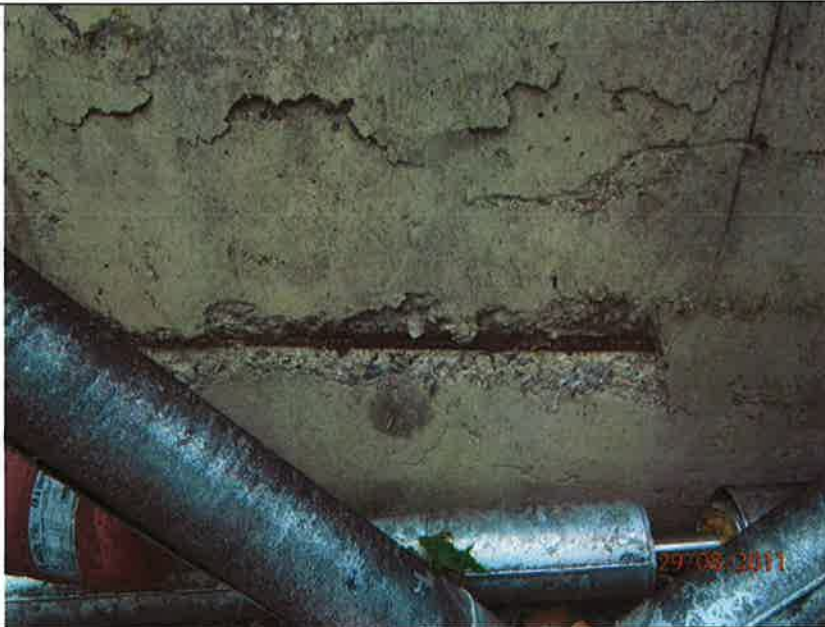
Fig 28.6: Bund 28 – Minor damage to exterior of bund wall on east side

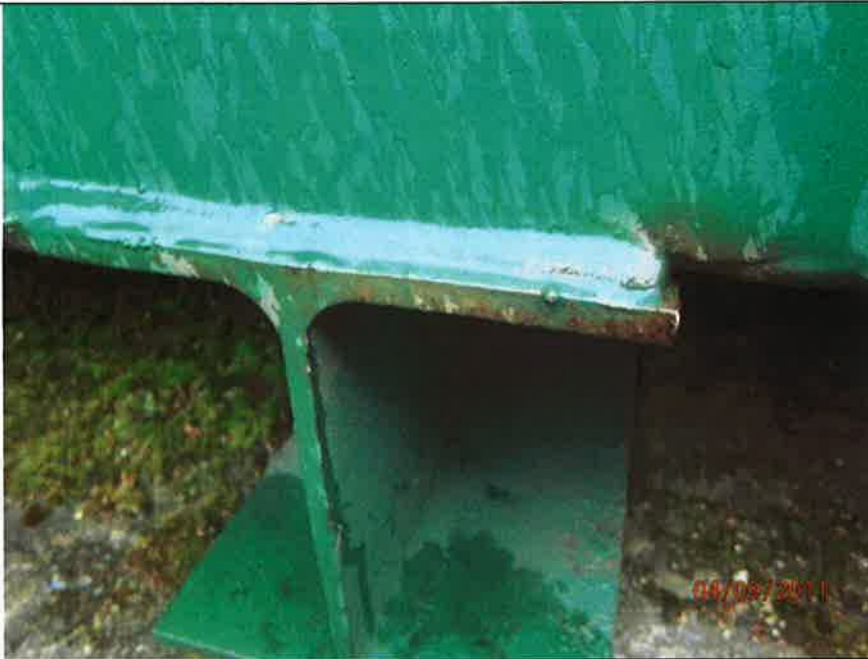
Fig 31.2: Bund 31 - Minor rusting where support welded to tank

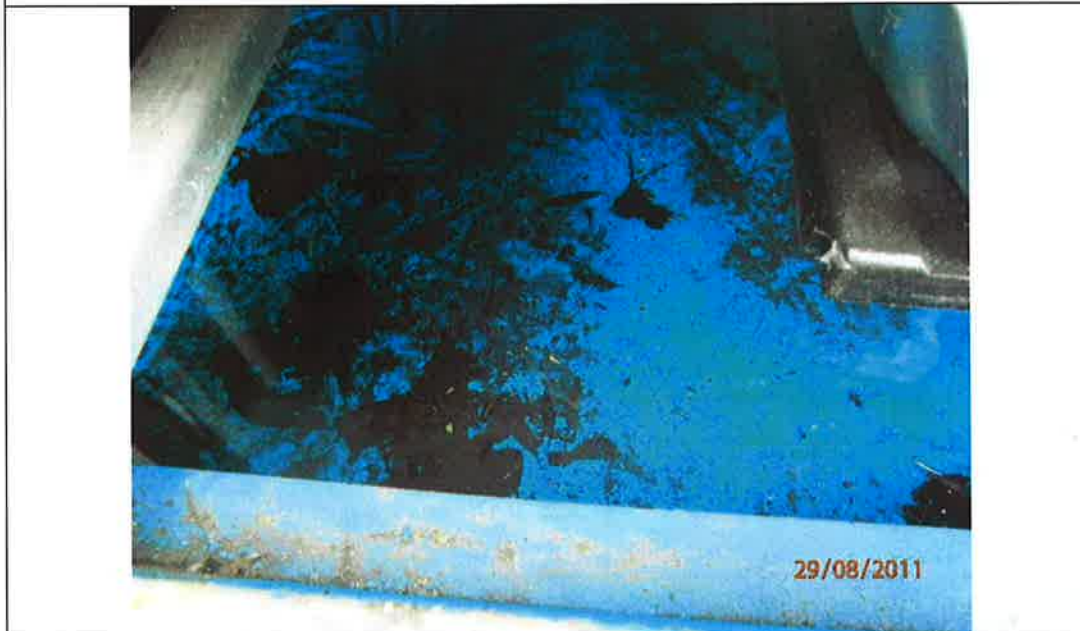
Fig. 33.2: Liquid present in base of bund

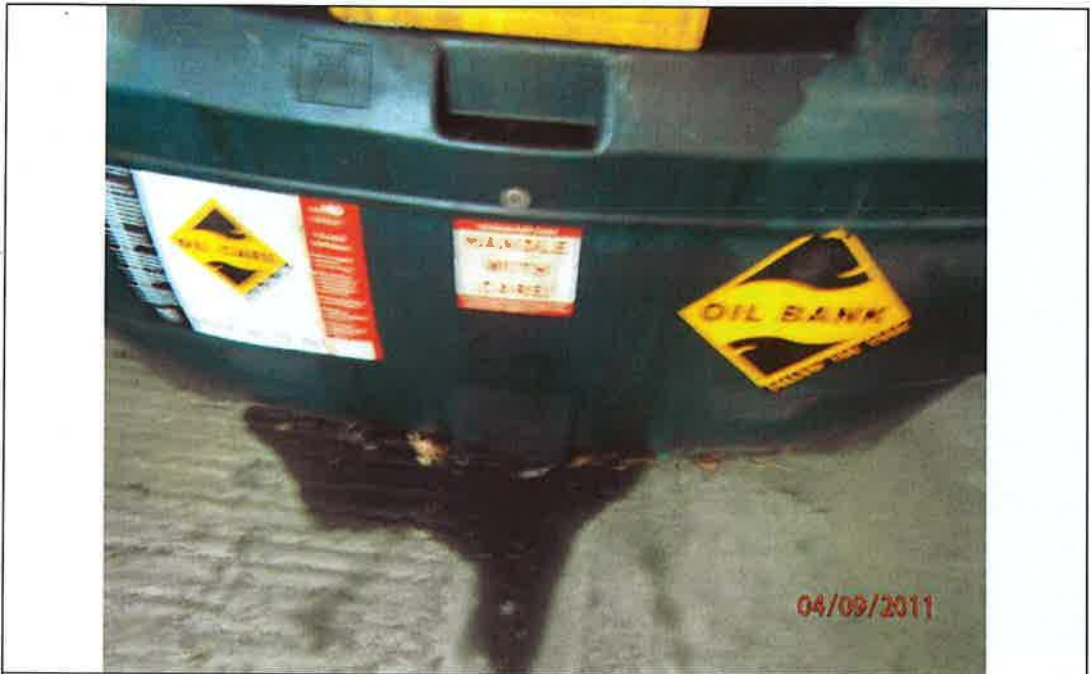
Fig. 38.2: Oil residue from filling (Drip tray required)

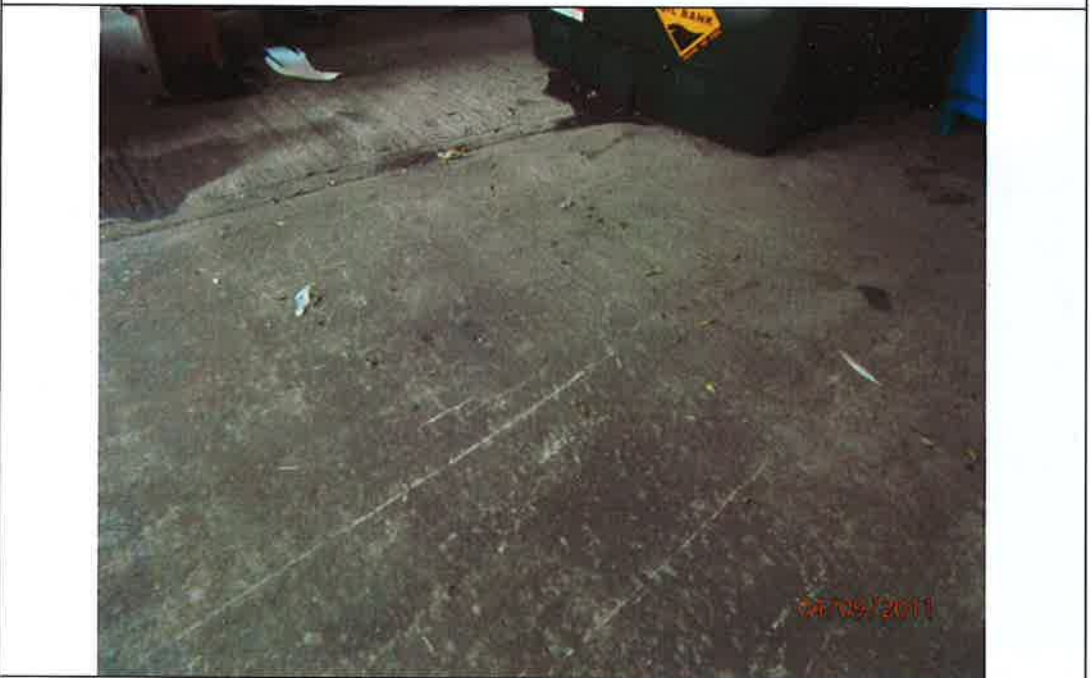
Fig. 38.3: Markings on ground from forklift activity in vicinity of bund

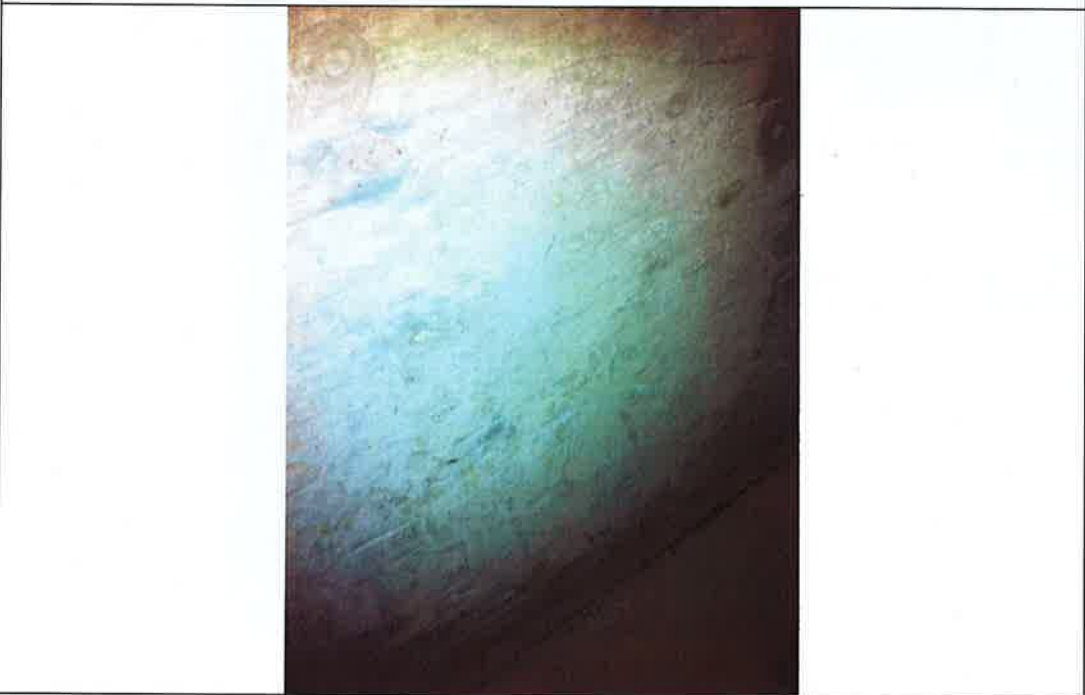
Fig. 41.2: Condition of bund wall
