**Roadstone Wood Ltd.**

**Re: Annual Environmental Report 2011 for W0269-01, Fassaroe Waste Recovery Facility**

## **Section 18 Stability Assessment Report**

## **Section 25 – Environmental Liabilities Risk Assessment Review**

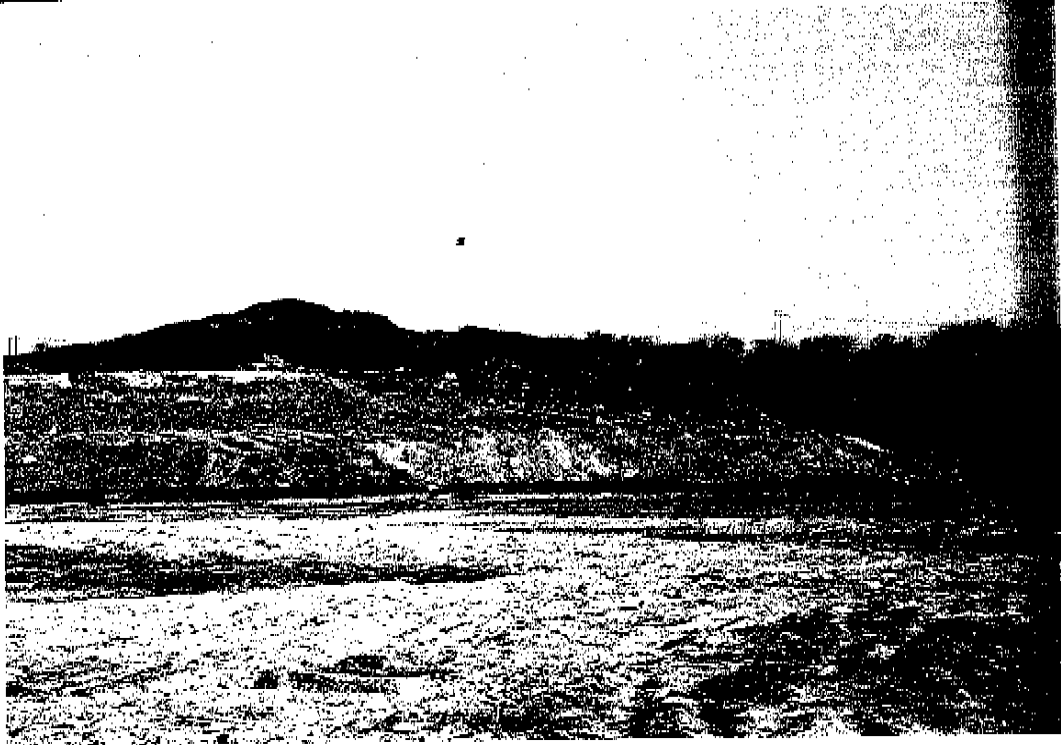
**Plate 1 : Global View of Slope in Backfilled Material in NW Corner of Former Pit**

In general, the temporary slopes developed in backfilled material around the north-western corner of the former pit, estimated to vary from approximately 12m to 16m high and approximately 20° to 30°, were observed to be marginally stable. Photographs of the existing slopes in backfilled material are presented in Plates 1 and 2.

The marginal stability of the backfilled slopes is only to be expected, given that they comprise imported material which has been end-tipped from HGV lorries and had not been spread or compacted by bulldozers or other earthmoving plant. That said, there was no evidence at the time of the site inspection of any recent or imminent instability across the temporary backfilled slopes such as development of tension cracks behind the crest, toe bulging, near-vertical backscarps etc.

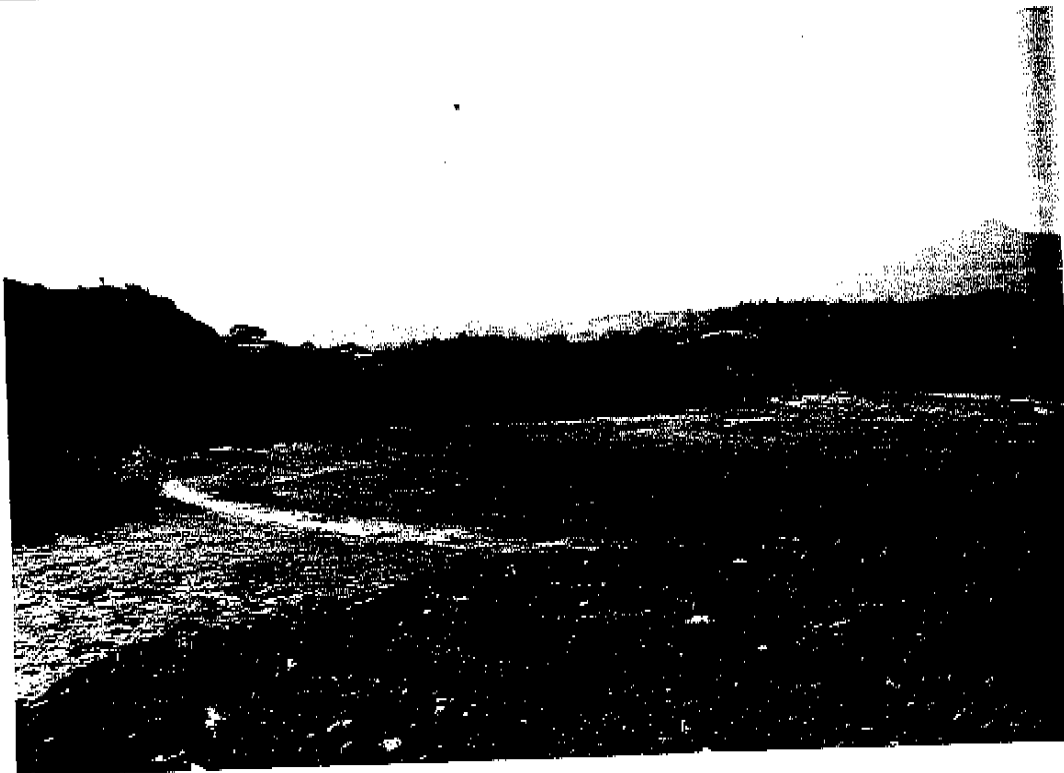
Plate 3 : View of Eastern and Southern Slopes of Former Pit from NW Corner

There does not appear to be any evidence of large scale (global) slope failure around the bare side slopes, rather it would appear that they are experiencing gradual regression, erosion and re-grading under both gravitational and climatic influences. No tension cracking or other sign of imminent instability was identified upslope or behind the crest of the steeper side slopes. The side slopes were generally dry, with no evidence of groundwater seepage, other than locally east of the descent ramp in the south-western corner of the former pit. It was also observed that

Taken together these observations indicate that the existing steep perimeter side slopes are relatively stable, albeit they are likely to be experiencing ongoing small scale spalling and erosion. This assessment concurs with experience and observations of Roadstone Wood's local site management.

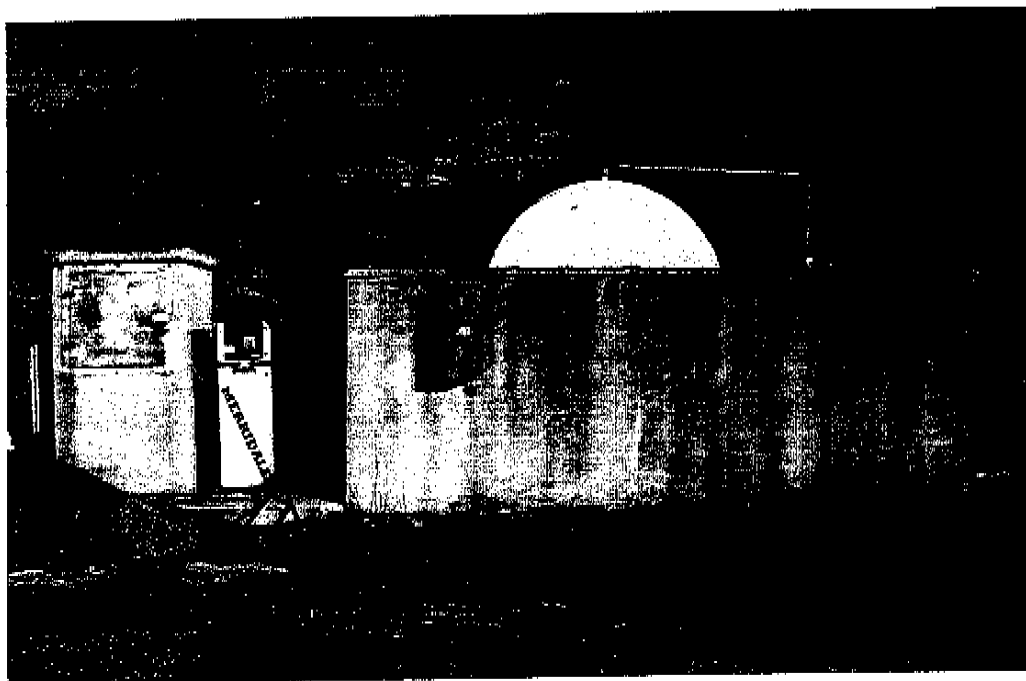
**Photo 1 - Bunded 70,000 litre Diesel Tank**

The site contains a 70,000 litre road diesel tank that is used to fuel company vehicles. The tank is protected against damage and leaks by a mass concrete bund, so the likely occurrence of a major rupture to the tank is considered low. However, without mitigation, there is a 'medium' risk of spillage of diesel during re-fuelling operations. The volume and location of such spillage may depend on mitigation measures employed at the site.

The severity of a 70,000 litre diesel spill to the gravel aquifer at the site is considered 'very high' as the clean-up costs could run to more than €100,000.

The 70,000 litre diesel tank is stored within a large concrete bund that is designed to contain more than the full volume of the tank. This provides mitigation against a major diesel spill at the site. An integrity test carried out in August 2011 showed that the bund is in very good condition and has capacity greater than 110% the capacity of the diesel tank.

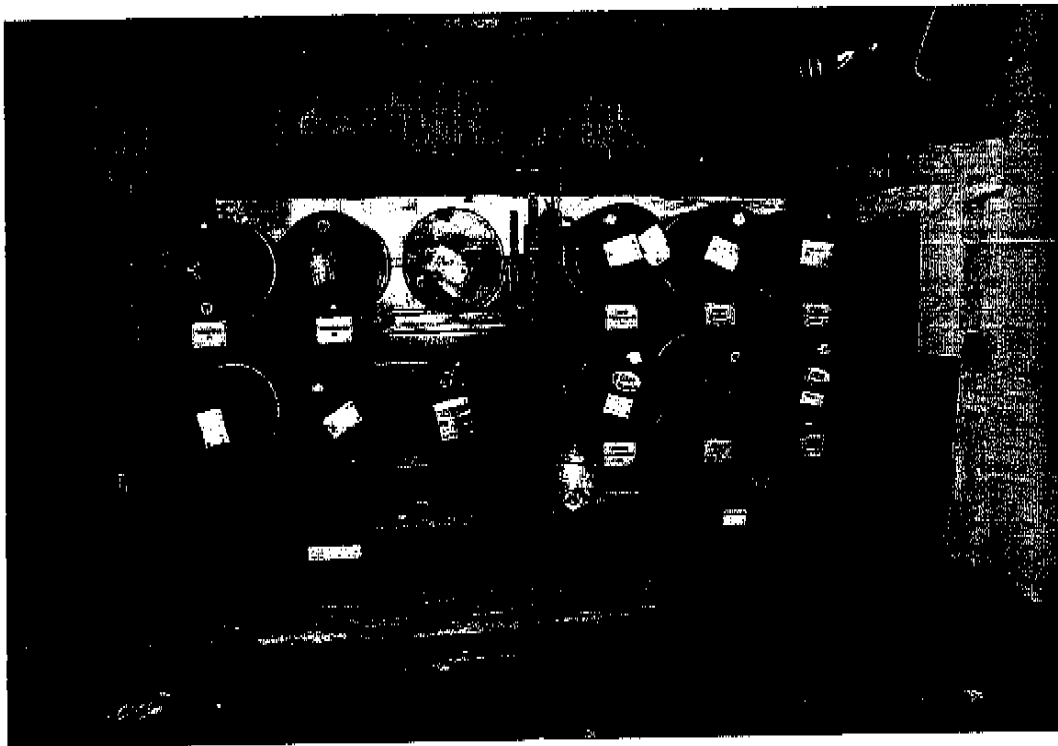
**Photo 2 – Bunded Oil Drums in Maintenance Shed**

There are a number of substances used on site that have the potential to cause environmental pollution if spilled. These include a 2,500 litre double-skinned tank for gas-oil (machine diesel) for fuelling mobile plant, a smaller waste oil tank and 200 litre drums filled with hydraulic oils, engine oils and transmission oils. These are all stored in the Maintenance Shed close to the site offices and are protected against leaks by bunding.

The gas-oil, hydraulic oils, engine oils, transmission oils, waste oils, etc. are currently stored within bunded areas in the maintenance shed. The operator must maintain adequate capacity in these bunds for them to be effective.

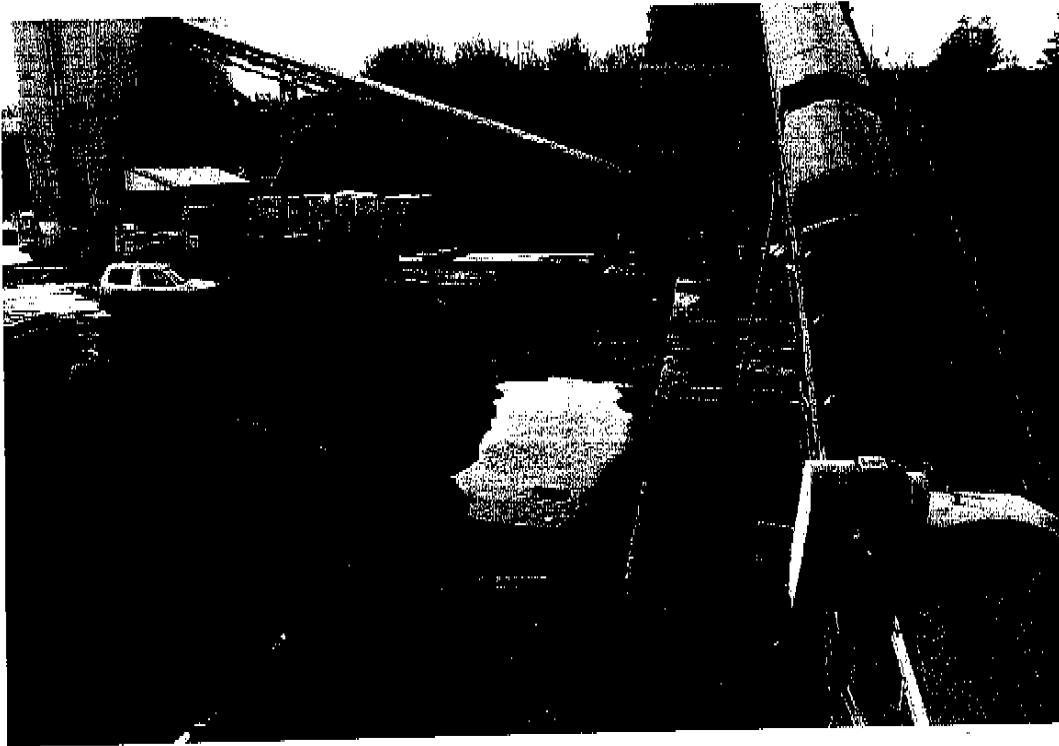
**Photo 5 – Yard Drainage Impeded by Concrete Platform**

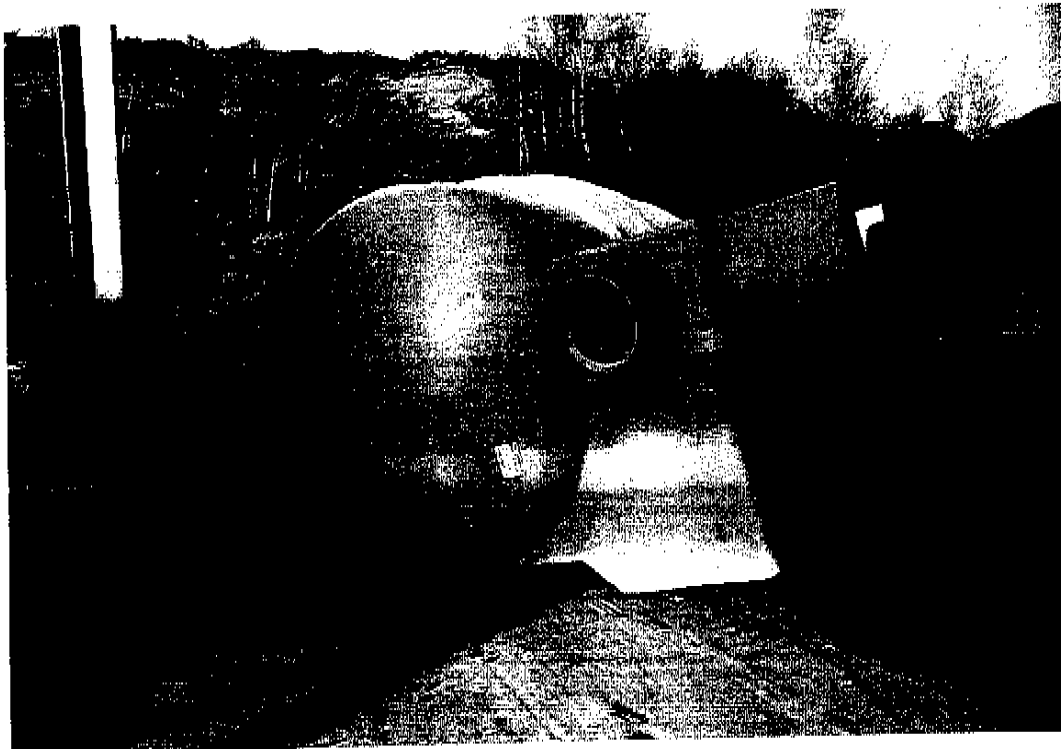
**Photo 6 – Hydrocarbon Interceptor Awaiting Installation**
