N89 DERRYCLURE, TULLAMORE, Co.OFFALY- Road Safety Audit

**N80 DERRYCLURE
TULLAMORE, Co. OFFALY
ROAD SAFETY AUDIT STAGE 1**

Project Title	Derryclure Energy Centre
Report Title	Road Safety Audit Stage 1
Revision	
Status	FIRST ISSUE
Control Date	May 2010

ROAD SAFETY AUDIT STAGE 1

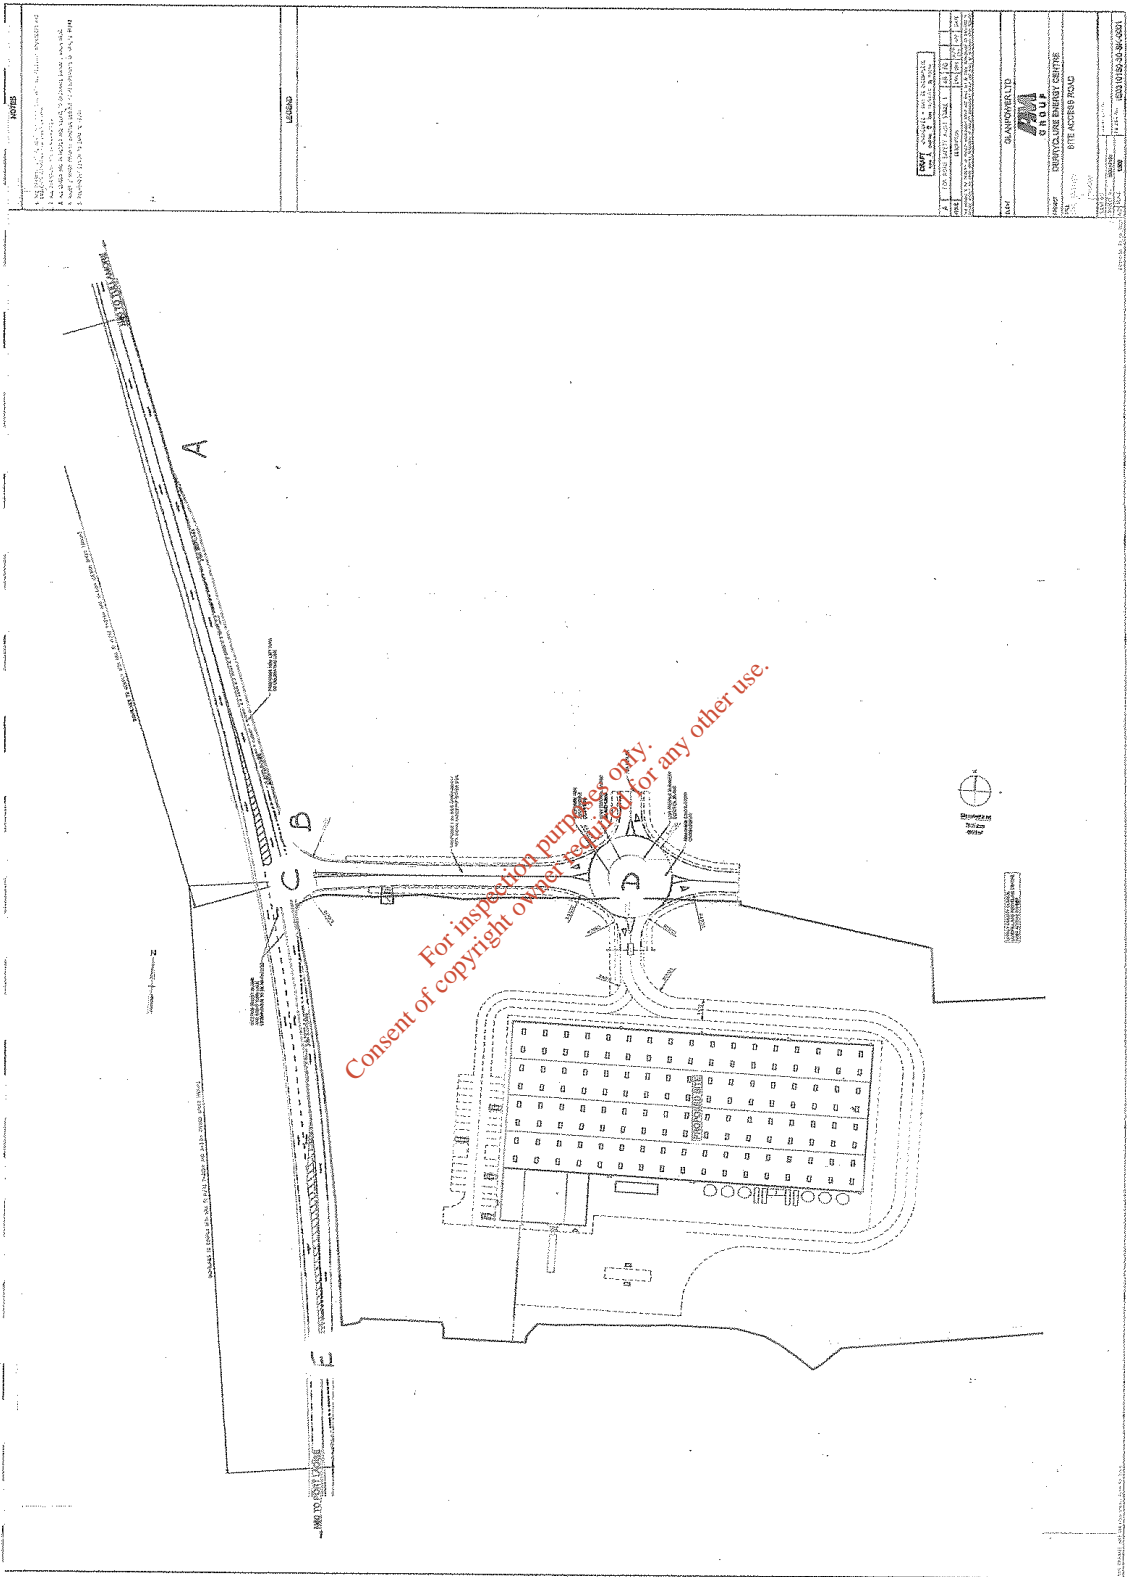
Drawing showing Problem Locations

Location – Southbound approach to the access road junction - Locations A to B

There is no information provided relating to the drainage of surface water on the main carriageway. The revised layout will need to be adequately drained.

A deceleration lane and a significantly greater left turn entry radius are proposed. The existing narrow hard shoulder runs close to a steep sided ditch and it appears that there may be inadequate clearance between the deceleration lane and the ditch hazard.

Location – The access junction – Location C

Visibility of and from the junction is currently inhibited by chain link fencing and support posts. The drawing shows a 'Y' distance visibility splay to the left that excludes the southbound lane. Inadequate visibility can result in 'pull-out' type accidents.

Location – The access junction - Location C

There is some concern that some large vehicles may have difficulty making some turning movements into and out from the access junction without the

risk of kerb collisions and over-run. For example, it appears that large vehicles may over-run the dedicated right turning lane when turning left from the access road. Restricted entry may extend the time required for turning movements with possible increased risk of collisions.

Location – The internal roundabout - Location D

The roundabout is to be provided with traffic separator islands on each of the four arms. This is supported as they provide clear guidance and control on vehicle entry and exit positions. There is some concern however that some large vehicles may have difficulty making some turning movements without the risk of kerb collisions and over-run.

Location – The new access junction and approaches - Locations A to E

There is no street lighting along this section of the N80. Large vehicles making right turns in or out from the access road will be exposed side-on to approaching main road traffic. During the hours of darkness on an unlit road, drivers approaching at up to 100 kph may not realise that a large vehicle is making such a turning movement. There may be a risk of side impacts.

Details of revised drainage arrangements should be provided at the detail design stage.

There should be an appraisal of the clearance. It may be necessary to pipe the ditch along this length.

It should be ensured that visibility from the junction is clear and unobstructed, in accordance with traffic speeds. The 'Y' distances from the access junction should be shown to the nearer edge of the major carriageway in both directions.

It should be ensured that all vehicle turning movements can be safely accommodated with adequate margins for error.

There should be street lighting through the junction and immediate approaches.
