ENVIRONMENTAL LIABILITIES RISK ASSESSMENT (ELRA)

**INERT WASTE RECOVERY FACILITY
HUNTSTOWN QUARRY
FINGLAS, DUBLIN 11**

Environmental Liabilities Risk Assessment

December 2013
SLR Ref: 501.00180.00074 ELRA Rev0

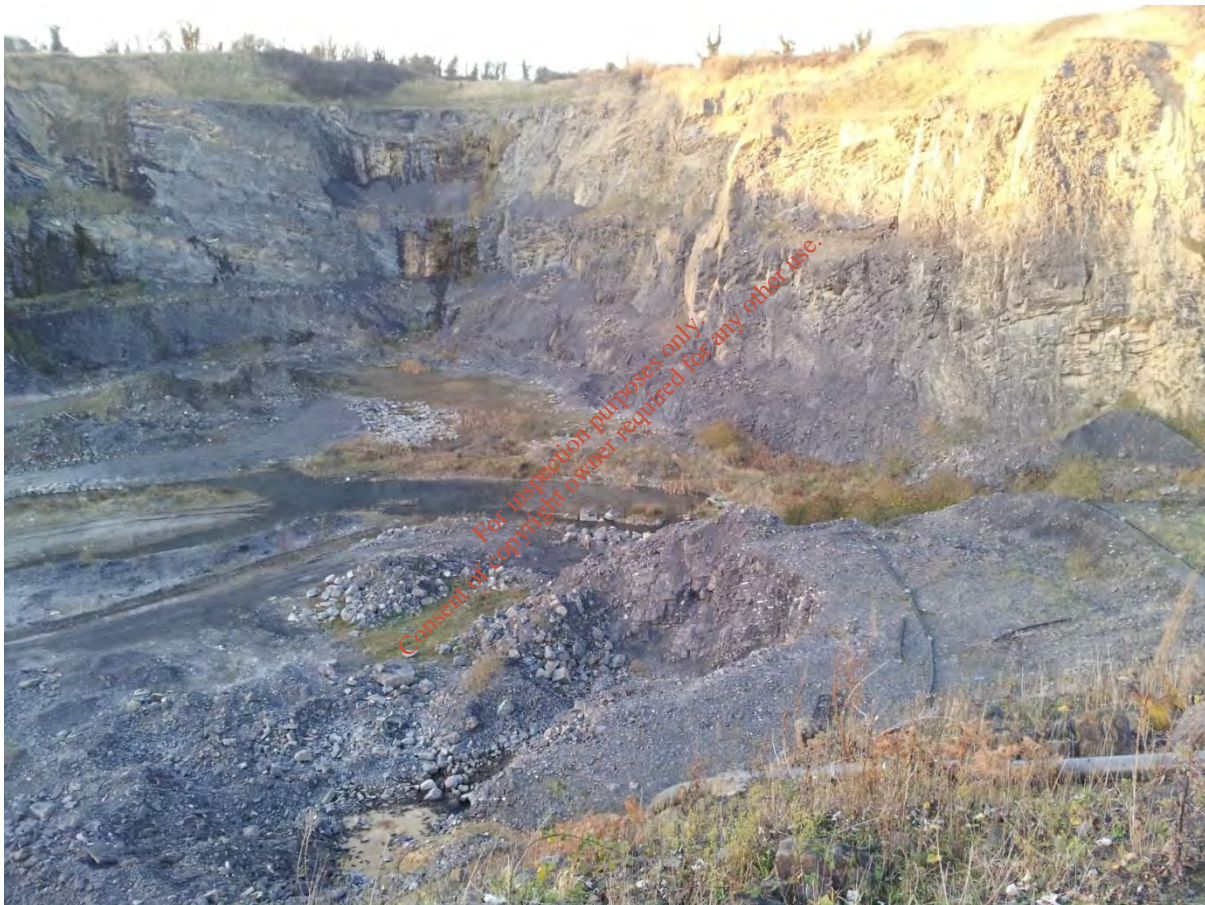
Photo 2
View of Northern Quarry Void in December 2013

The proposed recovery of inert soils at the North Quarry will provide for complete backfilling of a large open void above the groundwater table, facilitate the restoration of the worked out lands to agricultural use and improve protection of the underlying groundwater resource, which is currently classified as 'extremely vulnerable' due to the absence of any protective soil cover. Photo 2 below shows the quarry void in December 2013.

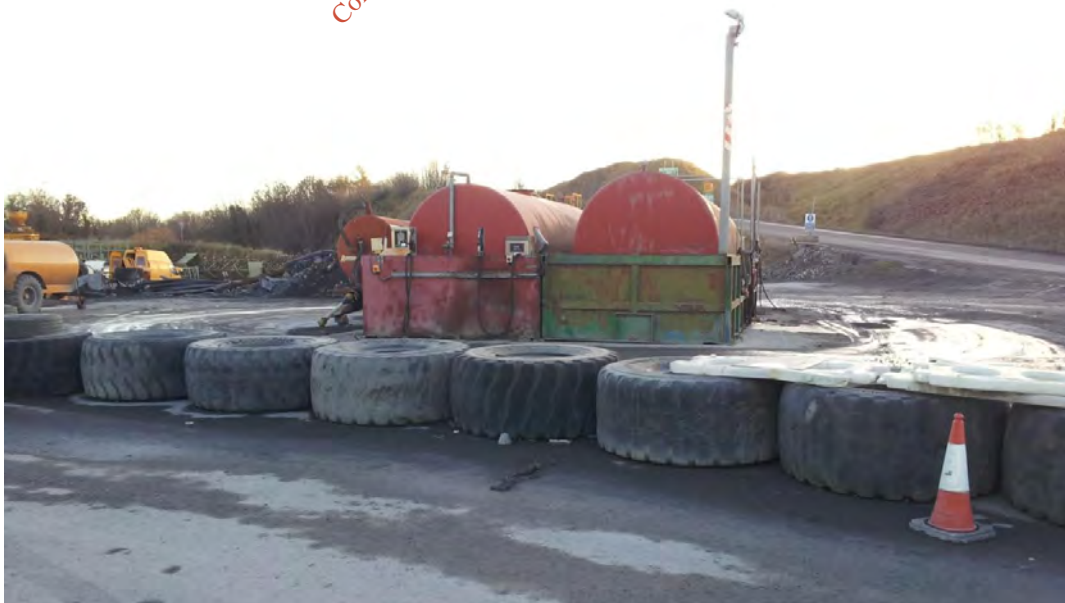
Photo 3
Bunded Fuel Tanks Close Maintenance Shed

There are two large fuel tanks contained by steel bunds located close to the maintenance shed and shown in Photo 3 below. The Road Diesel tank has a capacity of 44,000 litres and the Marked Diesel (Gasoil) tanks has a capacity of 53,000 litres.

All pumps and valves are contained within the bunds and the fuelling area drains to a hydrocarbon interceptor prior to discharge to surface water via the quarry water management system.

1	Fuel spillage during tanker unloading/delivery operations	8	Ensure driver adheres to speed limits and drives cautiously.	Better road safety.	Observe driving behaviour	Immediate	Facility Manager
2	Loss from diesel tanks, discharge to surface water	8	<ul style="list-style-type: none"> a) Maintain tanks and bunds in good condition. b) Ensure that bund has adequate capacity. c) Ensure that pumps to surface water are switched off as part of Emergency Response Procedure in the event of a major spill. 	<ul style="list-style-type: none"> a) Lower chance of tank or bund failure. b) Lower chance of overspill c) Less chance that contaminated water will be pumped to surface water. 	<ul style="list-style-type: none"> a) Regularly check integrity of tanks and bunds. b) Regularly remove rainwater from bund and send for appropriate disposal. c) Check ERPs 	<ul style="list-style-type: none"> a) Minimum every 3 years b) Minimum every month. c) Immediate 	Facility Manager

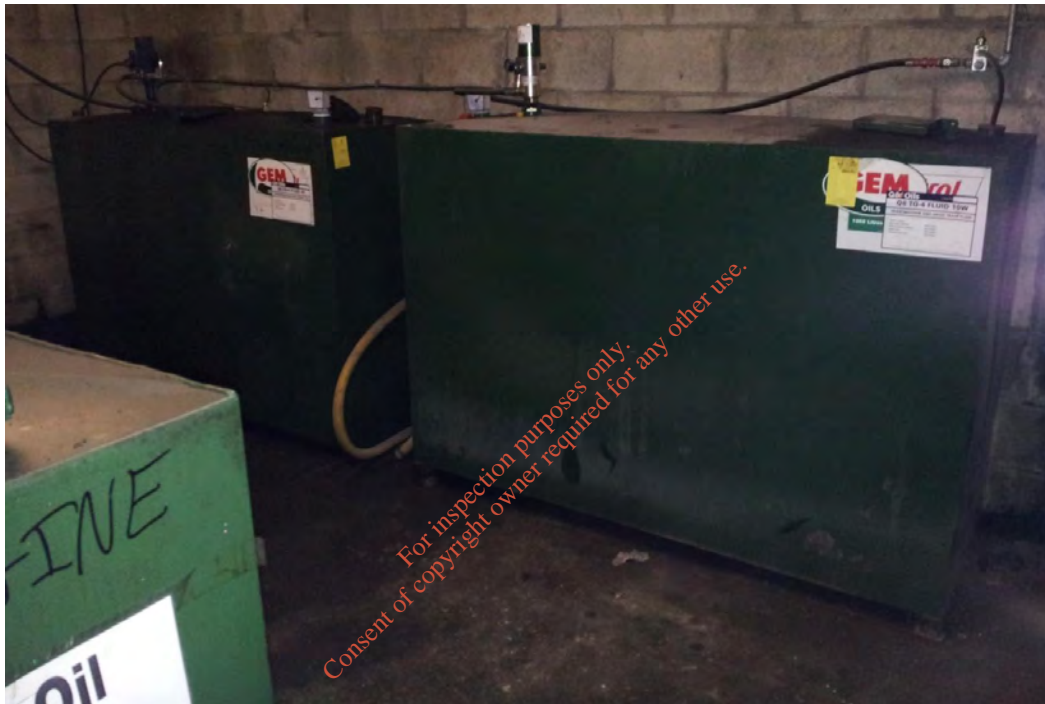
Photo 4
Hydrocarbon Tanks in Maintenance Shed

Oil and lubricant changes and servicing of wheeled or tracked plant will be undertaken at the existing maintenance sheds. Four tanks are provided in a back room in the maintenance shed as follows:

- 600 gallon (2,730 litres) double skinned steel tank containing diesel engine lubricant
- 600 gallon (2,730 litres) double skinned steel tank containing hydraulic oil
- 300 gallon (1,365 litres) double skinned steel tank containing transmission fluid
- 300 gallon (1,365 litres) double skinned steel tank containing transmission fluid

Two of these tanks are shown on Photo 4 below.

7	Spillage of Engine Oil, Transmission Oil and/ or Hydraulic Oil Tanks, discharge to groundwater	4	<ul style="list-style-type: none"> a) Ensure that tanks are in good condition. b) Repair walls of tank room to provide additional bunding. c) Ensure that waste oil is contained as part of Emergency Response Procedures in the event of a major spill. d) Ensure that staff are aware of ERPs 	<ul style="list-style-type: none"> a) Lower chance of tank failure. b) Provision of better containment. c) Less chance that contaminated water will discharge to groundwater. d) As above. 	<ul style="list-style-type: none"> a) Regularly check integrity of tanks. b) Repair gaps in walls of tank room. c) Check ERPs d) Check staff awareness of ERPs 	<ul style="list-style-type: none"> a) Minimum every 3 years b) Within 3 months c) Immediate d) Immediate 	Facility Manager
12	Suspended solids run-off to surface water	4	Ensure settlement before discharge.	Reduced suspended solids in discharge to surface water.	Maintenance of settlement ponds	Ongoing	Facility Manager

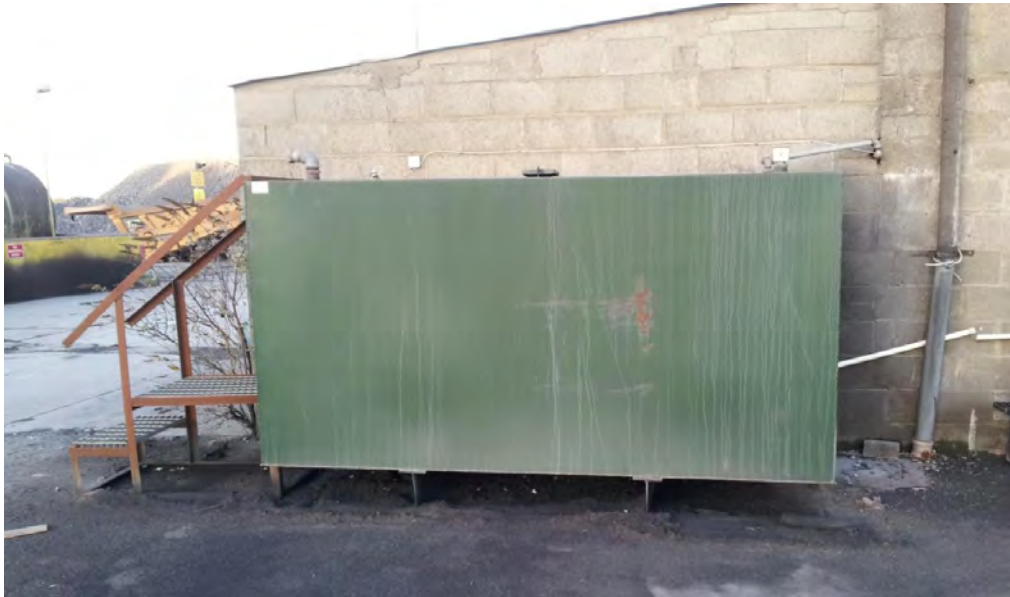
Photo 5
Waste Oil Tank at Back of Maintenance Shed

A 600 gallon (2,730 litres) double skinned steel waste oil tank is provided at the back of the maintenance shed as shown in Photo 5 below. This tank is emptied at intervals by a licensed waste contractor and recovered off-site at a suitably licensed waste facility.

9	Waste Oil Storage	Waste Oil Tank spillage, discharge to groundwater	Contamination of soil and groundwater.	2	Maximum 2,730 litres oil. Hazardous and persistent material.	3	Double skinned tank (self-bunded) in an area trafficked by cars, but not HGVs. Tanks are regularly inspected. Spill can be contained at base of quarry in hydraulic trap.	6
10	Hydrocarbon Drum Storage	Drum spillage, discharge to surface water	Contamination of surface water.	1	Maximum 200 litres per drum. Hazardous and persistent material.	2	Drums contained in bunded area or on bunded pallets inside maintenance shed. Spill can be contained at base of quarry and not pumped to surface water.	2
11	Hydrocarbon Drum Storage	Drum spillage, discharge to groundwater	Contamination of soil and groundwater.	1	Maximum 200 litres per drum. Hazardous and persistent material.	2	Drums contained in bunded area or on bunded pallets inside maintenance shed. Spill can be contained at base of quarry in hydraulic trap.	2

8	Waste Oil Tank spillage, discharge to surface water	6	a) Ensure that waste oil tank is in good condition. b) Provide concrete bund around waste oil tank. c) Ensure that bund has adequate capacity. d) Ensure that pumps to surface water are switched off as part of Emergency Response Procedure in the event of a major spill. e) Ensure that staff are aware of ERPs	a) Lower chance of tank failure. b) Lower chance of impact and provision of better containment. c) Lower chance of overflow. d) Less chance that contaminated water will be pumped to surface water. e) As above.	a) Regularly check integrity of tank b) Construct bund. c) Regularly remove rainwater from bund and send for appropriate disposal. d) Check ERPs e) Check staff awareness of ERPs	a) Minimum every 3 years b) Within 3 months c) Minimum every month. d) Immediate e) Immediate	Facility Manager

Risk ID.	Potential Risks	Risk Score	Mitigation Measures to be Taken	Outcome	Action	Date For Completion	Owner/ Contact person
9	Waste Oil Tank spillage, discharge to groundwater	6	<ul style="list-style-type: none"> a) Ensure that waste oil tank is in good condition. b) Provide concrete bund around waste oil tank. c) Ensure that bund has adequate capacity. d) Ensure that waste oil is contained as part of Emergency Response Procedures (ERPs) in the event of a major spill. e) Ensure that staff are aware of ERPs 	<ul style="list-style-type: none"> a) Lower chance of tank failure. b) Lower chance of impact and provision of better containment. c) Lower chance of overspill. d) Less chance that contaminated water will discharge to groundwater. e) As above. 	<ul style="list-style-type: none"> a) Regularly check integrity of tank. b) Construct bund. c) Regularly remove rainwater from bund and send for appropriate disposal. d) Check ERPs e) Check staff awareness of ERPs 	<ul style="list-style-type: none"> a) Minimum every 3 years b) Within 3 months c) Minimum every month. d) Immediate e) Immediate 	Facility Manager

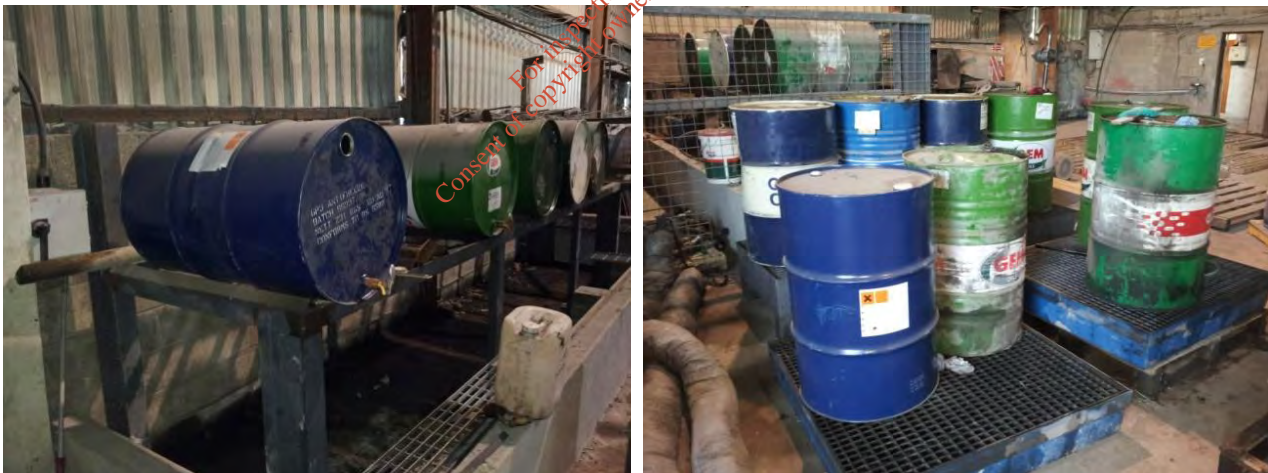
Photo 6
Storage of Drums in Maintenance Shed

The maintenance shed also contains a number of 200 litre drums containing various hydrocarbon fluids and gels. These are stored in a bunded area or on bunded pallets as shown on Photo 6 below:
