Client:
G.Bruss GmbH DICHTUNGSTECHNIK
Finisklin Road
Sligo, Ireland

Site: Bruss Sligo

RE: Summary Report of CCTV Drain Survey

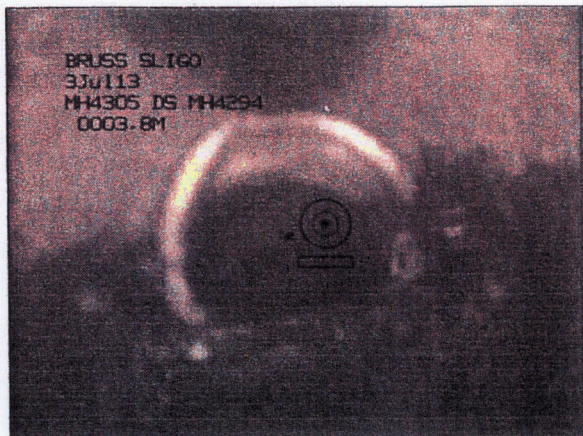
MH 4345	0.00	ST	Start of Survey			0
	3.80	DC	Dimension of sewer changes, new dimension dia 100 mm. Remark: NO ASSESS FOR CAMERA			0
MH 4294	3.90	FH	Finish Survey		19_2a	0

Photo: 19_2a, Tape No.: 1
3.9m, Finish Survey

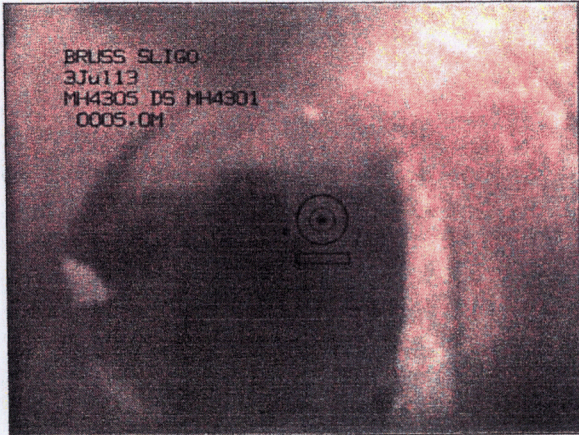
1:500	position	code	observation	MPEG	photo	grade
	0.00	ST	Start of Survey			0
	2.80	CN	Connection, at 02 o'clock, dia 150 mm			0
	4.50	CN	Connection, at 09 o'clock, dia 150 mm			0
	5.00	JDM	Joint displaced. Medium		7_5a	2
	7.00	X	Collapsed Pipe, 60 % cross-sectional loss		7_6a	5
	7.10	FH	Finish Survey			0

Photo: 7_5a, Tape No.: 1
5m, Joint displaced. Medium

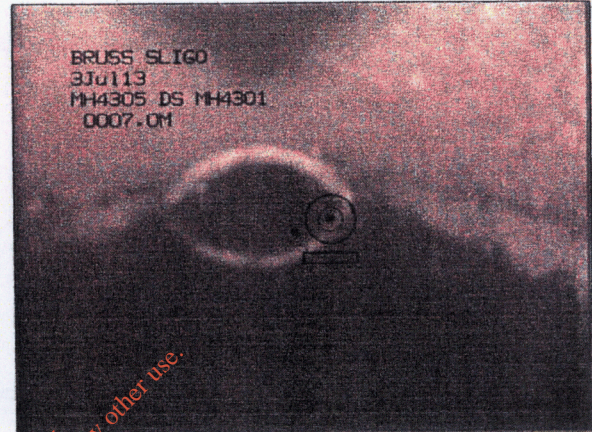
Photo: 7_6a, Tape No.: 1
7m, Collapsed Pipe, 60 % cross-sectional area loss

Fig 1,2 MH 4345 7m of pipework to be replaced

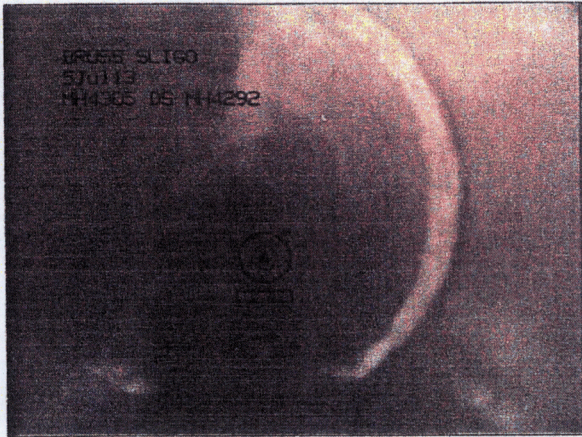
Photo: 11_3a, Tape No.: 1
10.5m, Joint displaced. Medium

- We recommend that the system is cleaned once annually going forward.
- MH 4305 d/s to MH4294 (Mains), There are 2no dislocated joints on this line that will require repair. We recommend a part liner on each section. It would be prudent to treat this work as priority.
- Price: €3450.00
A risk assessment and method statement can be provided.
- MH 4345 u/s to MH4301 from 7m the line dips and is holding water to 70%, however it is running freely we recommend that over the next 3 years that line is renewed.
- MH 4345 down stream is connected to MH 4305. We carried out a dye test as the camera could not access the flexibly pipe work used to run the drain around underground tanks.

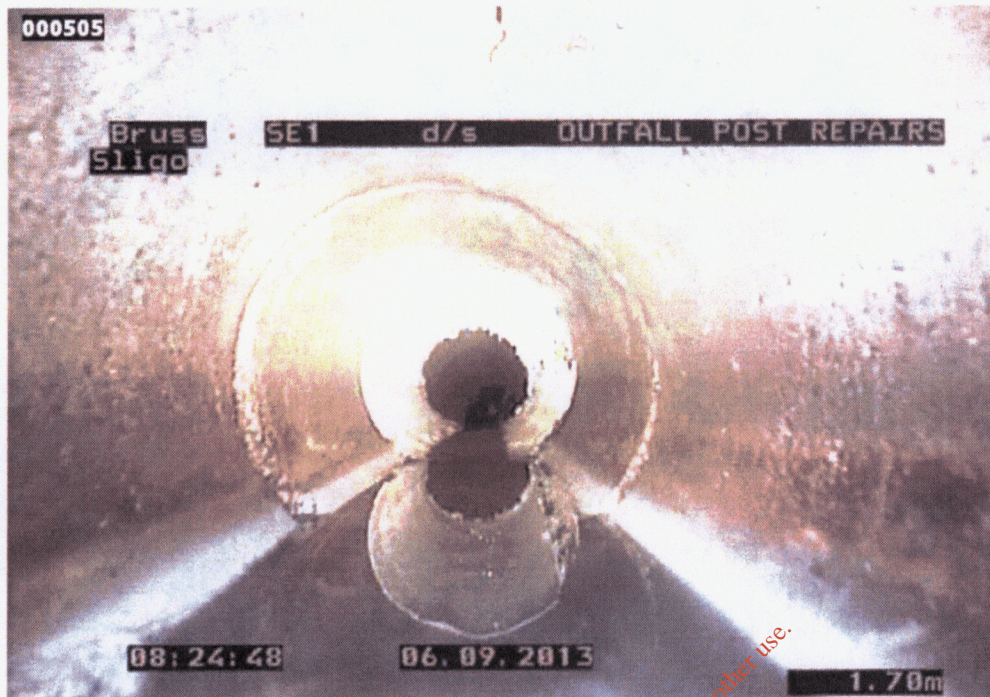
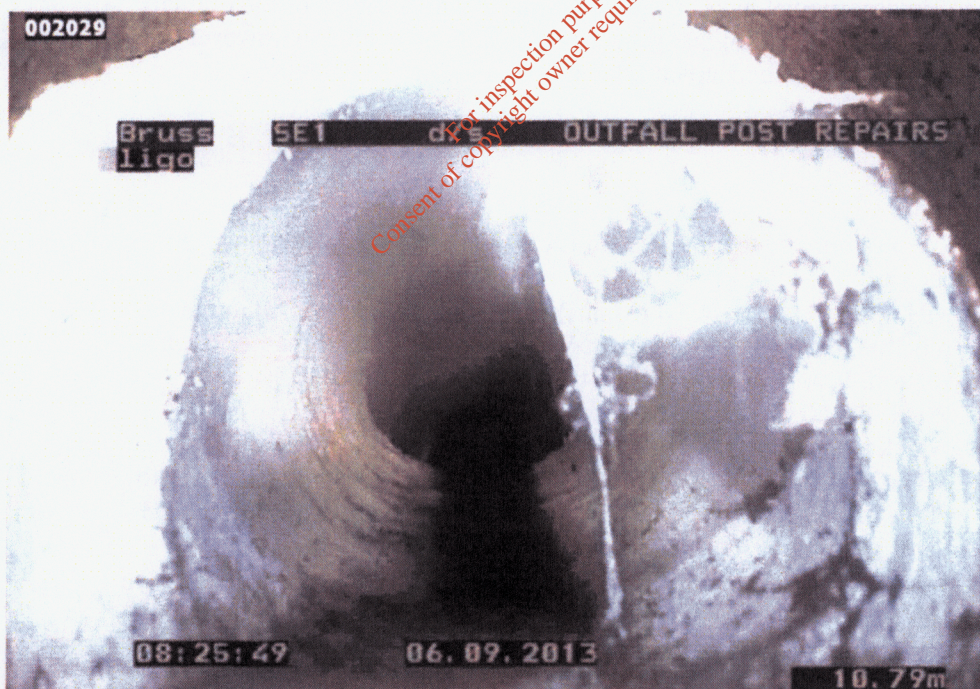
Fig 1,2 MH 4305 to MH 4294 2no dislocated joints - Liner inserts completed.

Work carried out 27th August 2013

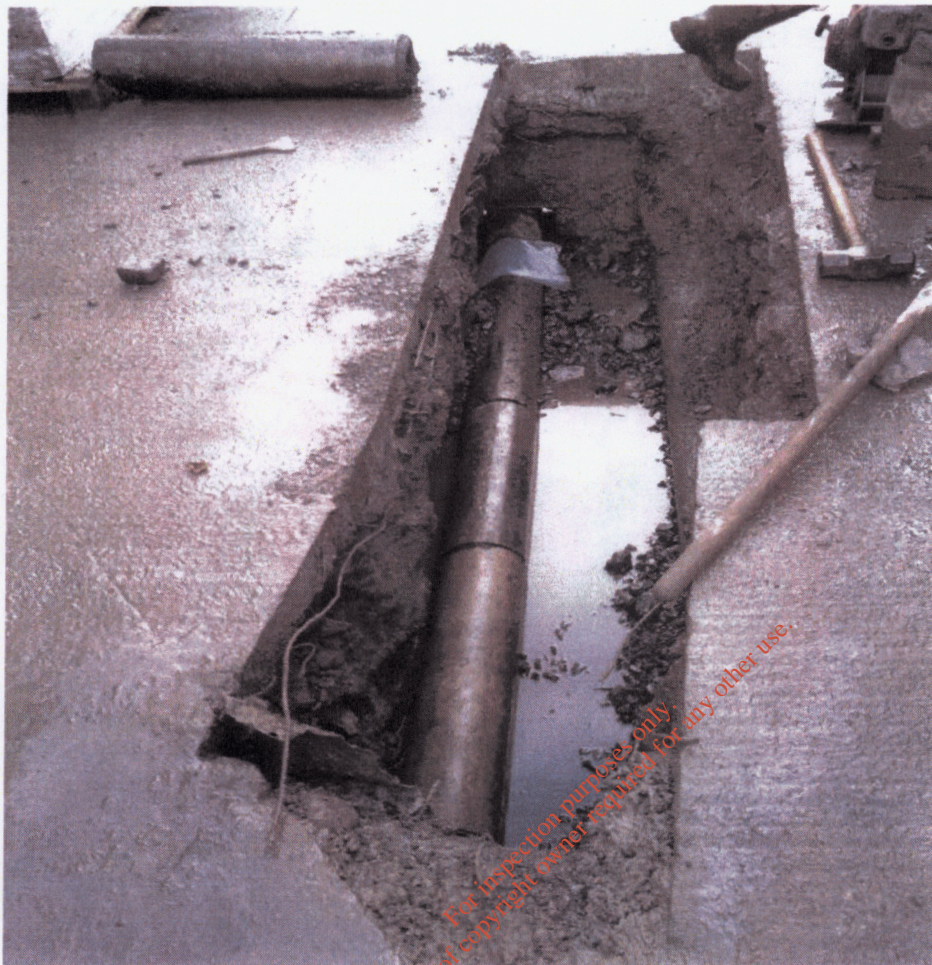
Fig 1 New Pipework in place – MH 4301 – MH 4345 7 m

Work carried out 29 Nov – 01 Dec 2013
