Roadstone Ltd  
Fortunestown,  
Tallaght,  
Dublin 24.

**A.E.R. W0269-01**

**Re: 2014 Annual Environmental Report for W0269-01, Fassaroe Waste Recovery Facility**

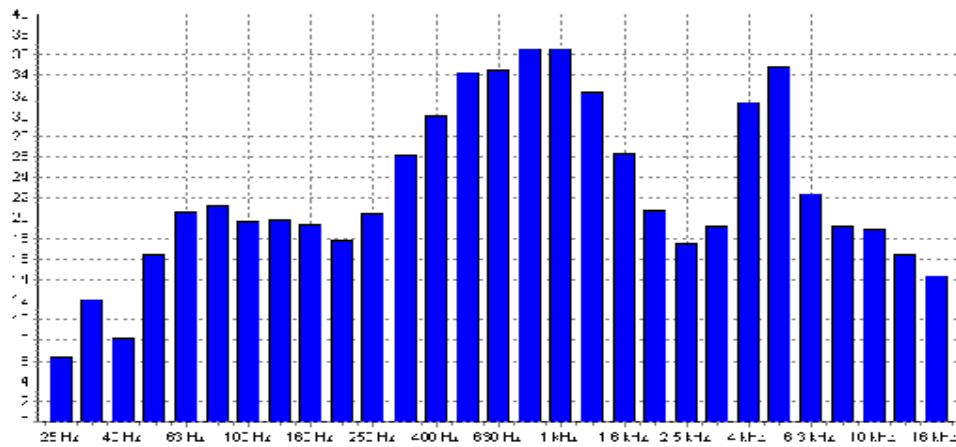
- No observed tonal noise.
- Birdsong and machine working during the measurement period.

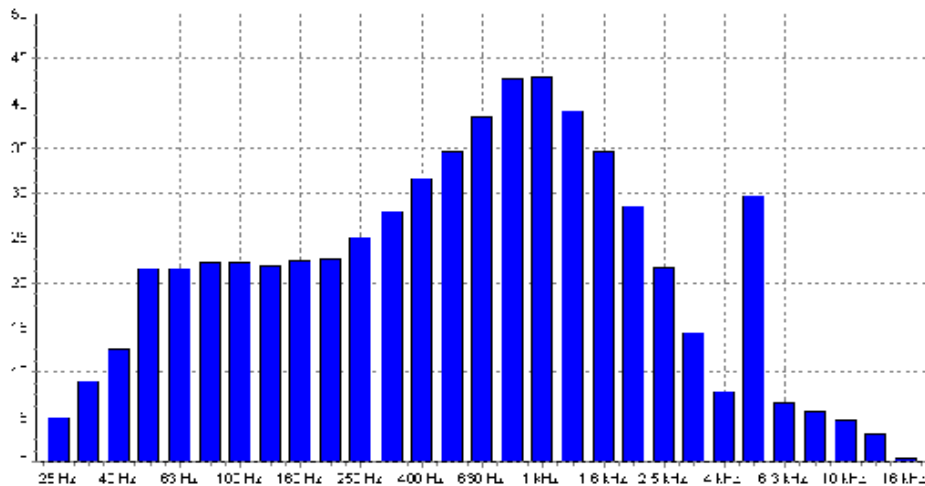
- No observed tonal noise.
- Noise anomaly not related to the facility at 5kHz (birdsong).

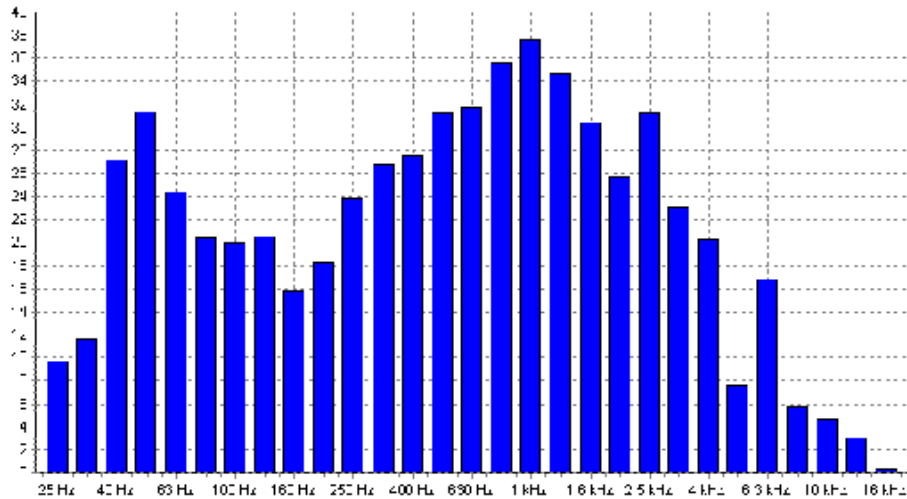
- No observed tonal noise.
- Noise anomaly not related to the facility at 2.5kHz and 6.3kHz (one plane flew over head quickly).

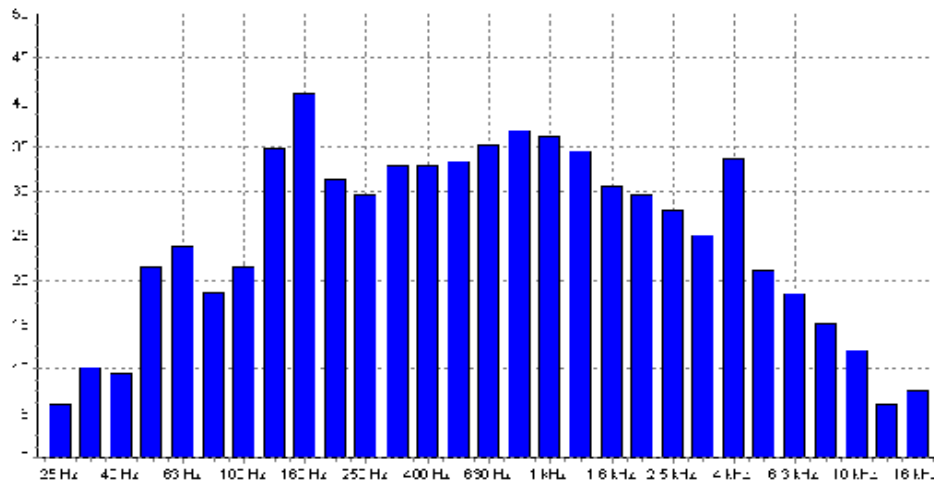
- No observed tonal noise.
- Noise anomaly not related to the facility at 4kHz (machine working in yard with reversing alarms) Site notes show that the reversing alarm isn't loud enough at this location to be considered tonal.

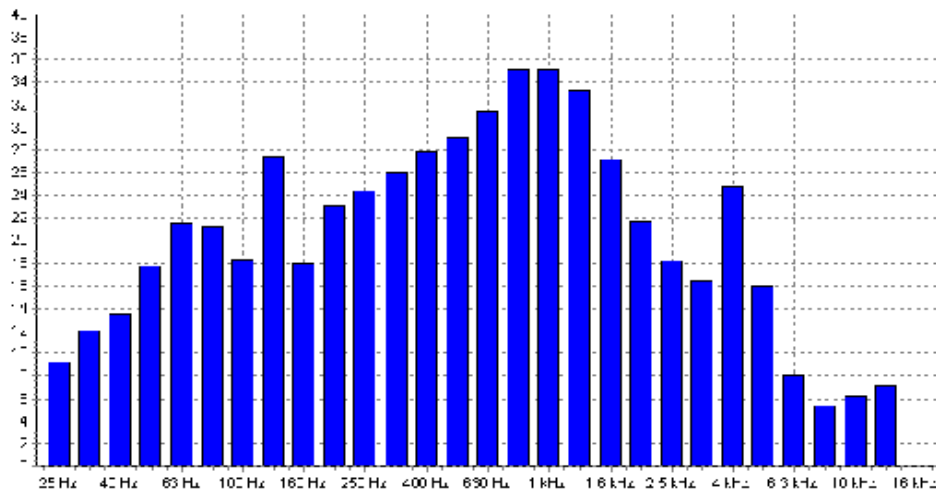
- No observed tonal noise.
- Noise anomaly not related to the facility at 125Hz and 4kHz (a plane went overhead at the start of the run and there was birdsong at the location).

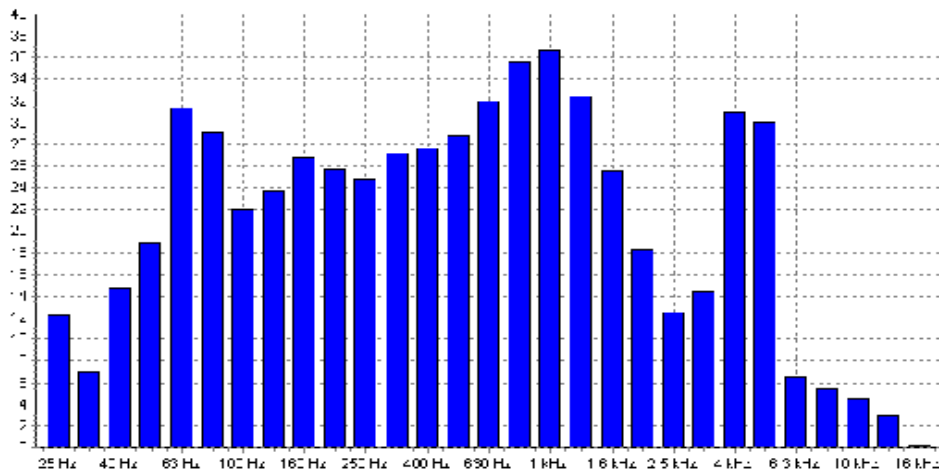
- No observed tonal noise.
- Birdsong at 4 and 5 kHz.

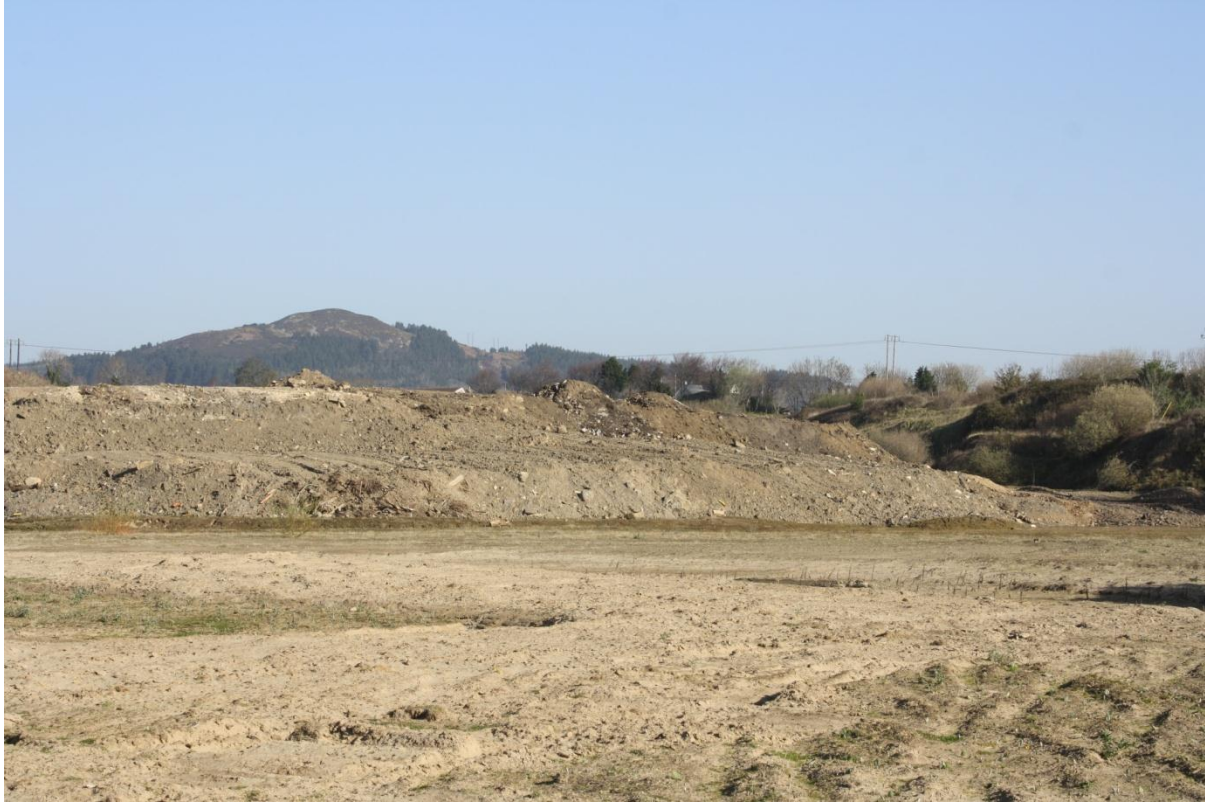
**Plate 1 : Global View of Slope in Backfilled Material in NW Corner of Former Pit**

In general, the temporary slopes developed in backfilled material around the north-western corner of the former pit, estimated to vary from approximately 12m to 16m high and approximately 20° to 30°, were observed to be marginally stable. Photographs of the existing slopes in backfilled material are presented in Plates 1 and 2.

The marginal stability of the backfilled slopes is only to be expected, given that they comprise imported material which has been end-tipped from HGV lorries and had not been spread or compacted by bulldozers or other earthmoving plant. That said, there was no evidence at the time of the site inspection of any recent or imminent instability across the temporary backfilled slopes such as development of tension cracks behind the crest, toe bulging, near-vertical backscarps etc.

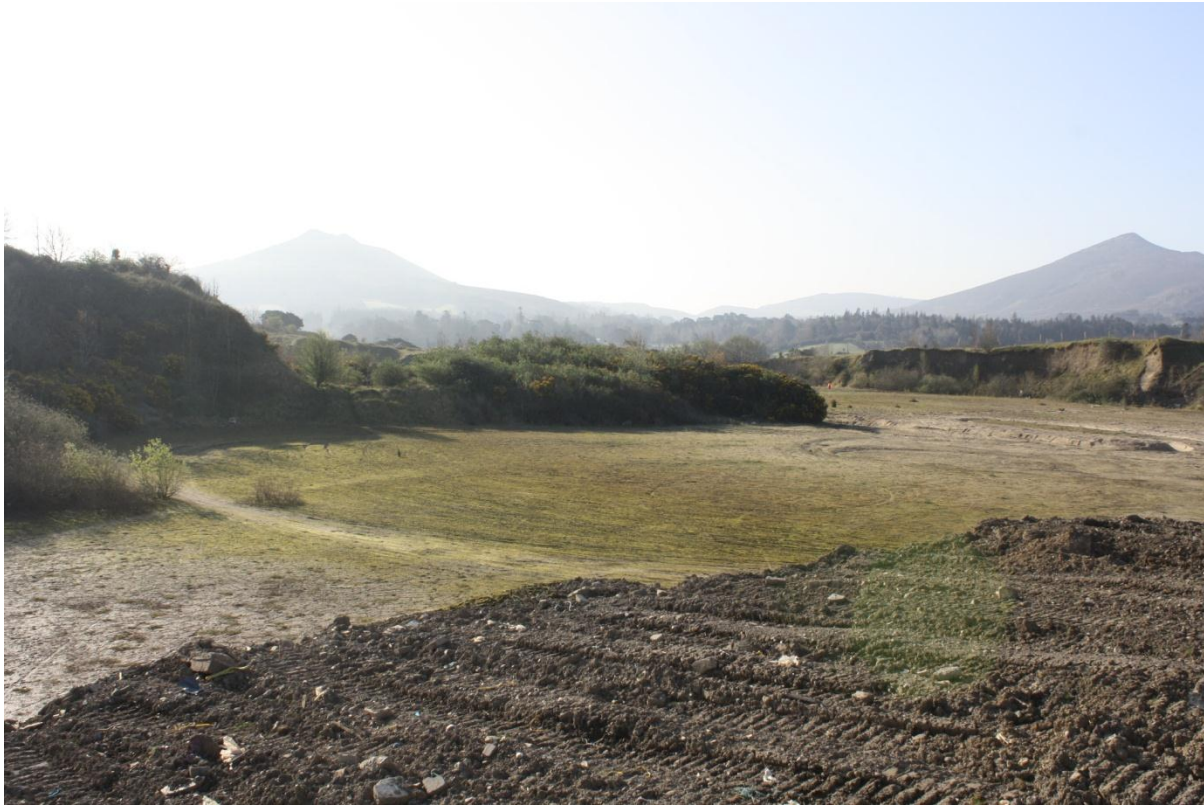
**Plate 3 : View of Eastern and Southern Slopes of Former Pit from NW Corner**

There does not appear to be any evidence of large scale (global) slope failure around the bare side slopes, rather it would appear that they are experiencing gradual regression, erosion and re-grading under both gravitational and climatic influences. No tension cracking or other sign of imminent instability was identified upslope or behind the crest of the steeper side slopes. The side slopes were generally dry, with no evidence of groundwater seepage, other than locally east of the descent ramp in the south-western corner of the former pit. It was also observed that

Taken together these observations indicate that the existing steep perimeter side slopes are relatively stable, albeit they are likely to be experiencing ongoing small scale spalling and erosion. This assessment concurs with experience and observations of Roadstone Wood's local site management.

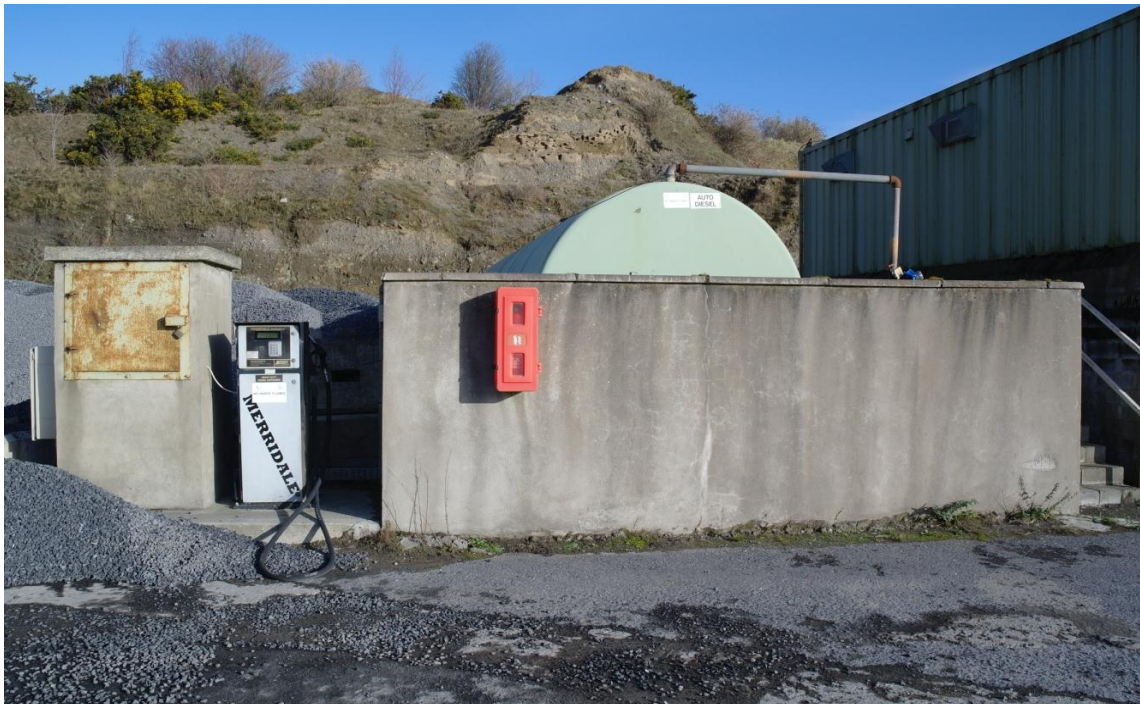
**Photo 1 - Bunded 70,000 litre Diesel Tank**

The site contains a 70,000 litre road diesel tank that is used to fuel company vehicles. The tank is protected against damage and leaks by a mass concrete bund, so the likely occurrence of a major rupture to the tank is considered low. However, without mitigation, there is a 'medium' risk of spillage of diesel during re-fuelling operations. The volume and location of such spillage may depend on mitigation measures employed at the site.

The severity of a 70,000 litre diesel spill to the gravel aquifer at the site is considered 'very high' as the clean-up costs could run to more than €100,000.

The 70,000 litre diesel tank is stored within a large concrete bund that is designed to contain more than the full volume of the tank. This provides mitigation against a major diesel spill at the site. An integrity test carried out in August 2011 showed that the bund is in very good condition and has capacity greater than 110% the capacity of the diesel tank.

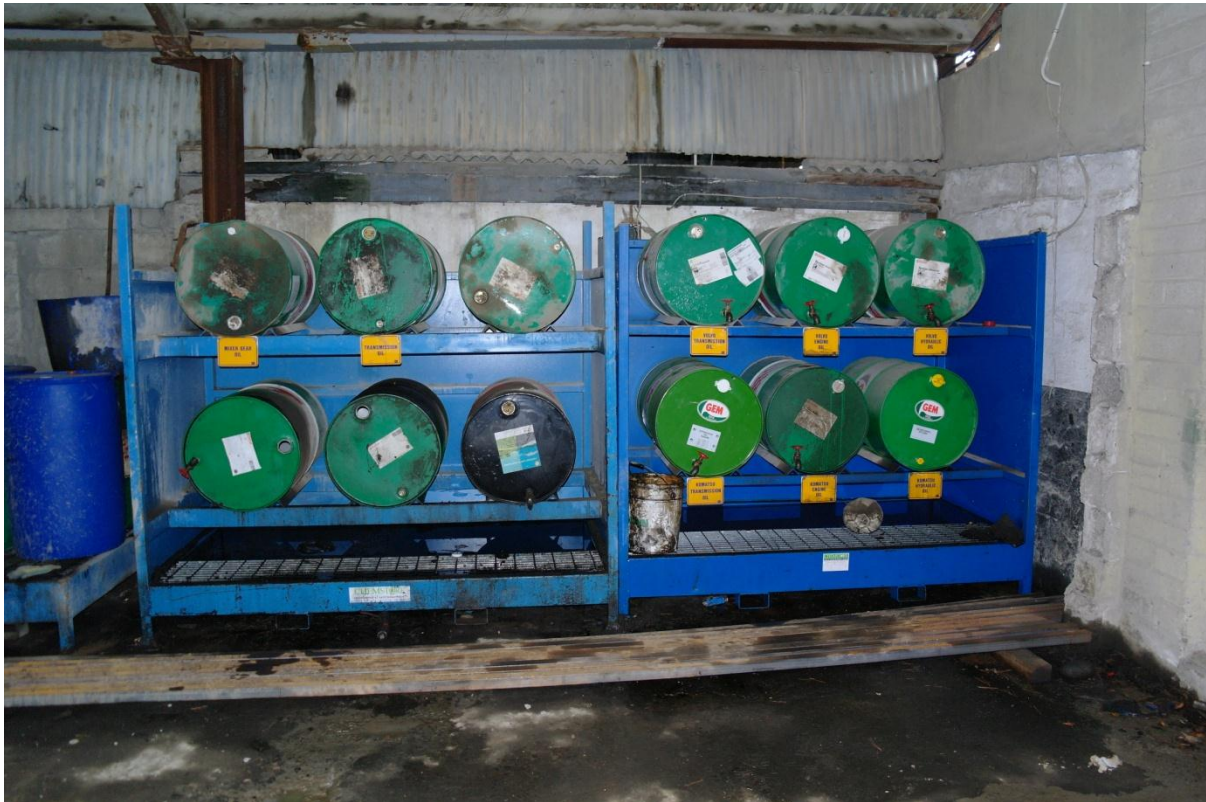
**Photo 2 – Bunded Oil Drums in Maintenance Shed**

The gas-oil, hydraulic oils, engine oils, transmission oils, waste oils, etc. are currently stored within bunded areas in the maintenance shed. The operator must maintain adequate capacity in these bunds for them to be effective.

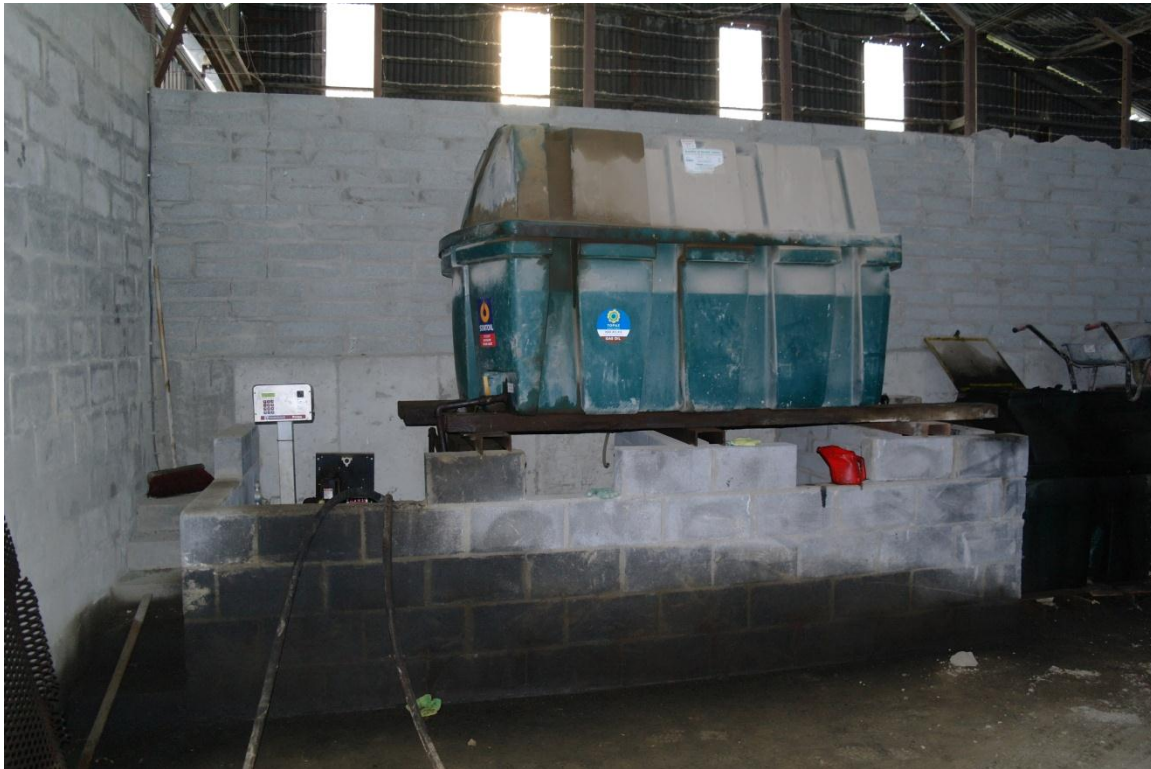
**Photo 3 – Bunded Gas Oil (Diesel) Tank in Maintenance Shed**

The 2,500 litre gas-oil tank consists of a self-bunded tank that is supported by the walls of a block-work bund (See Photo 3 below). There is a risk that a vehicle colliding with the bund wall would cause the tank to topple outside the bund and spill on the floor of the maintenance shed. The risk of such an occurrence is considered 'high'.

A spill of up to 2,500 litres of gas oil (diesel) in the maintenance shed would be directed to the adjacent yard area. This is an unpaved yard, so we expect a spill of this size to percolate to ground rather than drain to the downgradient site pond, located approximately 200 metres away. The severity of such an event is considered ‘medium’ with clean-up costs between €10,000 and €50,000.

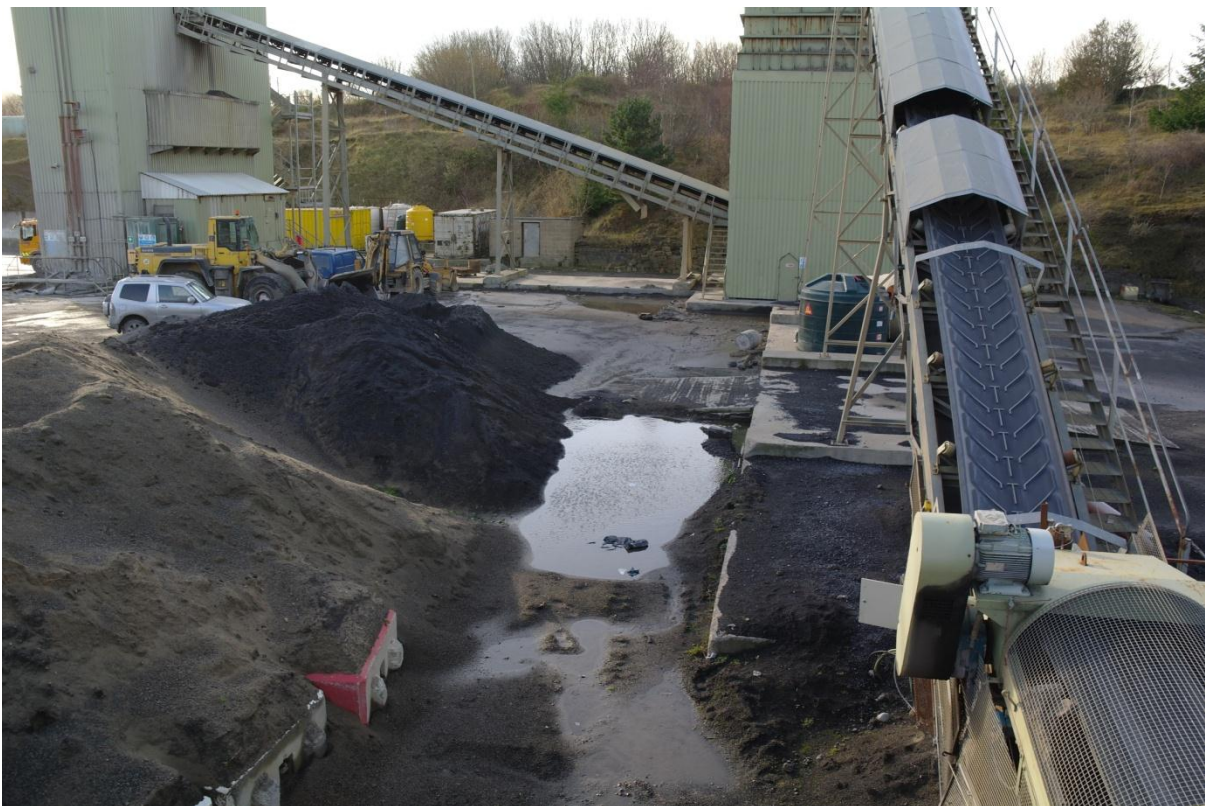
**Photo 5 – Yard Drainage Impeded by Concrete Platform**

The licensee is currently in the process of installing a Class II By-Pass Separator that will contain minor hydrocarbon spills or leaks emanating from the concrete production yard. The interceptor must be regularly inspected and adequately maintained. These mitigation measures, when fully installed and properly maintained reduce the risk of occurrence of this event from 'Medium' to 'Low'.
