Diageo St. Francis Abbey Brewery
Kilkenny

**Industrial Emissions Licence
Surrender**

CRAMP Report

Issue 4 | 16 October 2014

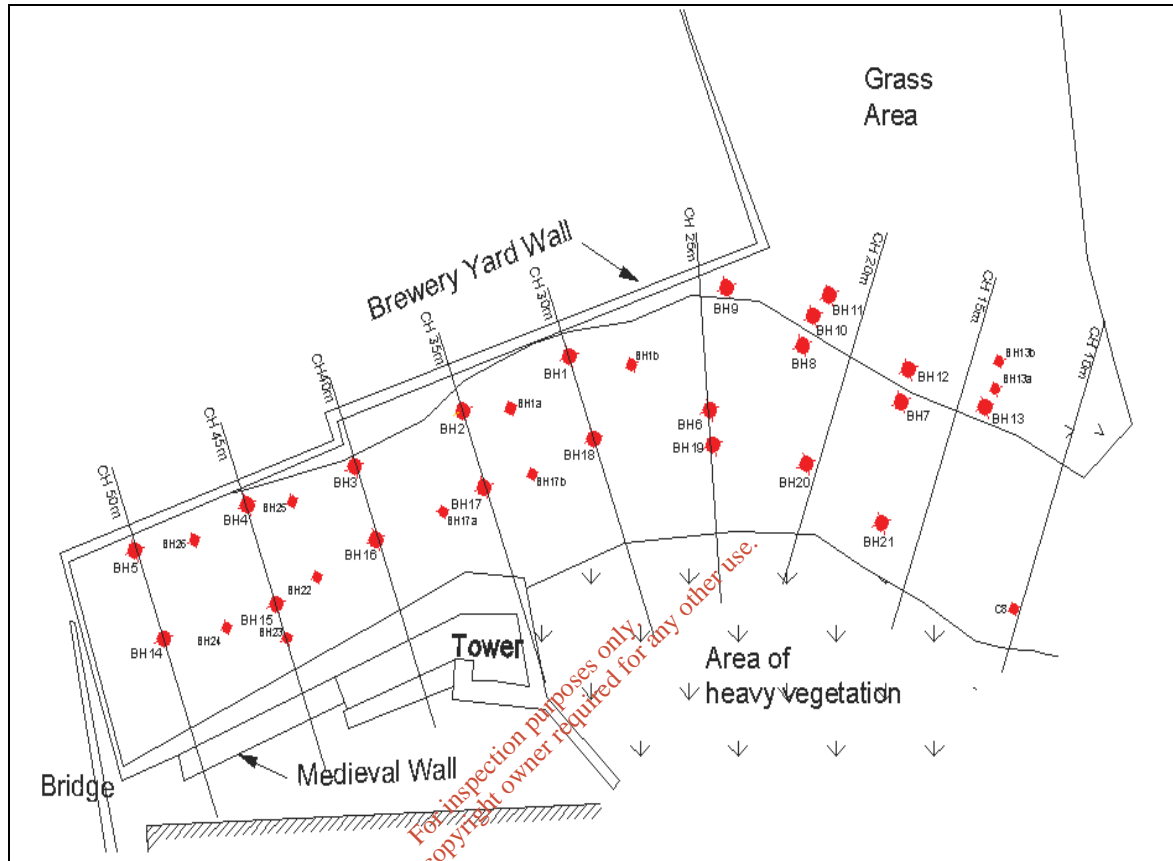
Figure 4: Borehole Locations Downstream of the On-site Bridge, Chainage 55 - 0, Validation Sampling

1. All depths are relative to required OPW bed level.
2. All lab analyses results are mg/kg Σ PCB₇ dry weight. All assays results indicate whether or not the PCB concentration exceeds the specific detection level noted.
3. This is same location as one of the boreholes in April 2001 survey

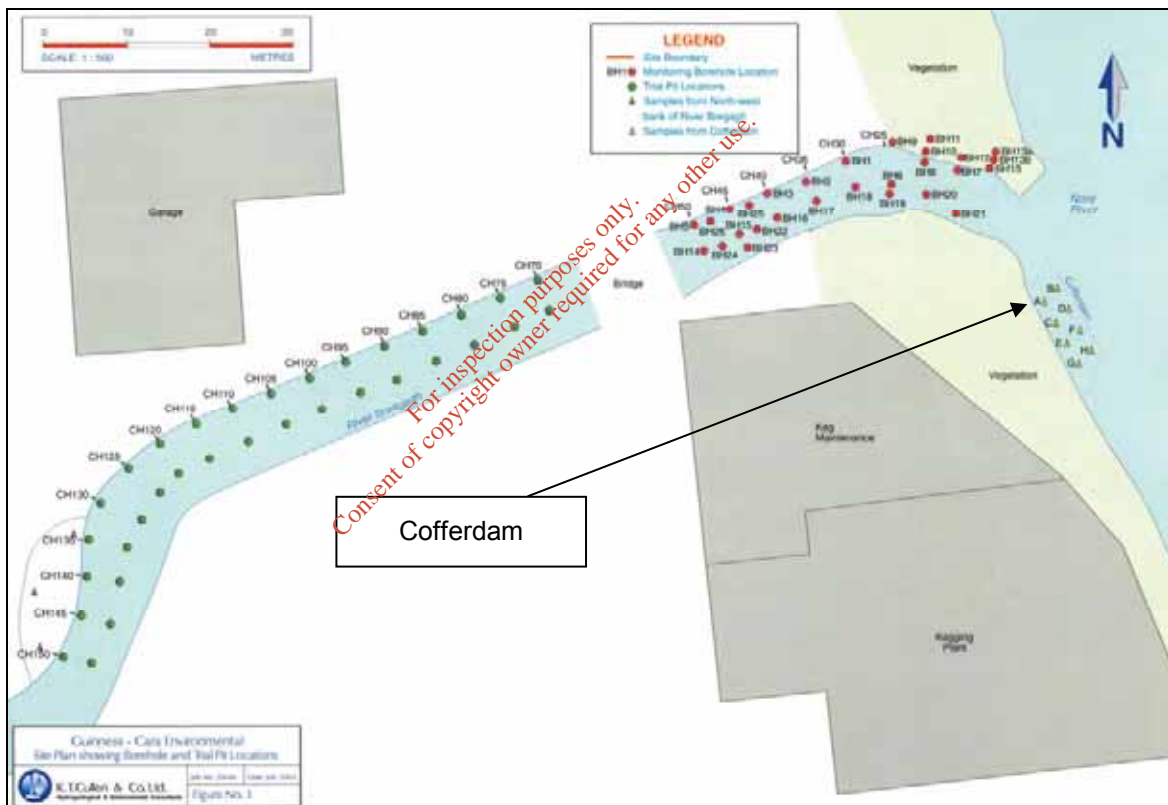
Figure 5: Location of Sampling Points in Cofferdam

Location	A	B	C	D	E	F	G	H
Sample Depth (m)	3	3	3.3	3.3	3.3	3.3	3	3
Units	mg/kg	mg/kg	mg/kg	mg/kg	mg/kg	mg/kg	mg/kg	mg/kg
Site Test	<0.1	<0.1	<0.1	<0.1	<0.1	<0.1	<0.1	<0.1

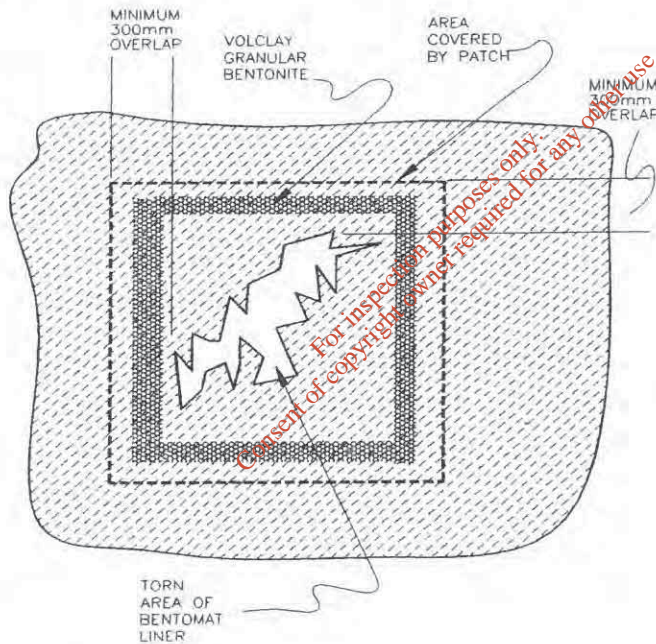
- 30 If the GCL is damaged (torn, punctured, perforated, etc.) during installation, it is possible to repair it by placing a patch over the damaged area (Figure 4). The patch shall be obtained from a new GCL roll and shall be cut to size such that a minimum overlap of 300 mm is achieved around all parts of the damaged area. Granular bentonite should be applied around the damaged area prior to placement of the patch. Smaller patches also may be tucked *under* the damaged area to prevent patch movement during placement of cover material.

A MINIMUM OF 300mm OVERLAP IS REQUIRED.

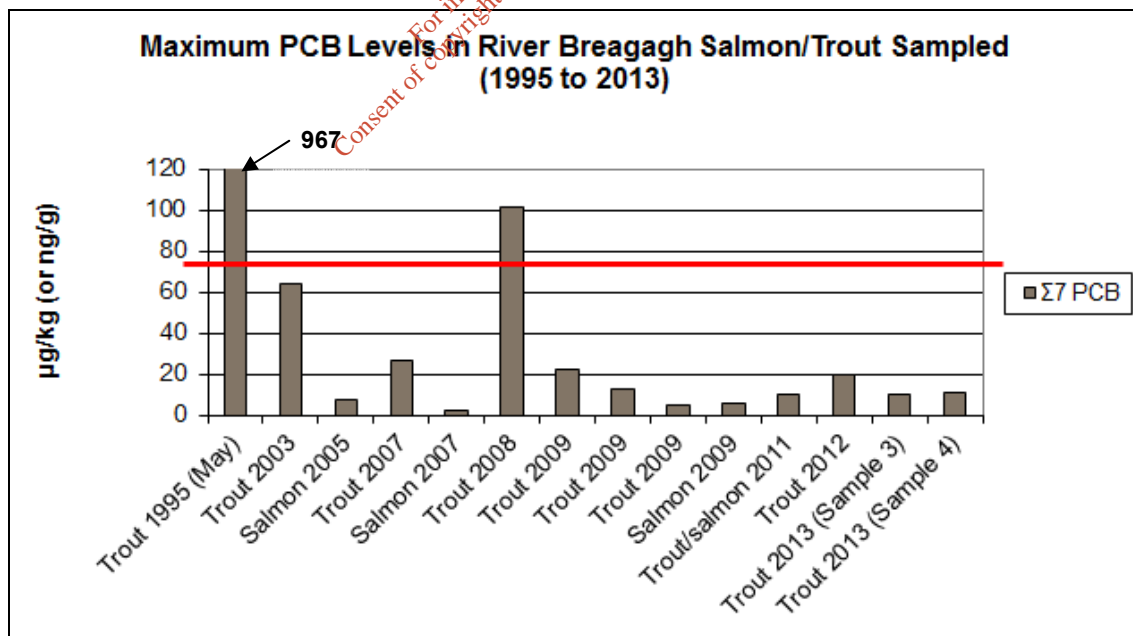
Figure 2.1: Maximum Σ7 PCB Levels in River Breagagh Salmon/Trout (1995 – 2013)

For trout and salmon, PCB levels have been shown to be within relevant EU Food Safety limits for all samples between 2003 and 2013, i.e. post remediation, with the exception of a single sample of trout in 2008 (Figure 2.1 below).

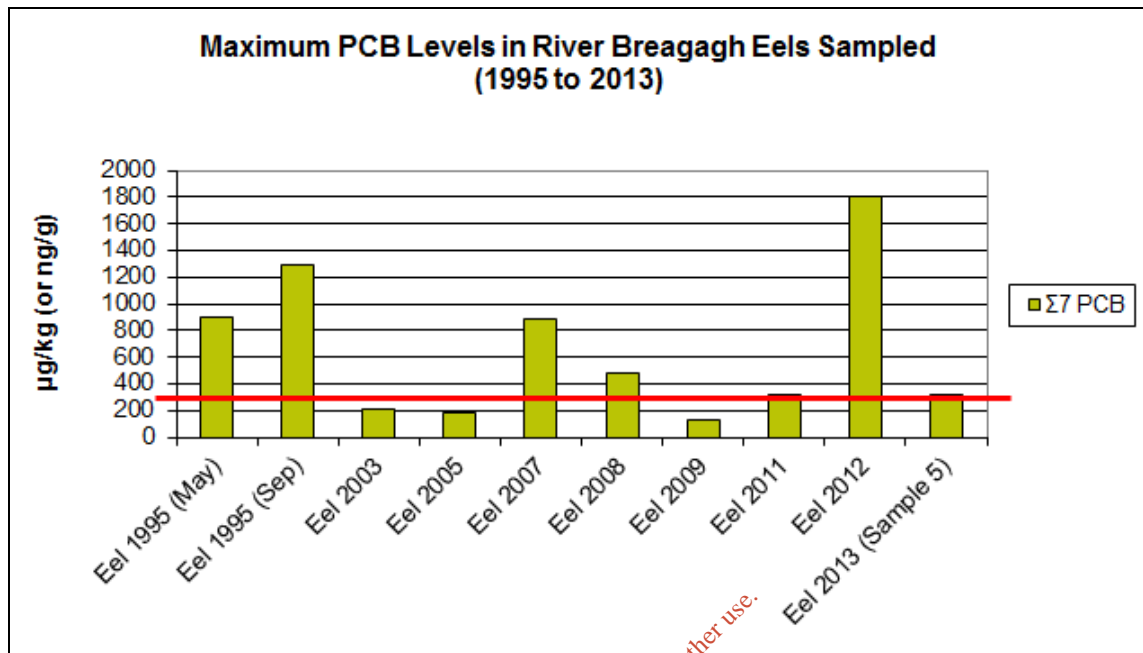
Figure 2.2: Maximum Σ7 PCB Levels in River Breaghagh Eel (1995 – 2013)

A number of eel samples have continued to show results in excess of the EU maximum value for sum of non dioxin-like PCBs (Figure 2.2 overleaf), again with regard to food safety. It is noted that the results for sum of dioxin-like PCBs in the same samples were within the corresponding EU maximum value.
