Attachment H.1 Raw Materials, Intermediates and Product Handling

Project Name: 126-22855 Greenstar, Ballyc	Project number:	Date: 27/04/2016	Contact:	
--	-----------------	---------------------	----------	--

Inspection report

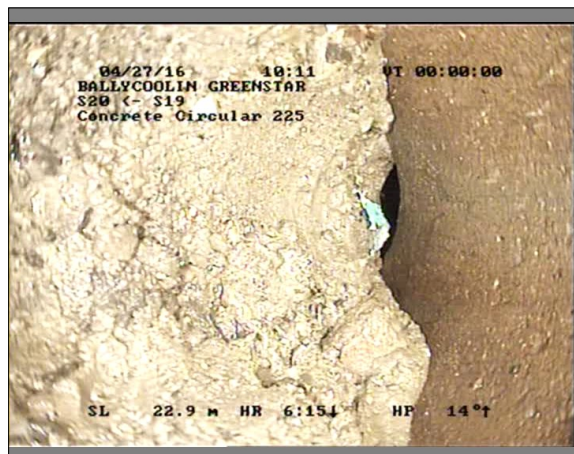
1:195	Position	Code	Observation	Photo	Grade
	S20				
	1.20	MH	Start node type, manhole, reference number S20		0
	1.20	WL	Water level, 10% of the vertical dimension		0
	5.77	WL	Water level, 5% of the vertical dimension		0
	22.93	DEC	Settled deposits, hard or compacted, 95% cross-sectional area loss Remarks: Concrete	2_4A	5
	22.93	SA	Survey abandoned Remarks: due to concrete in line		0

Photo: 3_3_6_A.JPG
 22.93m, Settled deposits, hard or compacted, 95%
 cross-sectional area loss Remarks: Concrete

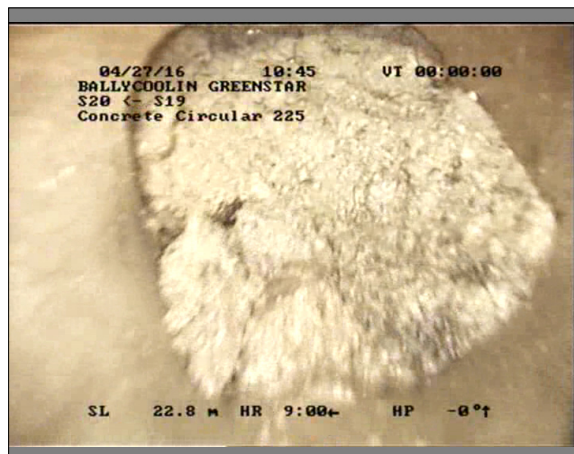
1:195	Position	Code	Observation	Photo	Grade
	S20				
	1.20	MH	Start node type, manhole, reference number S20		0
	1.20	WL	Water level, 5% of the vertical dimension		0
	2.95	DES	Settled deposits, fine, 5% cross-sectional area loss		2
	10.13	DES	Settled deposits, fine, 10% cross-sectional area loss		3
	23.06	DEC	Settled deposits, hard or compacted, 90% cross-sectional area loss Remarks: Concrete	2_5A	5
	23.06	SA	Survey abandoned Remarks: Due to concrete		0

Photo: 4_4_12_A.jpg
 23.06m, Settled deposits, hard or compacted, 90% cross-sectional area loss
 Remarks: Concrete

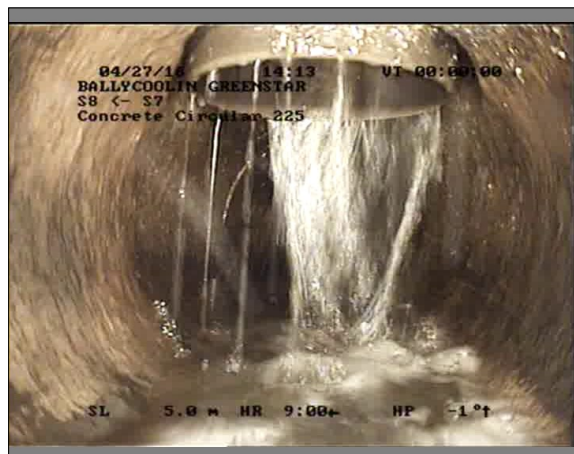
Photo: 13_13_55_A.JPG
 5.03m, Connection intruding, at 12 o'clock, diameter 150mm, intrusion 15%

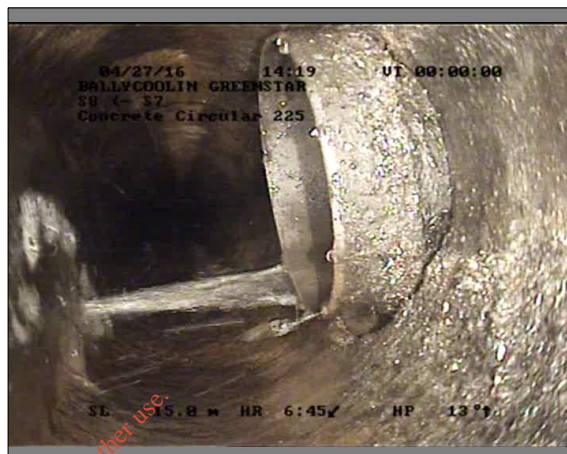
Photo: 13_13_56_A.JPG
 15.05m, Connection intruding, at 12 o'clock, diameter 150mm, intrusion 20%

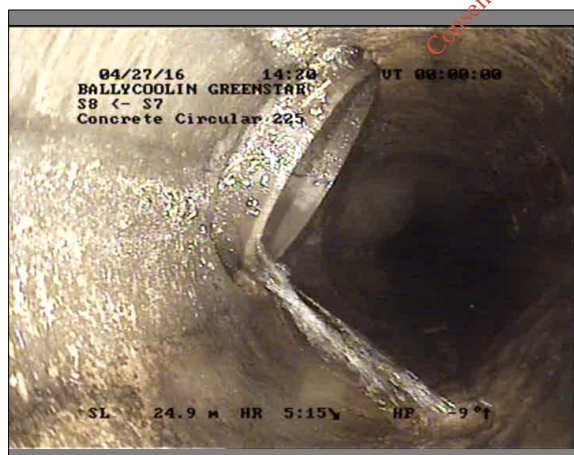
Photo: 13_13_57_A.JPG
 24.91m, Connection intruding, at 12 o'clock, diameter 150mm, intrusion 15%

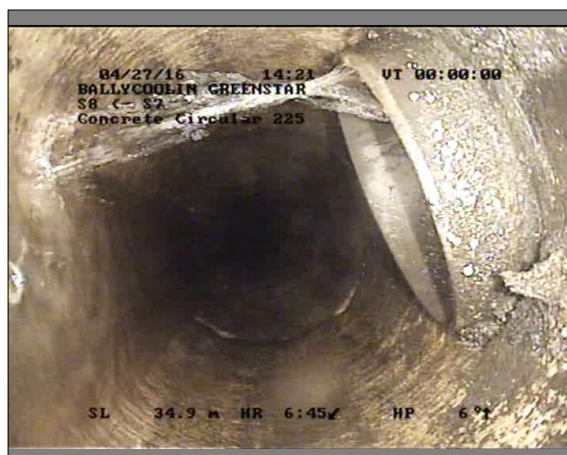
Photo: 13_13_59_A.JPG
 34.94m, Connection intruding, at 12 o'clock, diameter 150mm, intrusion 20%

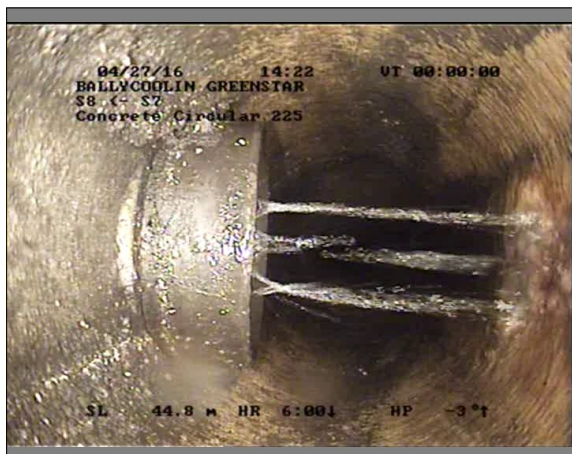
Photo: 13_13_61_A.JPG
 44.81m, Connection intruding, at 12 o'clock, diameter 150mm, intrusion 20%

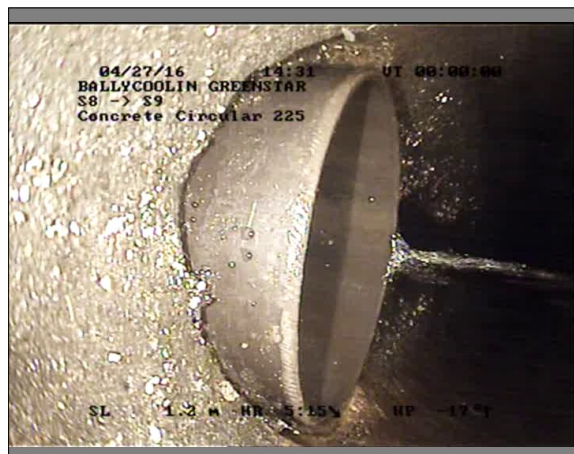
Photo: 14_14_65_A.JPG
1.28m, Connection intruding, at 12 o'clock, diameter 150mm,
intrusion 20%

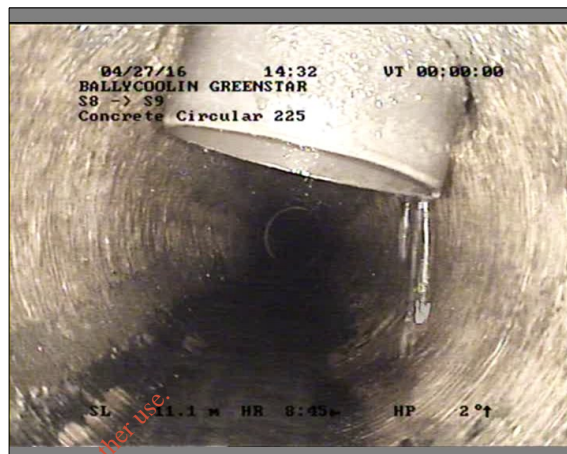
Photo: 14_14_67_A.JPG
1.1m, Connection intruding, at 12 o'clock, diameter 150mm,
intrusion 40%

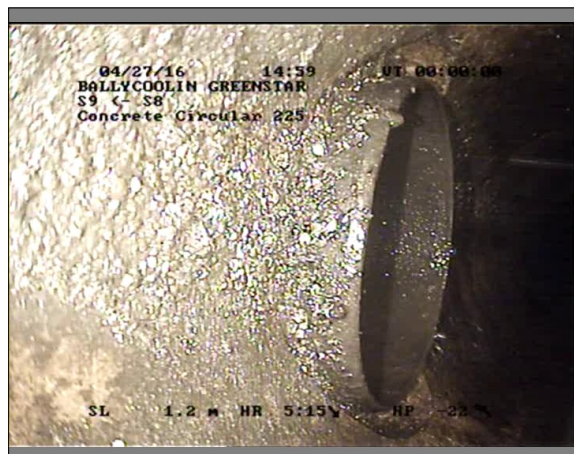
Photo: 15_15_71_A.JPG
 1.2m, Connection intruding, at 12 o'clock, diameter 150mm, intrusion 15%

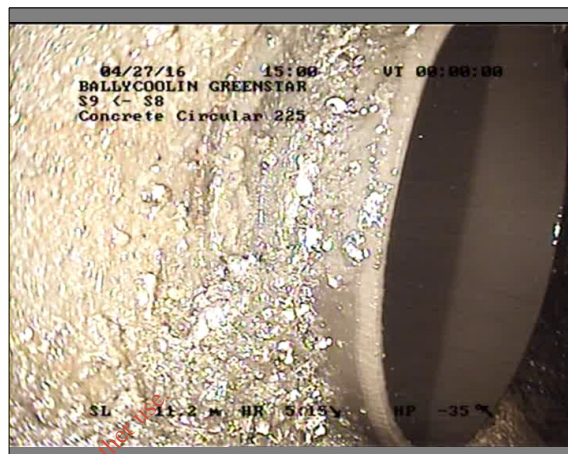
Photo: 15_15_73_A.JPG
 11.2m, Connection intruding, at 12 o'clock, diameter 150mm, intrusion 15%

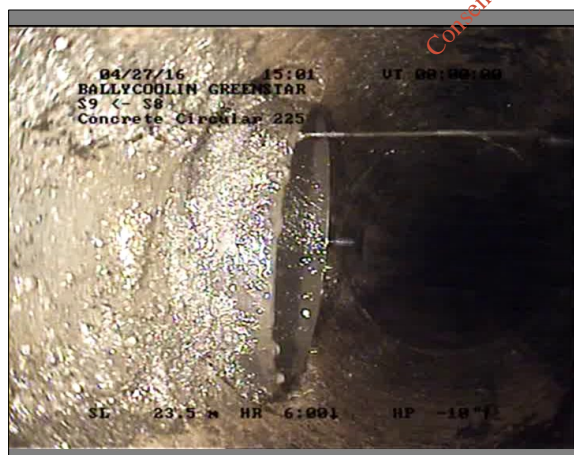
Photo: 15_15_74_A.JPG
 23.5m, Connection intruding, at 12 o'clock, diameter 150mm, intrusion 15%

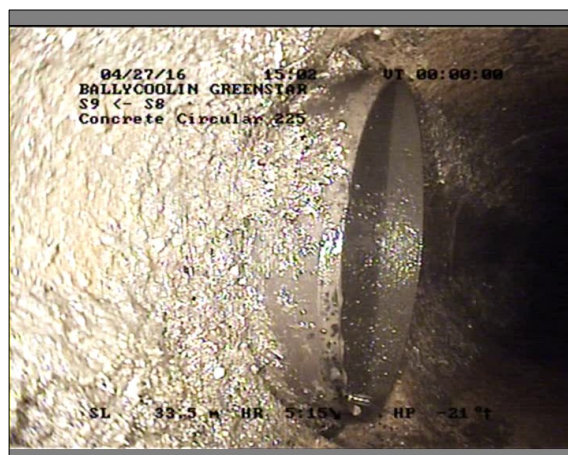
Photo: 15_15_76_A.JPG
 33.5m, Connection intruding, at 12 o'clock, diameter 150mm, intrusion 15%

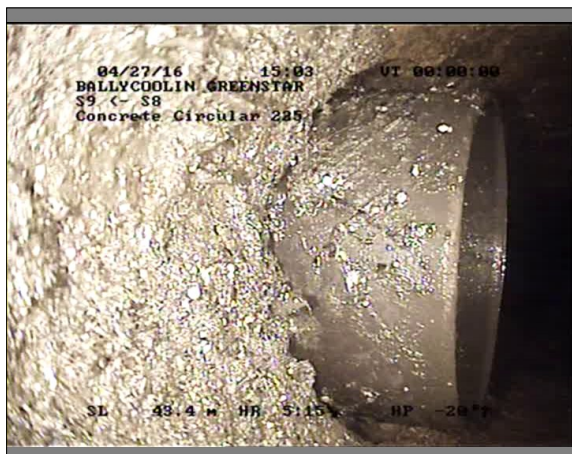
Photo: 15_15_78_A.JPG
 43.49m, Connection intruding, at 12 o'clock, diameter 150mm,
 intrusion 40%

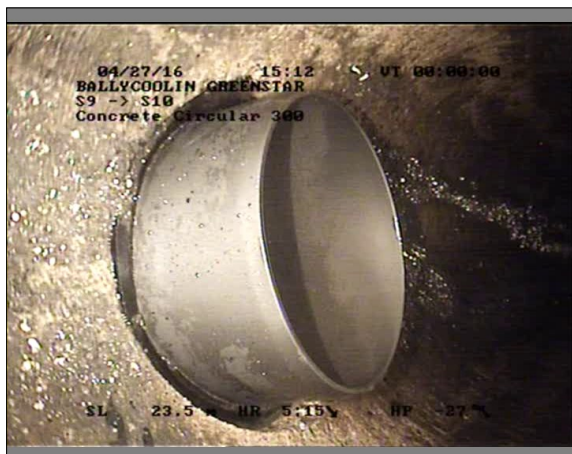
Photo: 16_16_83_A.JPG
23.52m, Connection intruding, at 11 o'clock, diameter 150mm, intrusion 30%

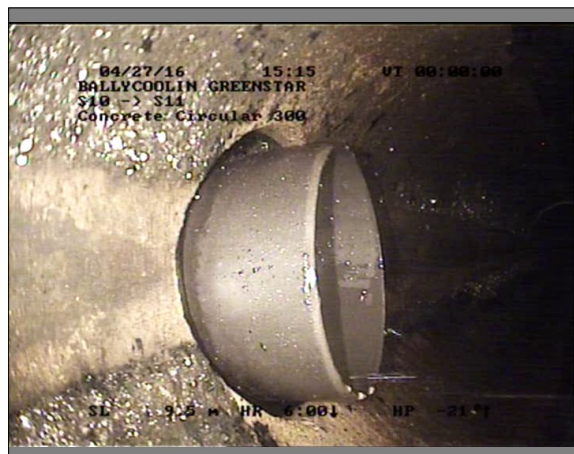
Photo: 17_17_87_A.JPG
9.57m, Connection intruding, at 12 o'clock, diameter 150mm, intrusion 30%

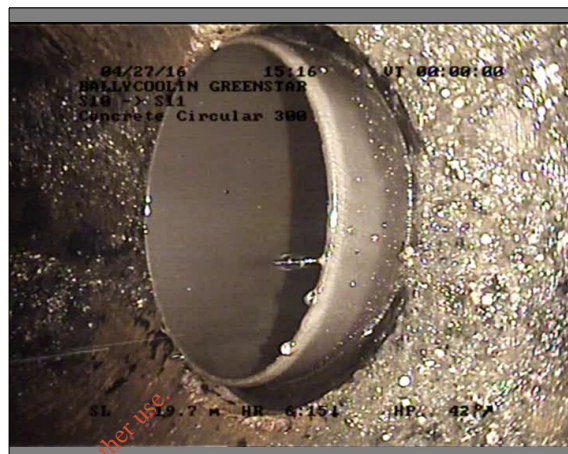
Photo: 17_17_88_A.JPG
19.75m, Connection intruding, at 12 o'clock, diameter 150mm, intrusion 15%

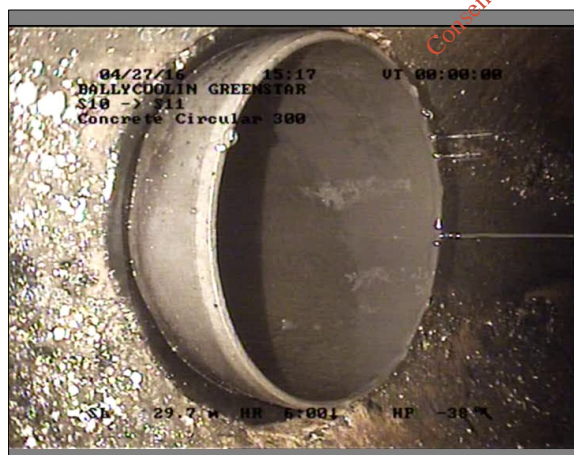
Photo: 17_17_89_A.JPG
29.75m, Connection intruding, at 12 o'clock, diameter 150mm, intrusion 15%

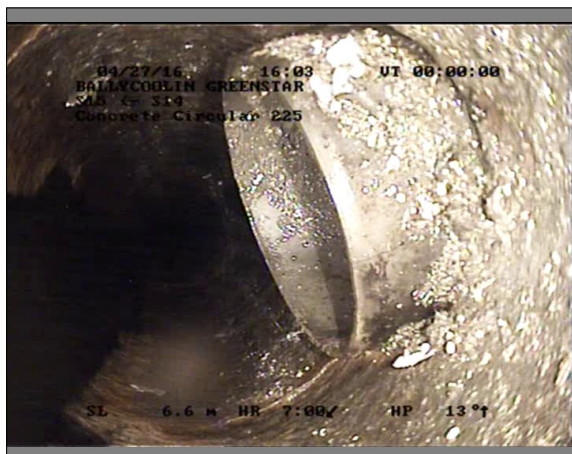
Photo: 18_18_93_A.JPG
 6.65m, Connection intruding, at 12 o'clock, diameter 150mm, intrusion 30%

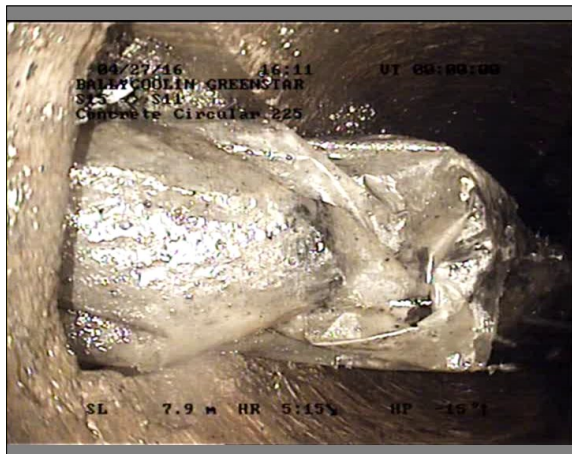
Photo: 19_19_99_A.JPG
 7.97m, Connection defective, connecting pipe is blocked, at 12 o'clock, diameter 150mm Remarks: OBSTRUCTION THROUGH CONNECTION

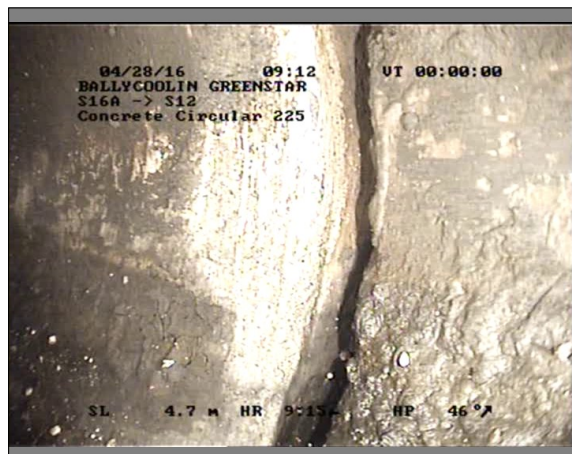
Photo: 22_22_114_A.JPG
 4.74m, Open joint, 5mm of diameter

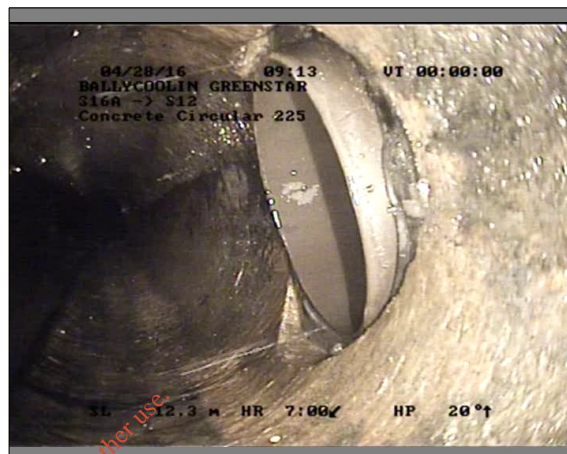
Photo: 22_22_115_A.JPG
 12.33m, Connection intruding, at 12 o'clock, diameter 150mm, intrusion 10%

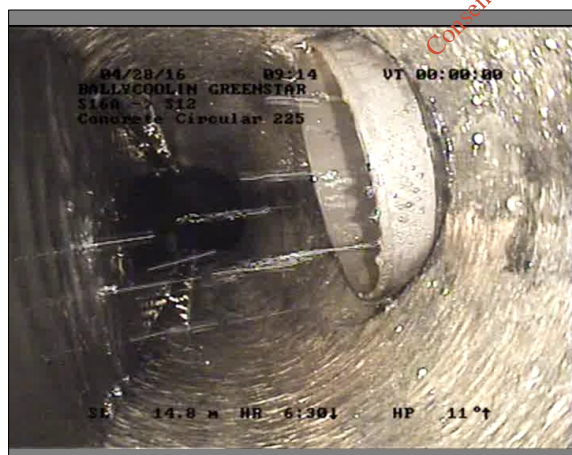
Photo: 22_22_117_A.JPG
 14.81m, Connection intruding, at 12 o'clock, diameter 150mm, intrusion 15%

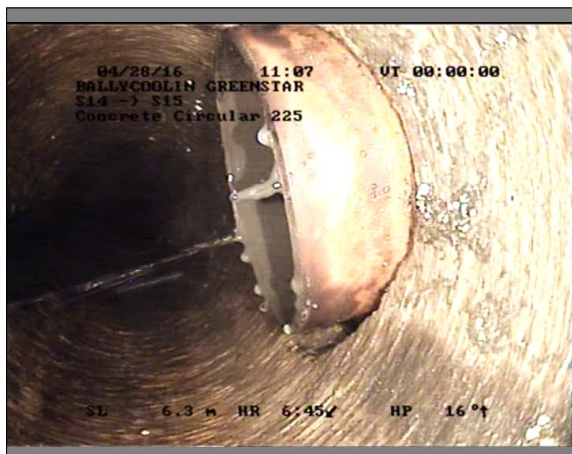
Photo: 23_23_122_A.JPG
6.38m, Connection intruding, at 12 o'clock, diameter 150mm, intrusion 20%

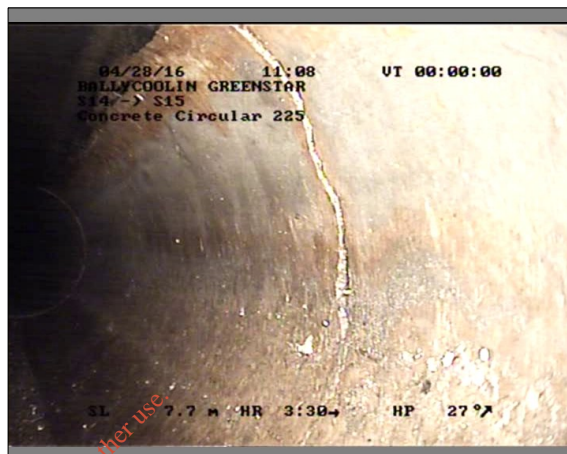
Photo: 23_23_123_A.JPG
7.7m, Fracture, circumferential, from 2 to 10 o'clock

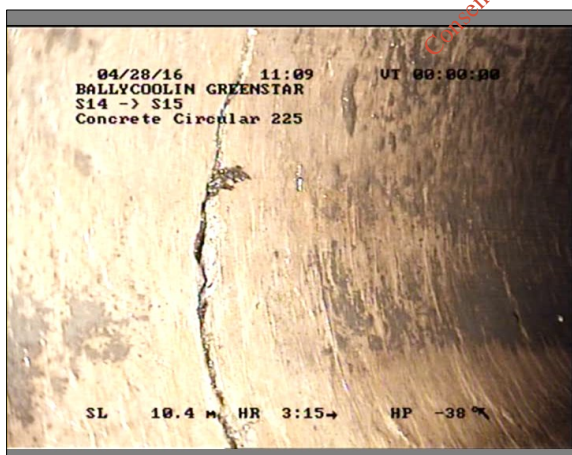
Photo: 23_23_124_A.JPG
10.47m, Fracture, circumferential, from 12 to 12 o'clock

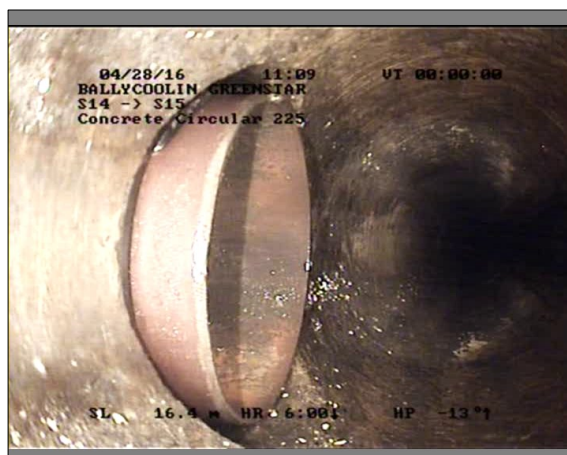
Photo: 23_23_125_A.JPG
16.47m, Connection intruding, at 12 o'clock, diameter 150mm, intrusion 10%

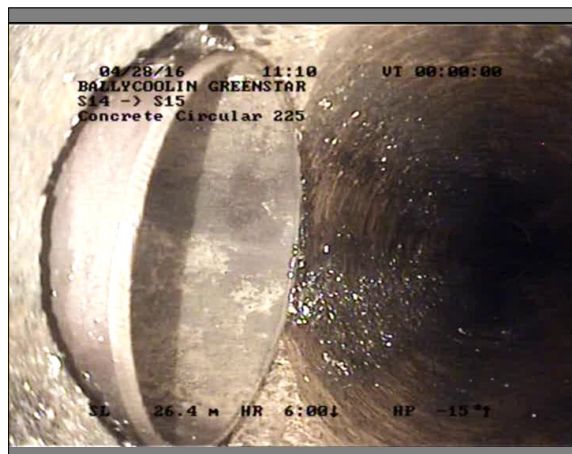
Photo: 23_23_126_A.JPG
26.48m, Connection intruding, at 12 o'clock, diameter 150mm, intrusion 10%

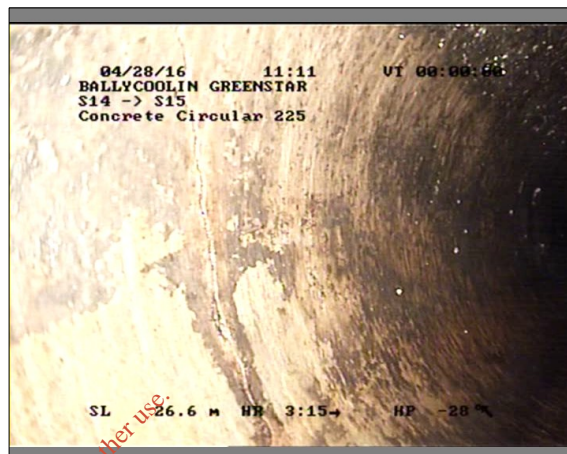
Photo: 23_23_127_A.JPG
26.67m, Fracture, circumferential, from 7 to 11 o'clock

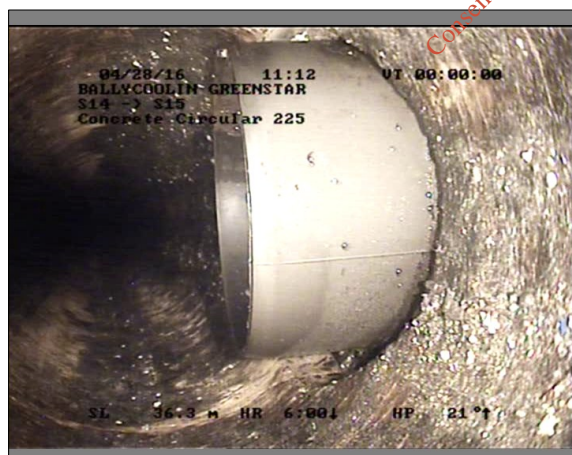
Photo: 23_23_129_A.JPG
36.37m, Connection intruding, at 12 o'clock, diameter 150mm, intrusion 40%

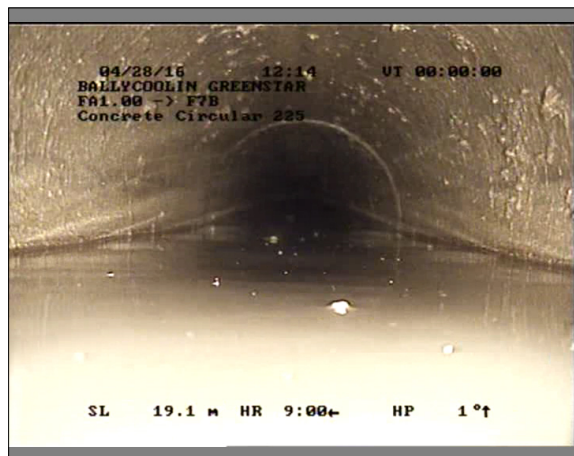
Photo: 24_24_136_A.jpg
 19.15m, Survey abandoned Remarks: EXCESS WATER LEVELS
