**ANNUAL ENVIRONMENTAL REPORT**  
**RILTA ENVIRONMENTAL LTD.**  
**SITE 14-A1 GREENOGUE BUSINESS PARK**  
**LICENCE NO. W0185-01**  
**JANUARY 2016 – DECEMBER 2016**

Rilta Environmental Ltd,  
Greenogue Business Park,  
Rathcoole,  
County Dublin.

Project	Annual Environmental Report 2016			
Client	Rilta Environmental Ltd W0185-01			
Report No	Date	Status	Prepared By	Reviewed By
161950209	23/03/2017	Draft	Mr Neil Sandes PGeo EurGeol	Mr Jim O'Callaghan MSc
	07/04/2107	Final

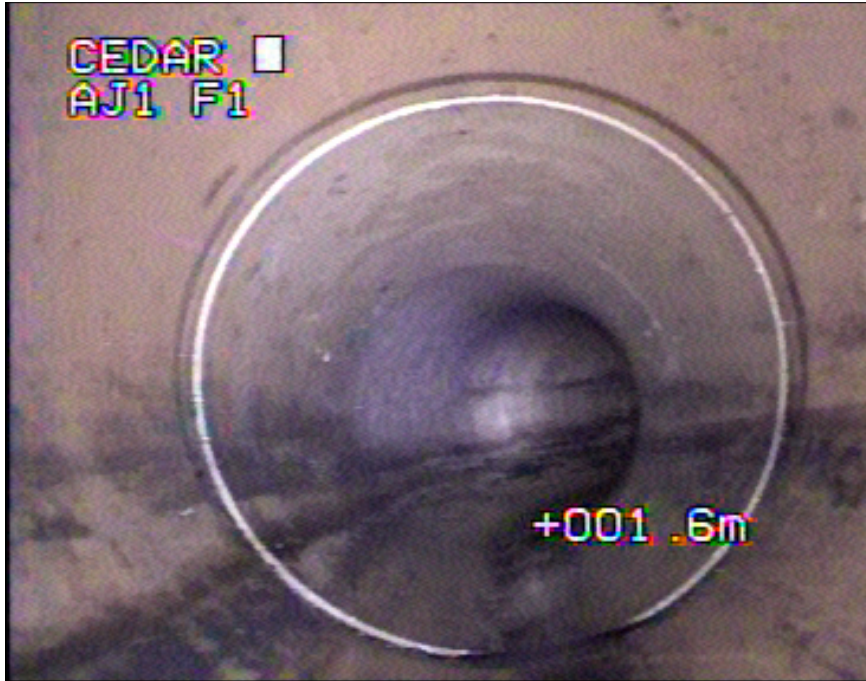
Photo: 1\_6A, MPEG #: 051216\_1, 00:00:00  
7.71m, Finish node type, manhole reference number: F1

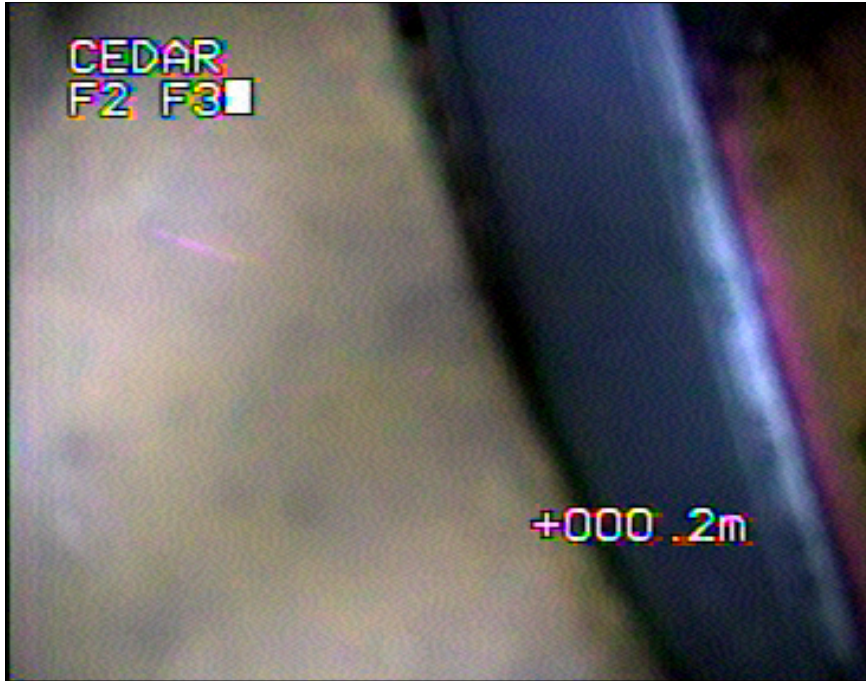
Photo: 4\_3A, MPEG #: 051216\_1, 00:00:07  
 0.2m, Sealing ring intruding, from 6 to 12 o'clock

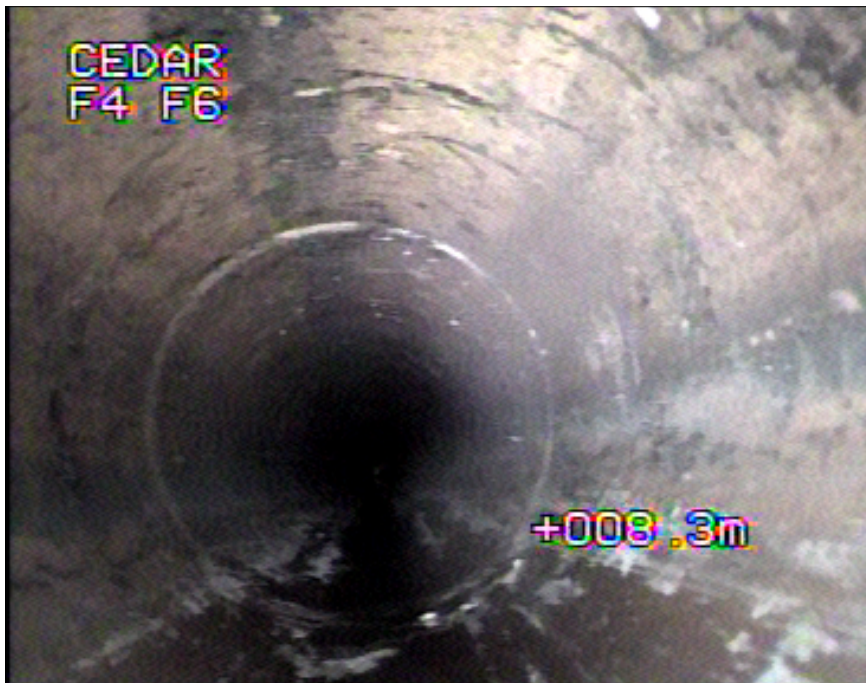
Photo: 7\_5A, MPEG #: 051216\_1, 00:01:22  
8.3m, Cracks, multiple, from 4 to 8 o'clock

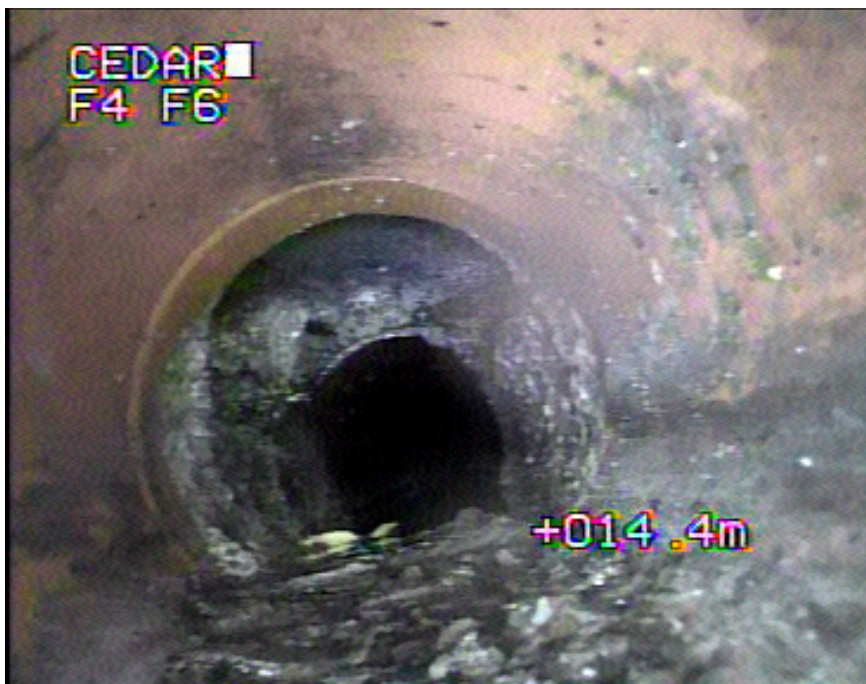
Photo: 7\_6A, MPEG #: 051216\_1, 00:02:24  
14.3m, Settled deposits, hard or compacted, 10% cross-sectional area loss

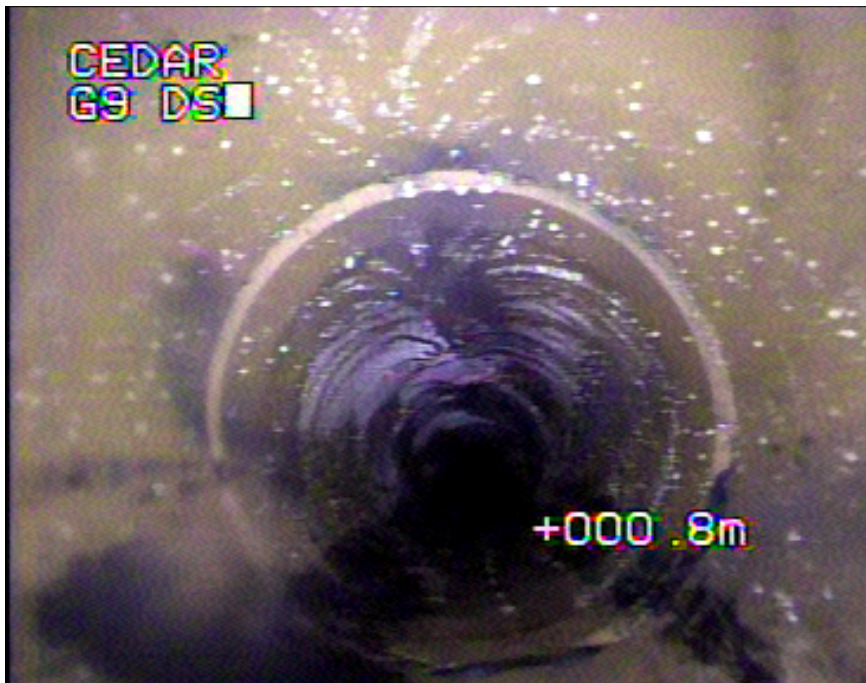
Photo: 22\_3A, MPEG #: 051216\_1, 00:00:12  
0.9m, Sealing ring intruding, from 5 to 7 o'clock

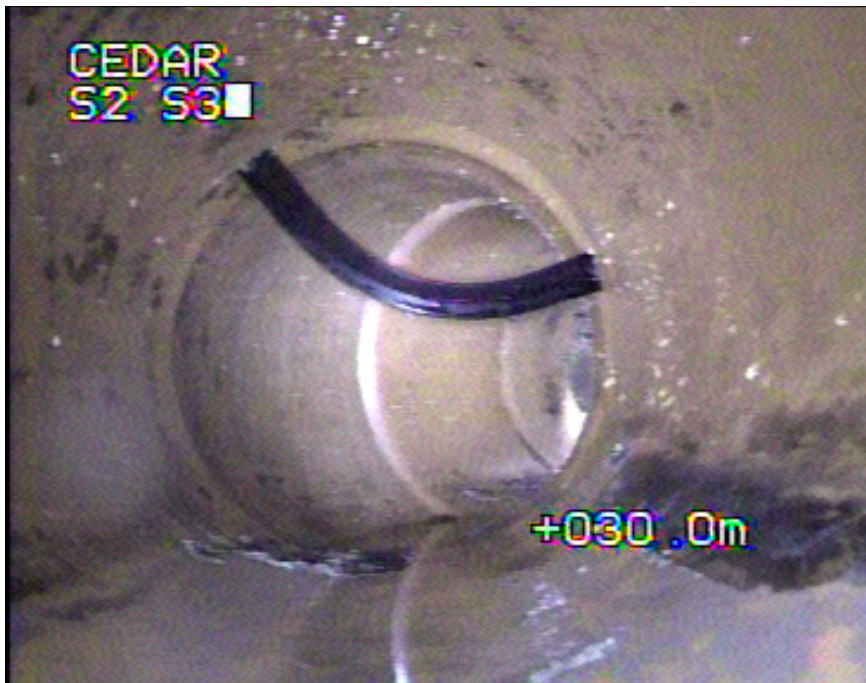
Photo: 23\_3A, MPEG #: 051216\_1, 00:04:31  
30m, Sealing ring intruding, from 11 to 3 o'clock

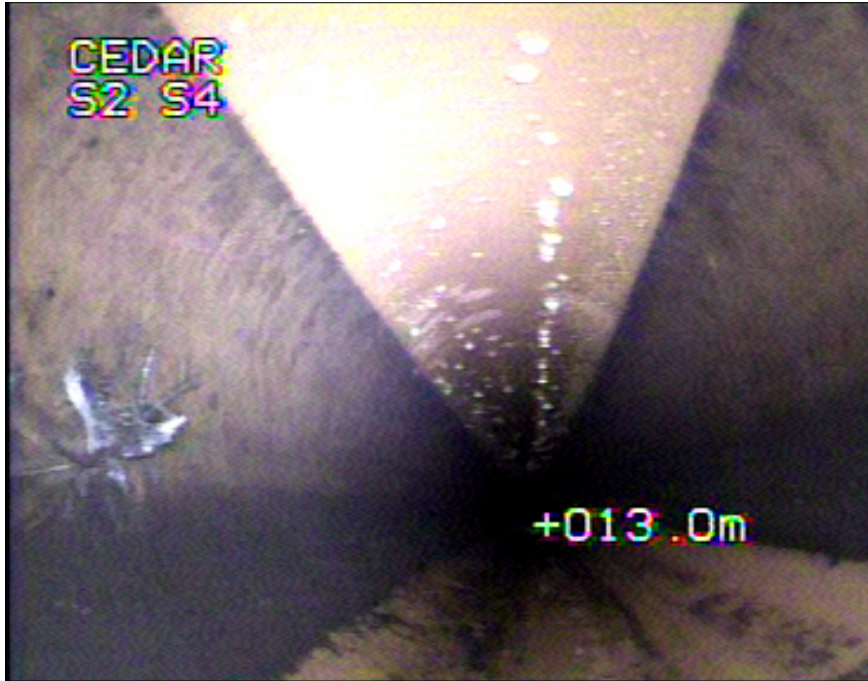
Photo: 24\_10A, MPEG #: 051216\_1, 00:02:35  
13m, Surface damage, other, from 8 to 9 o'clock

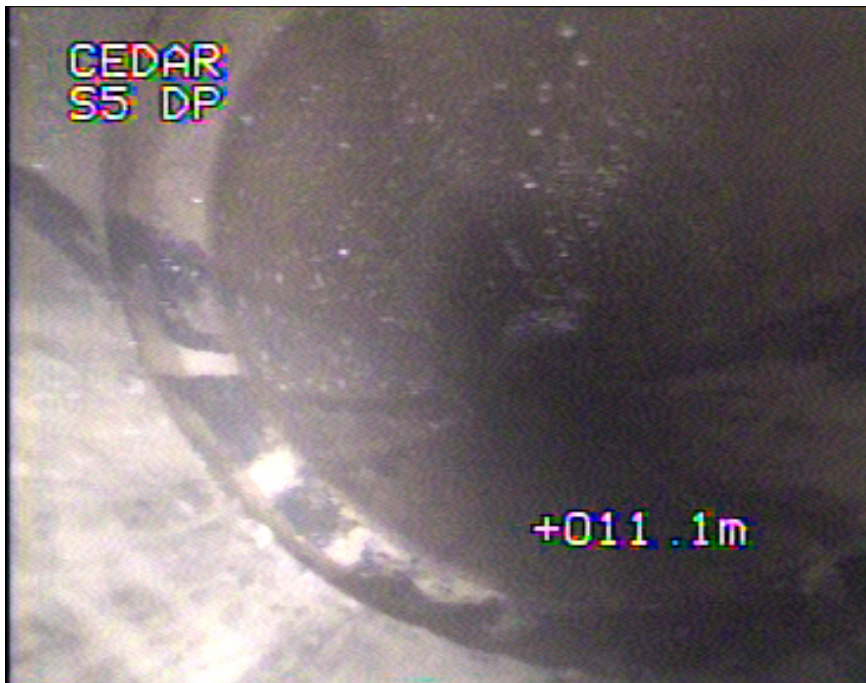
Photo: 27\_9A, MPEG #: 051216\_1, 00:01:44  
11.1m, Open joint, medium

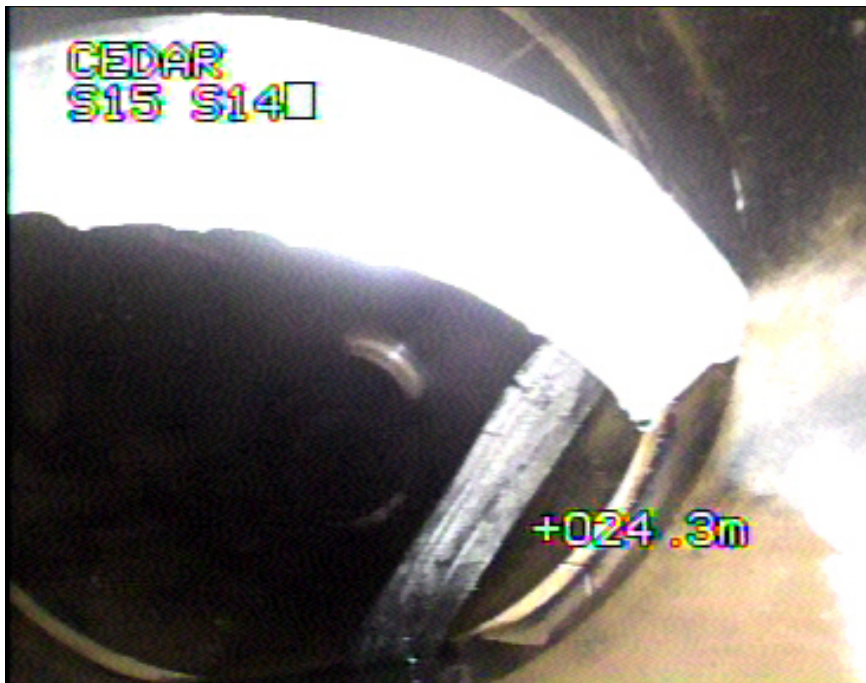
Photo: 47\_6A, MPEG #: 051216\_1, 00:02:39  
24.3m, Sealing ring intruding, from 10 to 6 o'clock

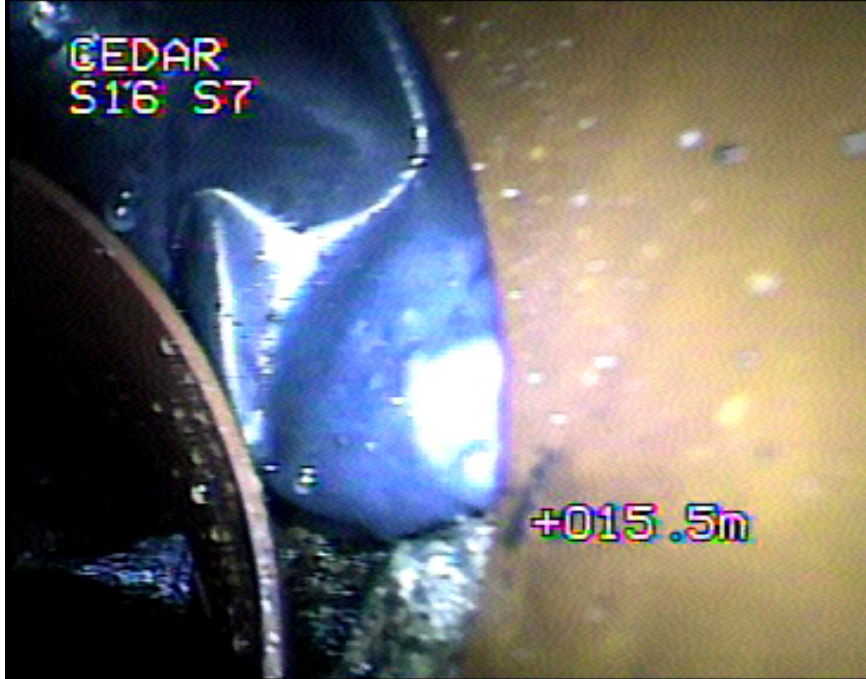
Photo: 49\_6A, MPEG #: 051216\_1, 00:02:41  
 15.4m, Joint displaced, large

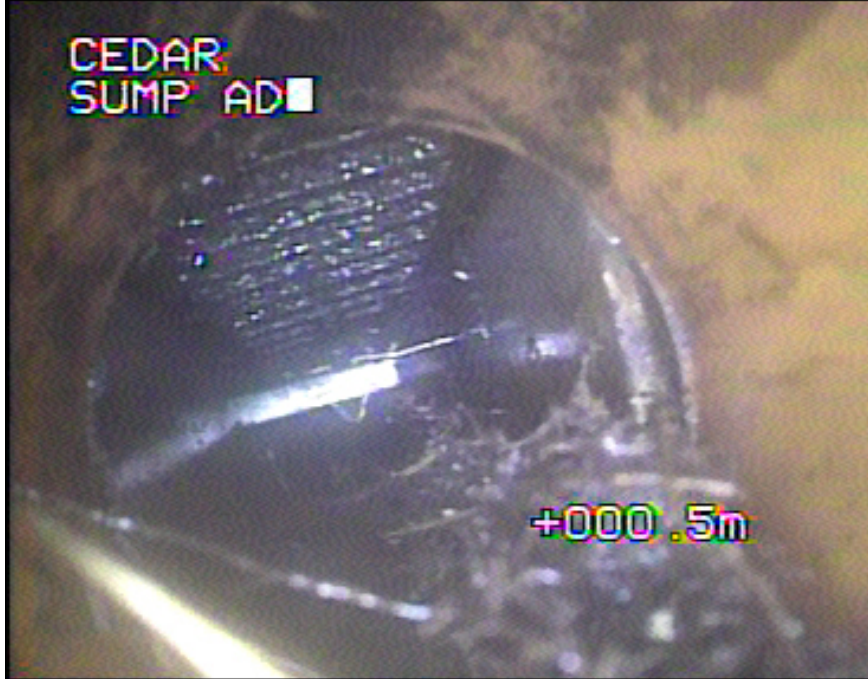
Photo: 50\_3A, MPEG #: 051216\_1, 00:00:12  
0.6m, Roots, fine

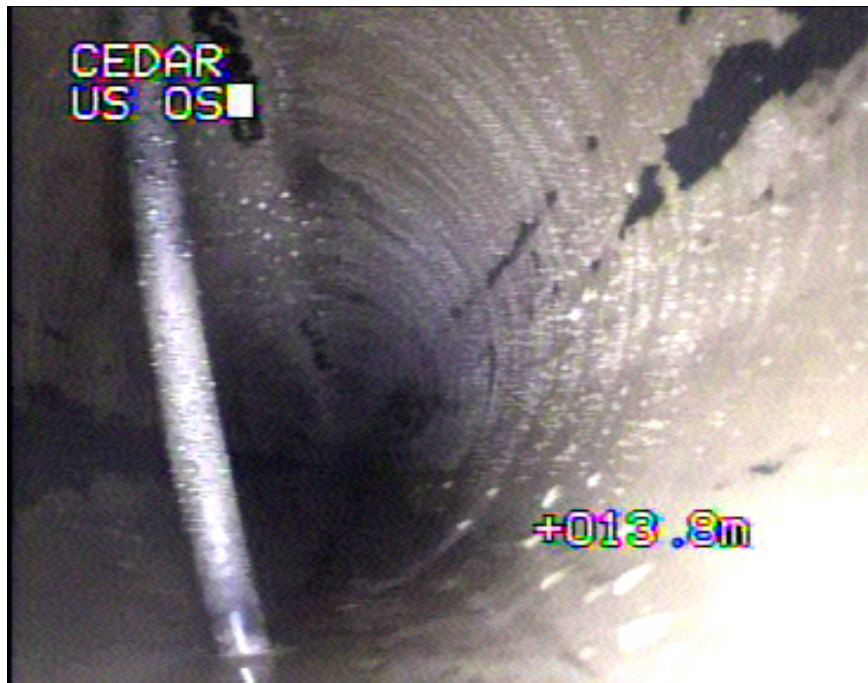
Photo: 52\_3A, MPEG #: 051216\_1, 00:01:52  
14m, Other obstacles protuding through wall, from 12 to 6 o'clock, 5% cross-sectional area loss

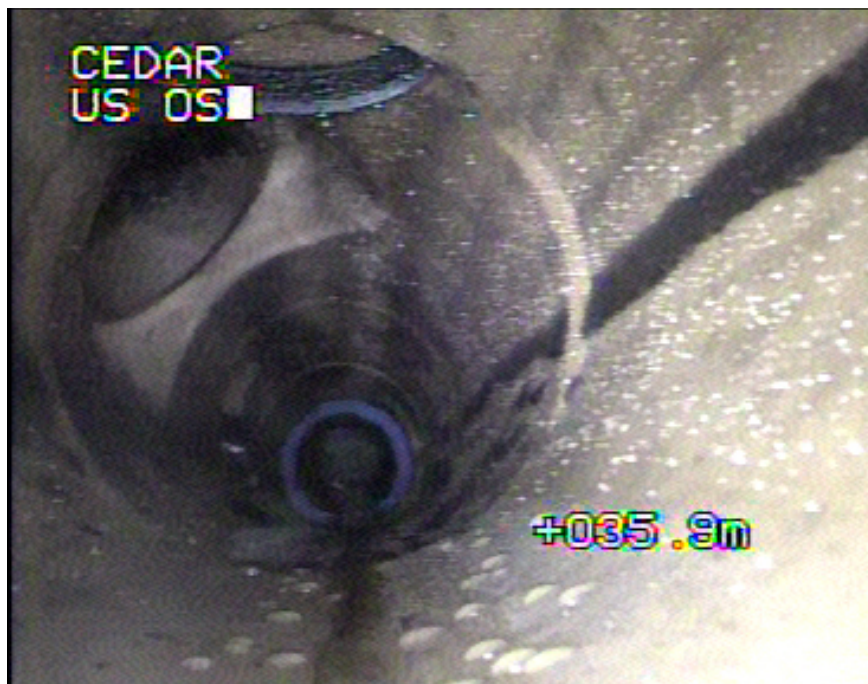
Photo: 52\_8A, MPEG #: 051216\_1, 00:05:26  
36.1m, Connection other than junction, at 10 o'clock, diameter 100mm
