ANNUAL ENVIRONMENTAL REPORT
RILTA ENVIRONMENTAL LTD.
SITE 14-A1 GREENOGUE BUSINESS PARK
LICENCE NO. W0185-01
JANUARY 2016 – DECEMBER 2016

Rilta Environmental Ltd,
Greenogue Business Park,
Rathcoole,
County Dublin.

Project	Annual Environmental Report 2016			
Client	Rilta Environmental Ltd W0185-01			
Report No	Date	Status	Prepared By	Reviewed By
161950209	23/03/2017	Draft	Mr Neil Sandes PGeo EurGeol	Mr Jim O'Callaghan MSc
	07/04/2107	Final

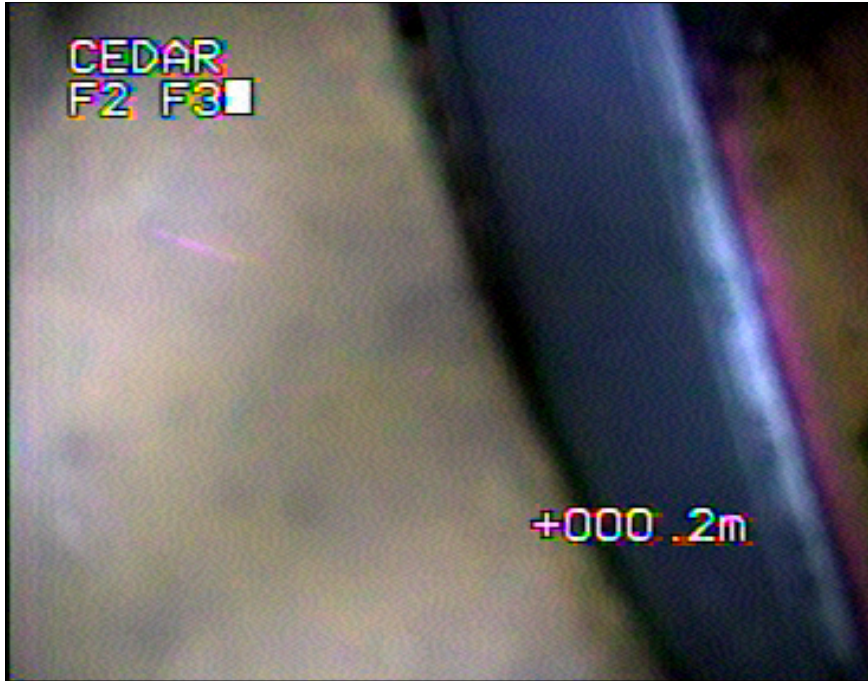
Photo: 4_3A, MPEG #: 051216_1, 00:00:07
0.2m, Sealing ring intruding, from 6 to 12 o'clock

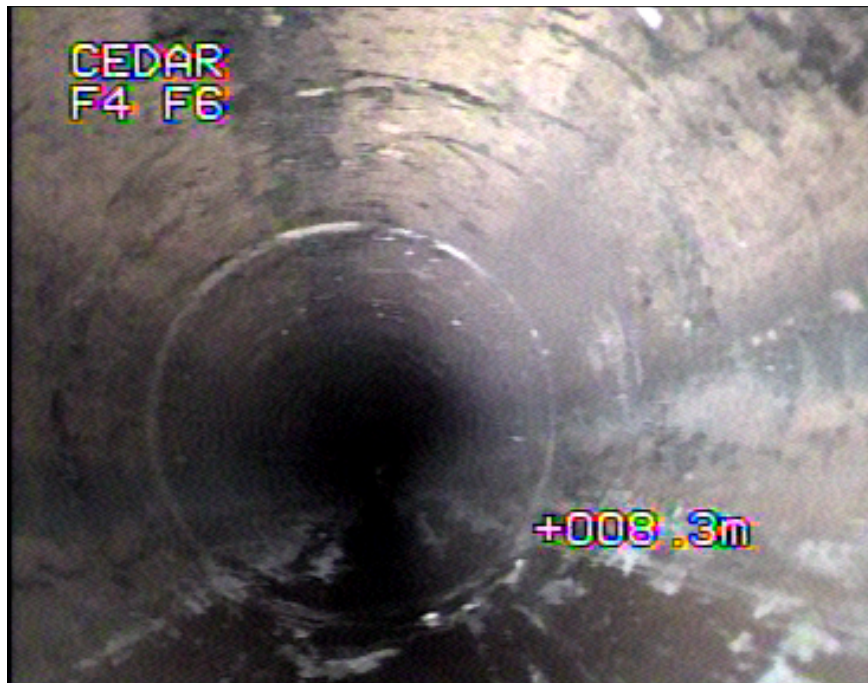
Photo: 7_5A, MPEG #: 051216_1, 00:01:22
8.3m, Cracks, multiple, from 4 to 8 o'clock

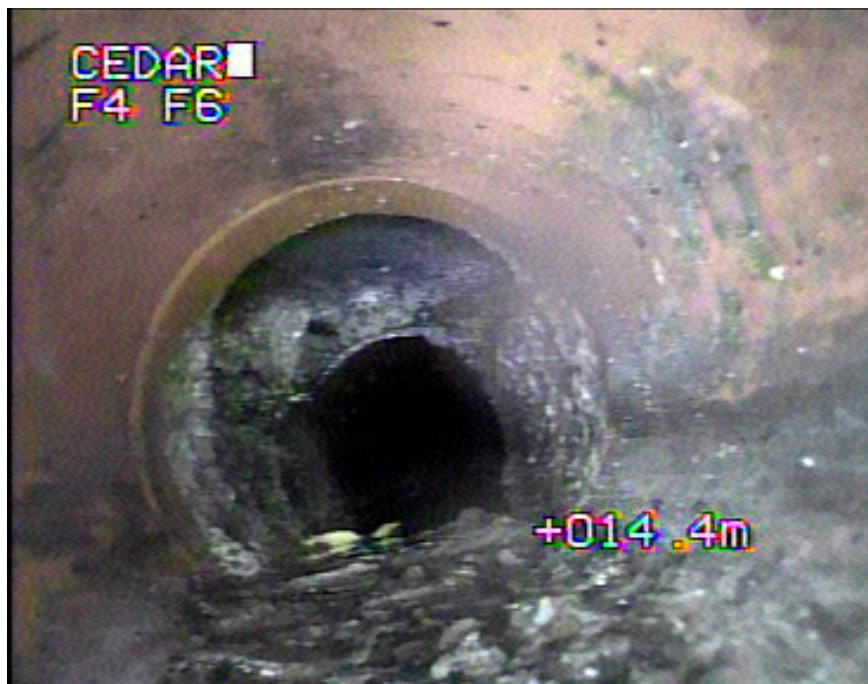
Photo: 7_6A, MPEG #: 051216_1, 00:02:24
14.3m, Settled deposits, hard or compacted, 10% cross-sectional area loss

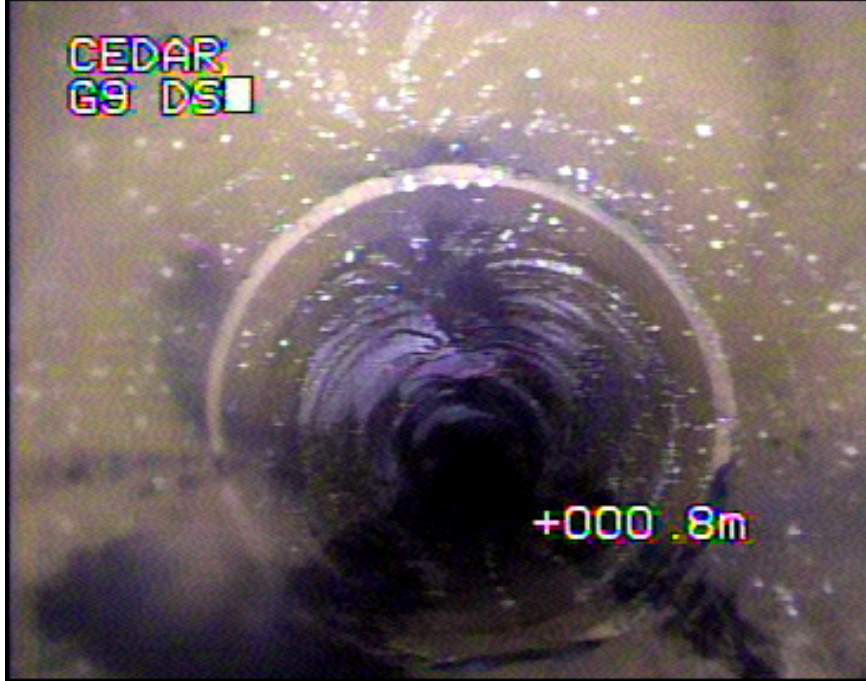
Photo: 22_3A, MPEG #: 051216_1, 00:00:12
 0.9m, Sealing ring intruding, from 5 to 7 o'clock

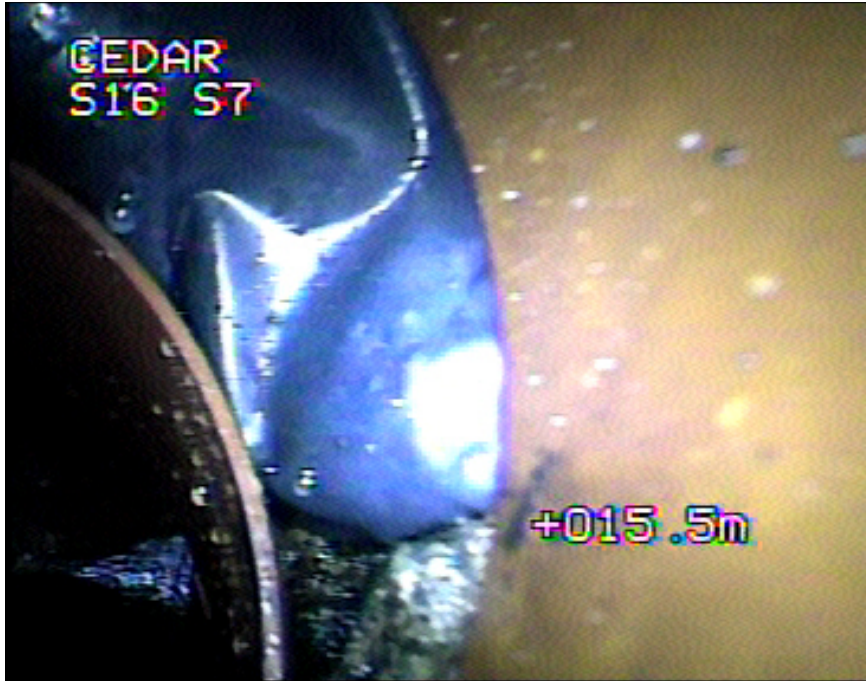
Photo: 49_6A, MPEG #: 051216_1, 00:02:41
 15.4m, Joint displaced, large

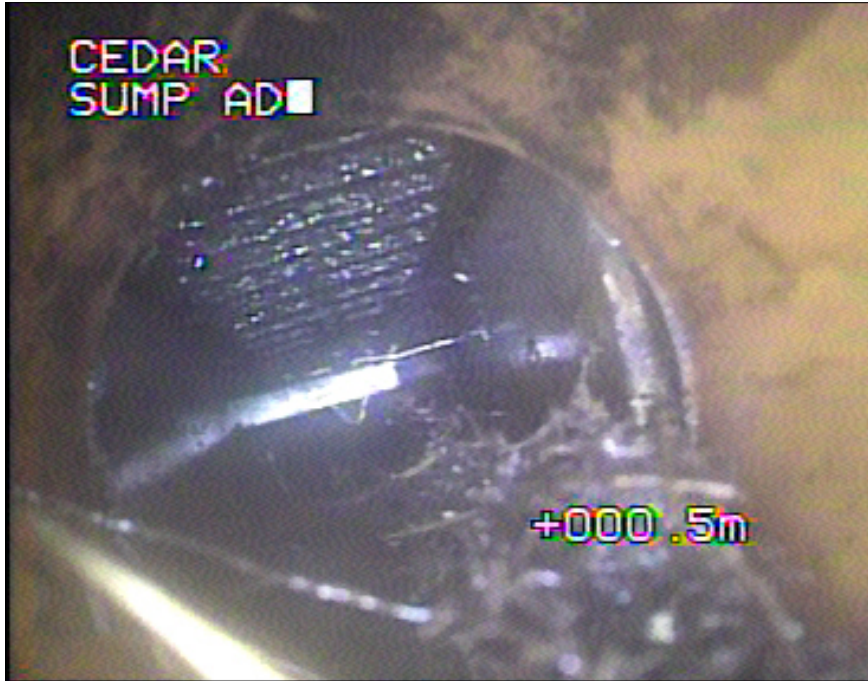
Photo: 50_3A, MPEG #: 051216_1, 00:00:12
0.6m, Roots, fine

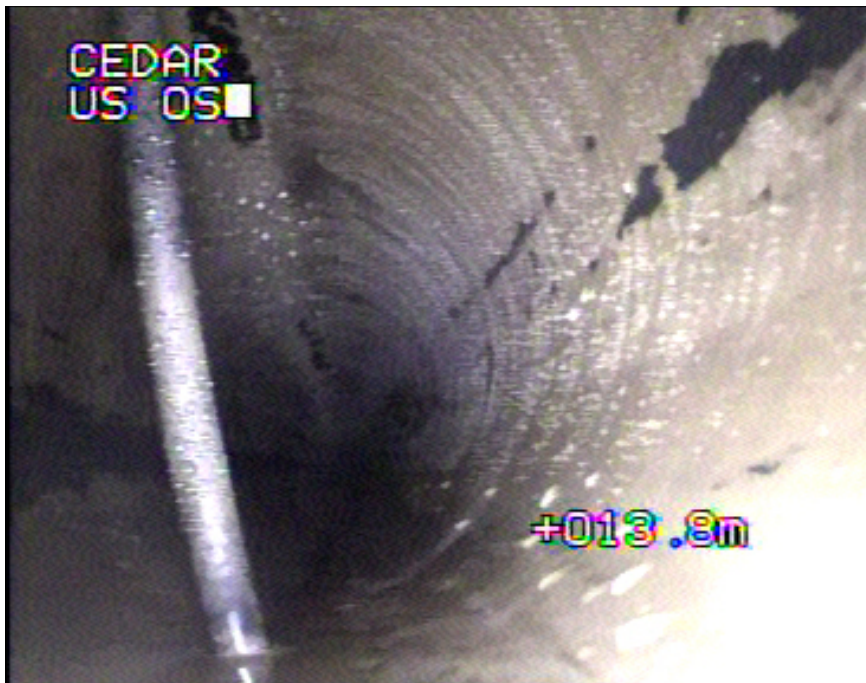
Photo: 52_3A, MPEG #: 051216_1, 00:01:52
14m, Other obstacles protuding through wall, from 12 to 6 o'clock, 5% cross-sectional area loss

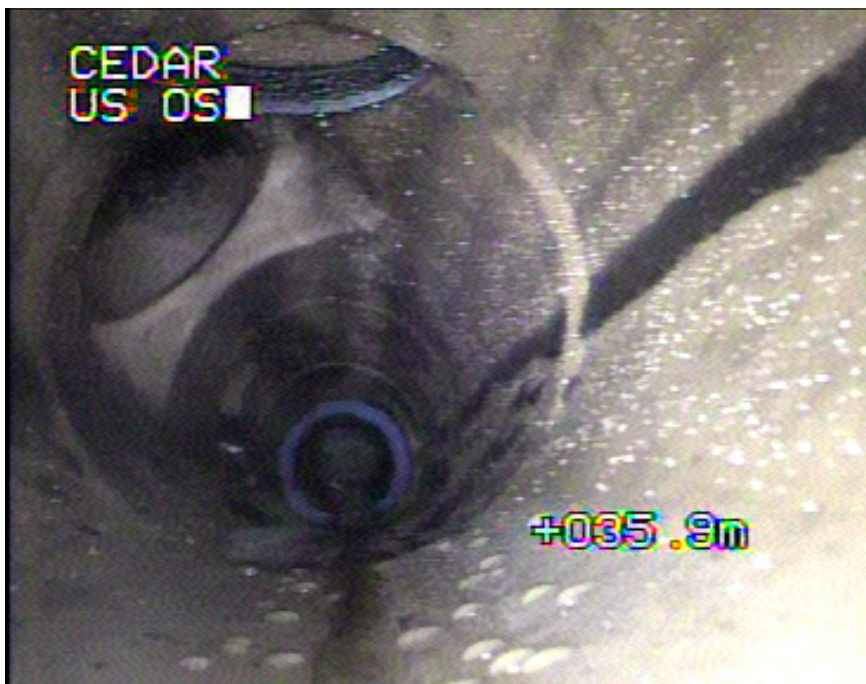
Photo: 52_8A, MPEG #: 051216_1, 00:05:26
36.1m, Connection other than junction, at 10 o'clock, diameter 100mm
