ANNUAL ENVIRONMENTAL REPORT
RILTA ENVIRONMENTAL LTD.
BLOCK 402 GREENOGUE BUSINESS PARK
LICENCE NO. W0192-03
JANUARY 2016 – DECEMBER 2016

Project	Annual Environmental Report 2016			
Client	Rilta Environmental Ltd W0192-03			
Report No	Date	Status	Prepared By	Reviewed By
161950109	26/05/2017	Draft	Mr Neil Sandes PGeo EurGeol	Mr Jim O'Callaghan MSc
	26/05/2017	Final

Bund Integrity Test Report 2016 / 2017

Block 402 - CCTV Drainage Inspection Report

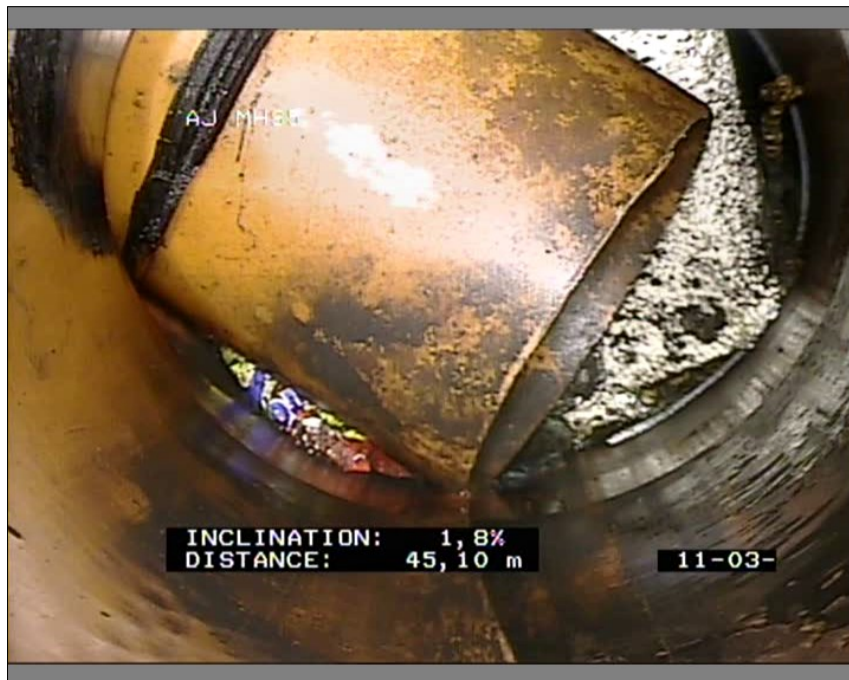
Photo: 8_14A, MPEG #: 280217_1, 00:13:29
45.49m, Connection other than junction, at 10 o'clock, diameter 100mm

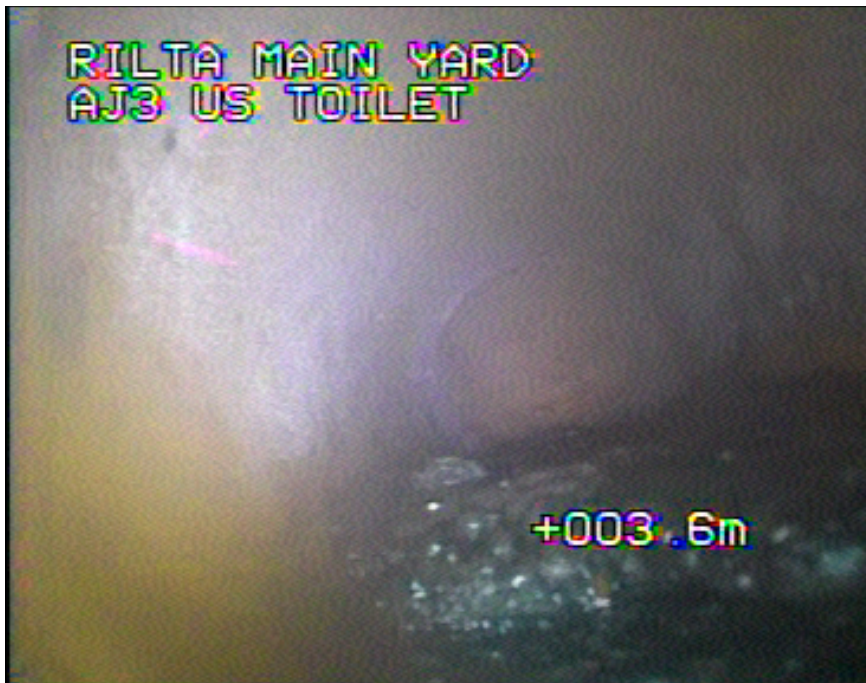
Photo: 10_5A, MPEG #: 280217_1, 00:00:35
3.6m, Settled deposits, fine, 15% cross-sectional area loss

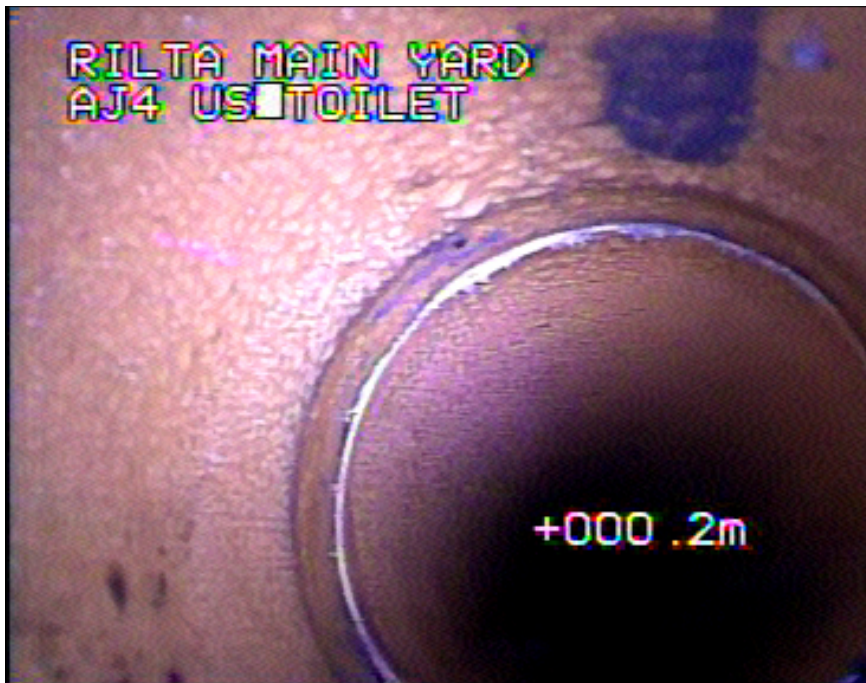
Photo: 13_3A, MPEG #: 280217_1, 00:00:03
0.3m, Open joint, medium

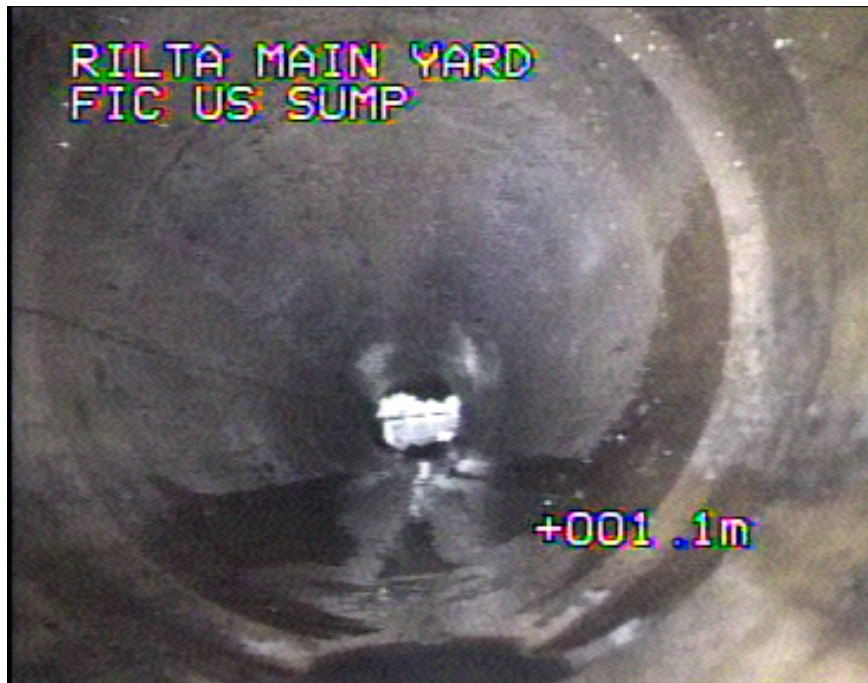
Photo: 19_3A, MPEG #: 280217_1, 00:00:27
1.1m, Open joint, medium

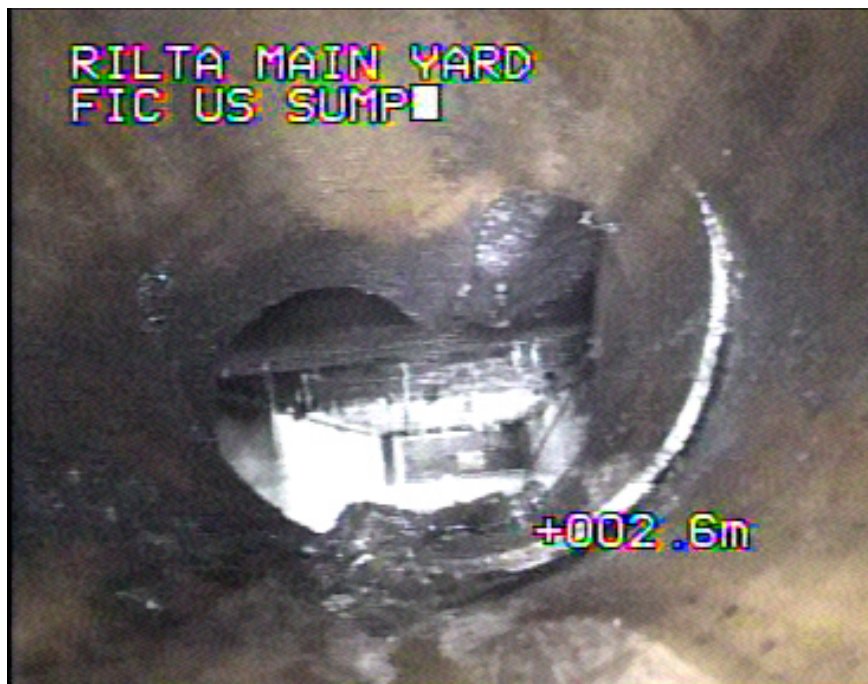
Photo: 19_4A, MPEG #: 280217_1, 00:00:51
2.8m, Fracture, circumferential, from 2 to 7 o'clock

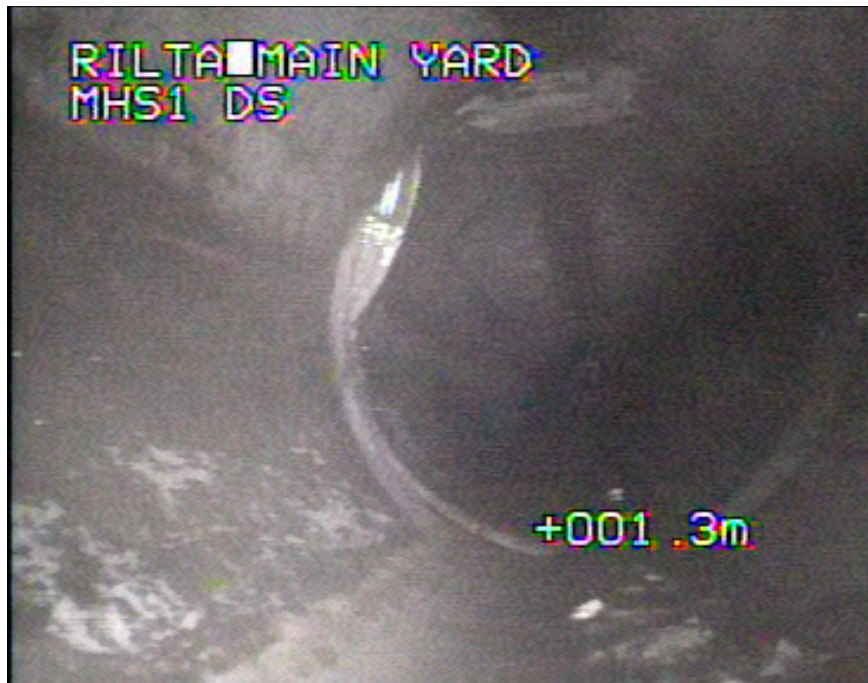
Photo: 27_4A, MPEG #: 280217_1, 00:00:47
1.5m, Sealing ring intruding, from 9 to 12 o'clock

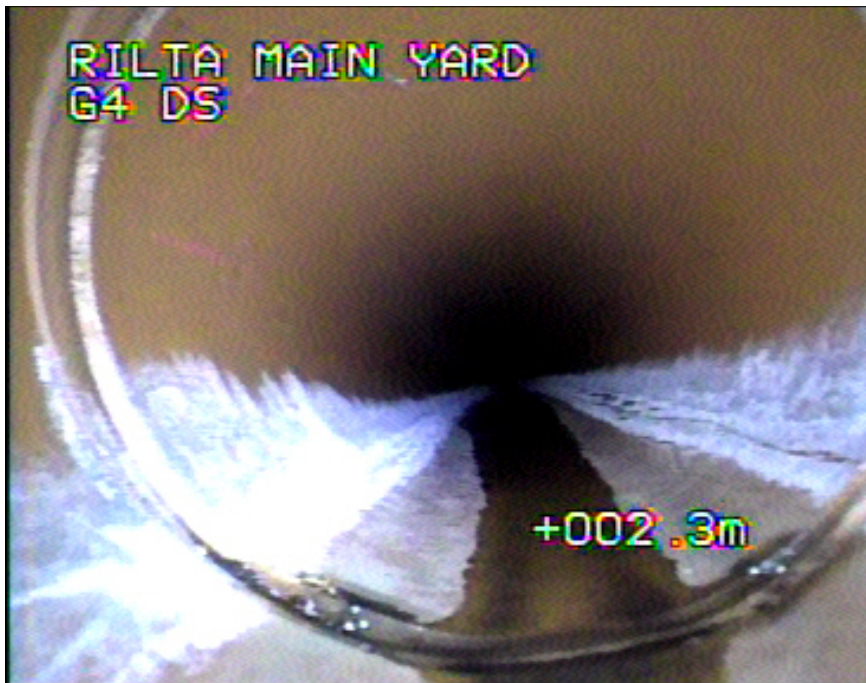
Photo: 38_3A, MPEG #: 280217_1, 00:00:12
2.2m, Open joint, medium

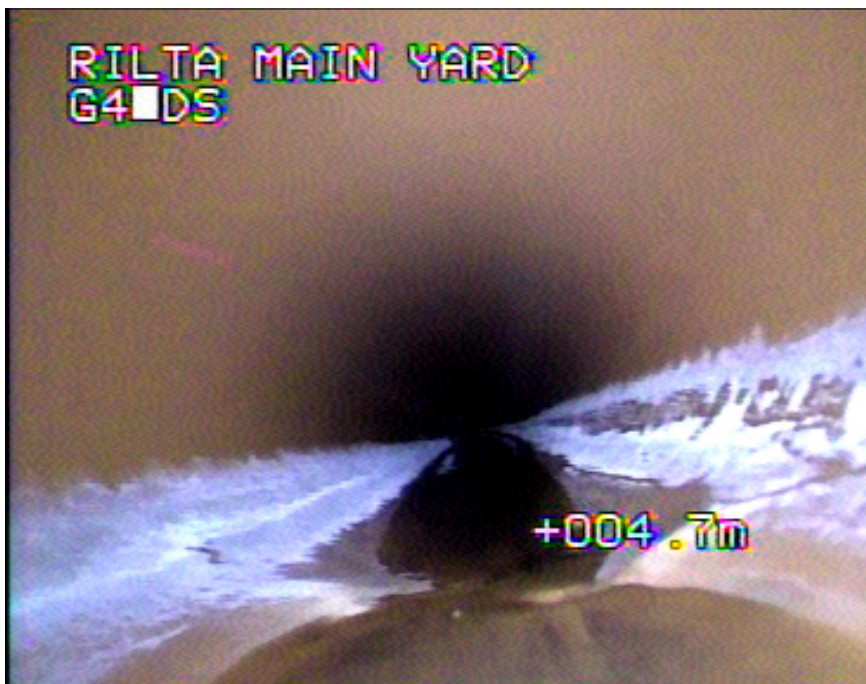
Photo: 38_5A, MPEG #: 280217_1, 00:00:33
4.7m, Surface damage, other, from 4 to 8 o'clock

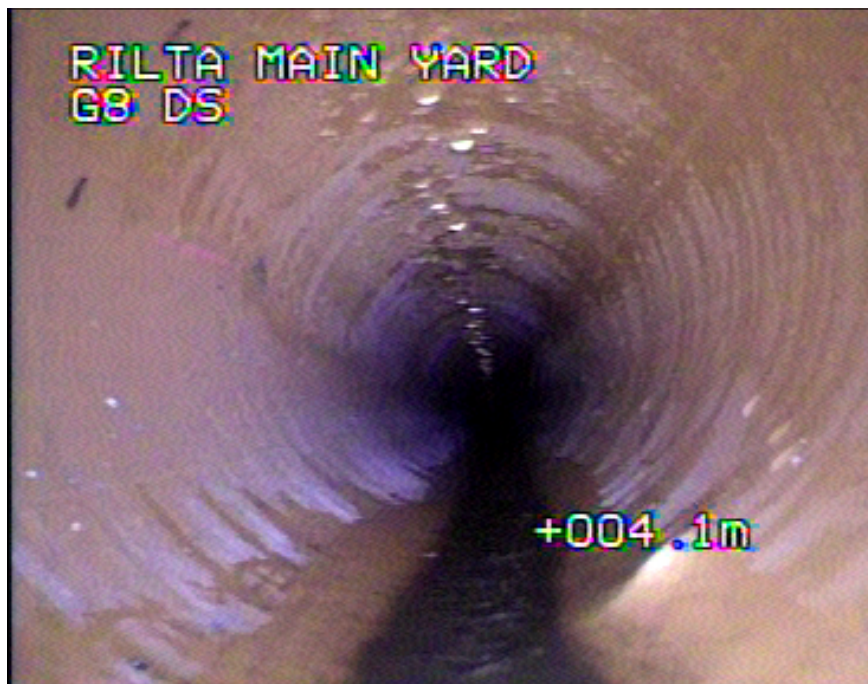
Photo: 42_4A, MPEG #: 280217_1, 00:00:36
4.1m, Surface damage, other, from 4 to 5 o'clock

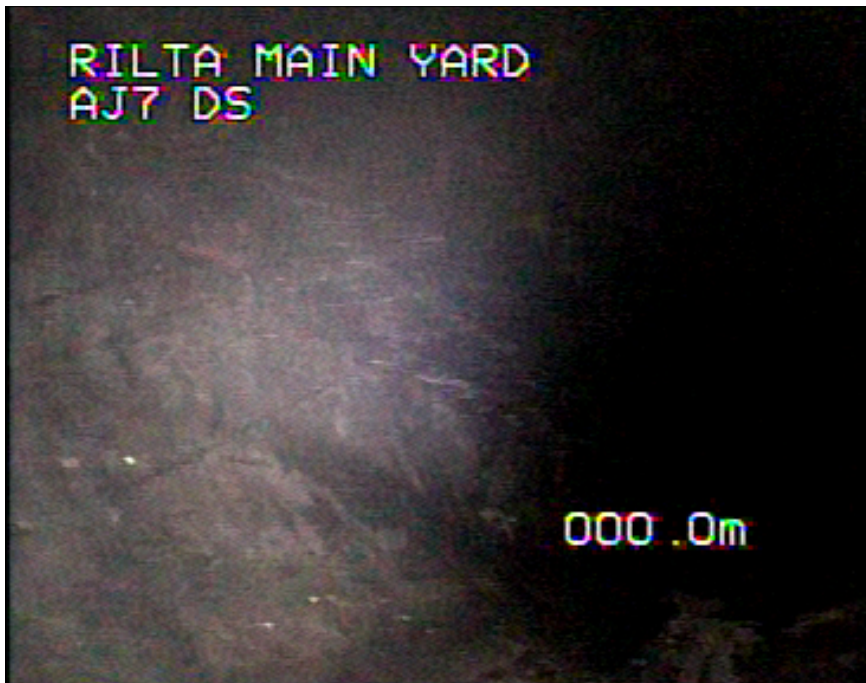
Photo: 45_9A, MPEG #: 280217_1, 00:00:00
39.59m, Other obstacles built into structure, from 1 to 3 o'clock, 75% cross-sectional area loss

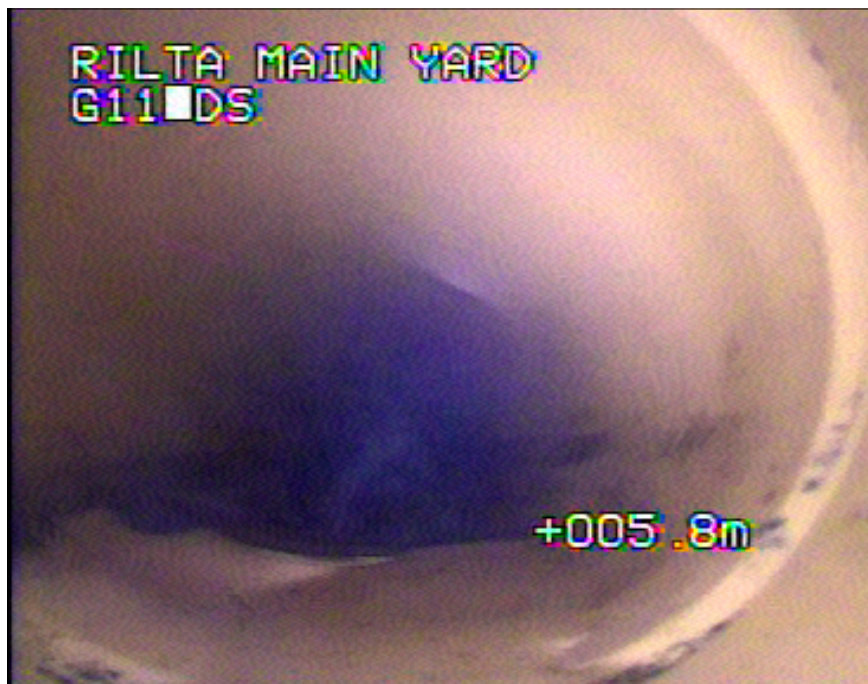
Photo: 47_4A, MPEG #: 280217_1, 00:01:48
5.8m, Deformed sewer/drain, 10%

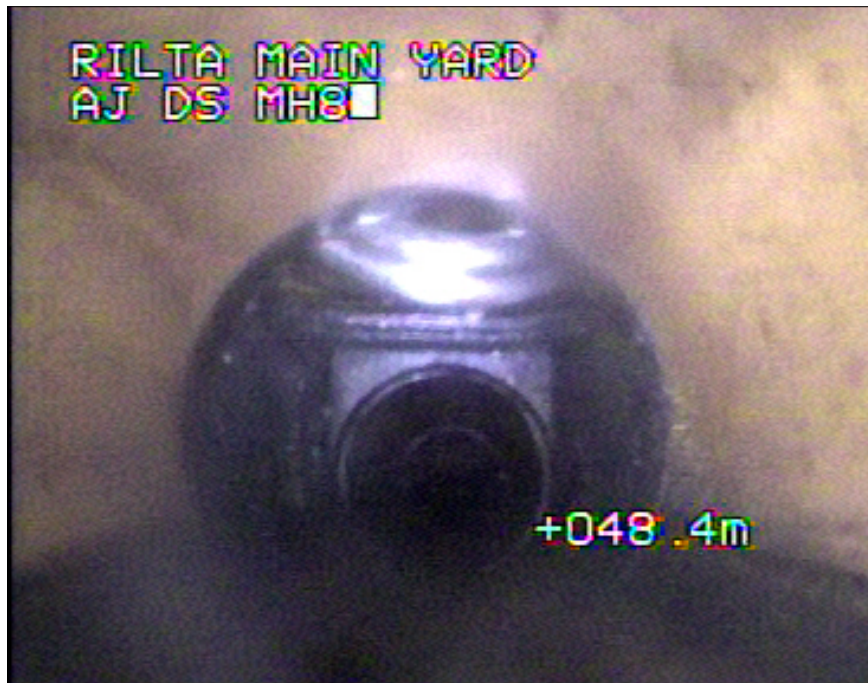
Photo: 53_17A, MPEG #: 280217_1, 00:07:29
48.5m, Sealing ring intruding, from 11 to 2 o'clock
