ANNUAL ENVIRONMENTAL REPORT
RILTA ENVIRONMENTAL LTD.
SITE 14-A1 GREENOGUE BUSINESS PARK
LICENCE NO. W0185-01
JANUARY 2016 – DECEMBER 2016

Project	Annual Environmental Report 2016			
Client	Rilta Environmental Ltd W0185-01			
Report No	Date	Status	Prepared By	Reviewed By
161950209	23/03/2017	Draft	Mr Neil Sandes PGeo EurGeol	Mr Jim O'Callaghan MSc
	07/04/2107	Final

CCTV DRAINAGE INSPECTION REPORT

**Block 14A1, Grants Road,
Greenogue Business Park,
Rathcoole, Co. Dublin.**

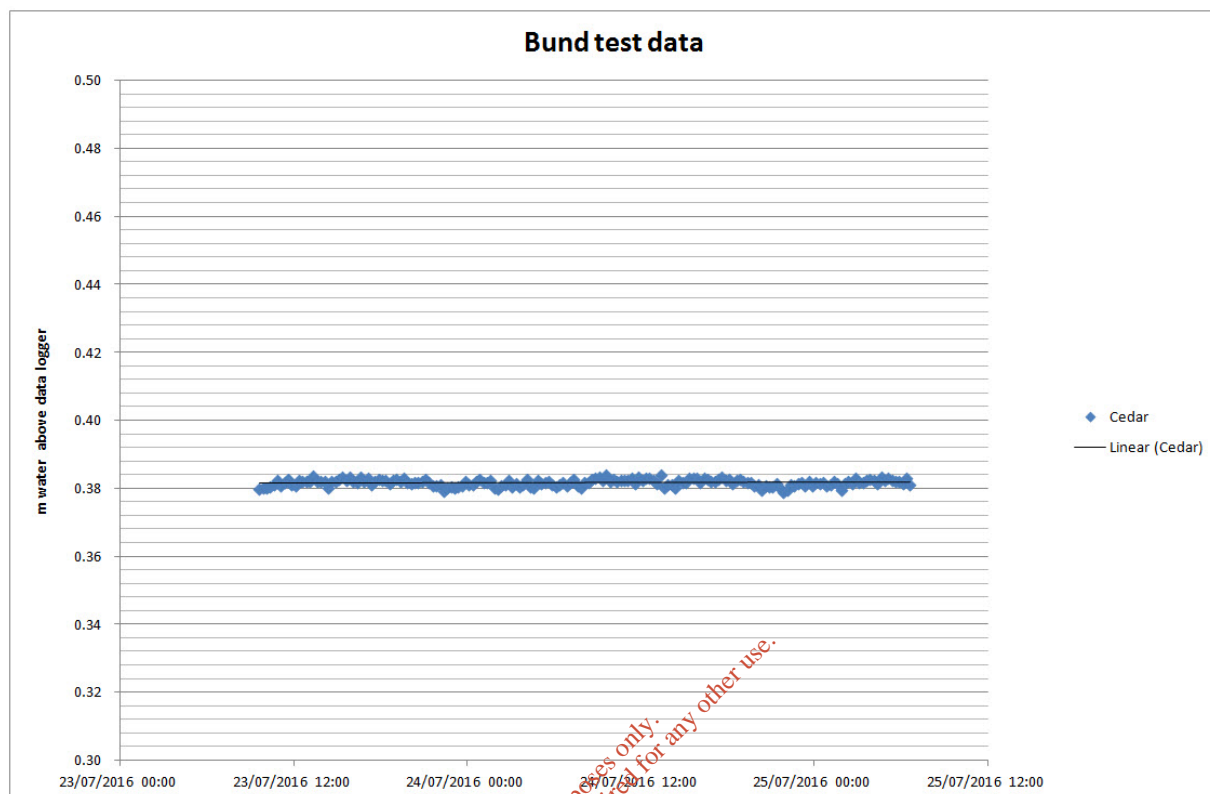
Table 4-15 Bund / Area No. 16 Test Result

Testing at this location was not impacted by facility operations.

As no fluctuation was noted in liquid levels during the measurement period and the control remained constant, it is determined that all tested bunds and tanks are in good structural condition. No ancillary works are required for these bunds

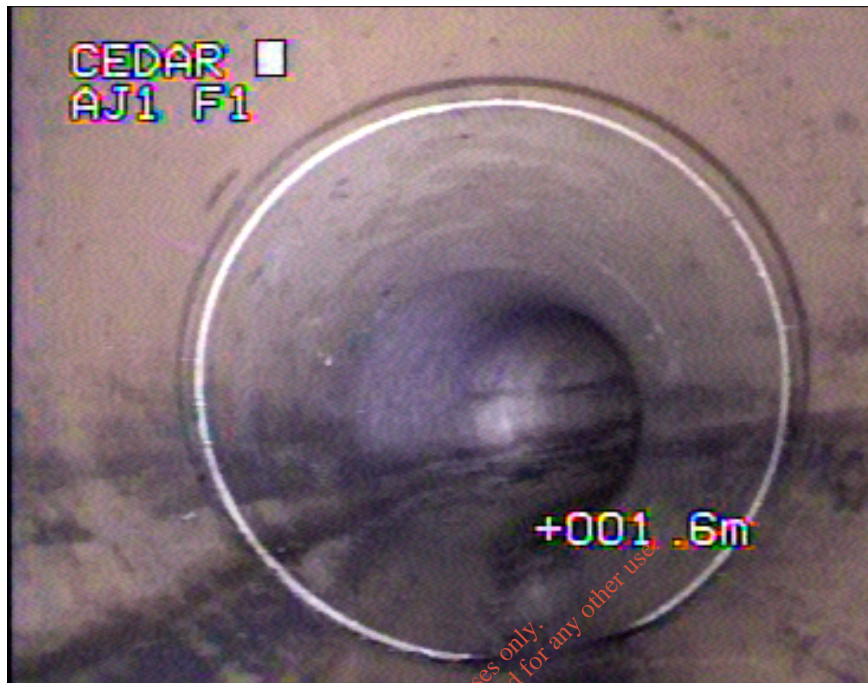
Photo: 1_6A, MPEG #: 051216_1, 00:00:00
7.71m, Finish node type, manhole reference number: F1

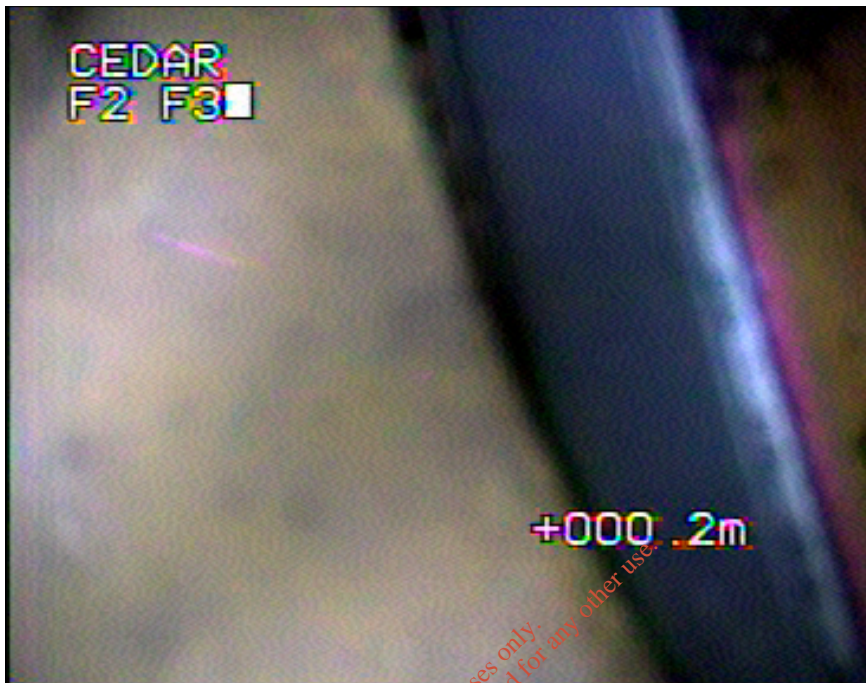
Photo: 4_3A, MPEG #: 051216_1, 00:00:07
0.2m, Sealing ring intruding, from 6 to 12 o'clock

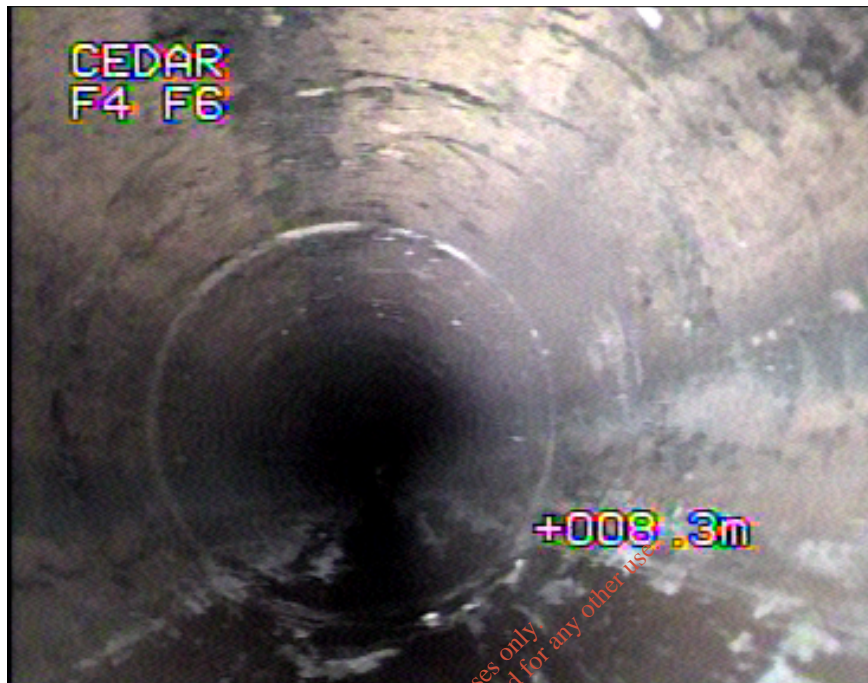
Photo: 7_5A, MPEG #: 051216_1, 00:01:22
8.3m, Cracks, multiple, from 4 to 8 o'clock

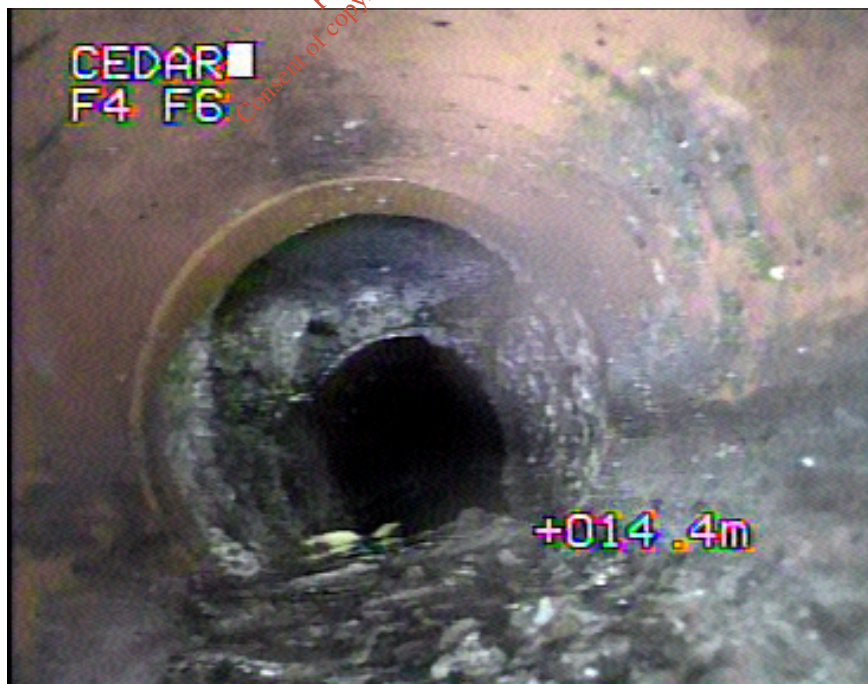
Photo: 7_6A, MPEG #: 051216_1, 00:02:24
14.3m, Settled deposits, hard or compacted, 10% cross-sectional area loss

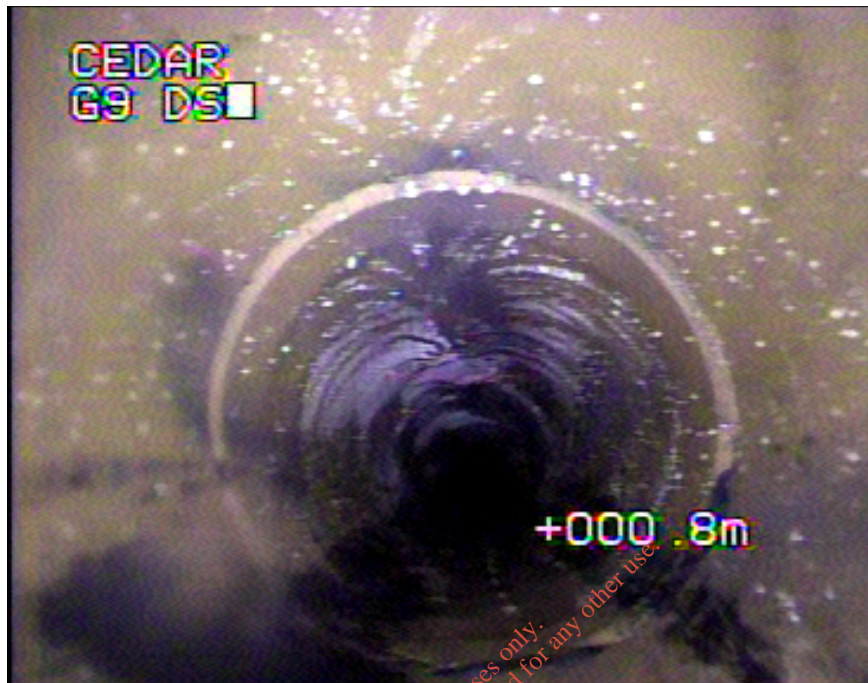
Photo: 22_3A, MPEG #: 051216_1, 00:00:12
0.9m, Sealing ring intruding, from 5 to 7 o'clock

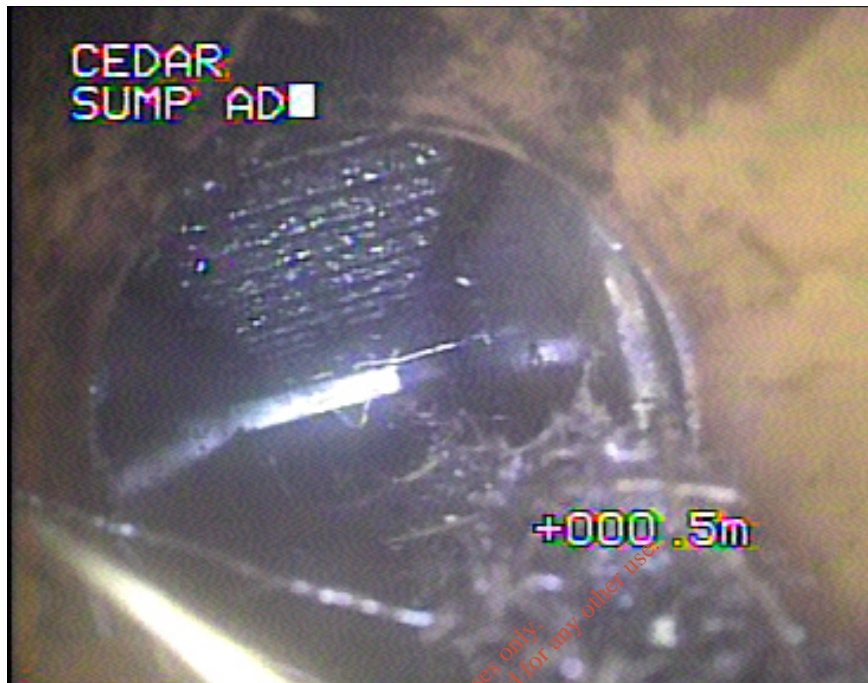
Photo: 50_3A, MPEG #: 051216_1, 00:00:12
0.6m, Roots, fine

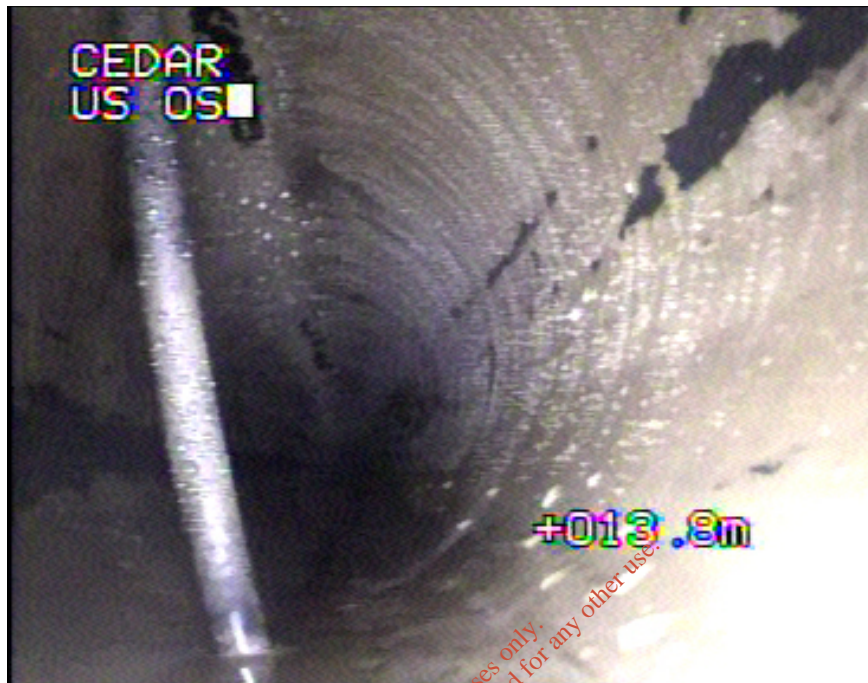
Photo: 52_3A, MPEG #: 051216_1, 00:01:52
14m, Other obstacles protruding through wall, from 12 to 6 o'clock, 5% cross-sectional area loss
