**Bund Integrity Testing
at Site 14A1,
Greenogue Business Park,
Rathcoole, Co. Dublin**

Bund Integrity Testing

**Site 14A1, Greenogue Business Park
Rathcoole, Co. Dublin**

CCTV DRAINAGE INSPECTION REPORT

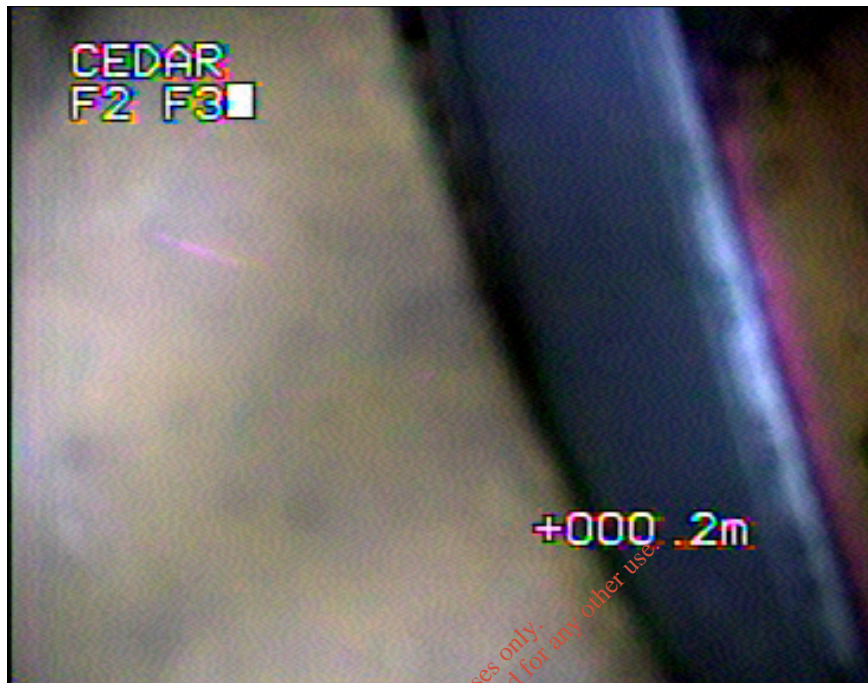
Photo: 4_3A, MPEG #: 051216_1, 00:00:07
0.2m, Sealing ring intruding, from 6 to 12 o'clock

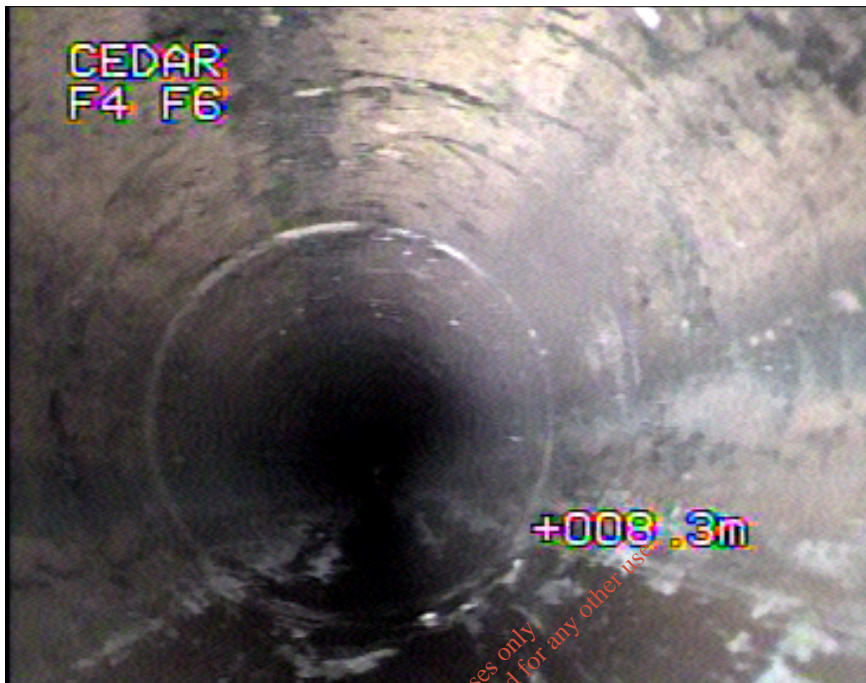
Photo: 7_5A, MPEG #: 051216_1, 00:01:22
8.3m, Cracks, multiple, from 4 to 8 o'clock

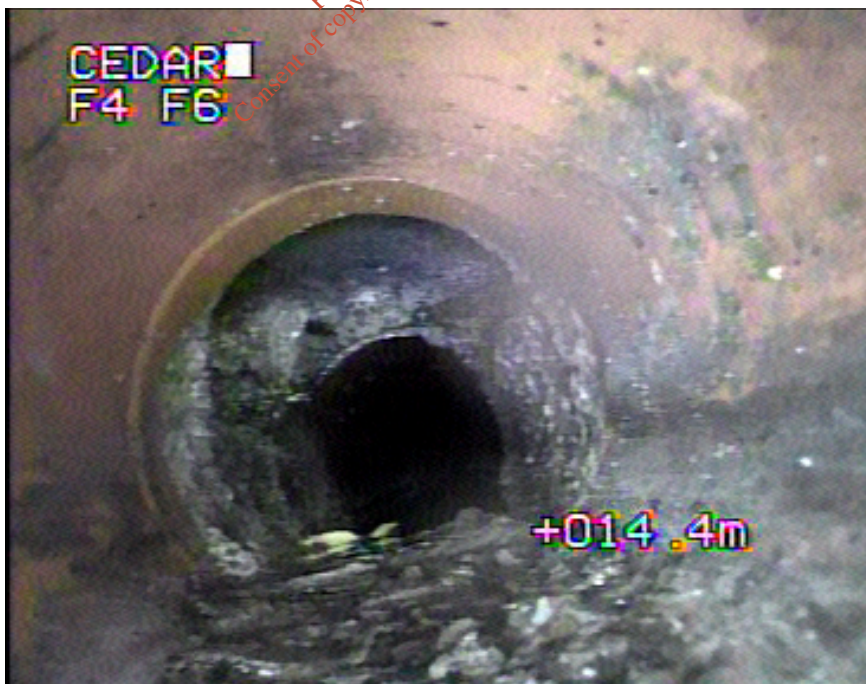
Photo: 7_6A, MPEG #: 051216_1, 00:02:24
14.3m, Settled deposits, hard or compacted, 10% cross-sectional area loss

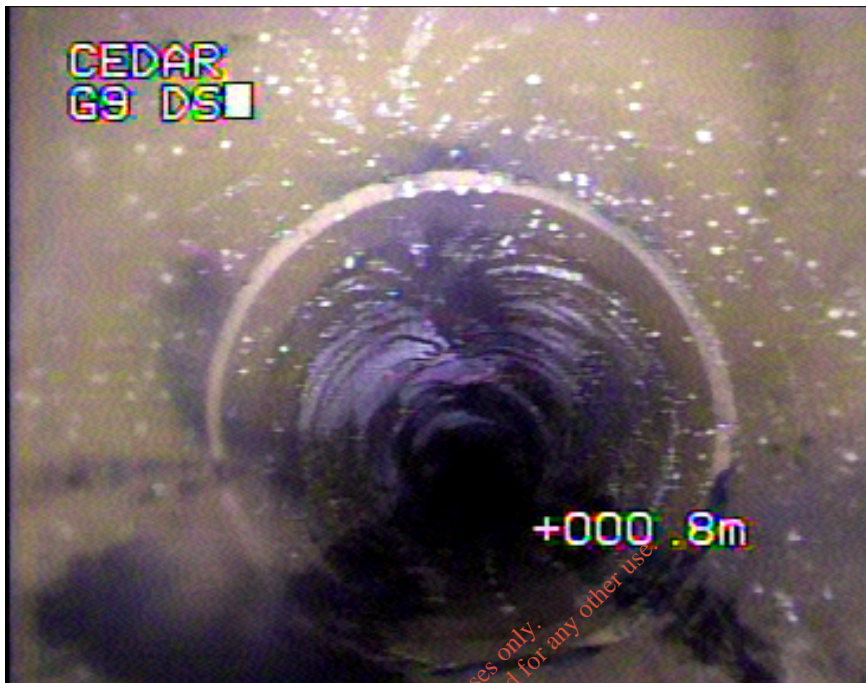
Photo: 22_3A, MPEG #: 051216_1, 00:00:12
0.9m, Sealing ring intruding, from 5 to 7 o'clock

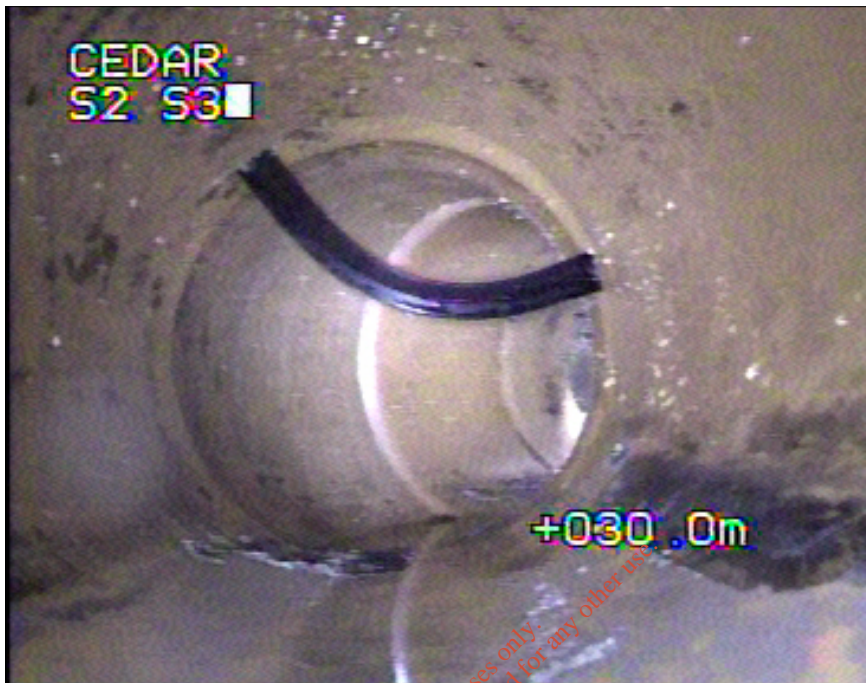
Photo: 23_3A, MPEG #: 051216_1, 00:04:31
30m, Sealing ring intruding, from 11 to 3 o'clock

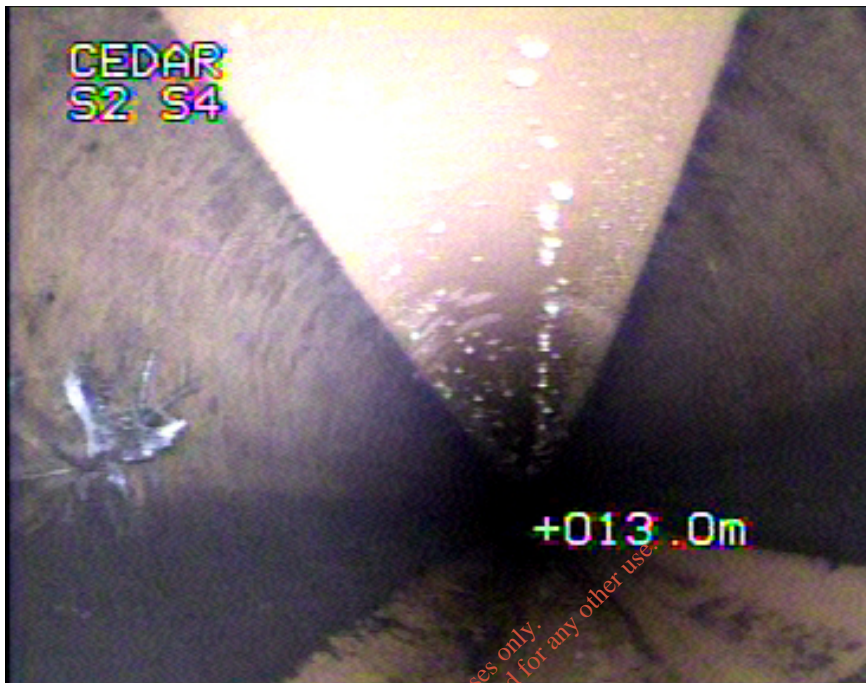
Photo: 24_10A, MPEG #: 051216_1, 00:02:35
13m, Surface damage, other, from 8 to 9 o'clock

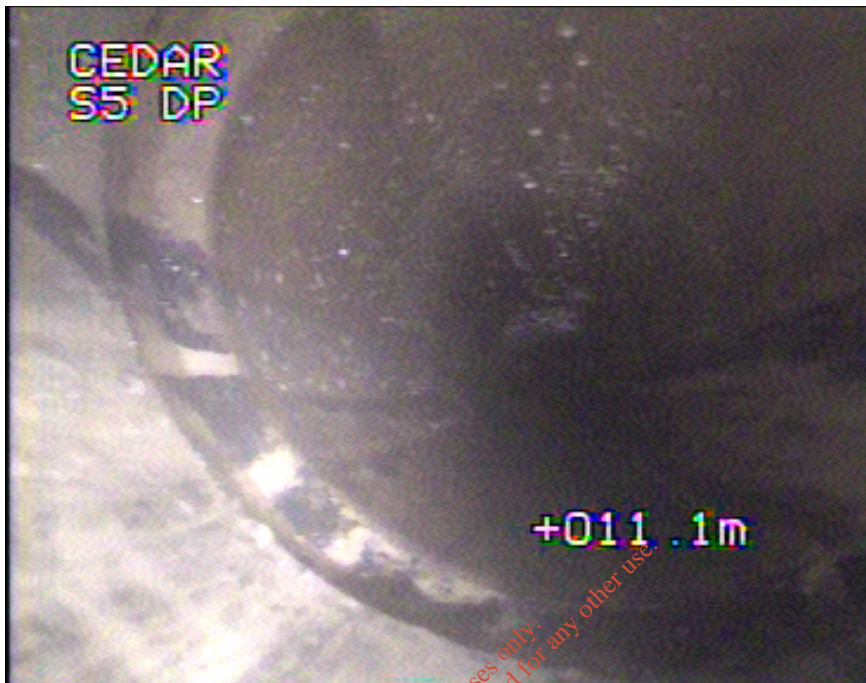
Photo: 27_9A, MPEG #: 051216_1, 00:01:44
11.1m, Open joint, medium

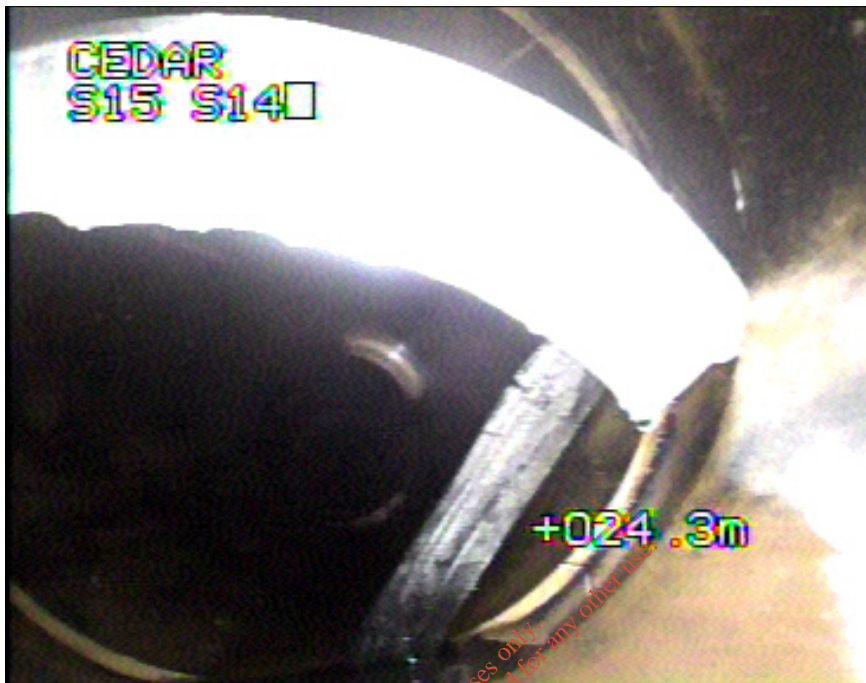
Photo: 47_6A, MPEG #: 051216_1, 00:02:39
24.3m, Sealing ring intruding, from 10 to 6 o'clock

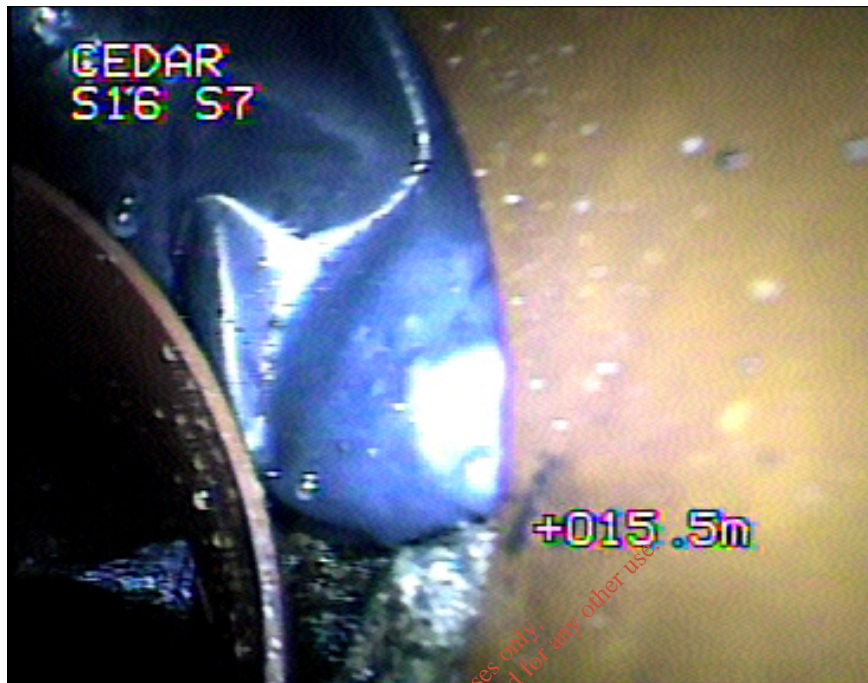
Photo: 49_6A, MPEG #: 051216_1, 00:02:41
15.4m, Joint displaced, large

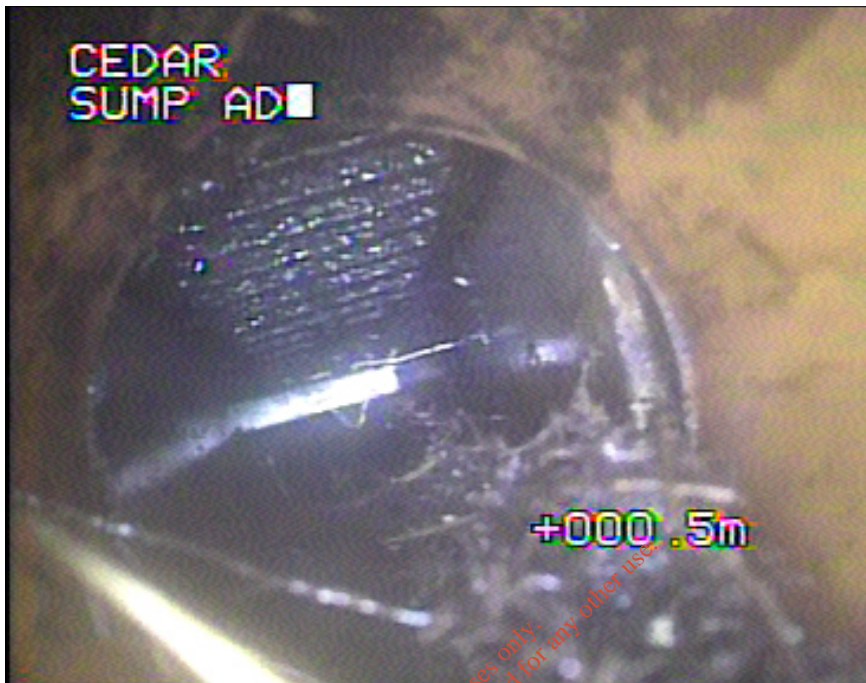
Photo: 50_3A, MPEG #: 051216_1, 00:00:12
0.6m, Roots, fine

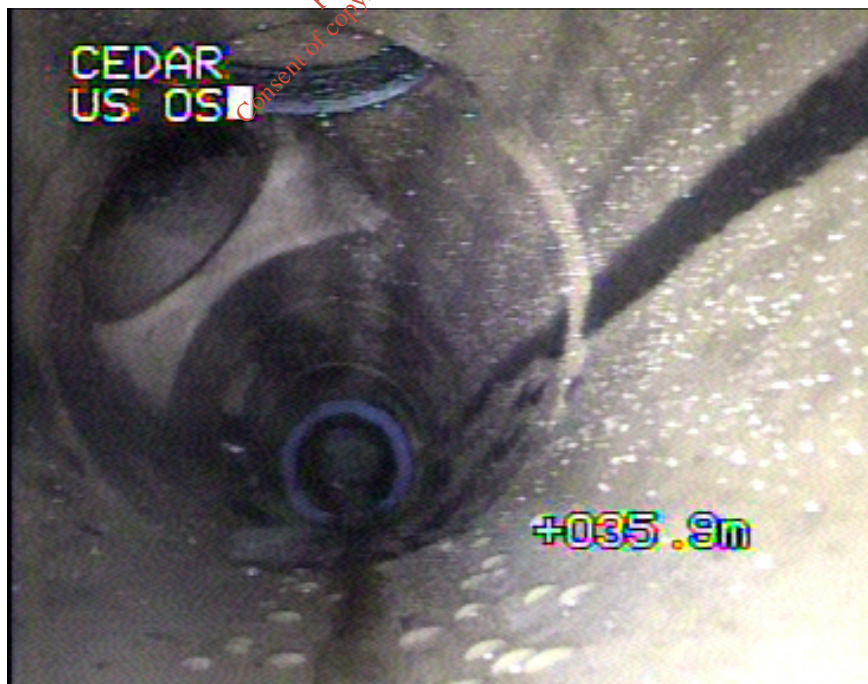
Photo: 52_8A, MPEG #: 051216_1, 00:05:26
36.1m, Connection other than junction, at 10 o'clock, diameter 100mm
