OFFICE OF ENVIRONMENTAL SUSTAINABILITY

INSPECTOR'S REPORT ON AN APPLICATION FOR A CERTIFICATE OF AUTHORISATION FOR A CLOSED LANDFILL

то:	DIRECTORS	
FROM:	Brian Meaney	- Environmental Licensing Programme
DATE:	25 September 2017	
RE:	Application for a Certificate of Authorisation from Cork County Council for a closed landfill at Kealanine	
	Certificate of Authorisation Register Number H0089-01.

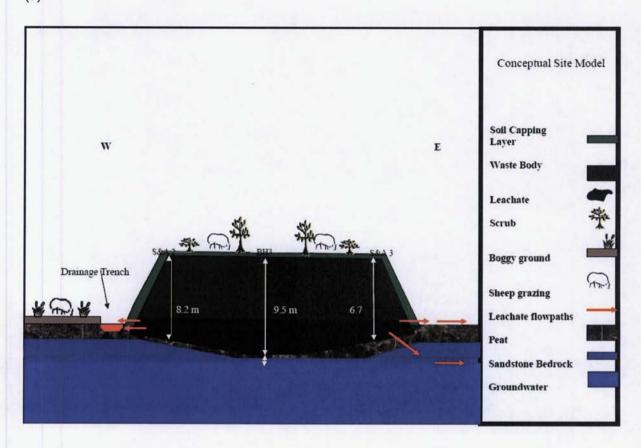
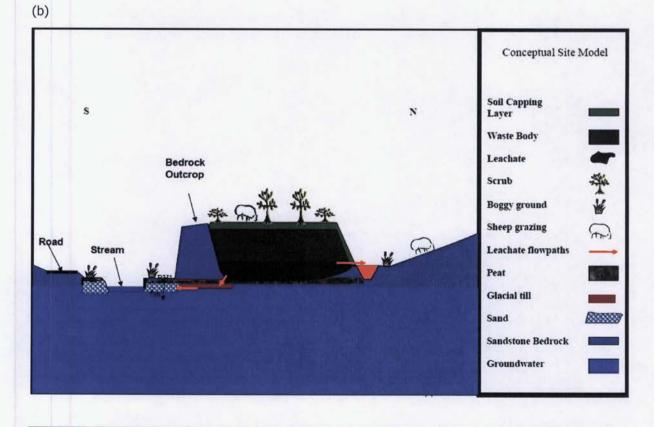
Figure 3 Conceptual site model (a)

Further monitoring in 2014 showed significantly elevated concentrations $(10-43\% \text{ v/v})$ at 4 locations, indicating that landfill gas continues to be generated in significant quantities.
	There are no potential receptors within 400m of the site.
Conceptual site model:	The conceptual site model is shown in Figure 3.

Rainfall on the landfill will preferentially percolate through the cap and into the waste.

Leachate is generated in the waste albeit at low strength.

Gas is generated at the landfill, primarily localised in the area of hydrocarbon disposal.

Leachate can migrate through the base of the landfill into peat, sand and gravel and bedrock layers beneath.

Surface seeps of leachate discharge to local drainage ditches.

Dominant flow pattern for groundwater is to discharge within a short distance to surface water.

Gas migration can occur through the permeable cap and in the sand and gravel deposits and fractured bedrock beneath the waste.

All houses are served by private wells. There are three located between 400m and 1,000m of the landfill.

Leachate discharges directly or via groundwater to a local stream which flows to the Coomhola River. The local stream is the dominant receptor for waterborne contamination. Water quality improves to background levels prior to its confluence with the Coomhola River.

There are no receptors for gas migration.
