## **HYDROGEOLOGICAL SURVEY REPORT**

**KILLARNEY WASTE DISPOSAL LTD**

**AUGHACURREEN**

**WASTE LICENCE NO. W0217-01**

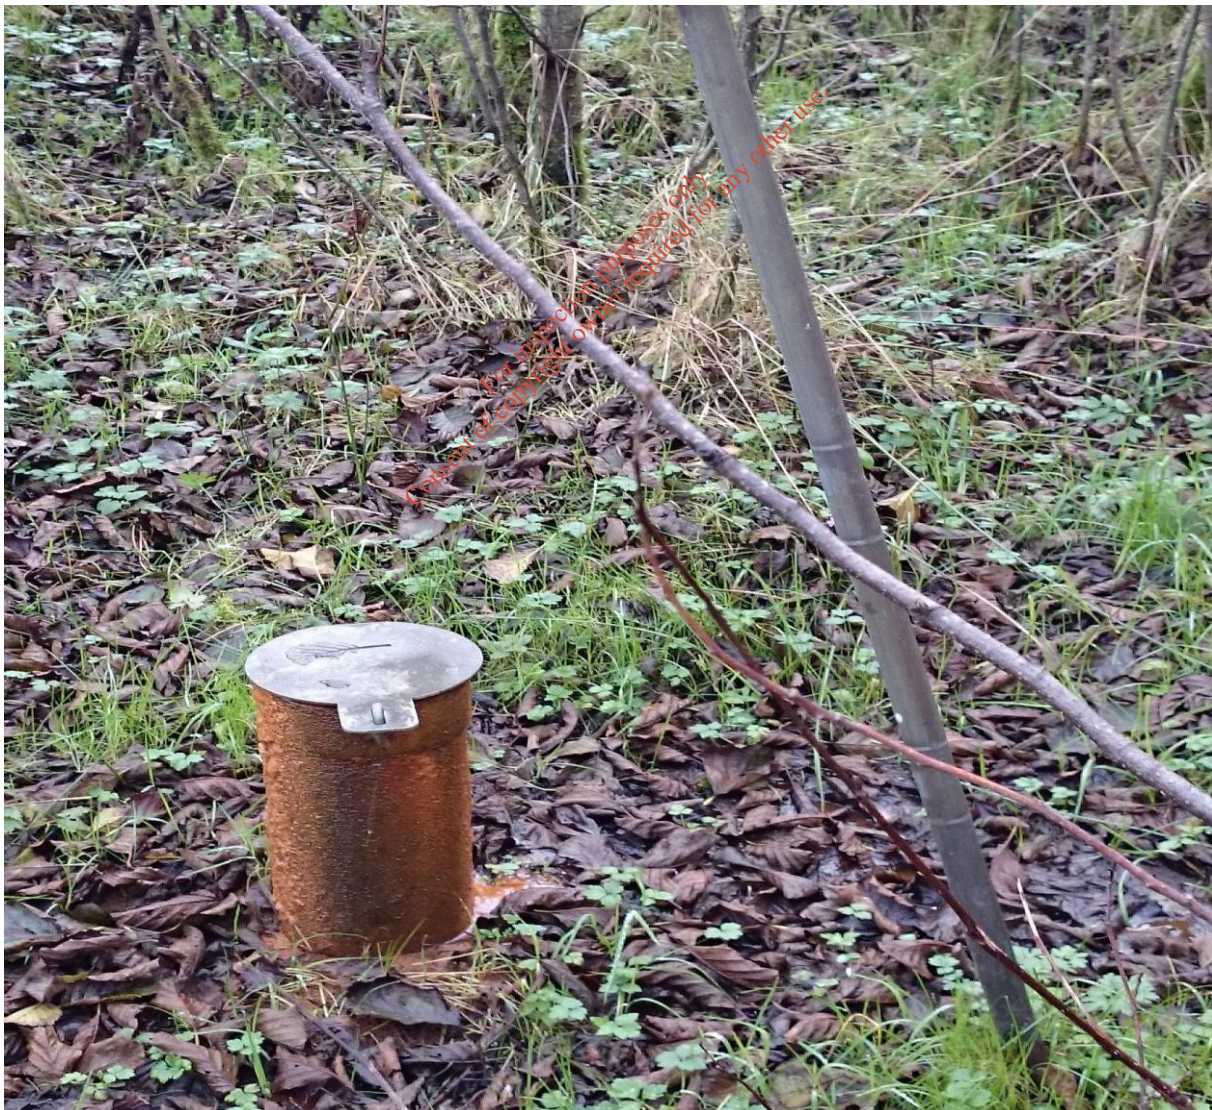
**Photograph 1 MW-1**

The well is located in a wooded area to the north of the drain that flows along the north-eastern boundary. The headworks are intact (Photograph 1) but there is evidence of artesian conditions.

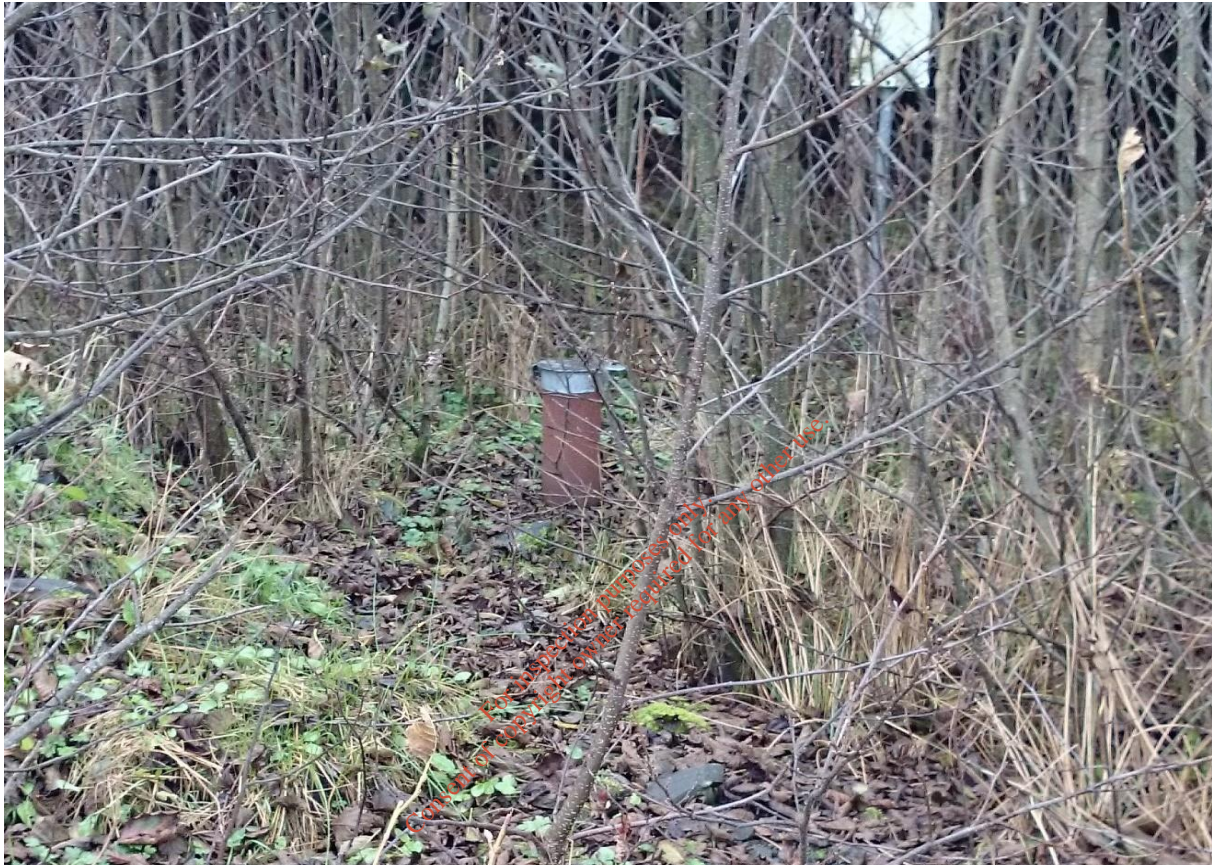
**Photograph 2 MW-2**

The well is located in a wooded area to the north of the drain that flows along the north-eastern boundary. The headworks are intact.

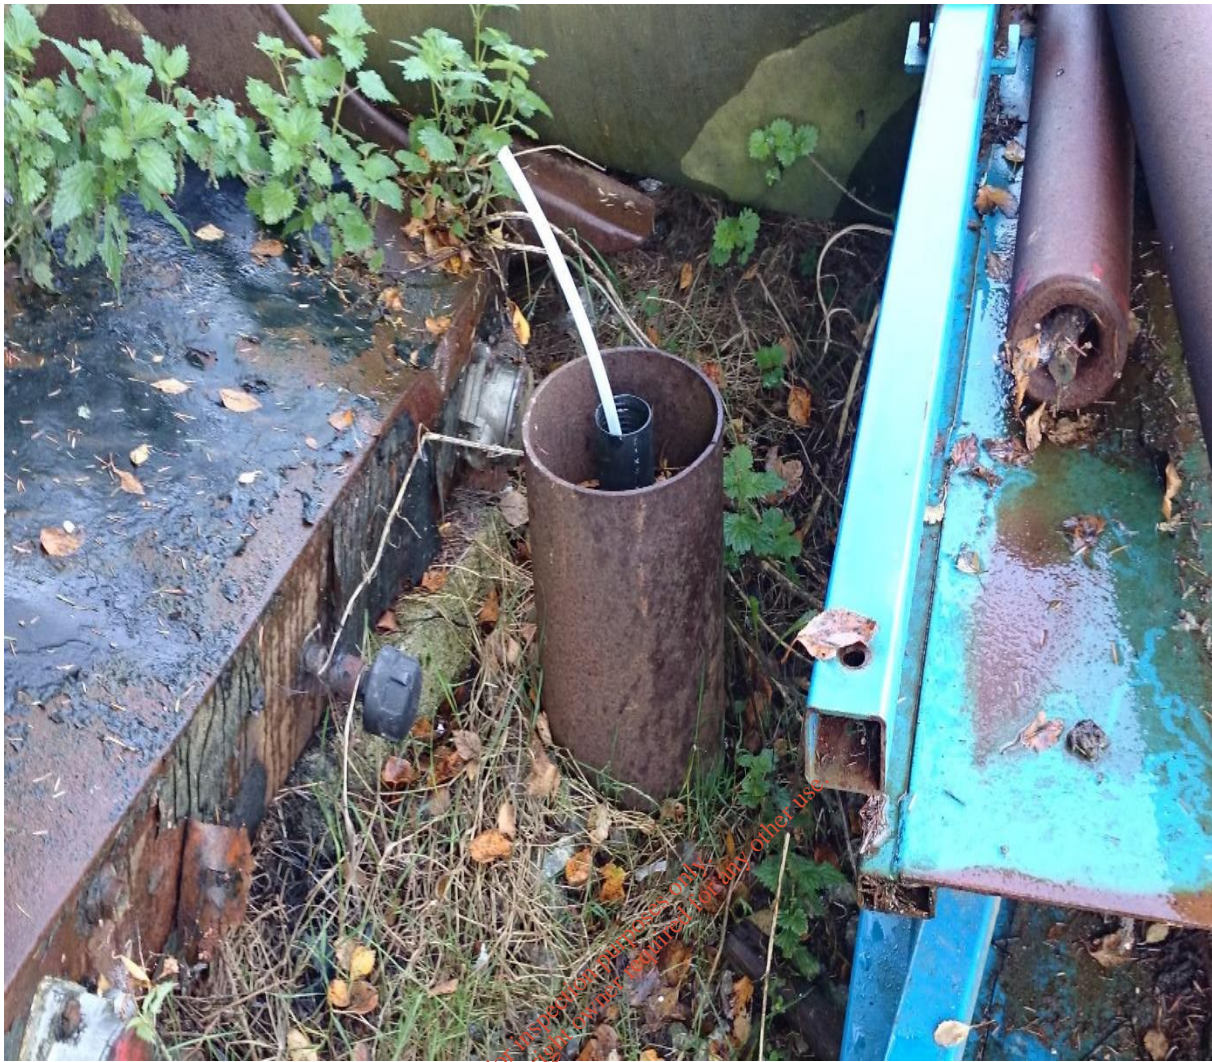
**Photograph 3 MW-3**

The well is located in the south-west of the site. The on the top of the steel casing has been removed and there is no cap on the top of the well pipe.

Given that the headworks on both MW-3 and MW-4 are damaged, there are no well caps and MW-4 is approximately 0.5 m below ground level, the likely source of the coliforms is faecal contamination by birds or small mammals and not off-site sources.

Faecal coliforms were detected in up gradient wells MW-3 and MW-4. The headworks on MW-3 and MW-4 wells are damaged and there are no well caps making both wells vulnerable to faecal contamination by birds and small mammals and in the case of MW-4, where the well pipe is below ground level, the entry of surface water run-off.

It is recommended that the headworks at MW-3 be repaired and a well cap provided. At MW-4, the well pipe should be extended above ground-level, fitted with a well cap and a steel headworks installed. Following the repairs both wells should be disinfected.

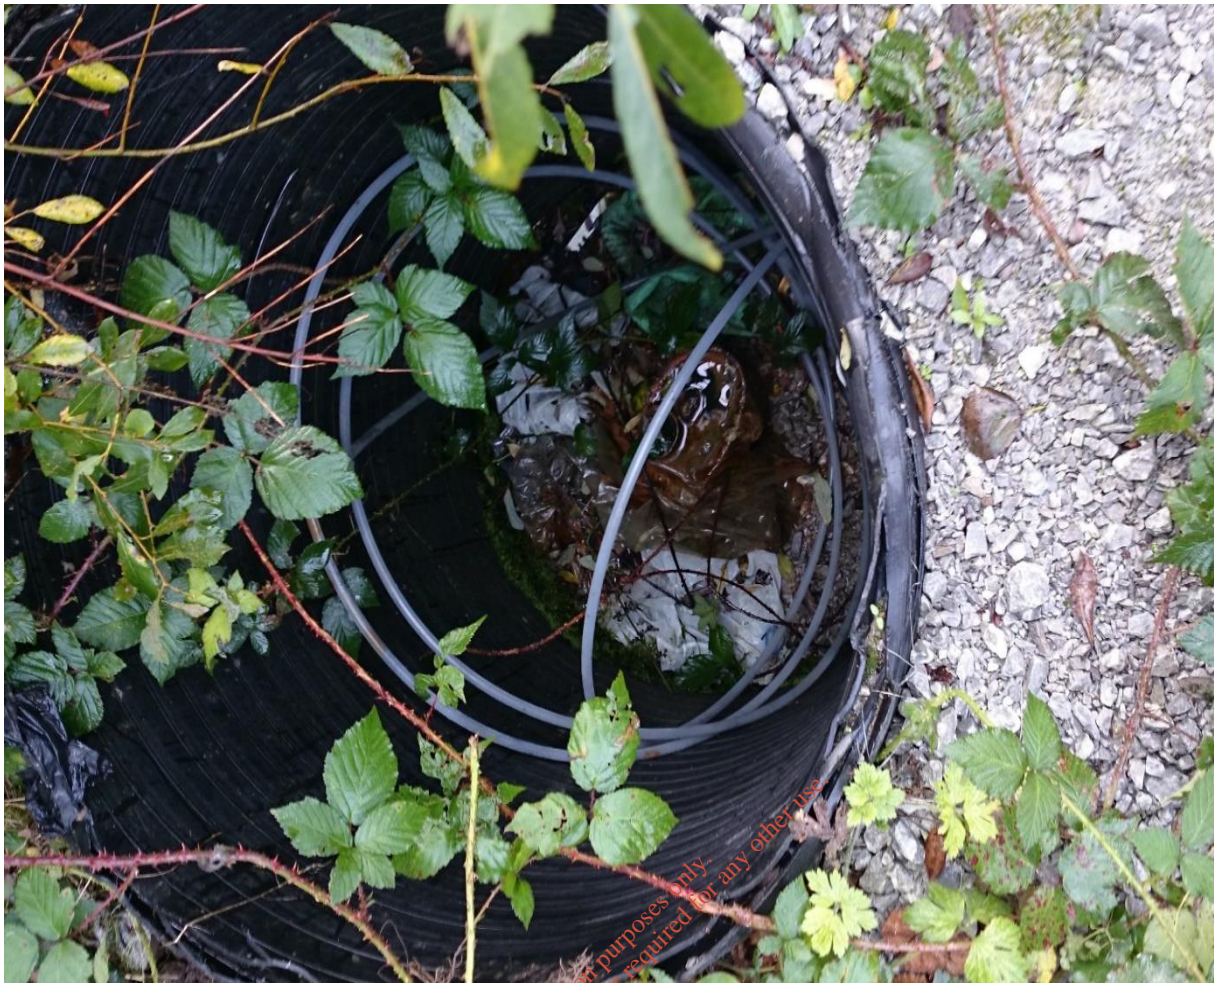
**Photograph4 MW-4**

MW-4 is located in the south-east of the site close to the rear wall of the materials recovery building. The top of the well pipe is approximately 1m below ground level as a result of the raising of the access road to the rear of the building.

The well was protected by placing a large diameter plastic pipe on the ground and backfilling around it. However the lid on top of the casing has been removed and there is no well cap. OCM observed water had accumulated in the base of the protective pipe and the level was just below the top of the well pipe and there were leaves and litter around the well pipes. It was not possible to determine if the water in the base was overtopping groundwater or surface water.
