Killarney Waste Disposal

Aughacureen, Killarney, Co Kerry
Waste Licence No. W0217-01

Report on Hydrogeological Survey

June 2010

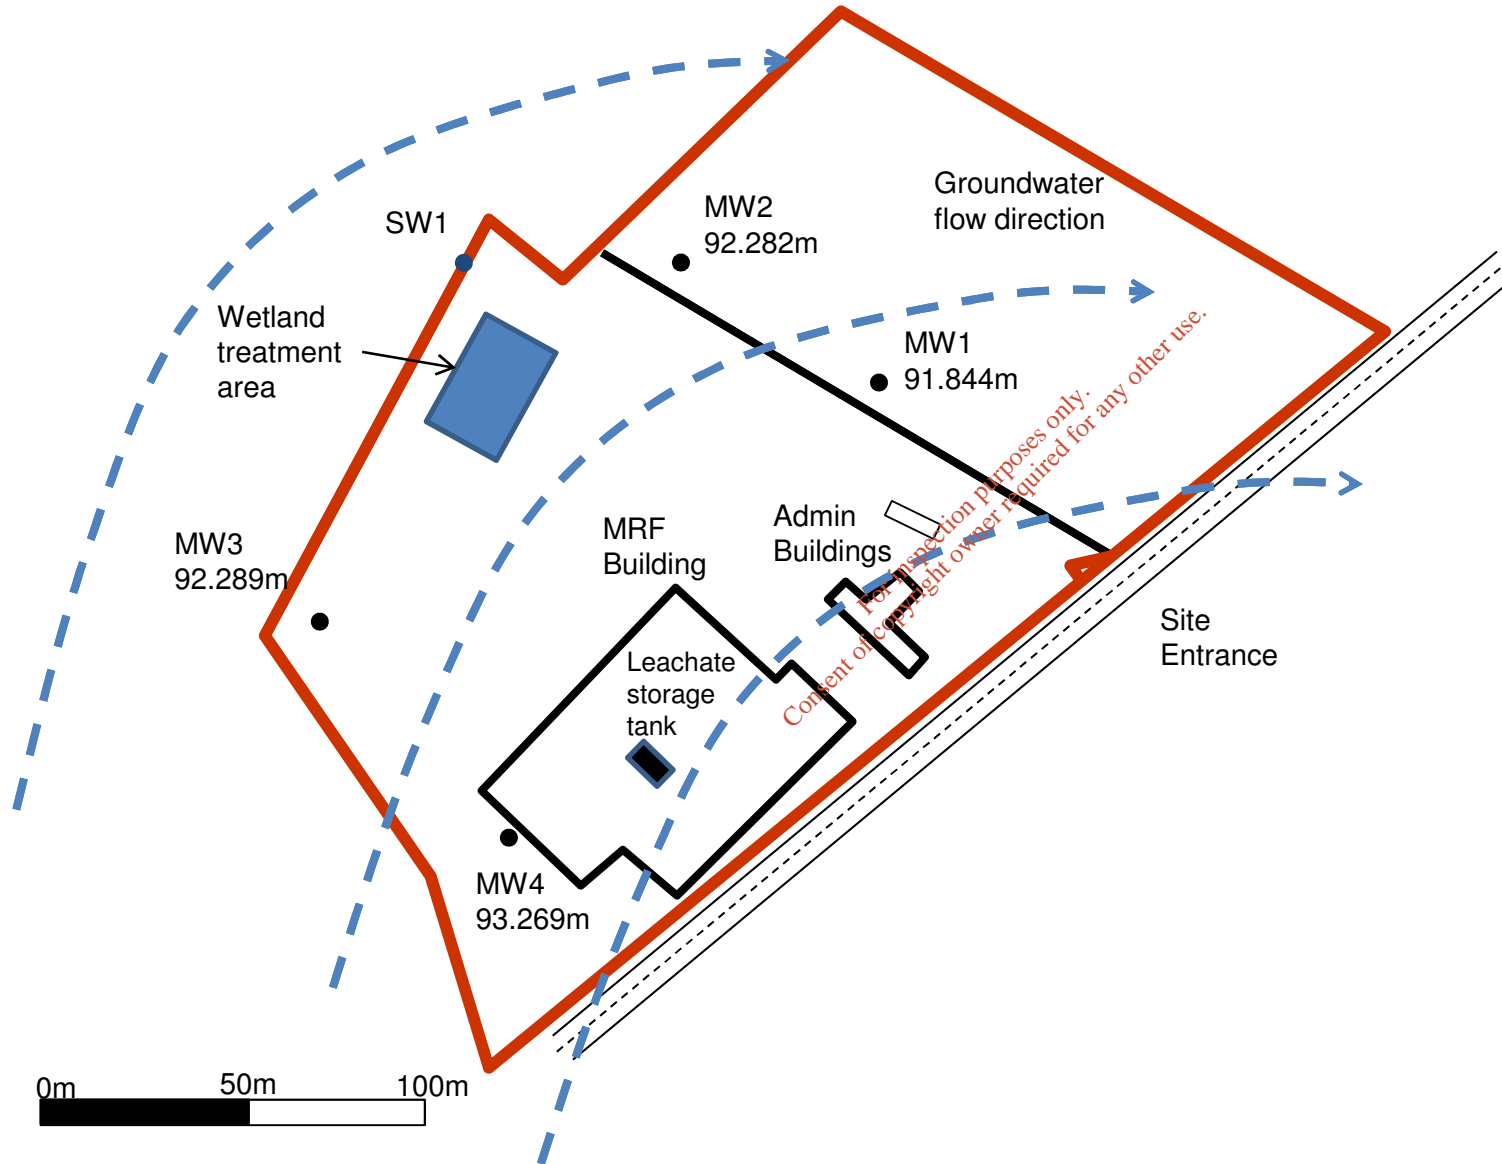
Client: Killarney Waste Disposal
Project Code: 1059_08
Title: MW Locations

The leachate storage tank is located in the centre of the MRF and is equipped with a volume alarm (see Figure 2). This storage tank was hydrostatically tested in March 2009 to check for integrity. The storage tank passed the integrity test. The bund integrity certificate is attached in Attachment D. This proves that there is no leachate being released into the environment as a point source from the leachate storage tank.

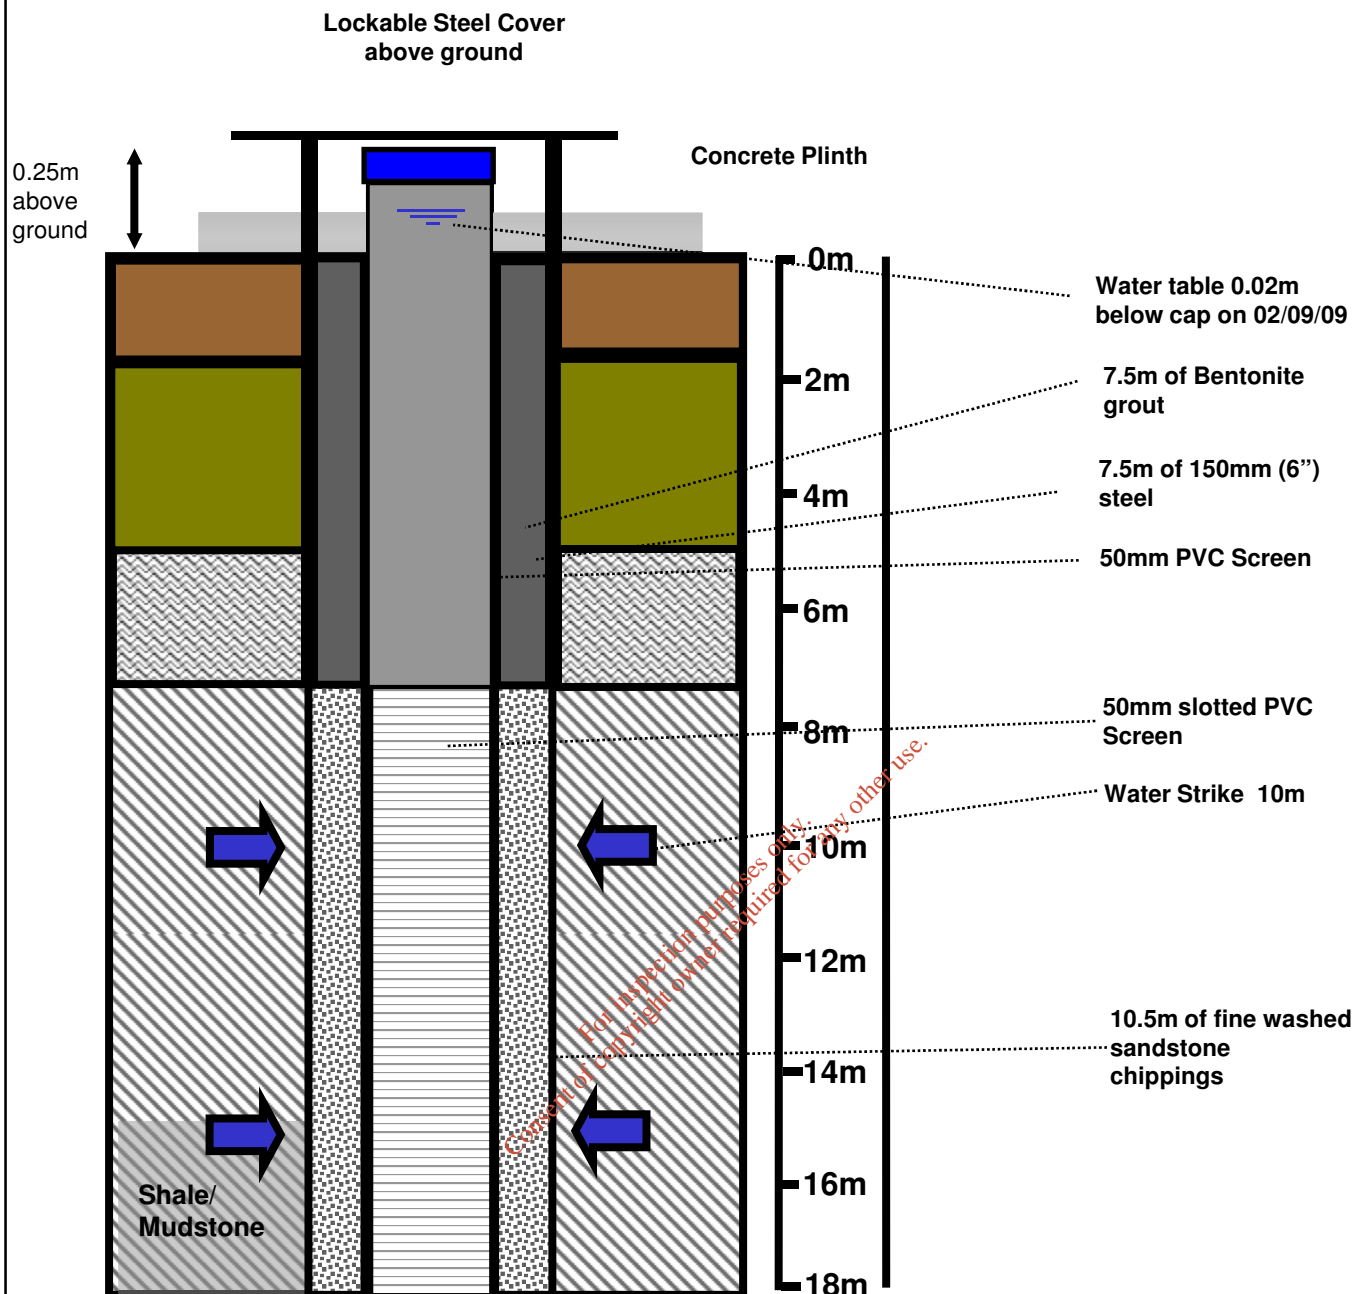
Client		Killarney Waste Disposal	
Title		MW1 – Borehole Construction	
Scale:	NTS	Project No.	1059-08
Figure	Figure 4	Rev.	A

- Drilling was initiated using a 140 millimetre hole, this was continued to a depth of 7.5 metres;
- Overburden was found to be topsoil from 0 to 0.5 metres with subsoil encountered from 0.5 to 5 metres;
- Soft black shale was encountered from 5 to 7.5 metres.
- Drilling continued to 18 metres below ground surface at a hole diameter of 120 millimetres.

- 10.5 metres of slotted 50 millimetre uPVC casing was installed from 7.5 metres to 18 metres;
- A gravel filter pack was installed in the annular space between the uPVC screen from 7.5m to 18 m below ground level;
- Bentonite seal was installed from 7.5m to ground level to seal the monitoring well from surface water intrusion;
- Raised headwork's were installed at this well to provide well security and groundwater protection of the well and
- A concrete plinth was placed around the top of the well for further groundwater protection.

In terms of the geological sequences encountered, the shale encountered between 5.0 and 7.5 metres was found to be a very fine black powder and slightly weathered and finely laminated.

During drilling, water strikes were recorded at 10 and 15 metres, while the well demonstrated artesian characteristics on the day of drilling.

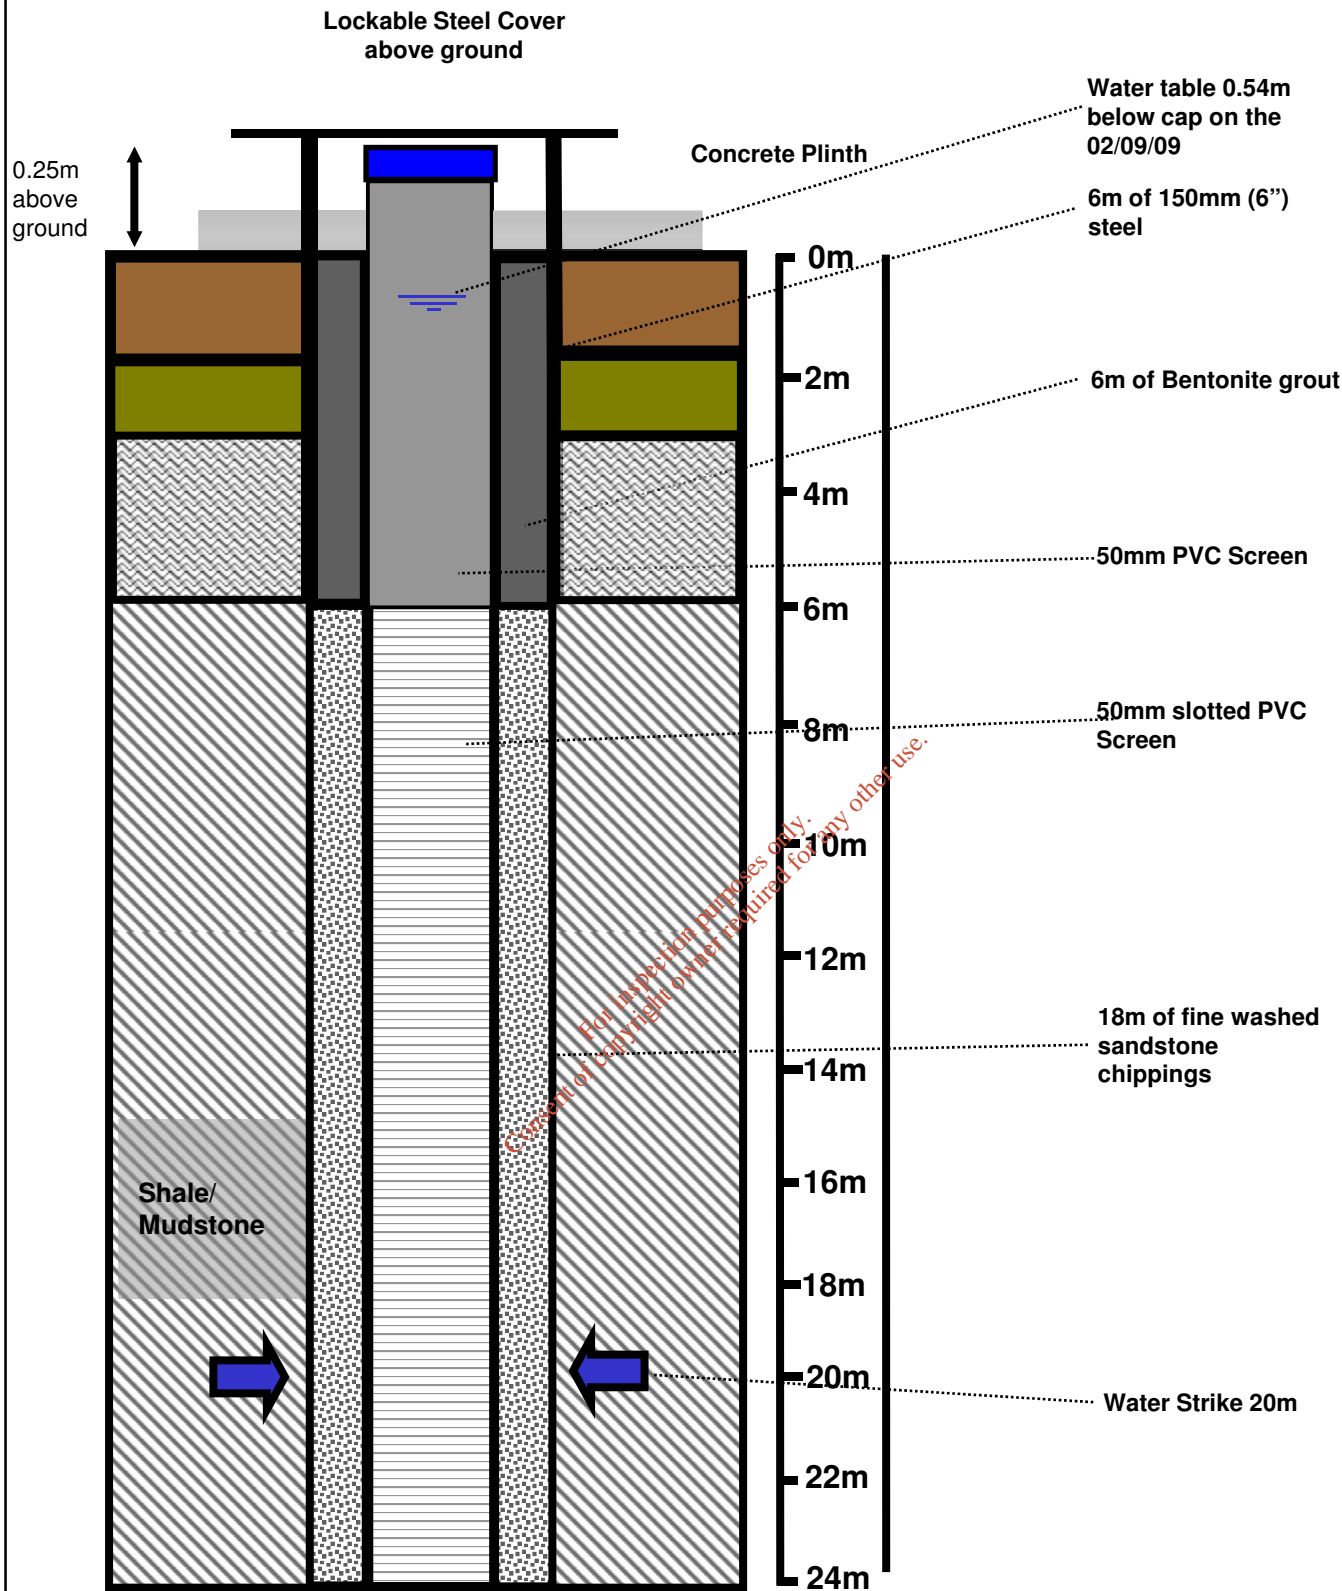
Client Killarney Waste Disposal	
Title MW2 – Borehole Construction	
Scale: NTS	Project No. 1059-08
Figure Figure 5	Rev. A

- Drilling was initiated using a 150 millimetre hole, this was continued to a depth of 6 metres;
- Overburden was found to be topsoil from 0 to 1 metres with bedrock (black shale) encountered from 1 to 3 metres;
- Steel casing from 0 to 6 metres was installed to stop the hole from caving in;
- Drilling continued to 24metres below ground surface at hole diameter of 120 millimetres.

- Slotted uPVC casing was installed from 6 to 24 metres;
- A gravel filter pack was installed in the annular space between the uPVC screen from 6m to 24m below ground level;
- Bentonite seal was installed from 6m to ground level to seal the monitoring well from surface water intrusion;
- Raised headwork's were installed at the at this well to provide security and protection of the well; and
- A concrete plinth was placed around the top of the well for further groundwater protection.

Whilst the well was being drilled, a minor water strike was encountered at 20 metres below ground level. Similar to MW 1 the drill cuttings were reported as being fine black powder which would indicate that the shale was weathered.

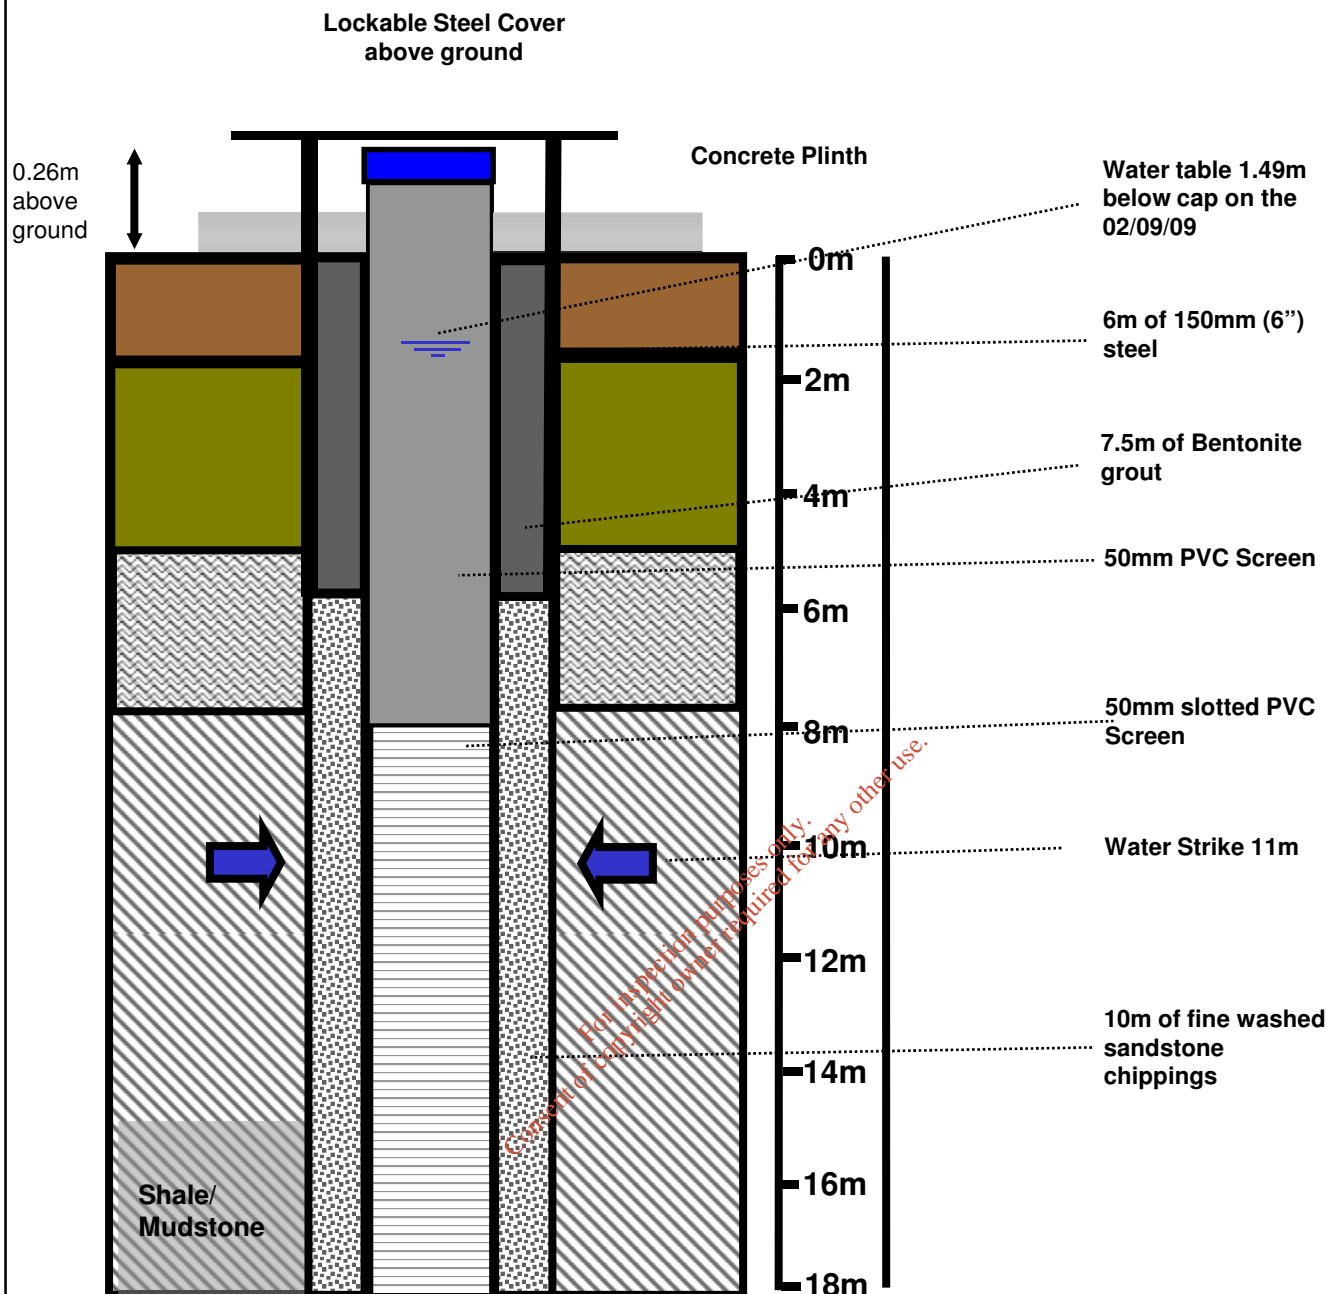
Client Killarney waste Disposal .	
Title MW3- Borehole Construction	
Scale. NTS	Project No. 1059-08
Figure Figure 6	Rev. A

- The monitoring borehole drilling was initiated using a 140 millimetre hole, this was continued to a depth of 6 metres;
- Overburden of topsoil and subsoil was encountered from 0 to 5 metres.

- Soft weathered black shale was encountered from 5 to 8 metres and 6 metres of steel casing was inserted from 0 to 6 metres to stop the borehole from caving in;
- Drilling continued to 18metres below ground surface at a hole diameter of 120 millimetres.

- 50 millimetre uPVC casing was installed from 0 metres to 7.5 metres below ground level;
- A gravel filter pack was installed around the uPVC from 6 to 18 metres;
- A Bentonite seal was installed from 6m to ground level to seal the monitoring well from surface water intrusion;
- Raised headwork's were installed at the at this well to provide security and protection of the well; and
- A concrete plinth was placed around the top of the well for further groundwater protection.

A minor water strike was encountered at 11m below ground level. Once the steel screen was installed in the upper 6 metres of the borehole the hole remained open for the duration of drilling.

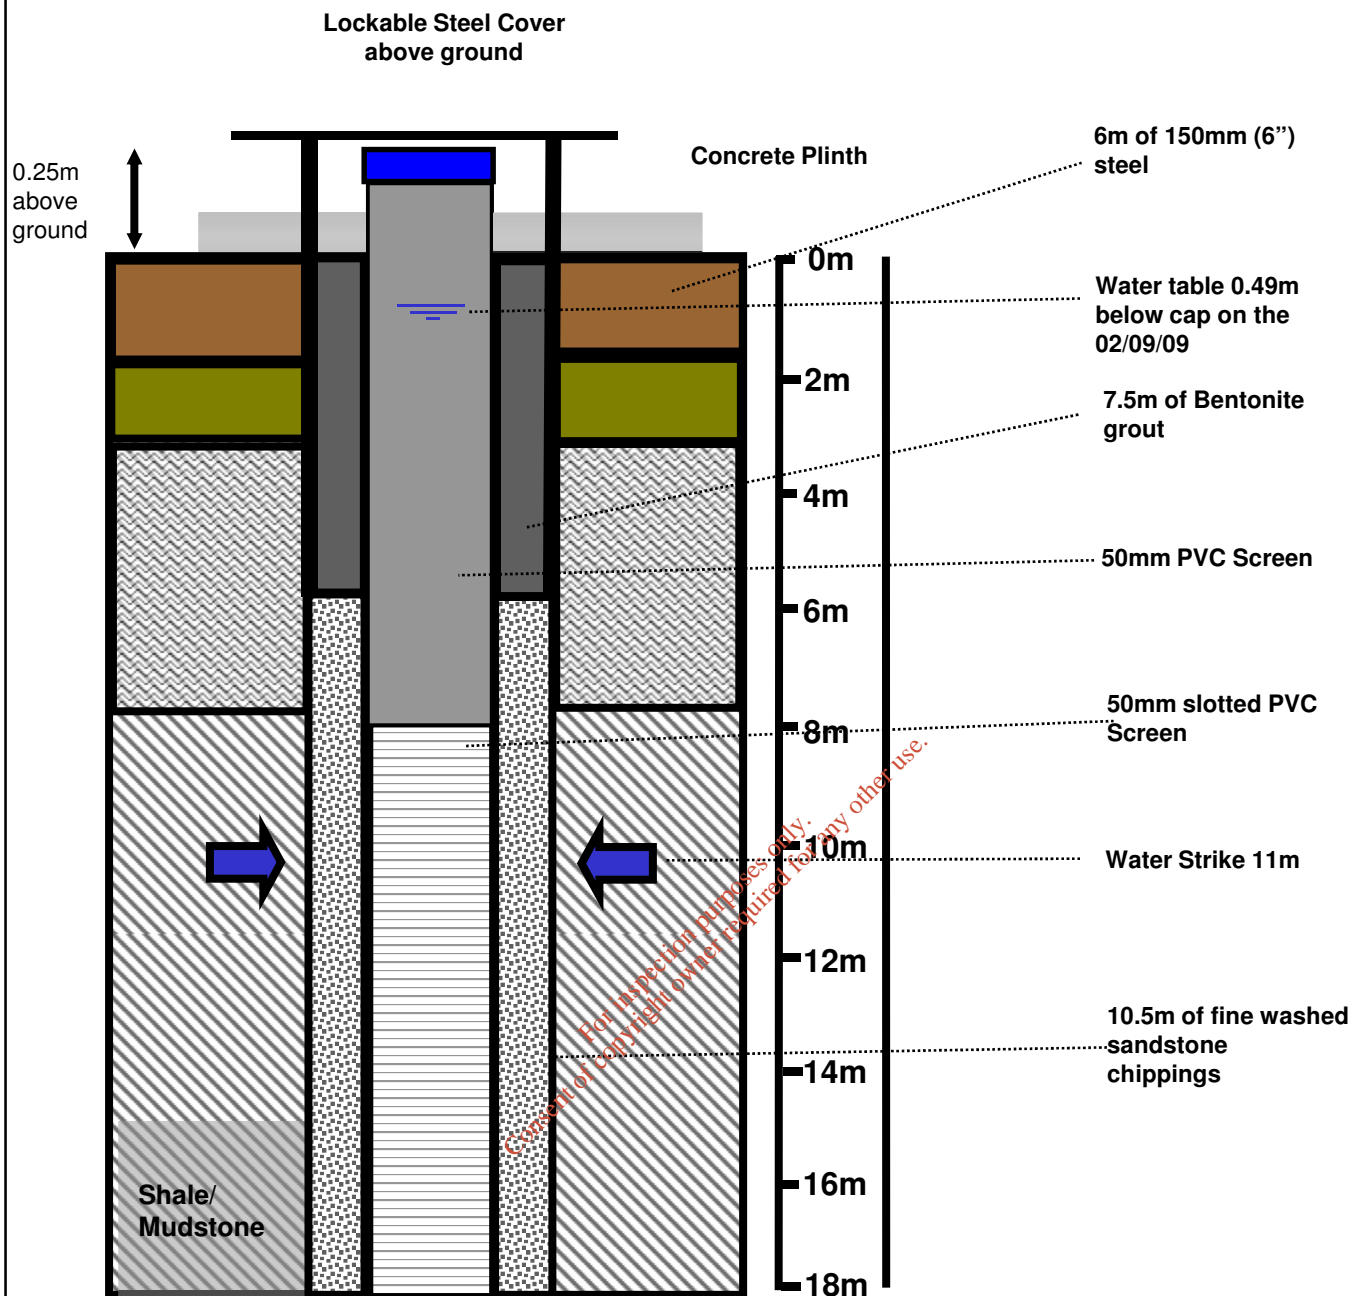
Client		Killarney Waste Disposal	
Title		MW4 – Borehole Construction	
Scale:	NTS	Project No.	1059-08
Figure	Figure 7	Rev.	A

- The monitoring borehole drilling was initiated using a 140 millimetre hole, this was continued to a depth of 6 metres;
- Overburden of topsoil and clay was encountered from 0 to 3 metres.
- Soft weathered black shale was encountered from 3 to 8 metres and 6 metres of steel casing was inserted from 0 to 6 metres to stop the borehole from caving in;
- Drilling continued to 18metres below ground surface at a hole diameter of 120 millimetres.

- 50 millimetre uPVC casing was installed from 6 metres to 18 metres below ground level;
- A gravel filter pack was installed in the annular space between the uPVC screen from 6m to 18m below ground level;
- A Bentonite seal was installed from 6m to ground level to seal the monitoring well from surface water intrusion;

- Raised headwork's were installed at the at this well to provide security and protection of the well; and
- A concrete plinth was placed around the top of the well for further groundwater protection.

Similarly to MW3 a water strike was detected at 11 metres.

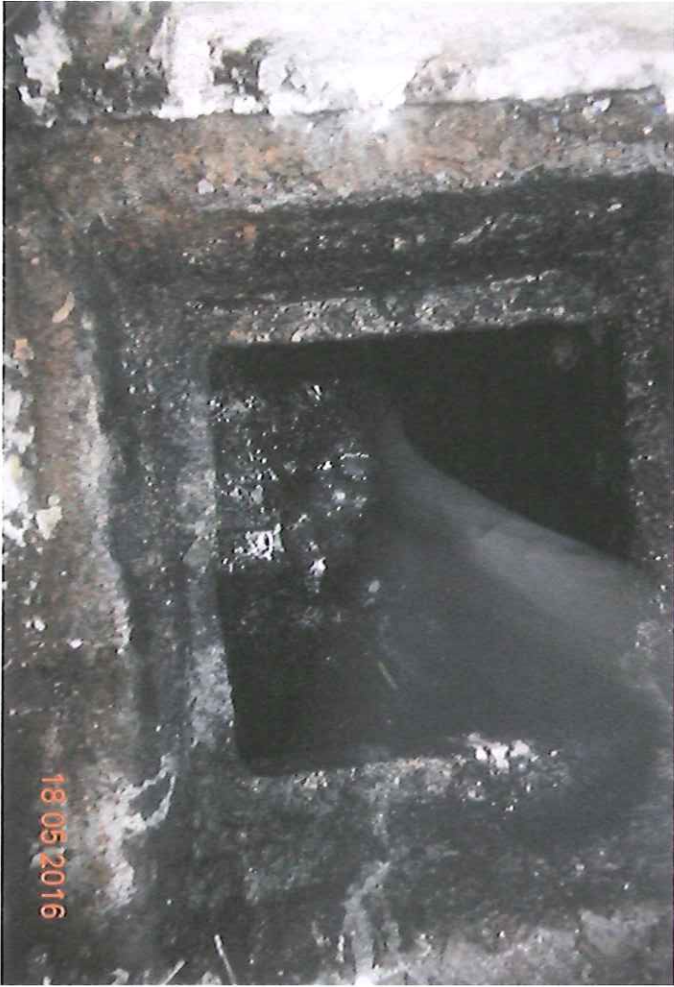
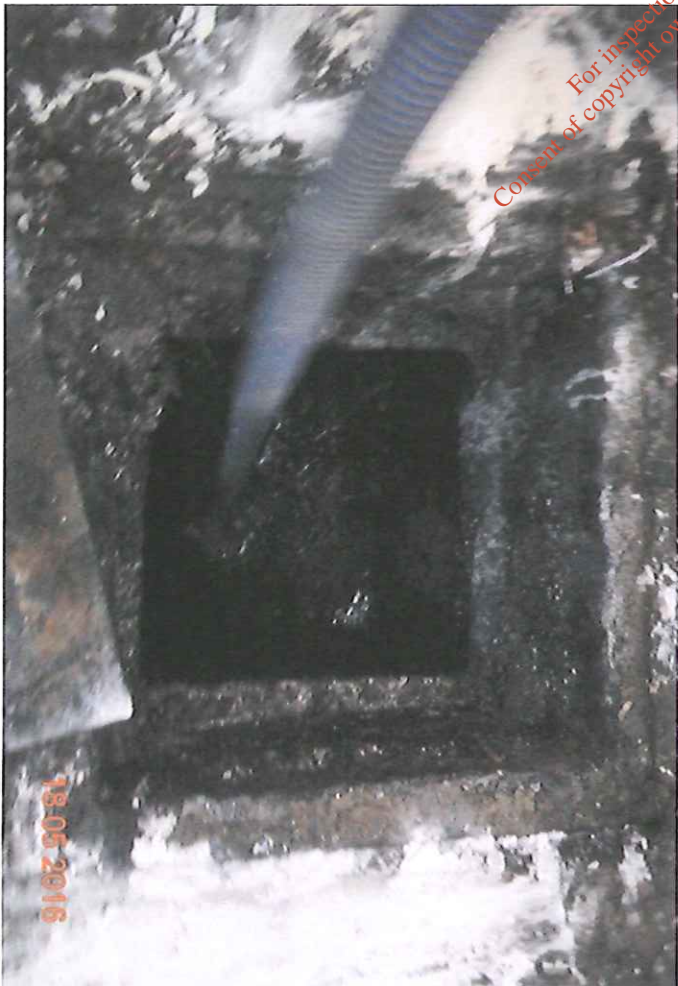
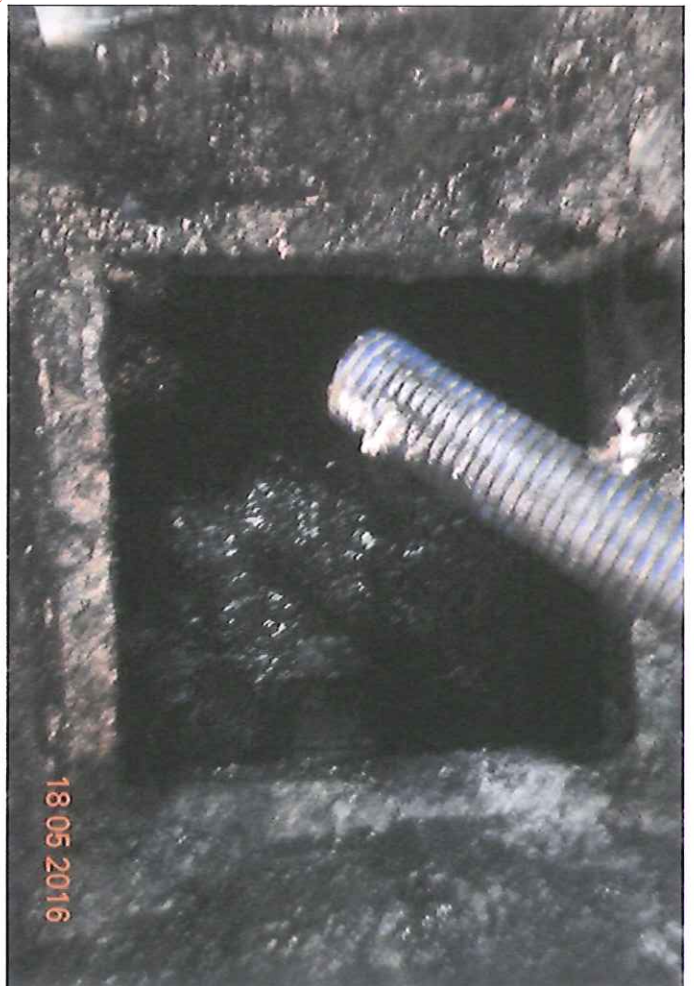
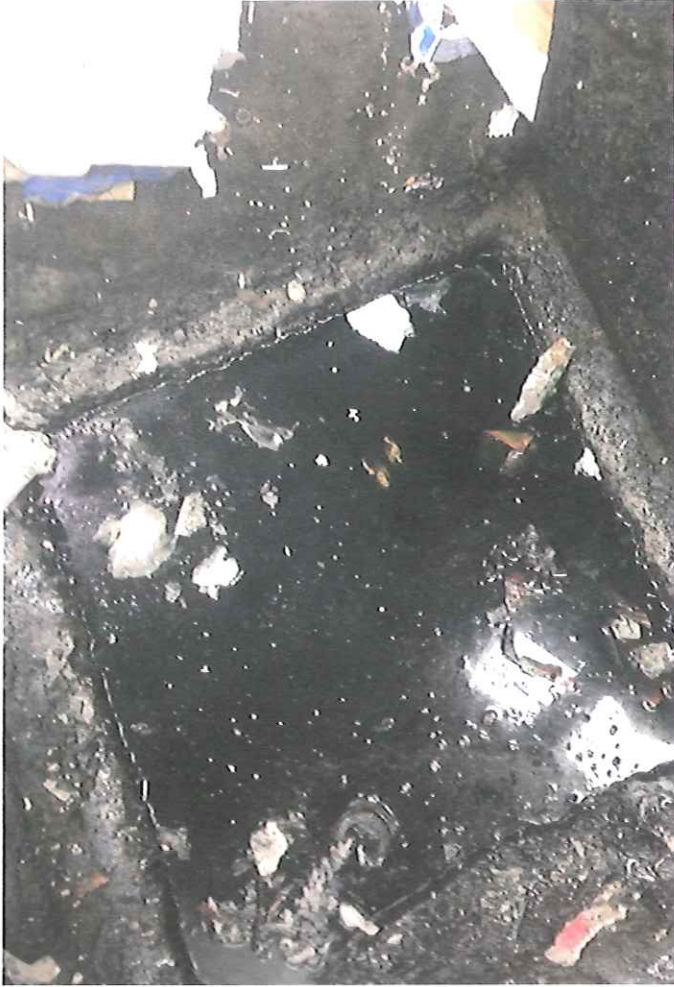
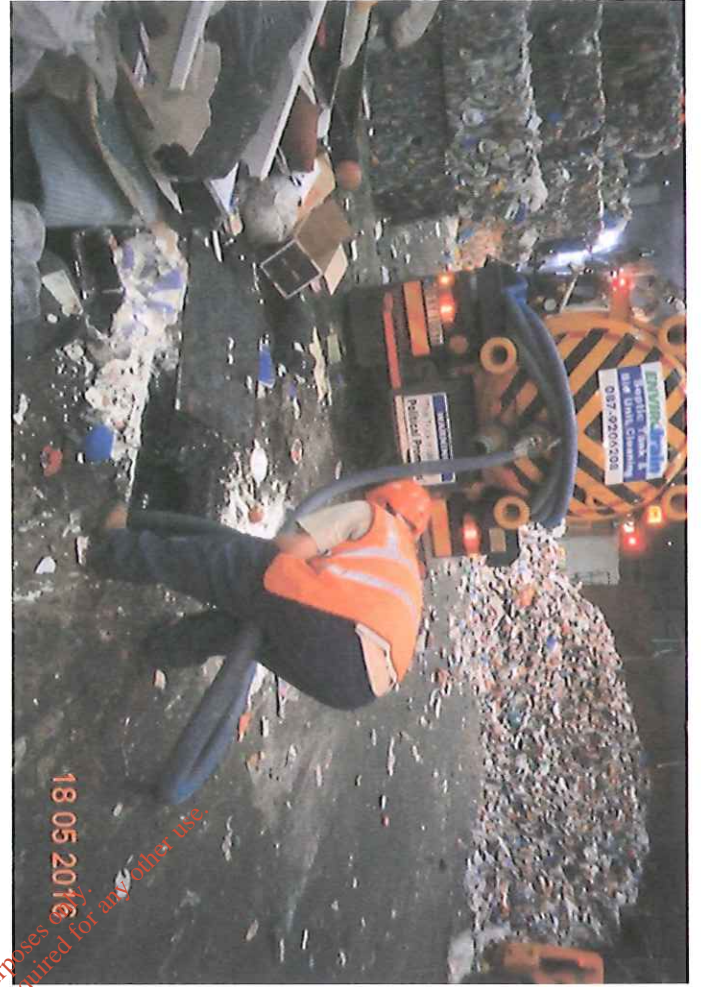
Sump 1

SUMP NUMBER	Date of Testing	Result	Comment
Sump No.1 (Leachate Sump)	17/5/2016-18/5/2016	Passed	Reinforced Concrete in good condition.
Sump No.2 (Near Office)	17/5/2016-18/5/2016	Passed	Reinforced Concrete in good condition.
Sump No.3 (Near Timber Shed)	17/5/2016-18/5/2016	Passed	Reinforced Concrete in good condition.
Sump No.4 (Oil Bund)	17/5/2016-18/5/2016	Passed	Reinforced Concrete in good condition.
Sump No.5 (Oil/Water Interceptor near Diesel Shed)	17/5/2016-18/5/2016	Passed	Reinforced Concrete in good condition.
