**KWD Recycling**  
Aghacurreen, Killarney, Co. Kerry

**Bund Integrity Inspections**  
In compliance with condition 3.11.5 of Waste  
Licence W0217-01

May 2016

**Prepared by: -** **Donal Moynihan BE, C. Eng, M.IEI,**  
**CHARTERED ENGINEER,**  
**Donal Moynihan Consulting Engineers Ltd,**  
**Boolacullane,**  
**Farranfore,**  
**Co. Kerry**  
**V93 XN22**

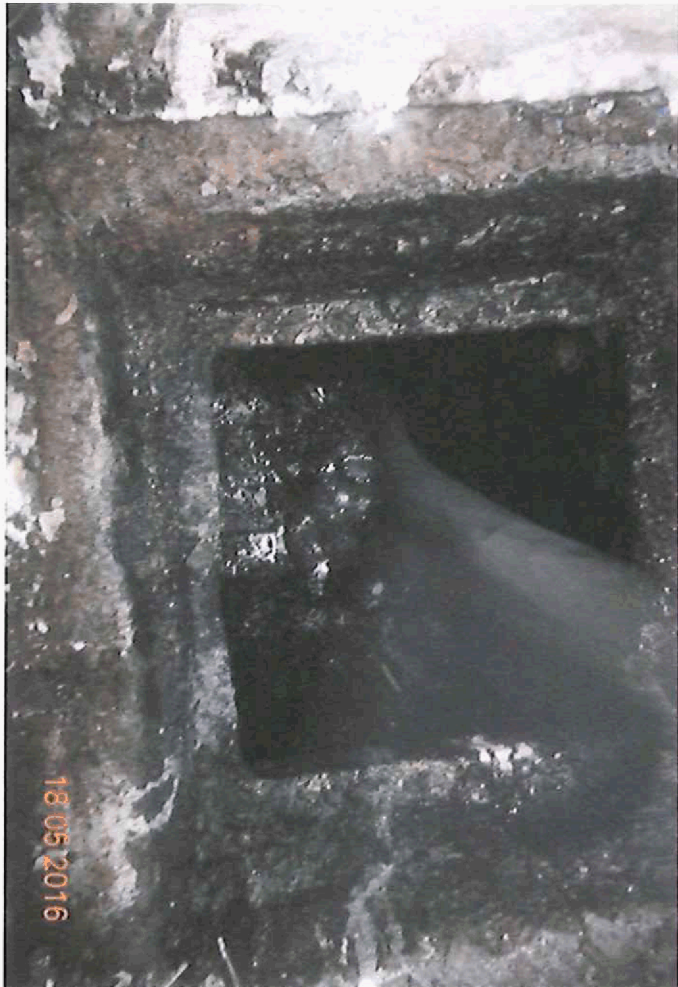
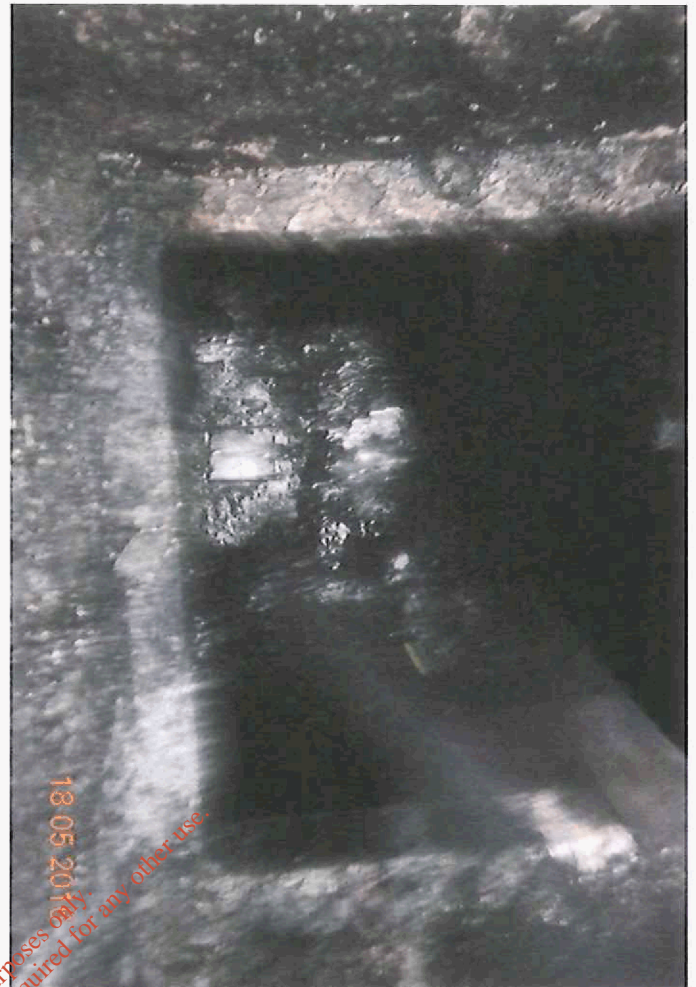
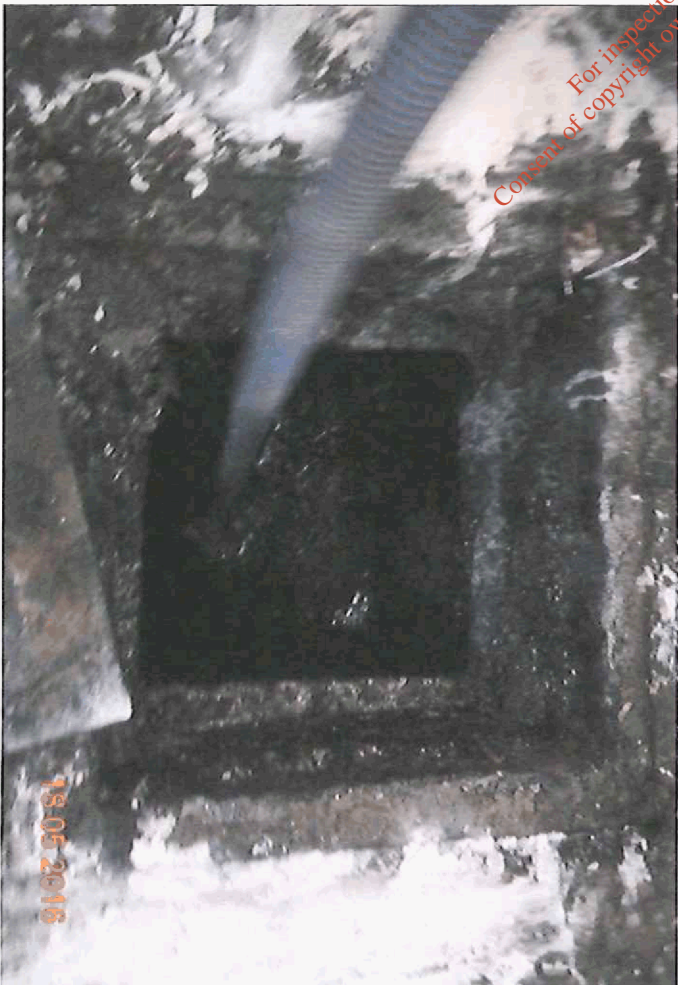
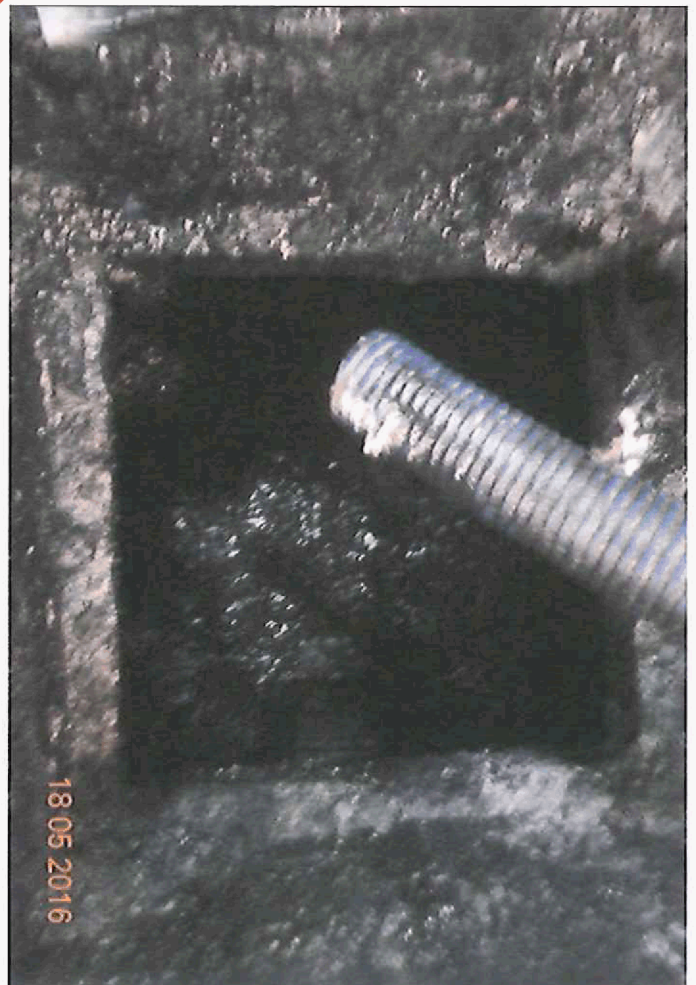
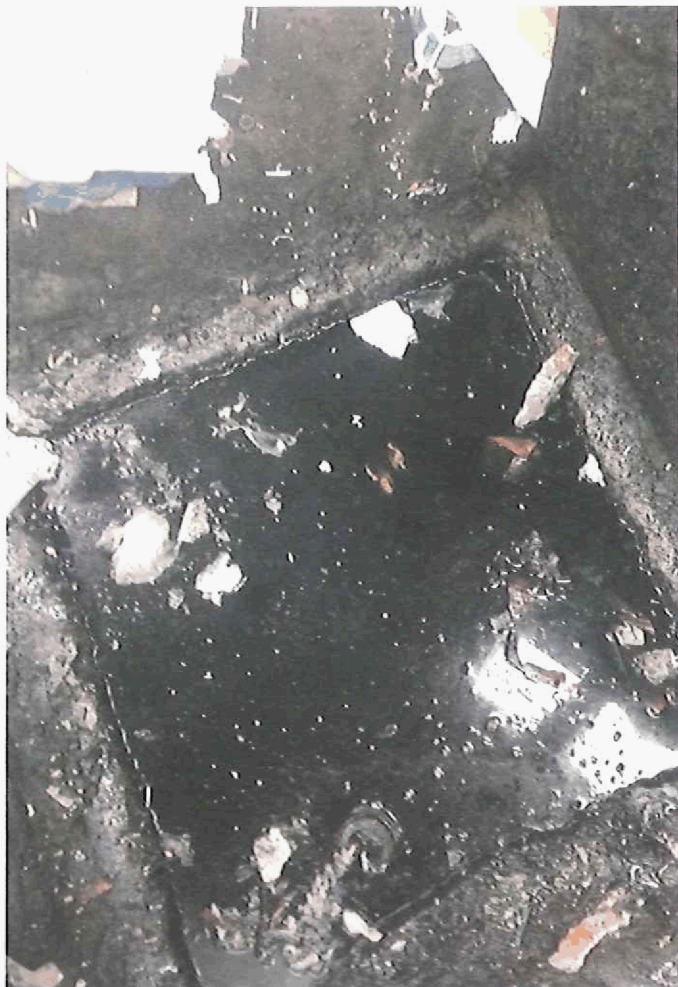
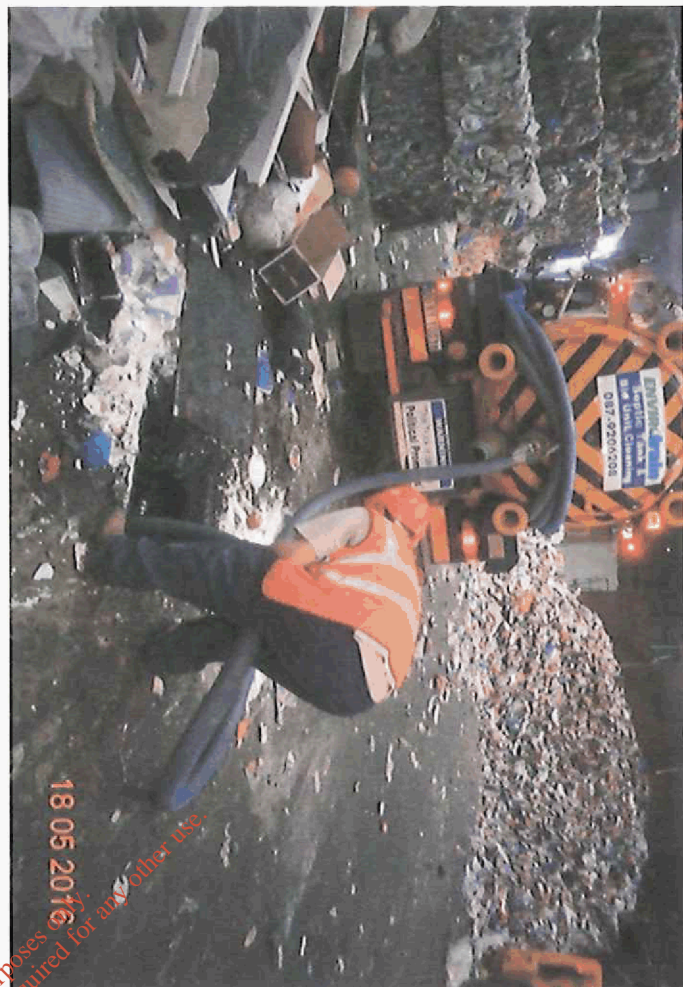
## Sump 1

SUMP NUMBER	Date of Testing	Result	Comment
Sump No.1 (Leachate Sump)	17/5/2016-18/5/2016	Passed	Reinforced Concrete in good condition.
Sump No.2 (Near Office)	17/5/2016-18/5/2016	Passed	Reinforced Concrete in good condition.
Sump No.3 (Near Timber Shed)	17/5/2016-18/5/2016	Passed	Reinforced Concrete in good condition.
Sump No.4 (Oil Bund)	17/5/2016-18/5/2016	Passed	Reinforced Concrete in good condition.
Sump No.5 (Oil/Water Interceptor near Diesel Shed)	17/5/2016-18/5/2016	Passed	Reinforced Concrete in good condition.
