HYDROGEOLOGICAL SURVEY REPORT

KILLARNEY WASTE DISPOSAL LTD

AUGHACURREEN

WASTE LICENCE NO. W0217-01

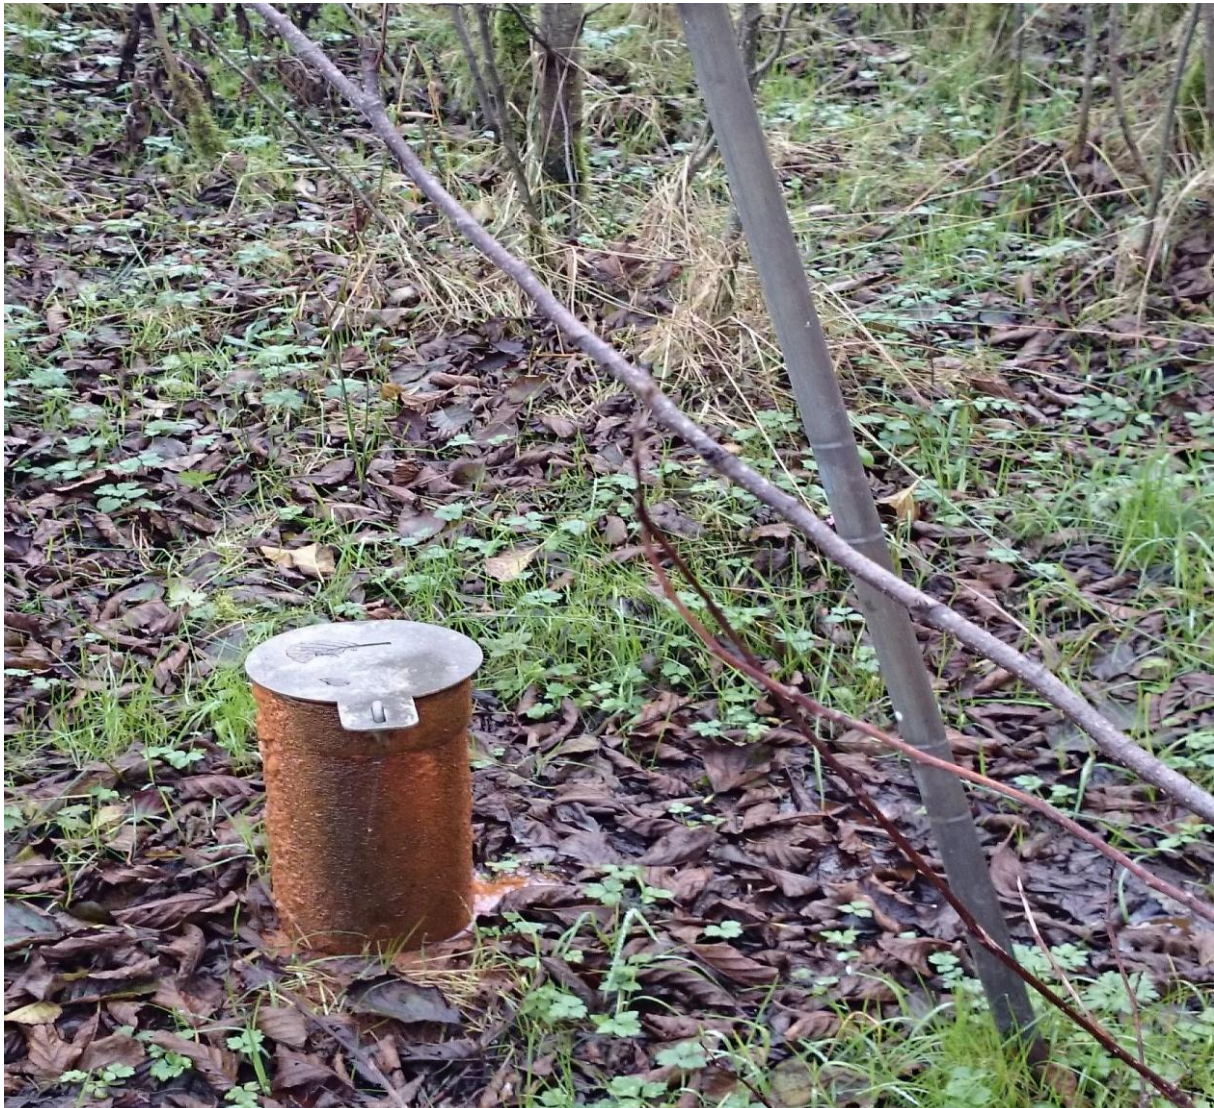
Photograph 1 MW-1

The well is located in a wooded area to the north of the drain that flows along the north-eastern boundary. The headworks are intact (Photograph 1) but there is evidence of artesian conditions.

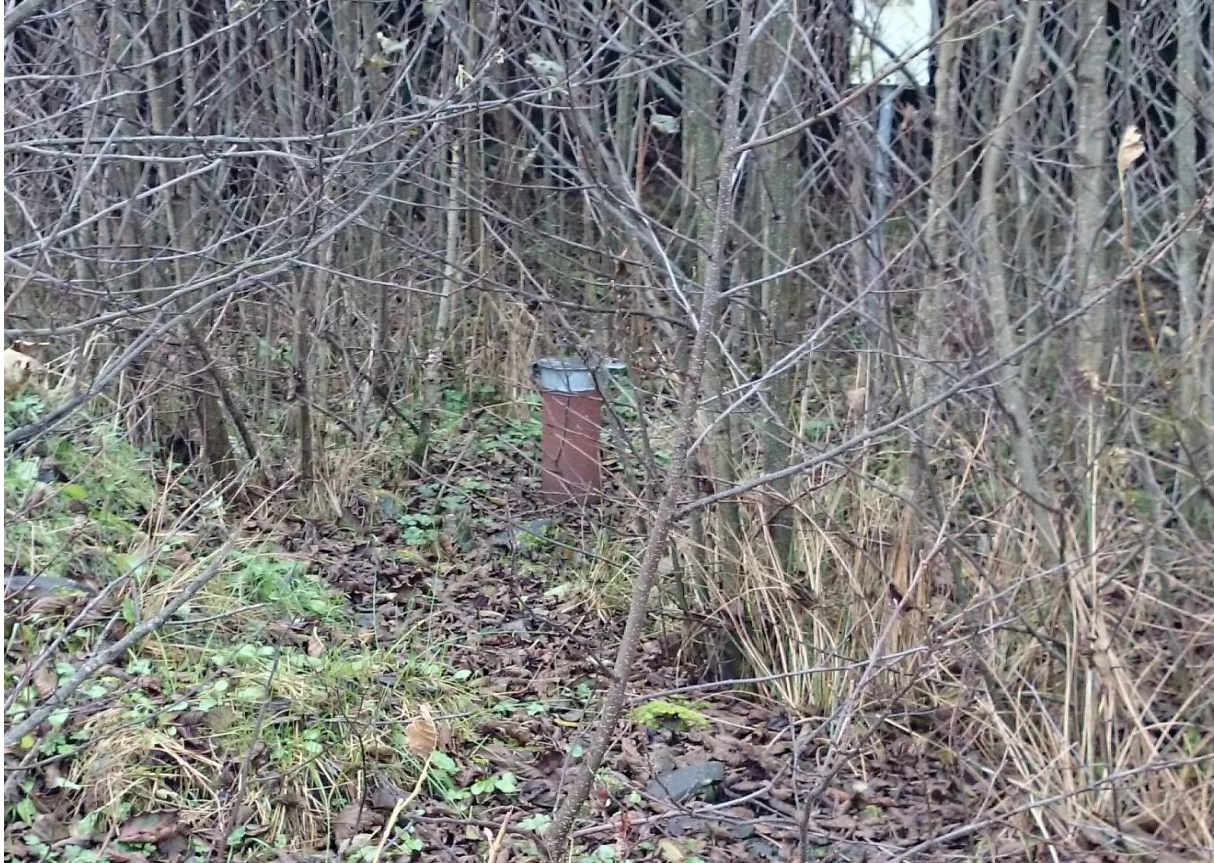
Photograph 2 MW-2

The well is located in a wooded area to the north of the drain that flows along the north-eastern boundary. The headworks are intact.

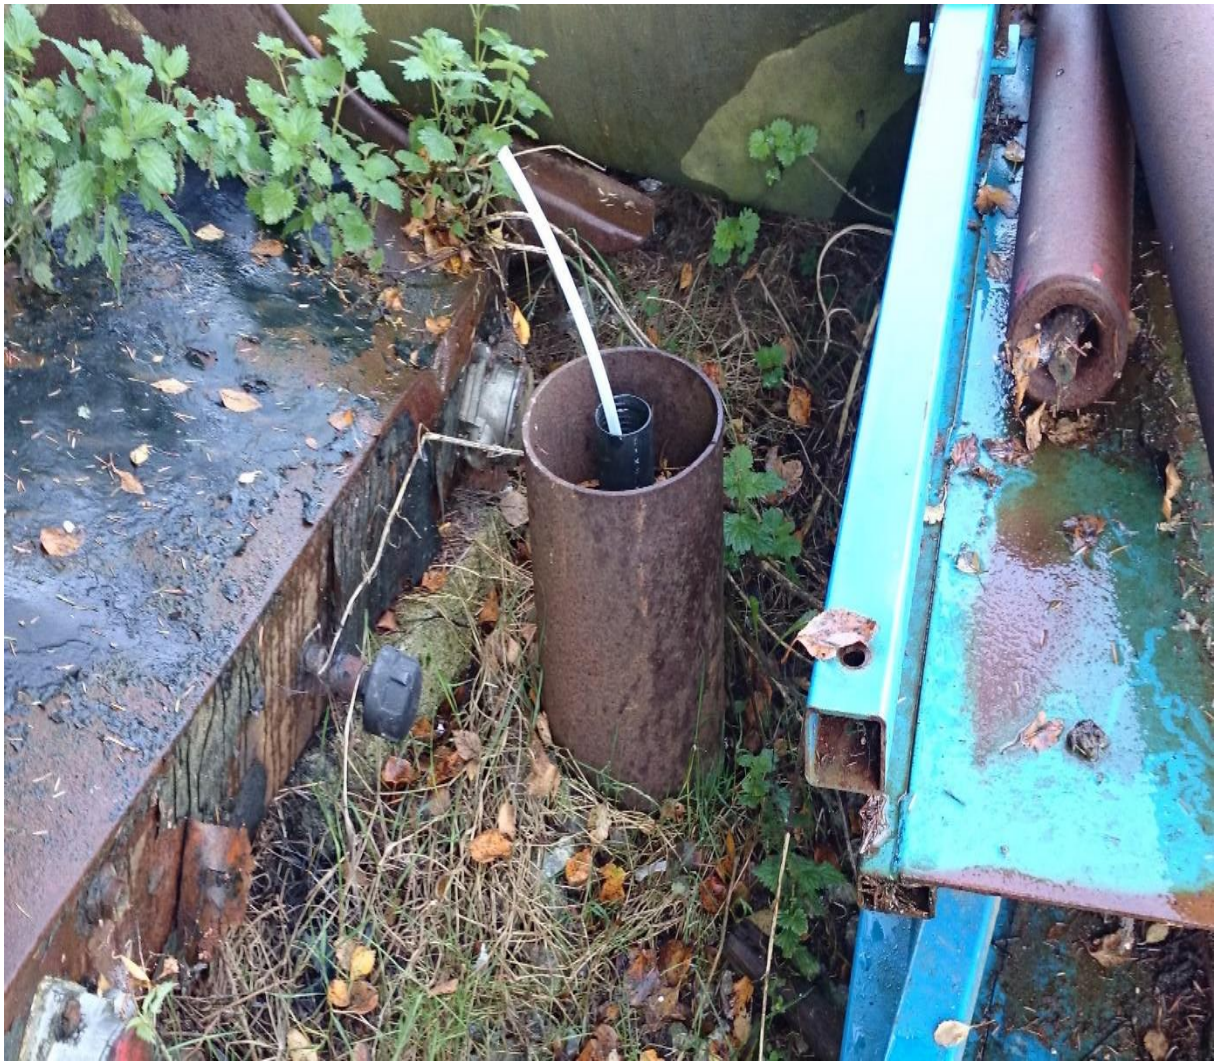
Photograph 3 MW-3

Faecal coliforms were detected in MW-3 and MW-4 in January 2017. The headworks of both wells are damaged and there are no well caps, meaning the wells are susceptible to faecal contamination by birds and small mammals, and, in the case of MW-4, the entry of surface water run-off.

The well is located in the south-west of the site. The on the top of the steel casing has been removed and there is no cap on the top of the well pipe.

Given that the headworks on both MW-3 and MW-4 are damaged, there are no well caps and MW-4 is approximately 0.5 m below ground level, the likely source of the coliforms is faecal contamination by birds or small mammals and not off-site sources.

The elevated ammonia detected in MW-1, MW-2 and MW-3 is due to naturally occurring reducing conditions in the aquifer. The condition of the well heads at MW-3 and MW-4 means they are vulnerable to contamination from the ground surface and it is recommended that they be repaired and the wells disinfected.

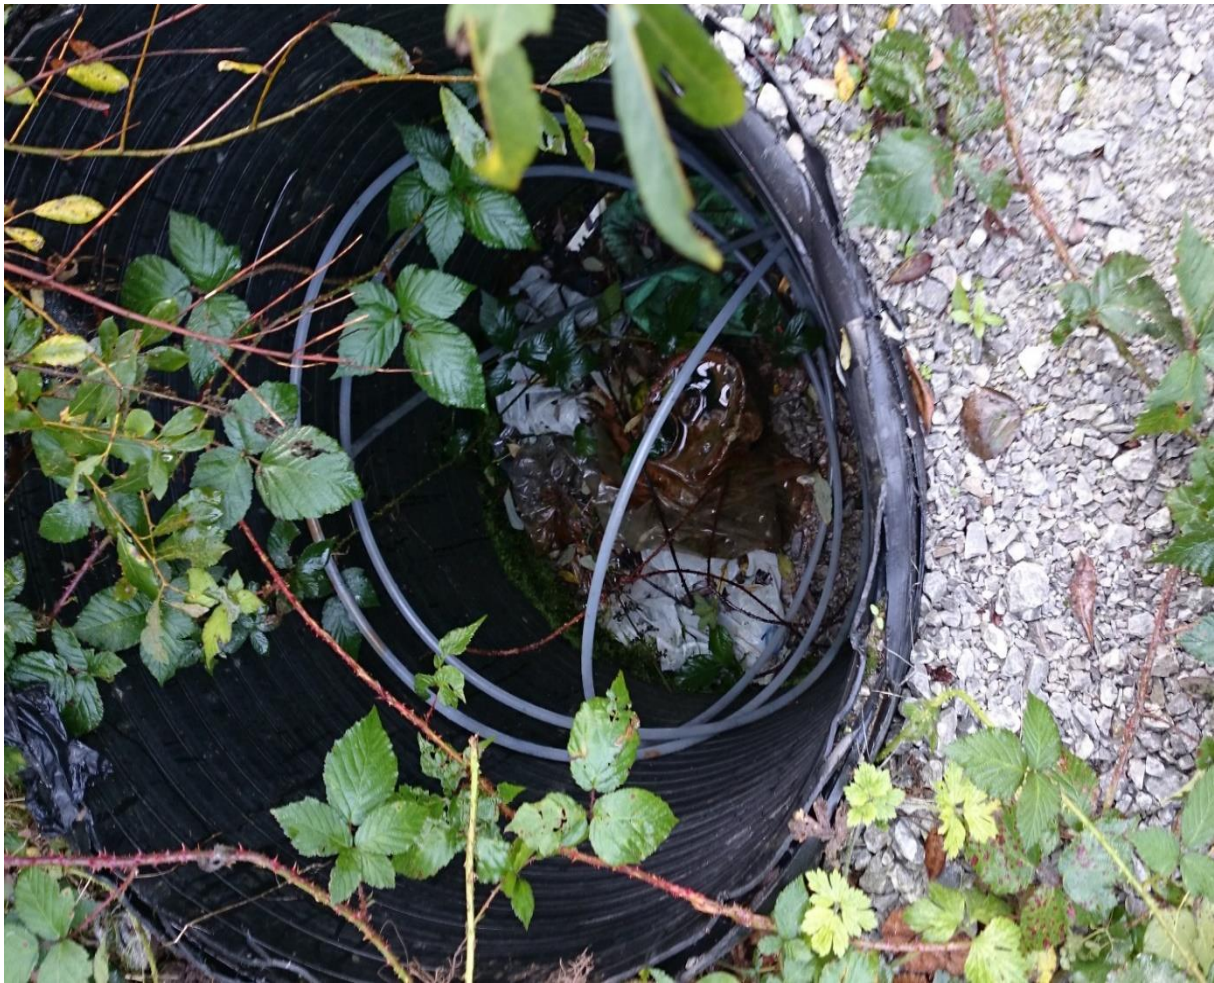
Photograph 4 MW-4

MW-4 is located in the south-east of the site close to the rear wall of the materials recovery building. The top of the well pipe is approximately 1m below ground level as a result of the raising of the access road to the rear of the building.

The well was protected by placing a large diameter plastic pipe on the ground and backfilling around it. However the lid on top of the casing has been removed and there is no well cap. OCM observed water had accumulated in the base of the protective pipe and the level was just below the top of the well pipe and there were leaves and litter around the well pipes. It was not possible to determine if the water in the base was overtopping groundwater or surface water.
