Site Visit Report

Licensee	
Name of Installation	Scarriff Civic Amenity Centre
Licensee	Clare County Council
Licence Register No.	W0150-01
CRO Number	
Site Address	Fossa Beg, Feakle Road, Scarriff, Clare
Site Visit Reference No.	SV02682

Report Detail	
Issue Date	05/10/2017
Prepared By	Caoimhin Nolan

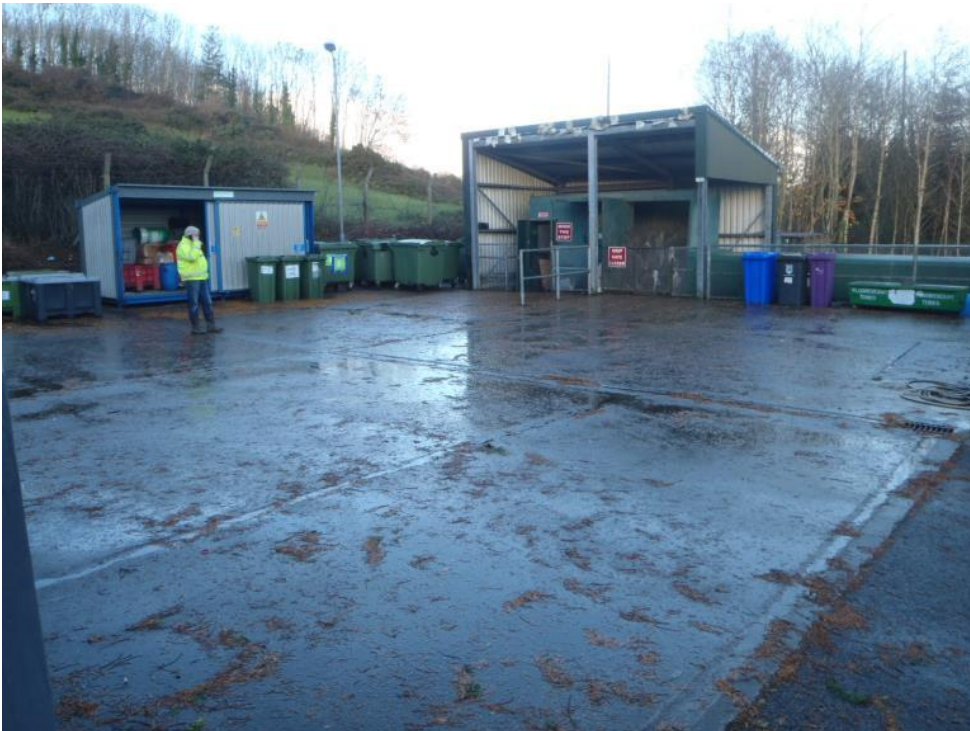
Photo 1: general view of upper yard area.

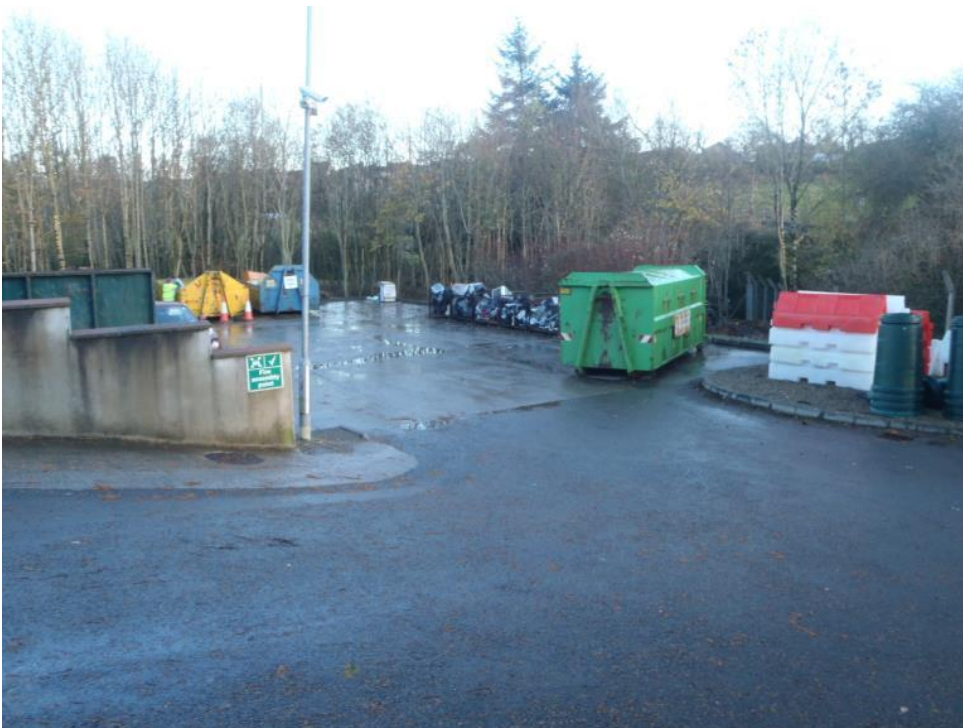
Photo 2: general view of lower yard area.

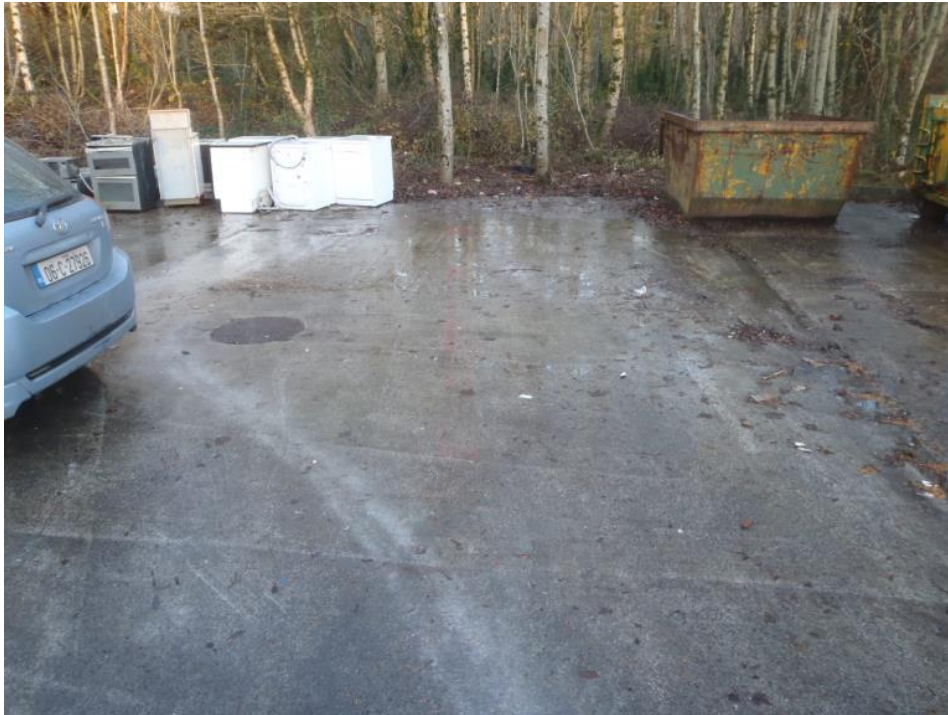
Stormwater run-off arising from the lower yard area was noted to be seeping into the ground to the east and south of the concrete pad. The lower yard area was being used for the outdoor storage of waste at the time of the inspection – e.g. white goods, timber, WEEE. The Inspector noted the presence of some oil and a white-coloured slime deposit on the concrete yard surface near where the run-off was being allowed to discharge to ground. The discharge to ground was facilitated by the absence/removal of kerbing around the concrete pad in two locations, which the Inspector considered may have been done intentionally to relieve the build-up of stormwater in the yard. It was noted for example, that no stormwater drains were visible in the lower yard, and no oil separator had been installed at the facility.

Photo 3: general view east from the lower yard area, with wooded copse area in the background. A foul sewer manhole is visible, with the septic tank located behind (beside white goods). Note the absence of kerbing at the edge of the concrete pad beside the white goods.

Reinstate the kerbing around the concrete pad associated with the lower yard so as to direct all run-off to a silt trap/oil separator and then to discharge point SW1. [Note: the licensee was requested at the audit closing meeting to submit a site drainage map/drawing, and one was subsequently included in the ICA report that was submitted to the Agency.]

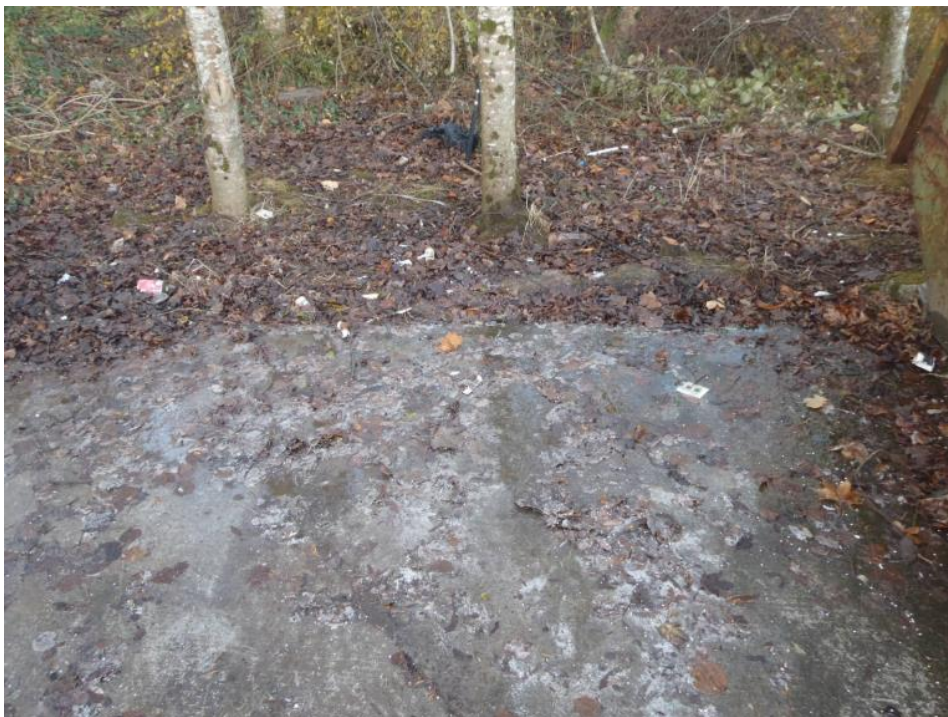
Photo 4: close-up of eastern edge of concrete pad (lower yard) where kerbing was absent and a white-coloured slime deposit was evident on the concrete surface.

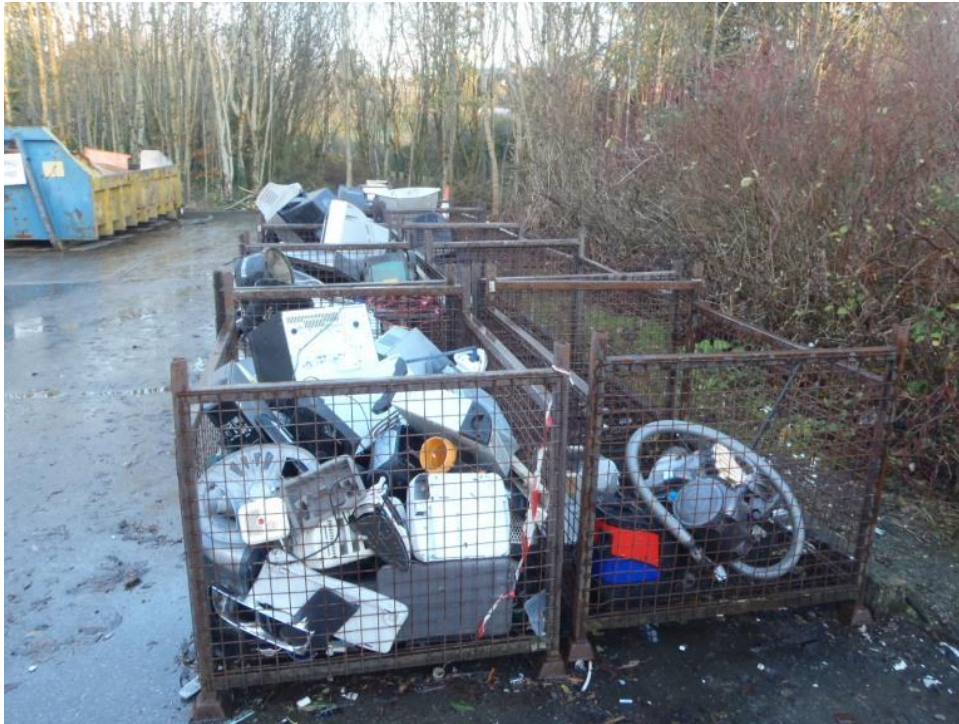
Photo 5: outdoor WEEE storage on the lower yard.

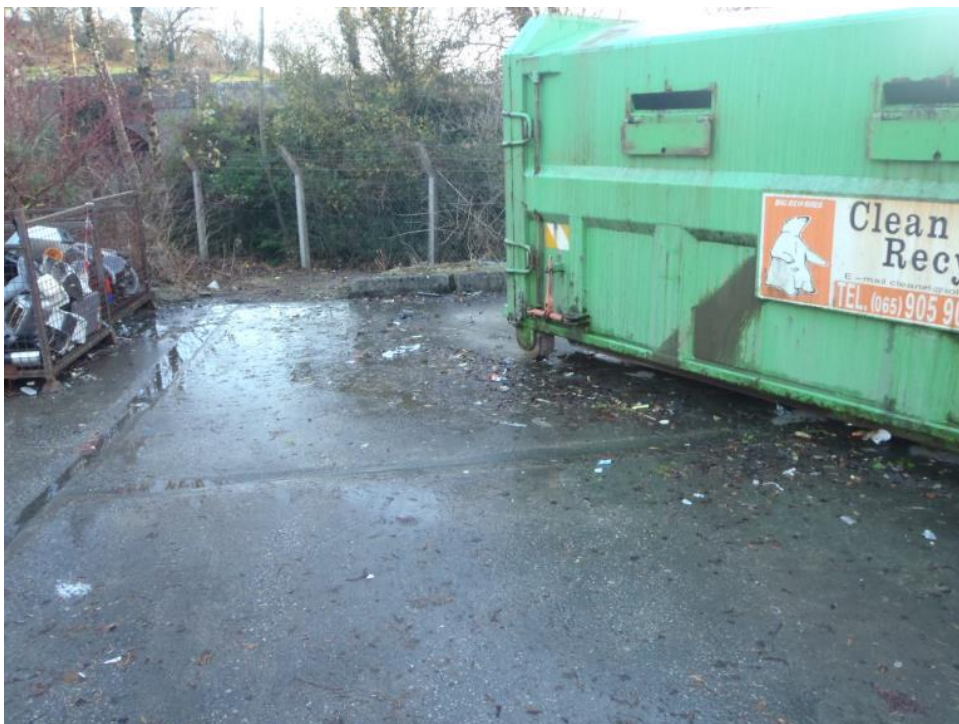
In relation to observation no. 1 above, the Inspector notes that soil sampling was done as part of the Independent Closure Audit in the vicinity of the two overspill points from the concrete pad of the lower yard area. While the presence of some extractible petroleum hydrocarbons was present in the upper layer of soil, the sampling did not identify any significant impact on soil quality.

Photo 6: general view of the southern edge of the lower yard (facing south). Note the absence of kerbing at the edge of the concrete pad beside the WEEE receptacles, and the seepage of run-off moving towards the unpaved area.

Complete the reinstatement of the kerbing around the concrete pad and install an oil

separator to prevent any impact on soil quality.

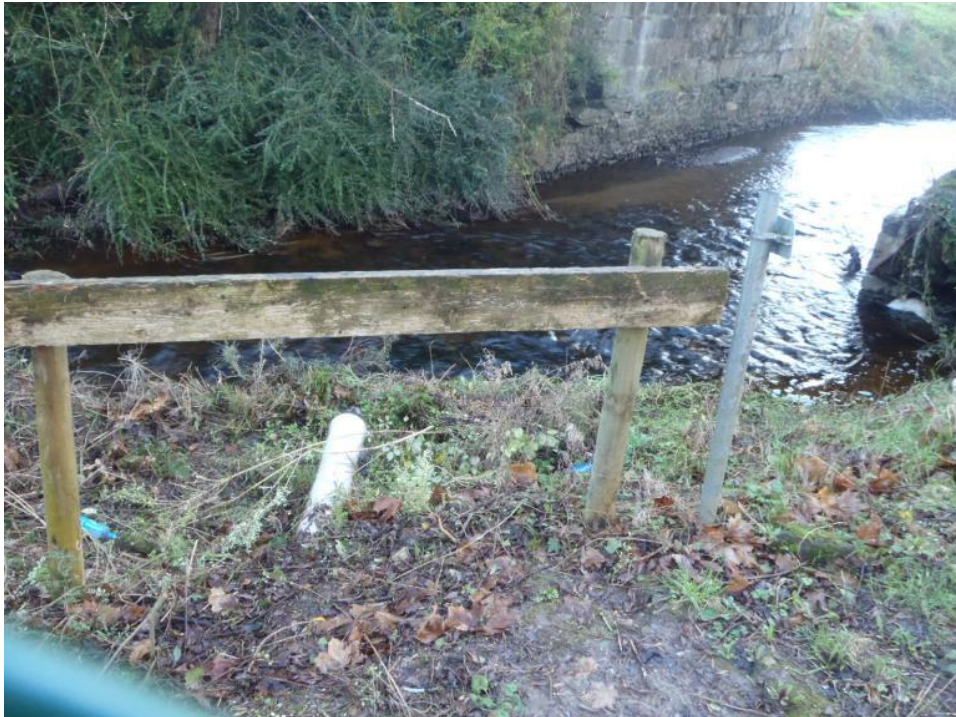
The licensee's surfacewater visual inspection records were reviewed on-site and were considered to be satisfactory. The Inspector also carried out visual observations at the surfacewater discharge point (SW1) and the receiving waterbody, both upstream and downstream of the facility, and no issues or evidence of pollution/contamination was noted. The Inspector notes that surfacewater sampling/analysis was done as part of the Independent Closure Audit, and the results provided in the ICA report were considered to be satisfactory. [Note: One set of lab results in the ICA report was noted to highlight the presence of very high levels of Ammoniacal Nitrogen in a number of groundwater wells, however these results related to Doora Landfill and not Scarriff Civic Amenity Centre.]

Photo 7: general view of the stormwater discharge point SW1 (facing south) and the receiving waterbody.
