TIER 3

ENVIRONMENTAL RISK ASSESSMENT

FORMER MUNICIPAL LANDFILL

BALLYRAGGET,

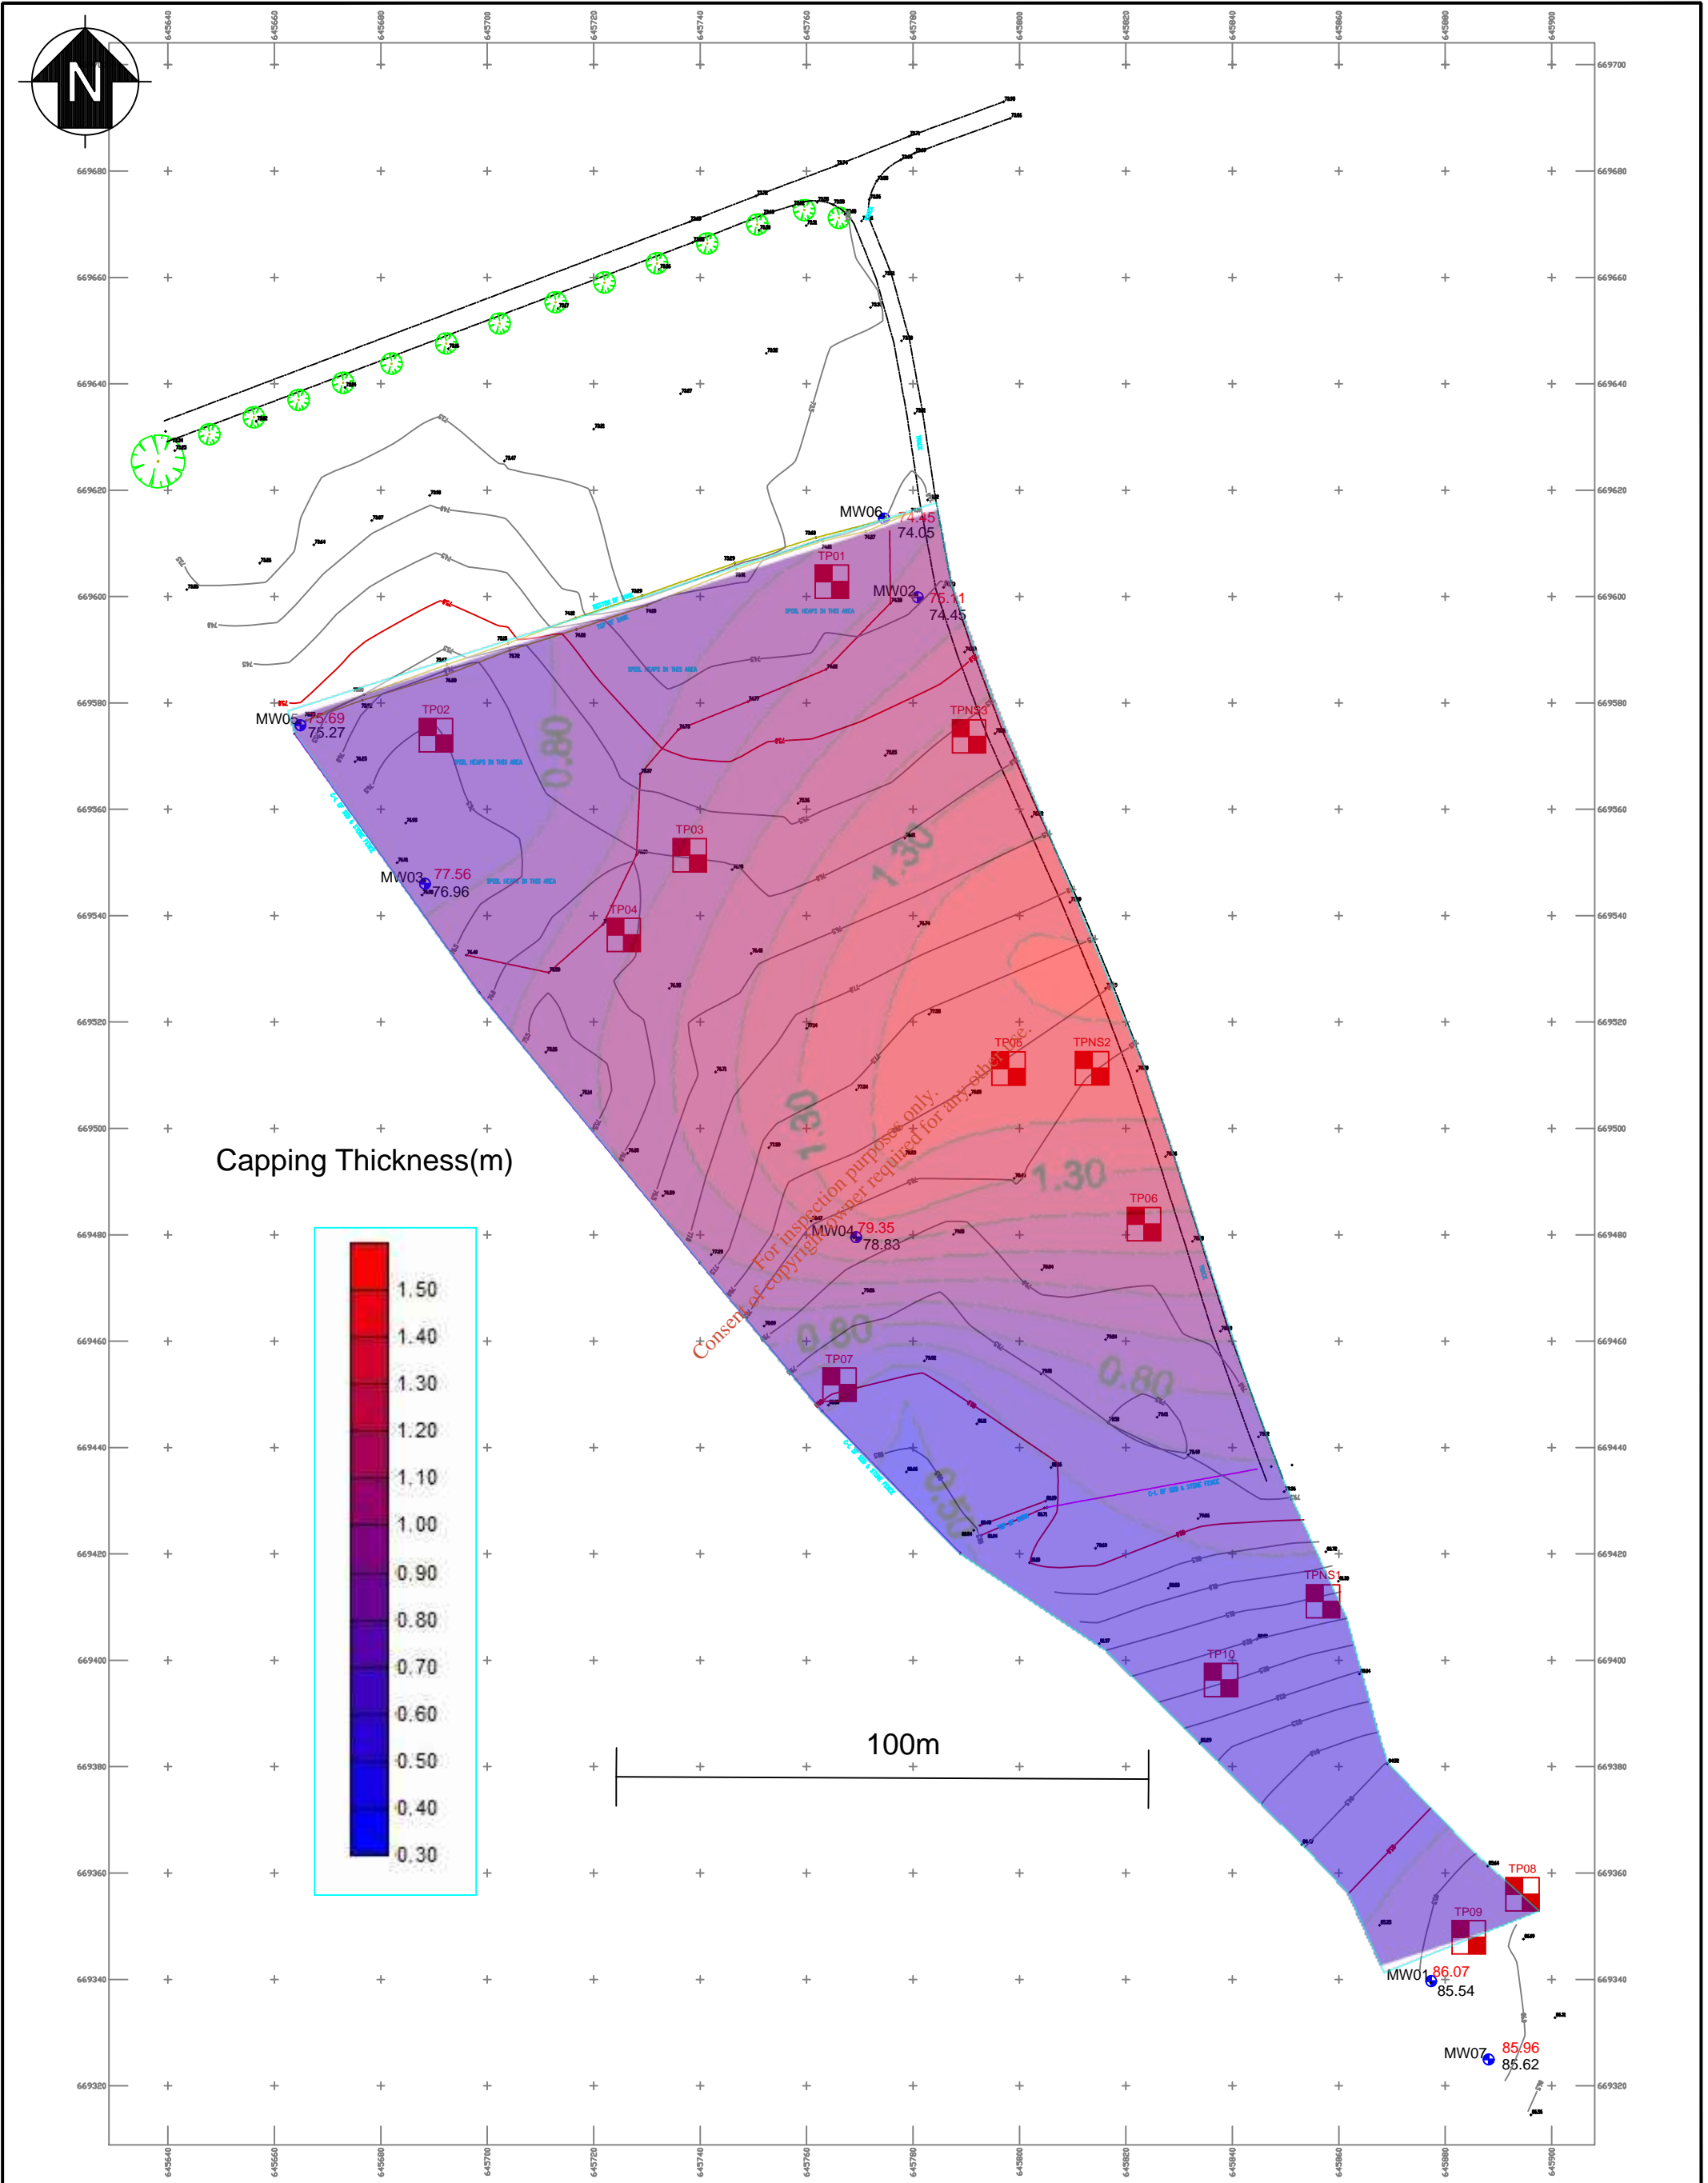
The landfill is capped with gravelly clay ranging in thickness from 1.5m (TP-5 and TP-6) in the east of the site, to 0.8 m (TP-2) in the north-west of the site and 0.3m (TP-8) in the south-east of the site.

Figure 3.2 which is based on the trial pit data from the Tier 2 site investigation shows the lateral and vertical capping distribution across the site. Figure 3.3 shows the thickness of the waste. The waste is generally thickest in the east central area and thins to the north-west and south. The depth of waste varies across the site from 0.5 m (TP-7) in the west of the site to 3.3 m (TP-6) in the east of the site.

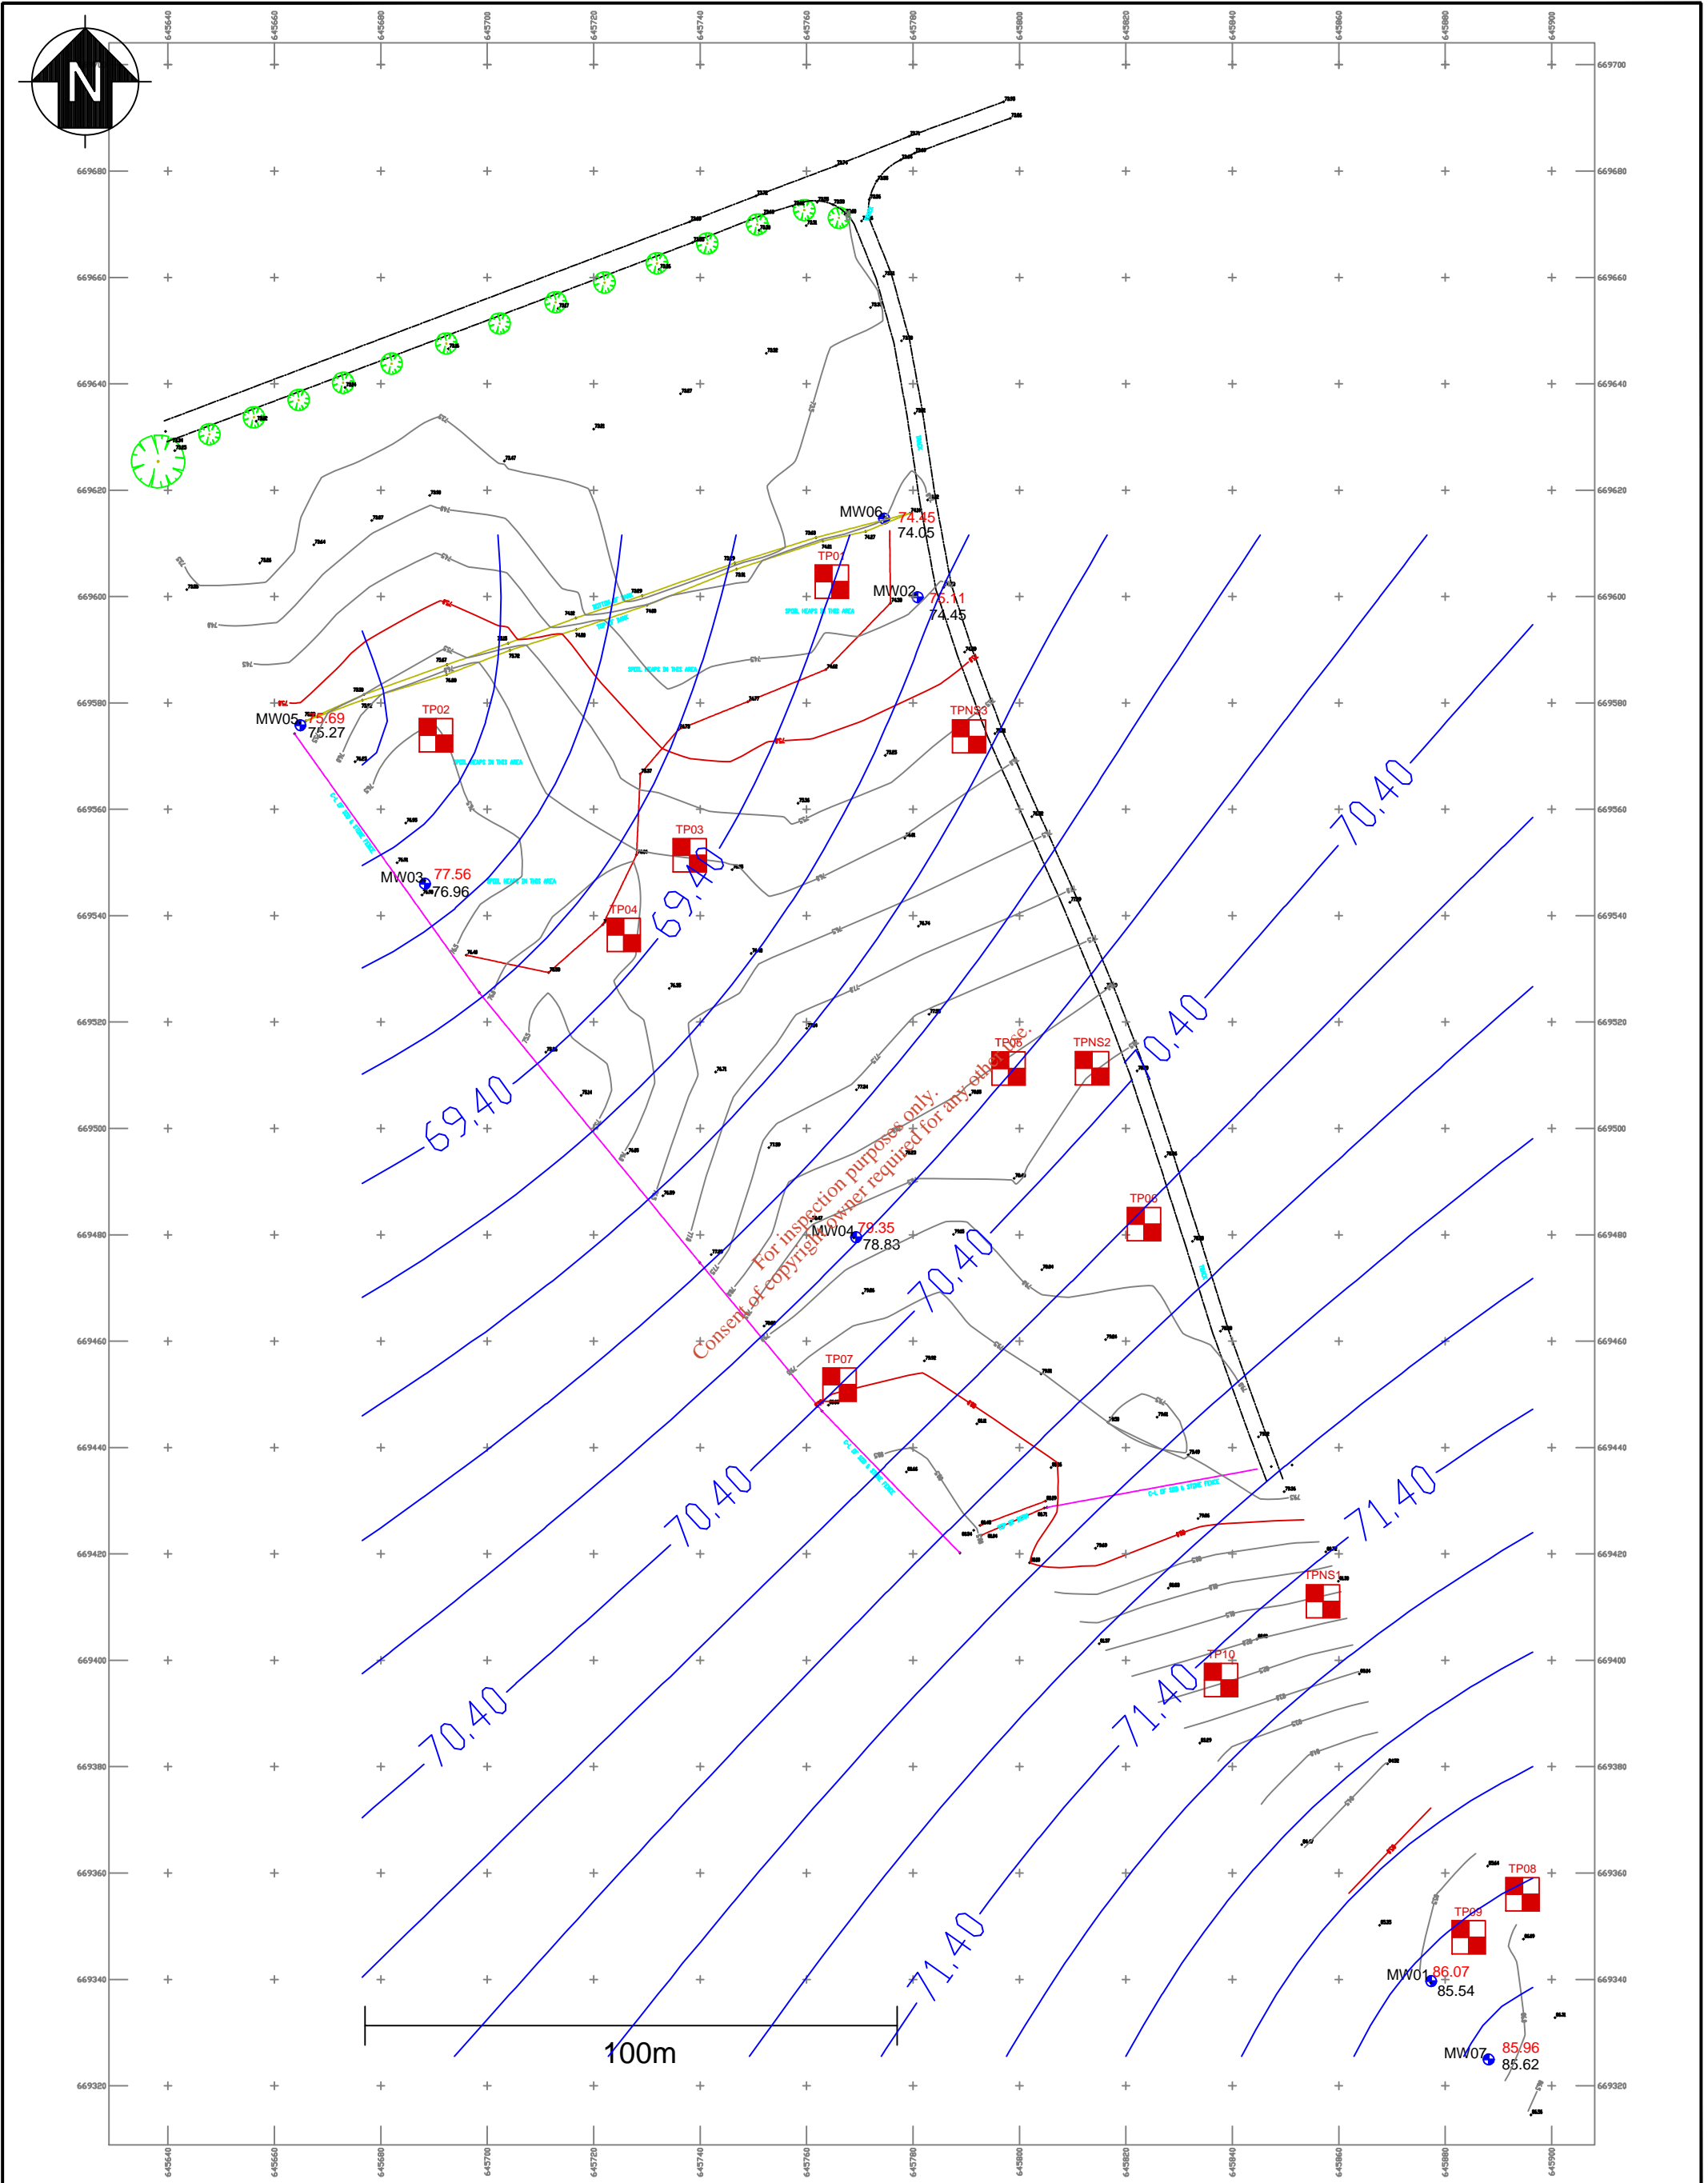
The results from MW-2, MW-5 and MW-6, which are down gradient of the waste, are indicative of leachate impacts. In MW-5 and MW-6 the results are indicative of with slightly reducing conditions, which are commonly associated with the migration of a leachate plume.

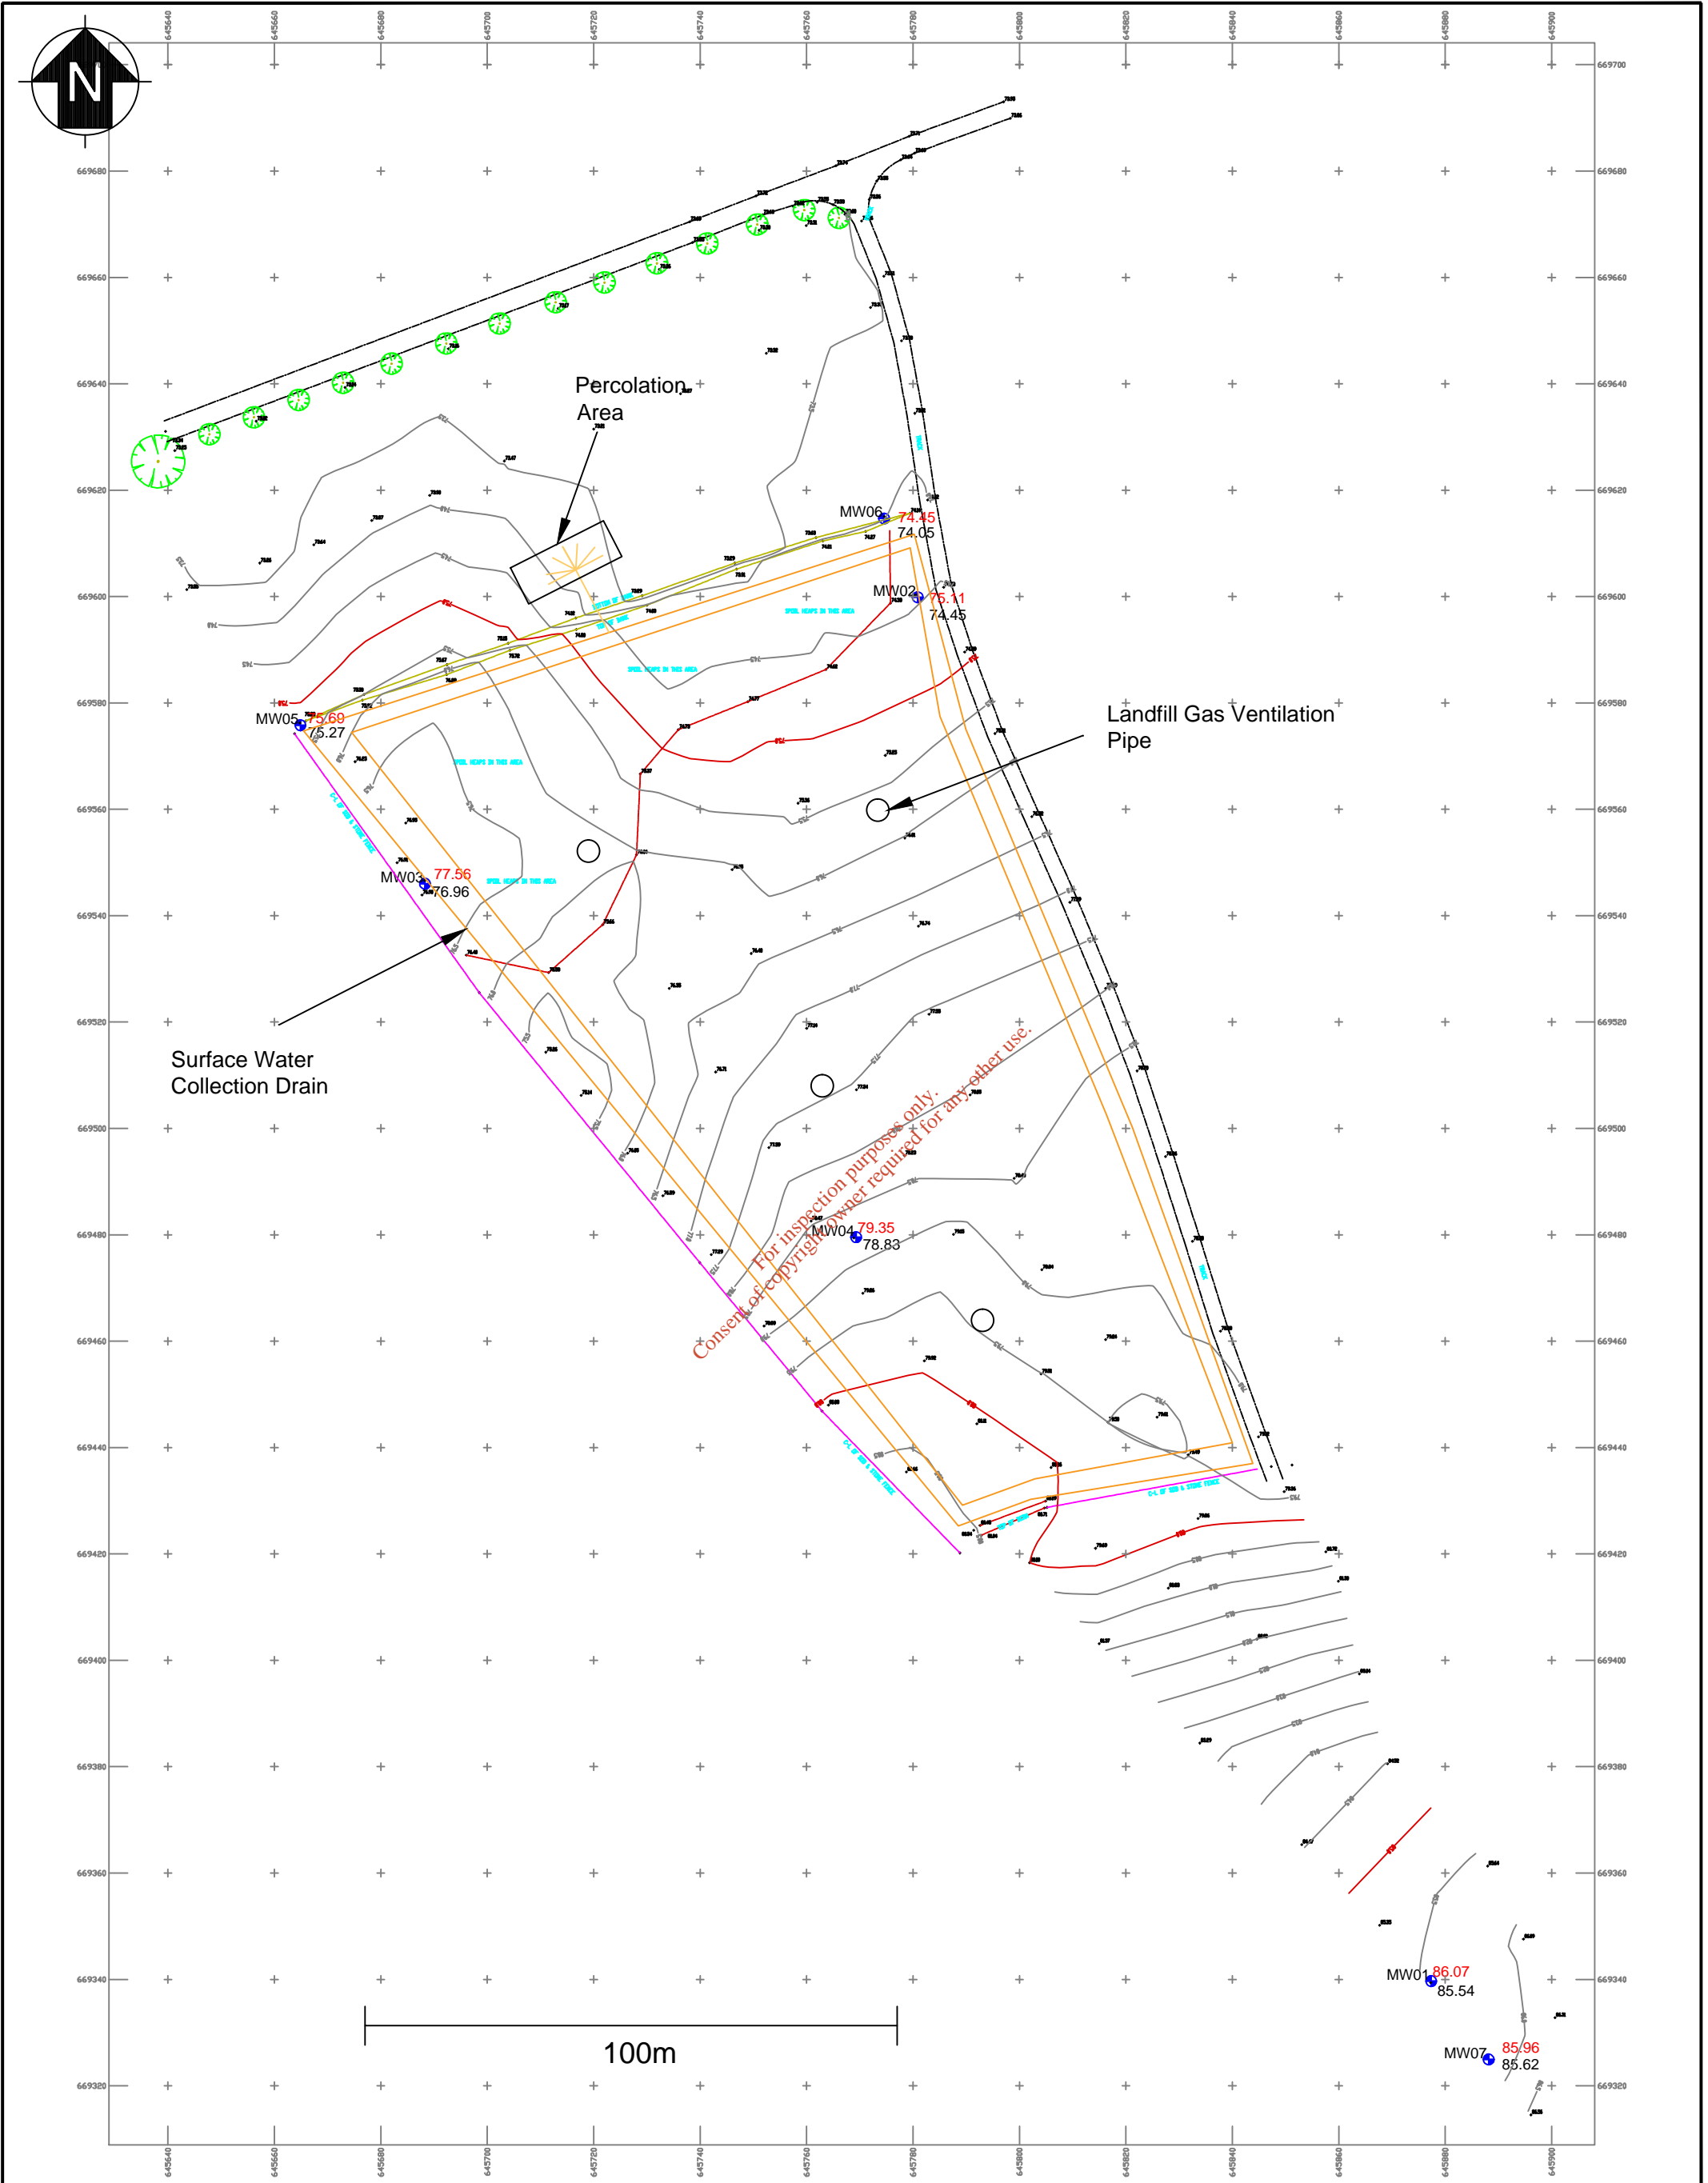
There is currently top soil and grass on the entire landfill and in some areas (central portion) this complies with the EPA recommended cap thickness. The topsoil will have to be stripped to allow additional capping soils to be placed and to allow for grading and compacting the entire capping layer.

The EPA Landfill Restoration and Aftercare Manual recommends that for Non-Inert Landfill with high amenity sward that a minimum subsoil thickness (after placement) of 700-850mm be placed over the landfill with a 150-300mm top soils layer. The combined thickness should be 1000mm. Non-inert landfills should also be provided with a gas collection and surface water drainage system.

A surface water collection drain should be installed around the perimeter of the landfill to collect run-off from the compacted clay layer. The drain should be lined with an LDPE membrane and piped to a percolation area located to the north of the landfill.

Four gas ventilation wells should be installed, one in each quadrant of the waste, to allow passive ventilation of the gas. The well pipes should be 100mm slotted uPVC and should extend 150mm above the top soil layer. These wells should be fitted with cowls and fenced off to prevent damage by livestock.
