**TIER 3 RISK ASSESSMENT**

**FORMER LANDFILL**

**GOWRAN**

**December 2017**

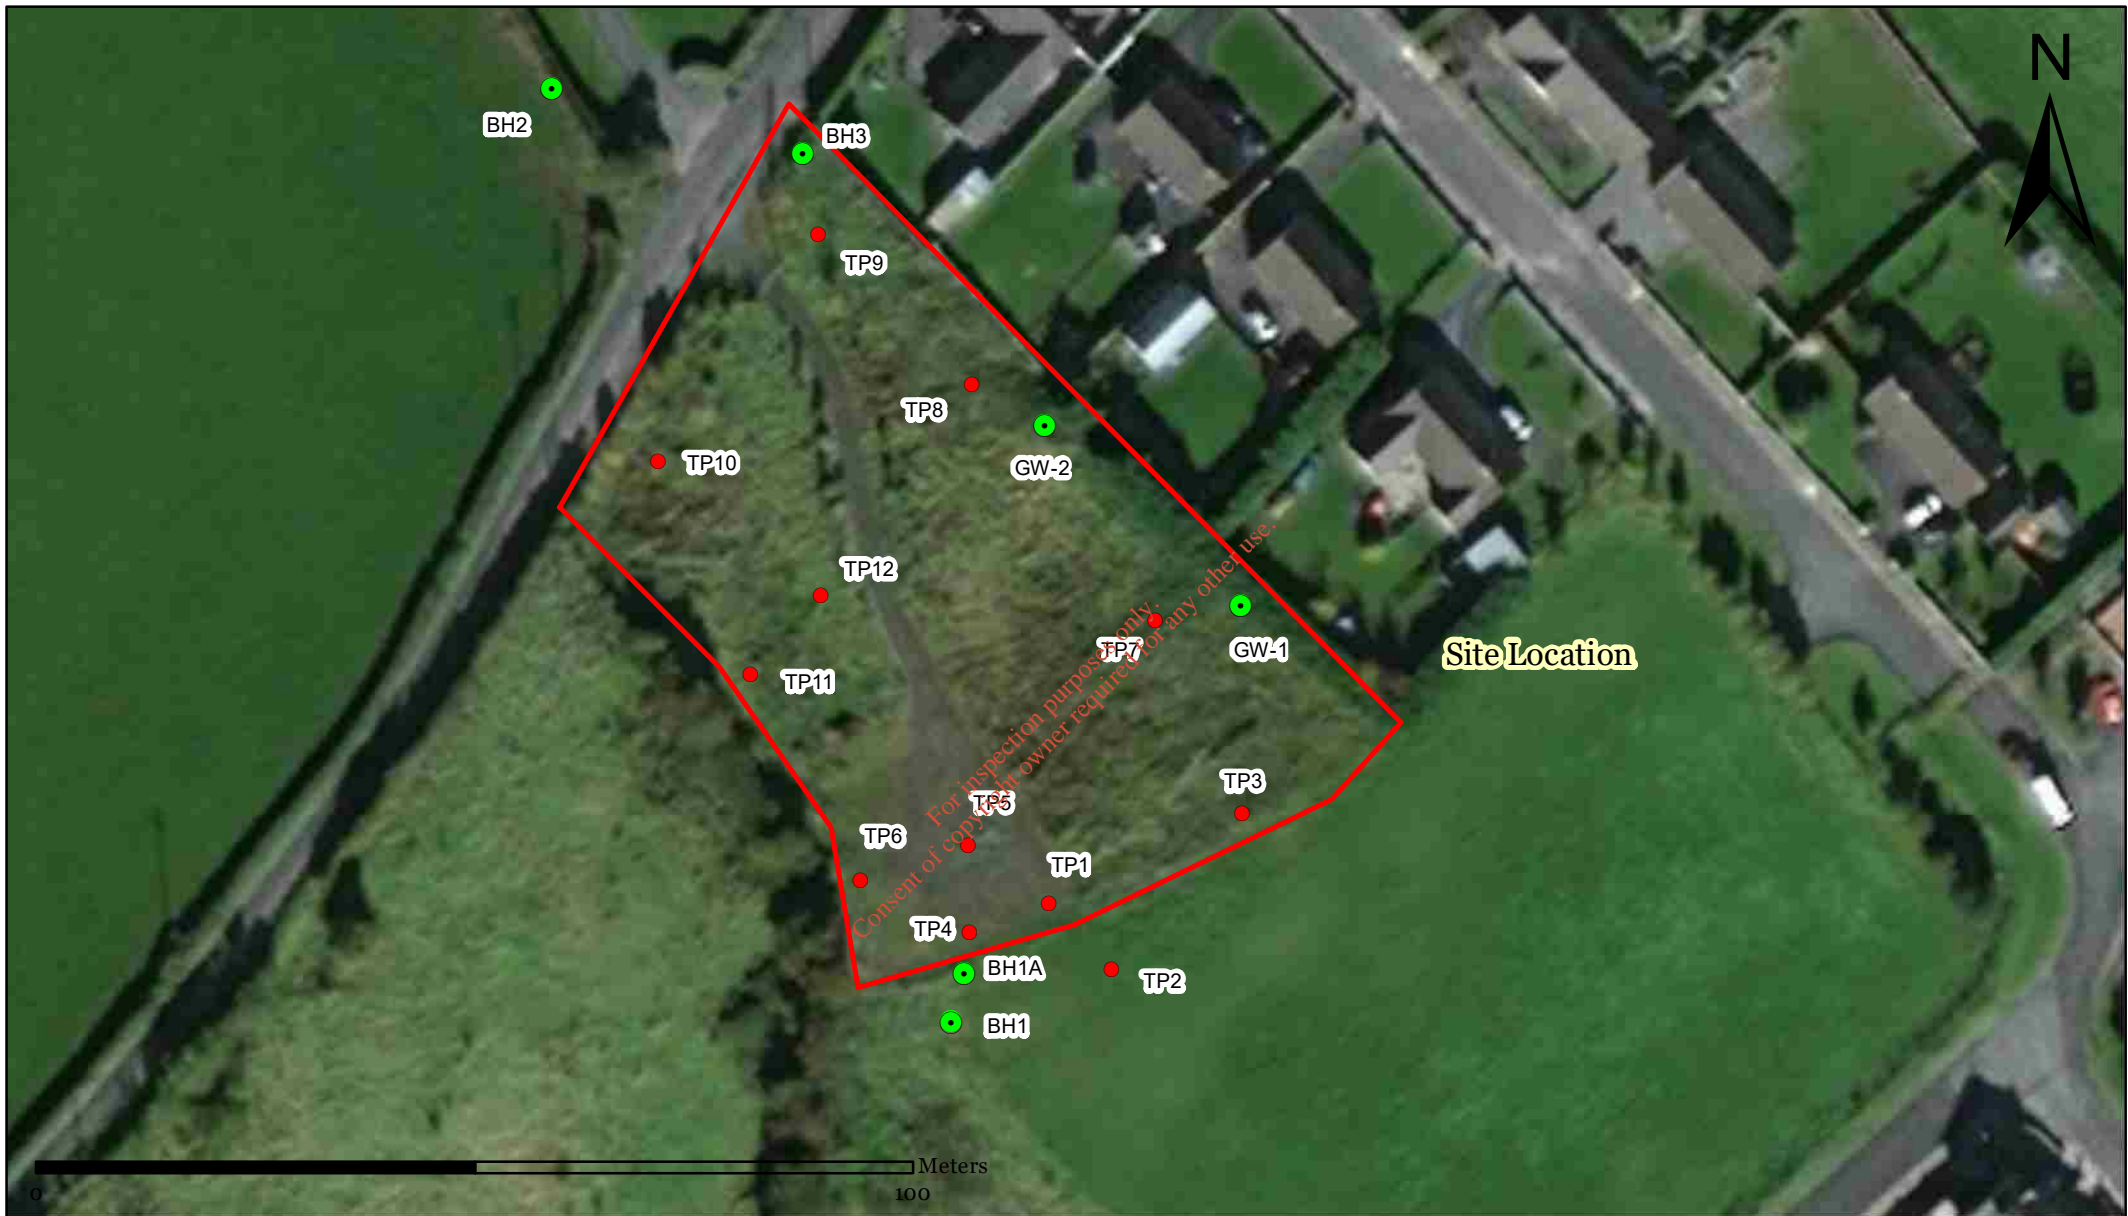
Figure 2.2

The site occupies 0.4 hectares (Figure 2.2). The land slopes from the north-east toward the south-west. The north of the site is uneven, poorly draining ground with scrub vegetation and a tree line along the northwest site boundary. In the south west of the site is a gravel hardstanding area which was used as a storage yard by KCC for aggregate, piping and lamp posts.

There is some fly tipped waste present on the site including black plastic bags of general household rubbish.

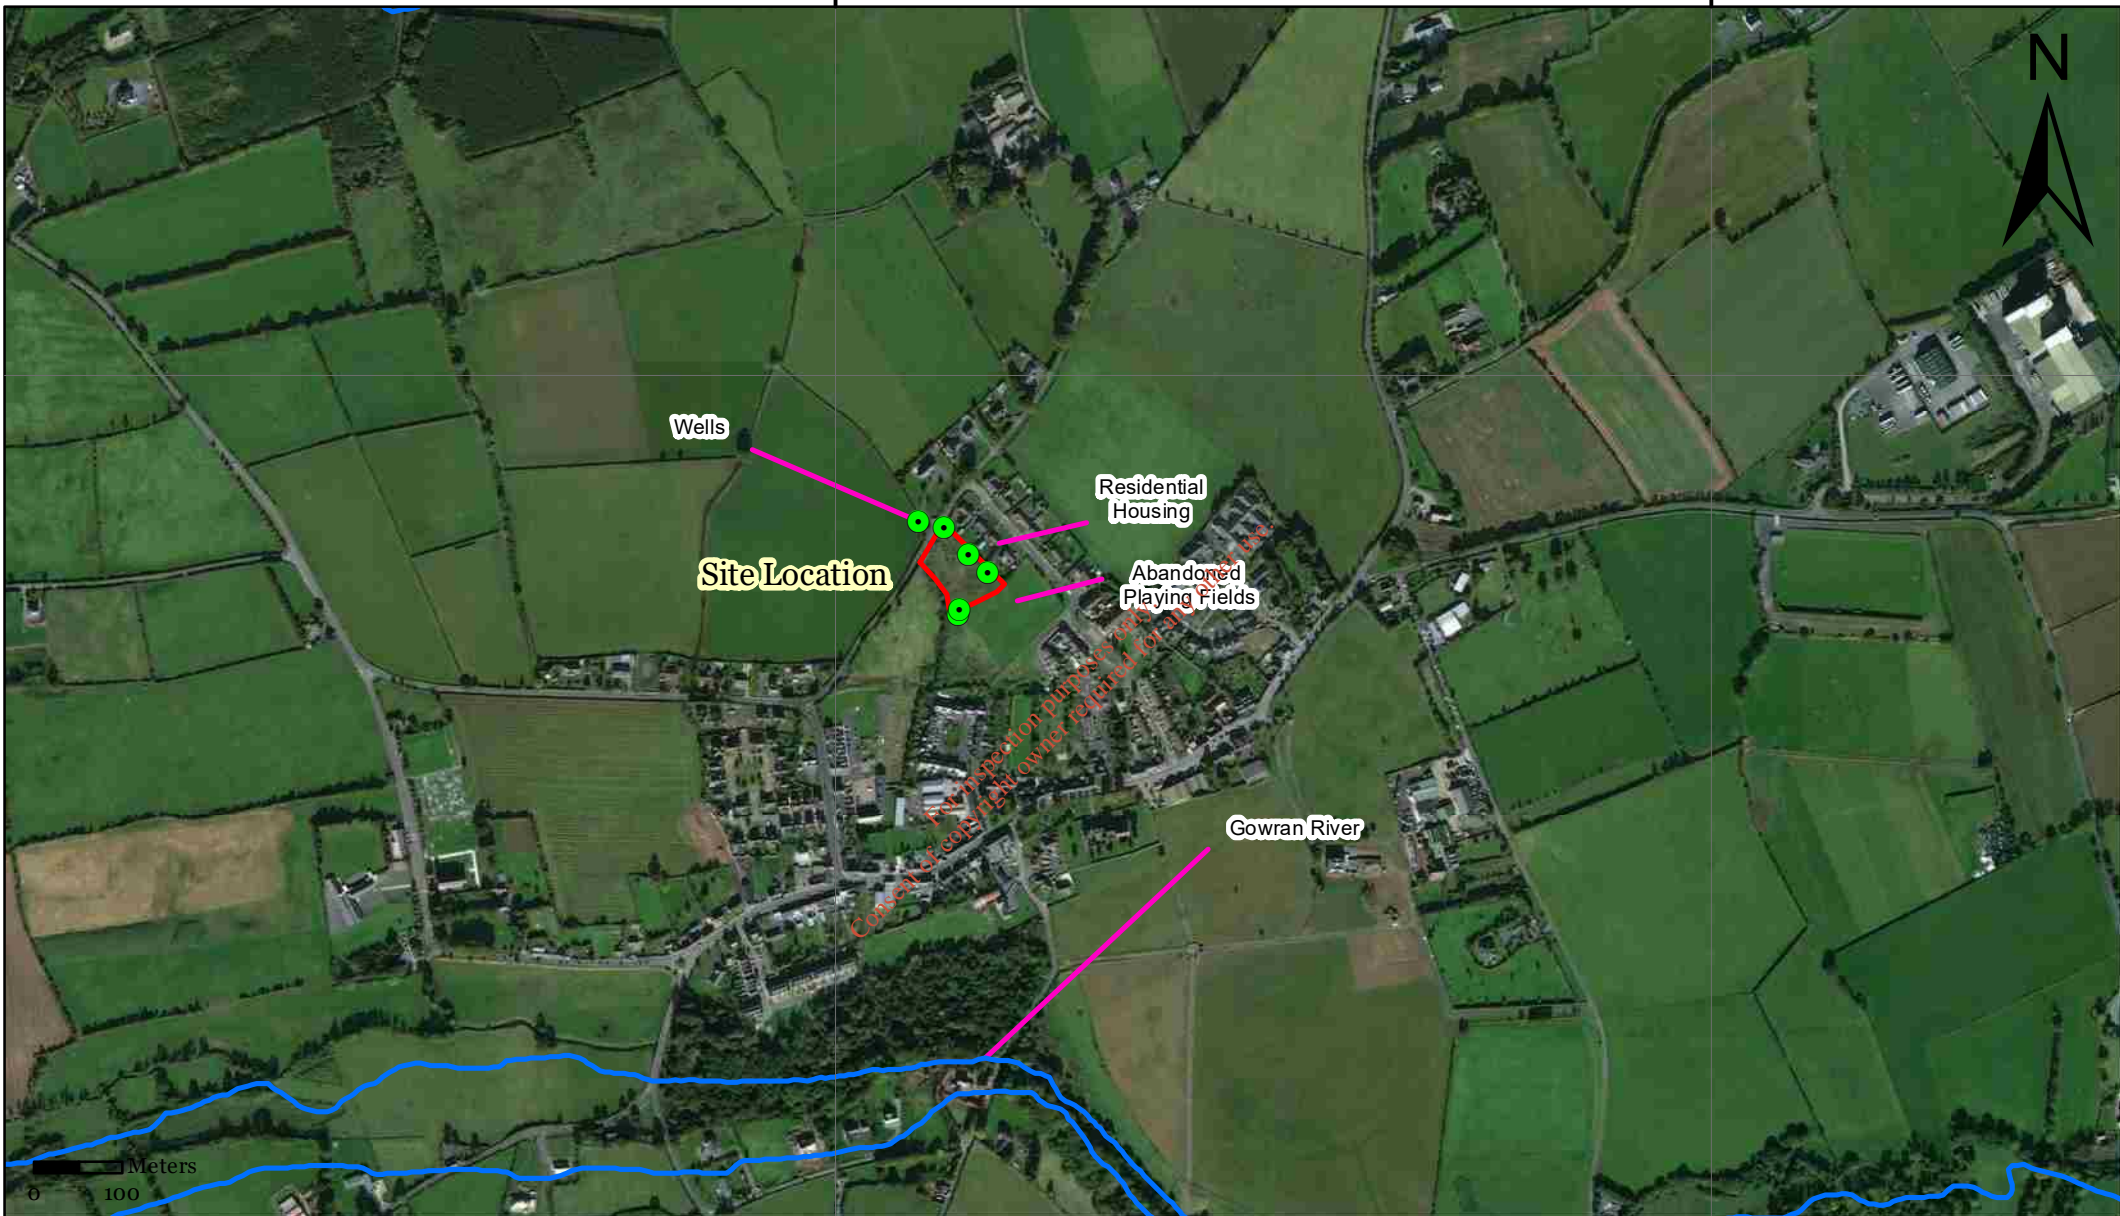
Figure 2.3

The surrounding land use is shown on Figure 2.3. The site is bounded to the south and south-east by disused playing fields. There is a residential housing estate (The Steeples) c150 to the south-east. To the west the land is undeveloped and slopes away to the west. Rockfield Road runs along the north-western boundary. The lands further to the north-west are agricultural pasture. There are four residential dwellings immediately to the north-east of the site.

A foul sewer servicing the residential development to the north-east of the site runs along the north-eastern boundary and connects to the foul sewer running along the Rockfield Road.

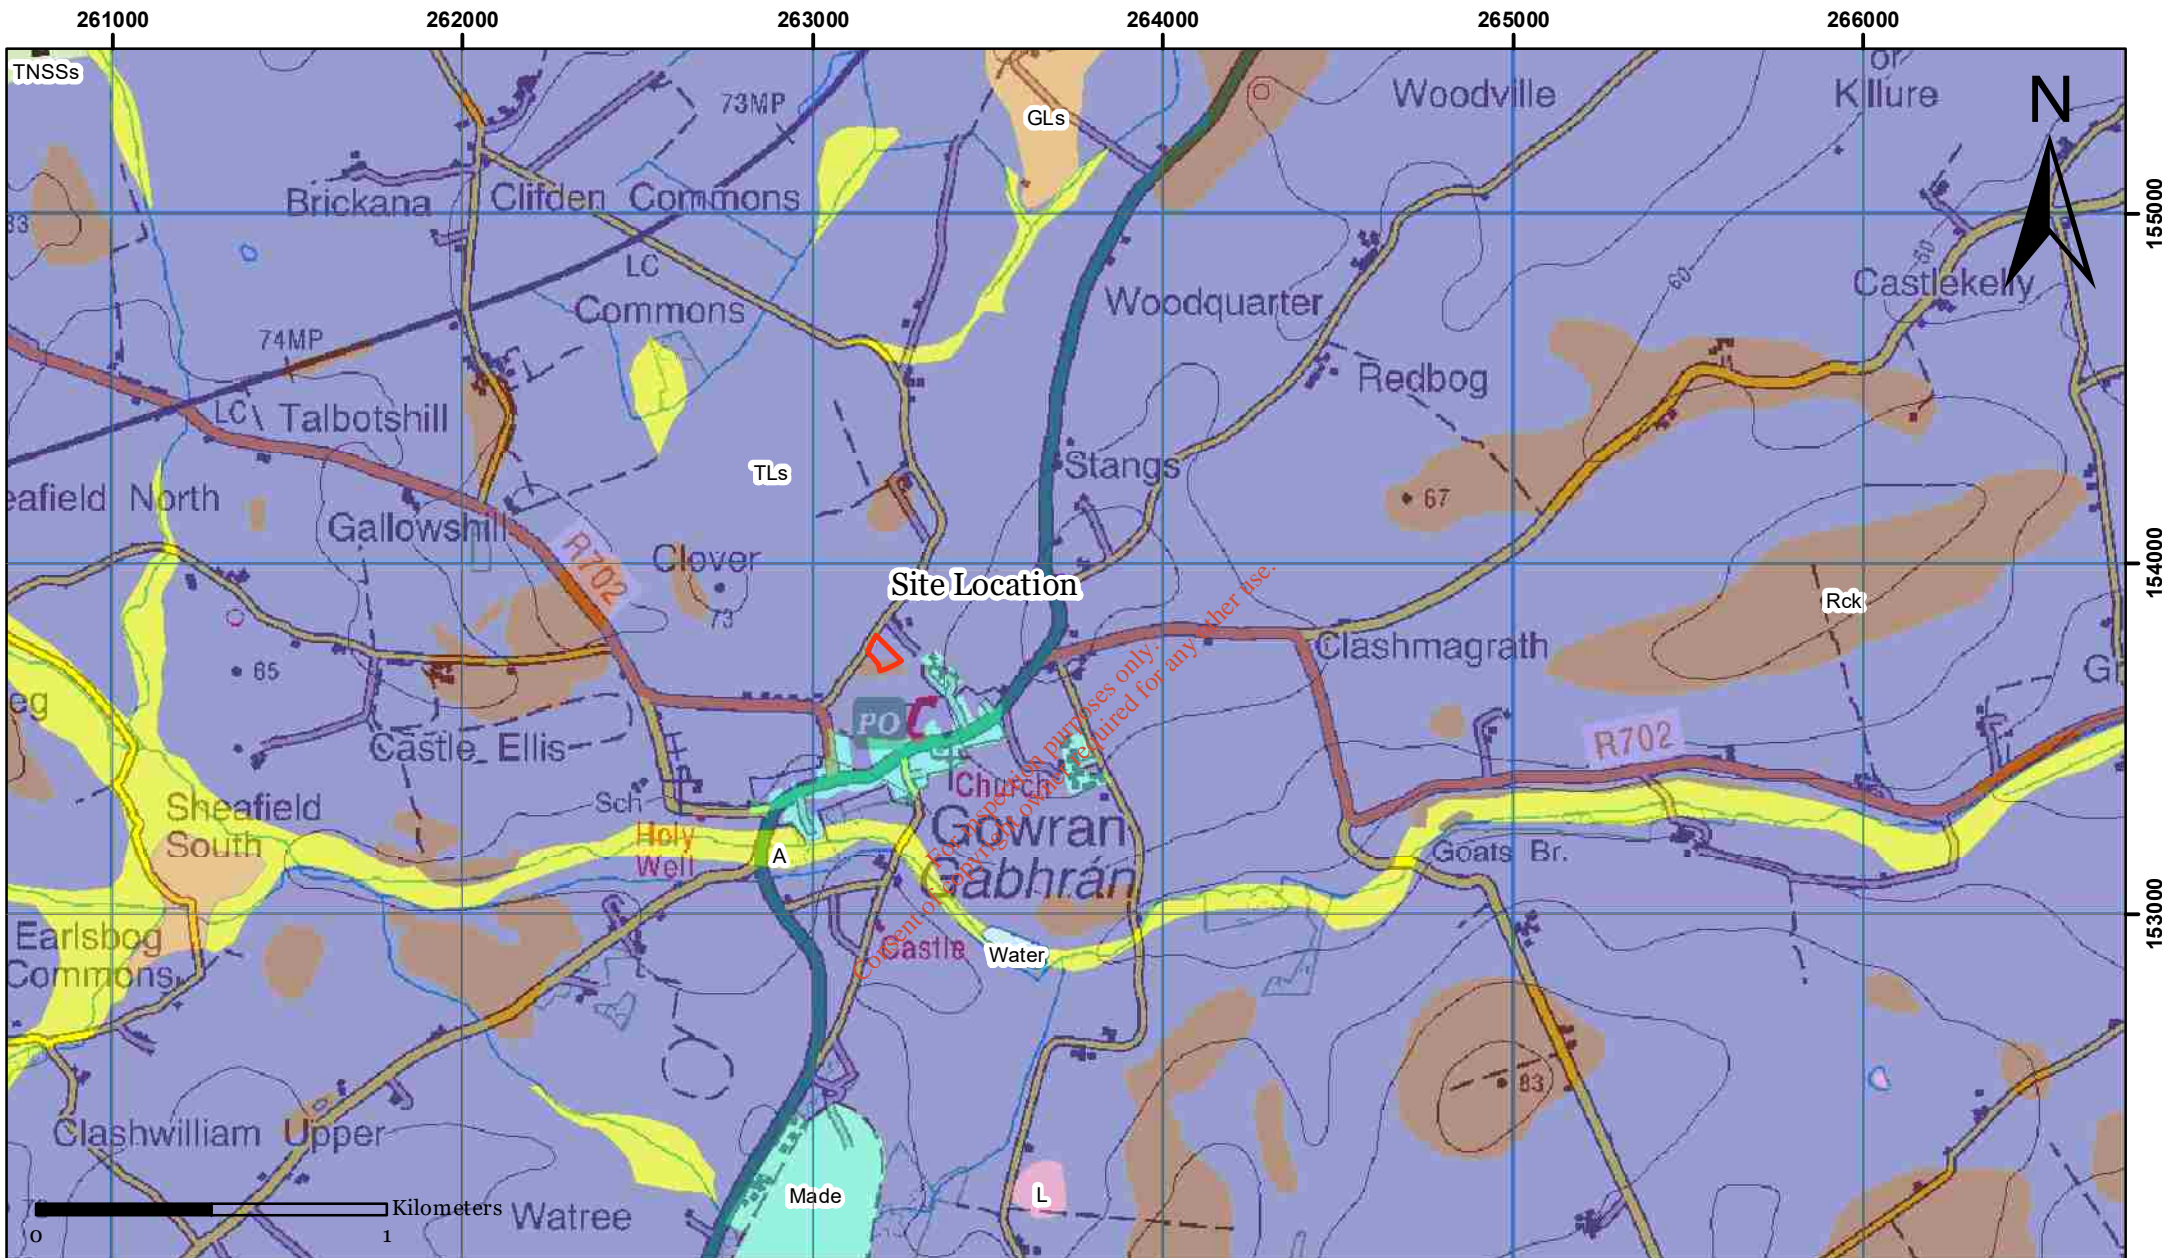
**Figure 2.5**

The Teagasc map indicates that the natural ground comprises Limestone till (Carboniferous) (Figure 2.5). Previous site investigations identified a cover layer of soft medium brown slightly sandy clay, ranging from 0.5 to 2.4m over most of the site. This overlies the municipal waste. The maximum depth of waste was found to be approximately 5 m below ground level (bgl) in the centre of the site.

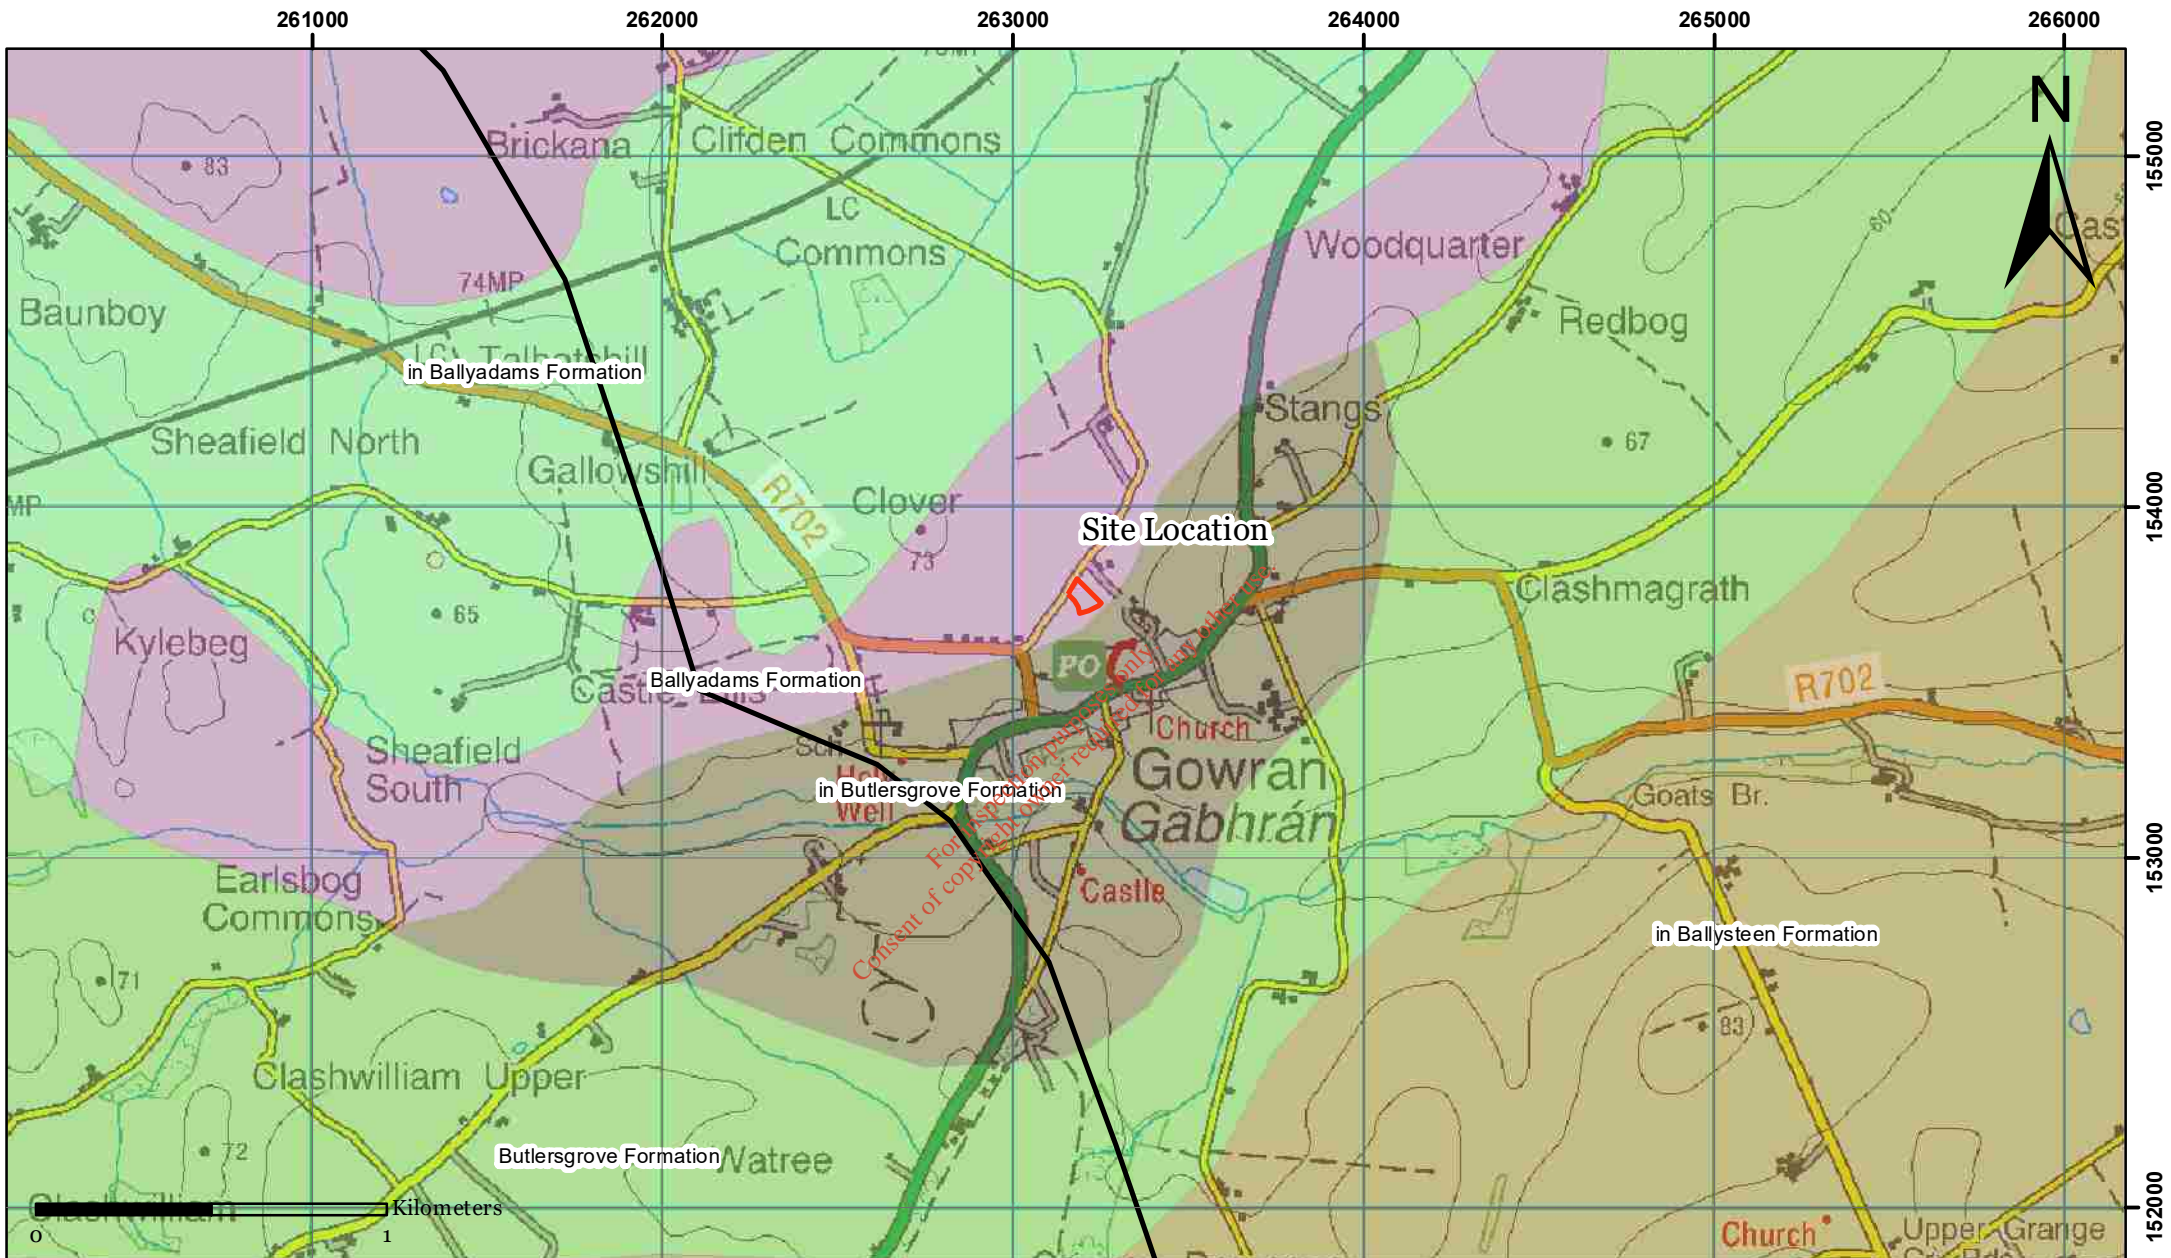
**Figure 2.6**

Information on the geology was derived from maps prepared by the GSI and site investigations completed by OCM. The regional bedrock geology is shown on Figure 2.6. The map shows the site underlain by crinoidal wackestone/packstone limestone from the Ballyadams Formation. The drilling programme completed by OCM confirmed the presence of limestone bedrock.

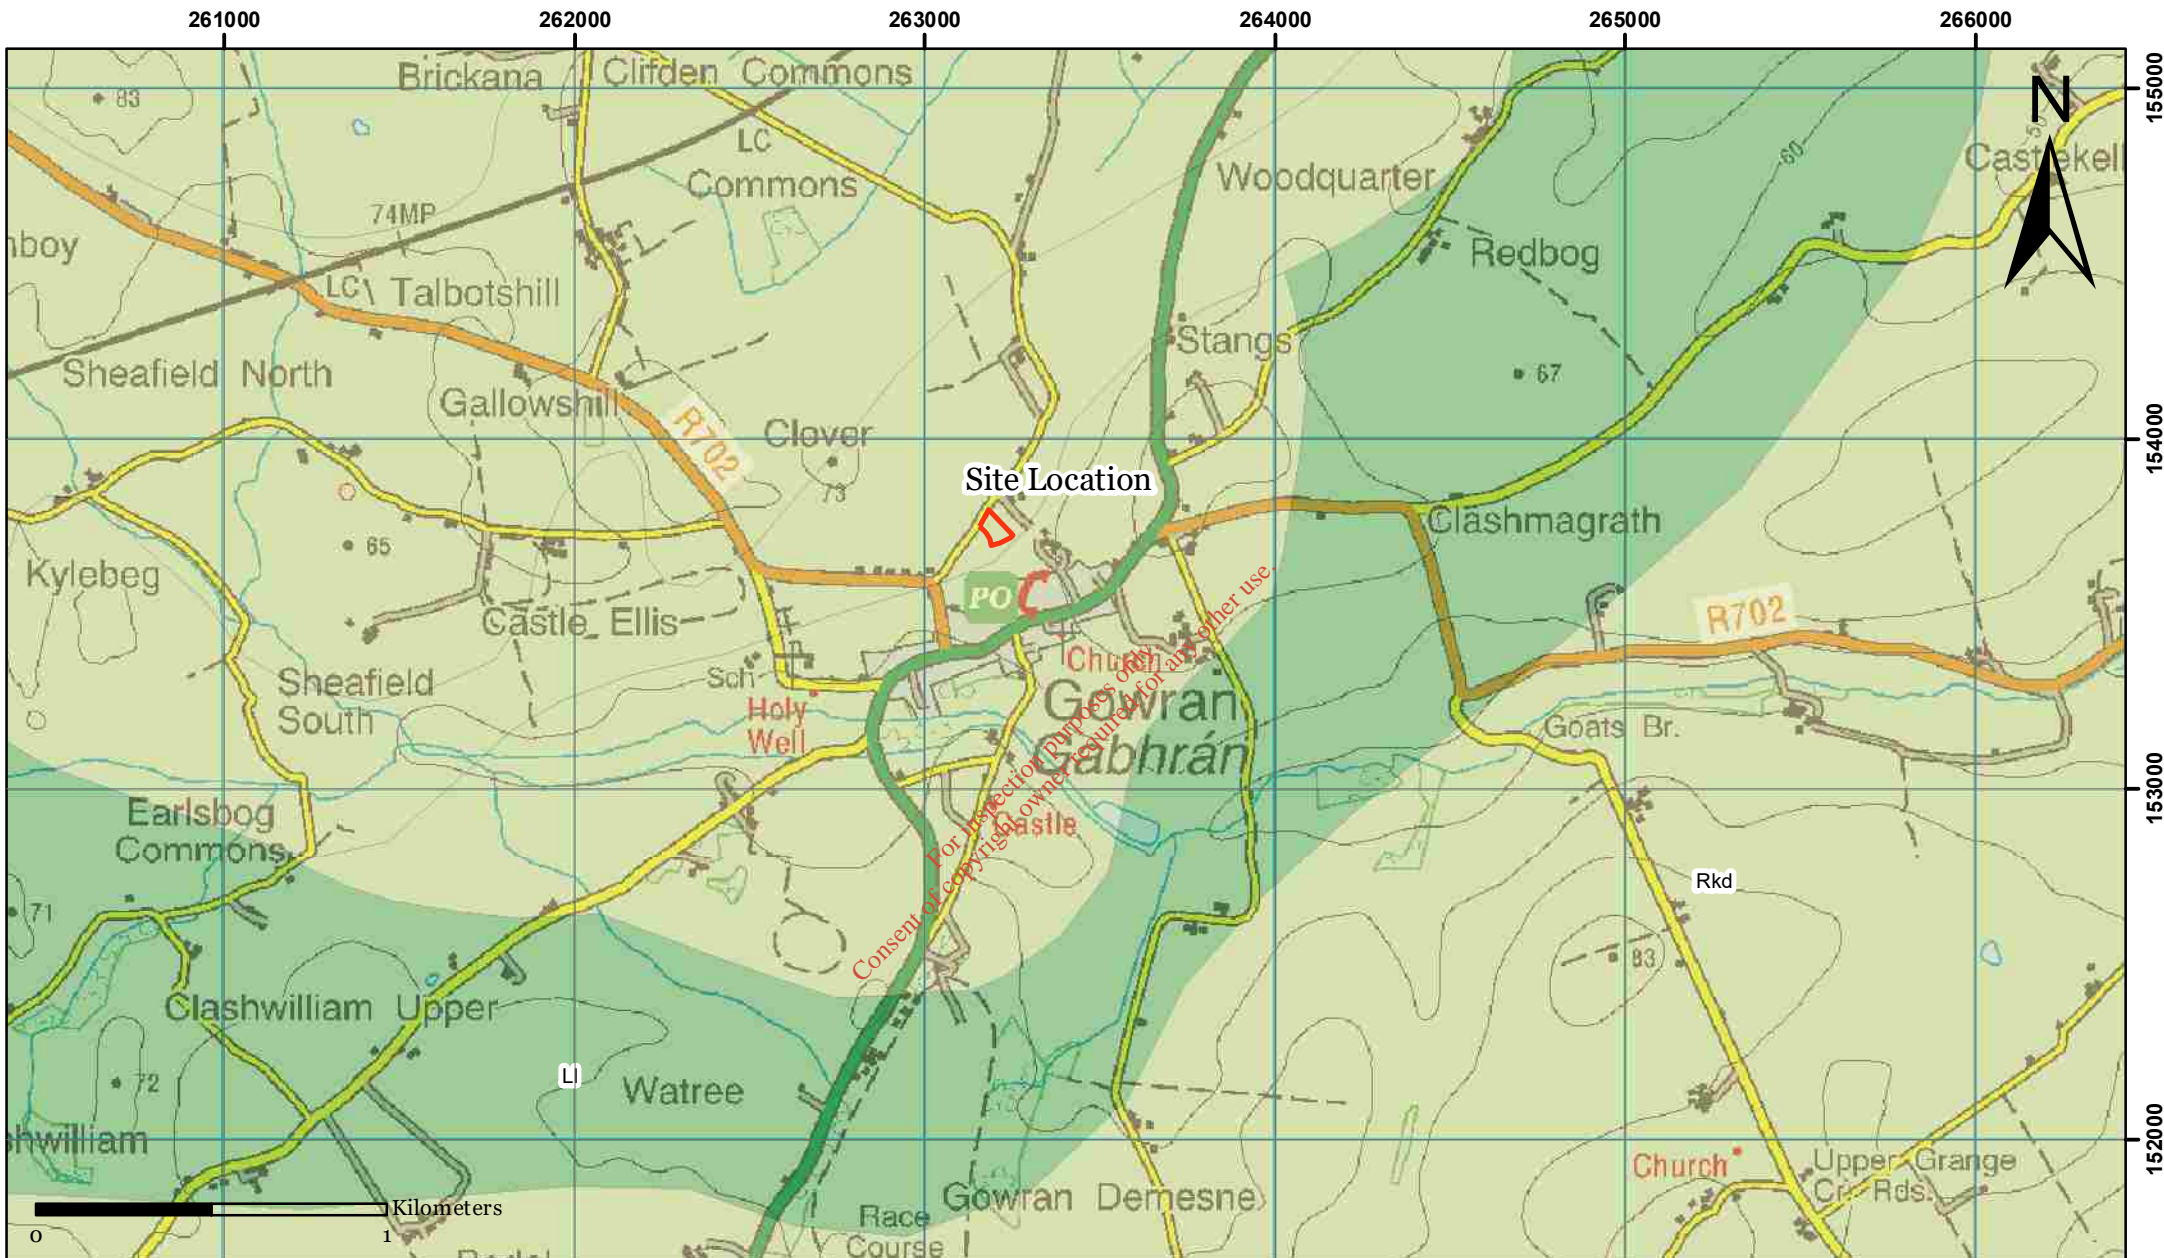
**Figure 2.7**

The GSI bedrock aquifer map identifies the bedrock underlying the site as a Regionally Important Aquifer (Rk(d))- (Karstified aquifer with diffuse flow paths) – The bedrock aquifer is capable of supplying groundwater yields >400 m<sup>3</sup>/d (Figure 2.7).

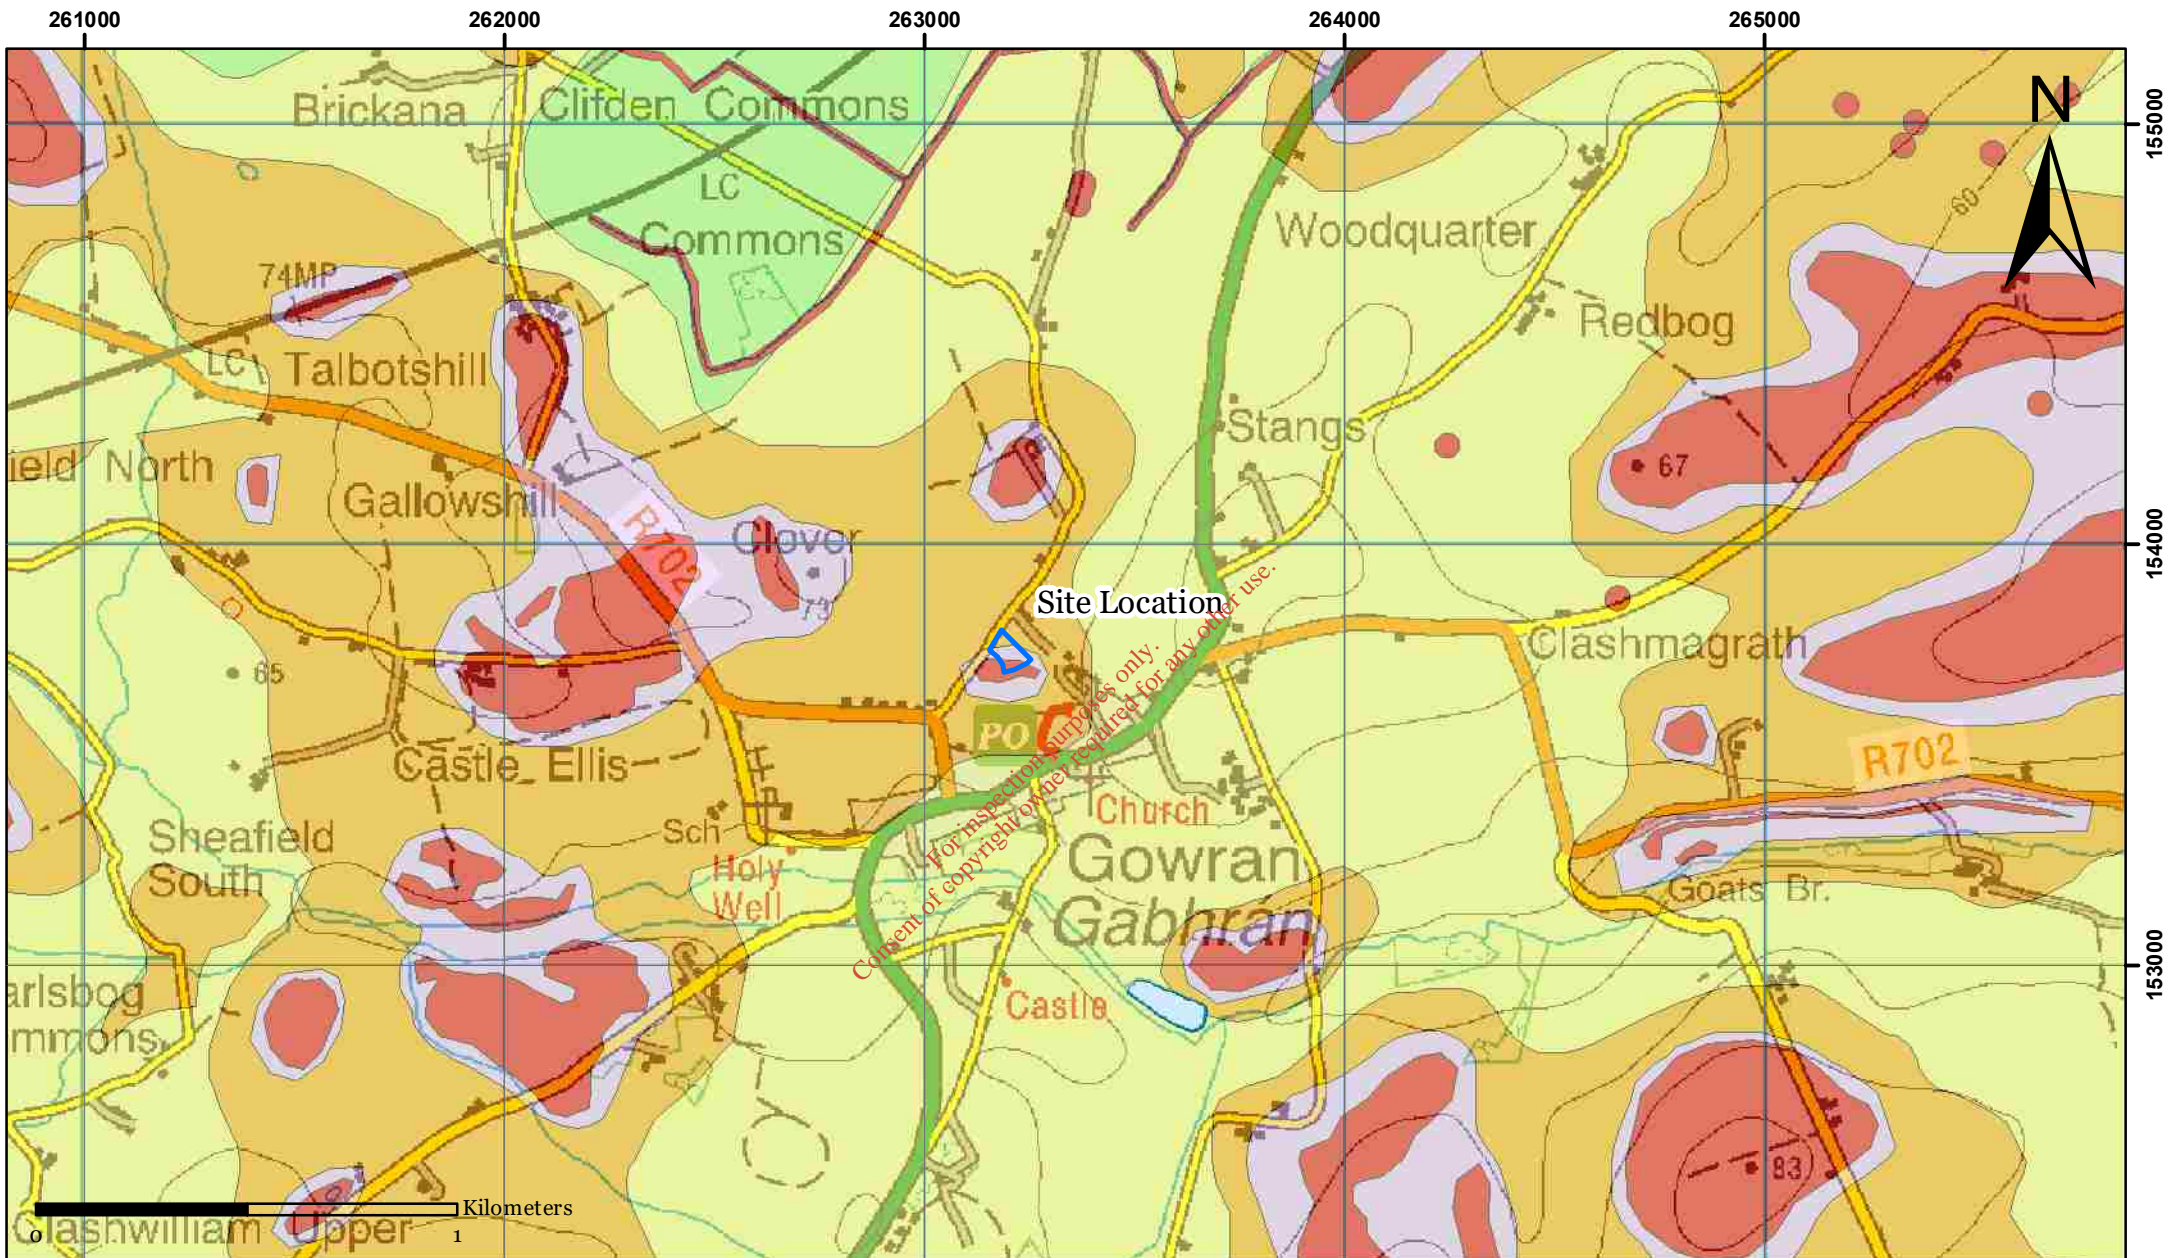
**Figure 2.8**

Groundwater vulnerability, as defined by the GSI, is the term used to represent the intrinsic geological and hydrogeological characteristics that determine the ease with which groundwater may be contaminated by human activities. The GSI Online mapping data set identifies that, the groundwater vulnerability for the site is classified as 'Extreme' (Figure 2.8).

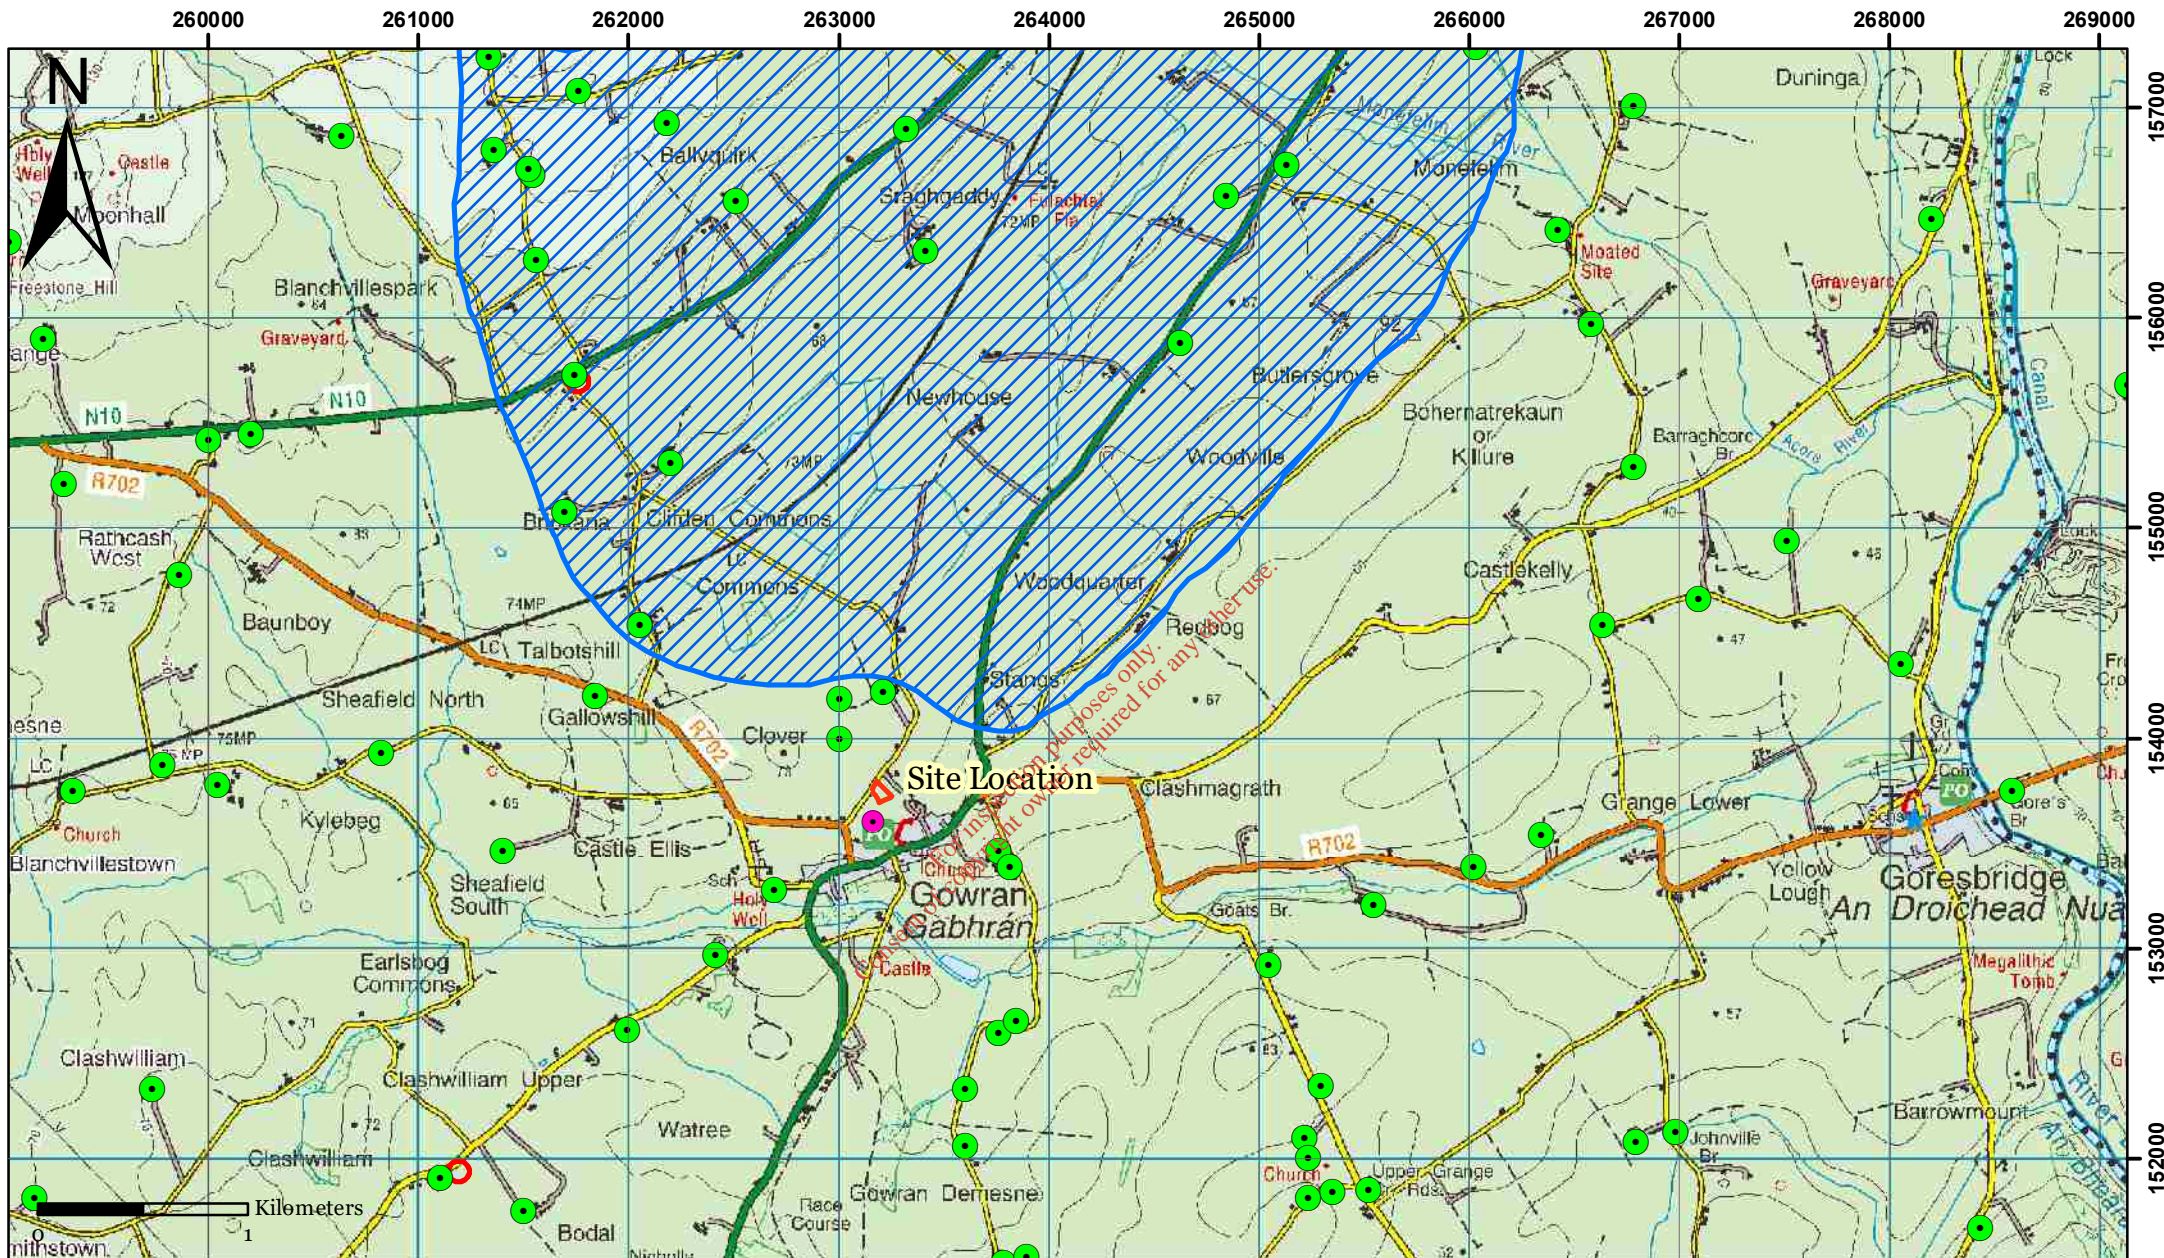
Figure 2.9

The closest water supply borehole is 150 m south-west of the site at the Steeples Housing Estate. The log for this well, which was installed in 2006 to supply a housing scheme, describes the ground conditions as red-brown clay and limestone boulders underlain by a bed of weathered dolomite and then dark grey weathered limestone typical of the Butlersgrove Formation. Other water supply boreholes in the surrounding area are shown on Figure 2.9.

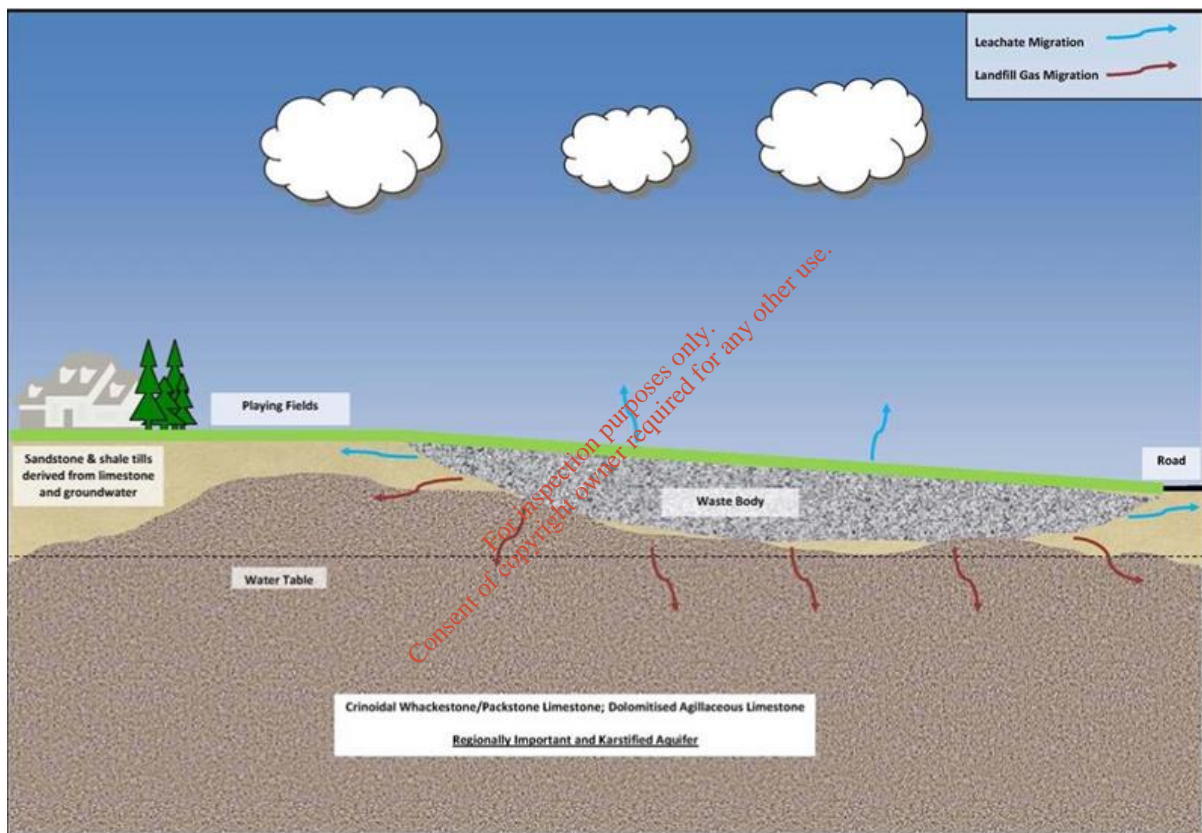
**Figure 4.1 FTC Schematic of the Conceptual Site Model**

The FTC Risk scoring shows a Moderate Risk Site due to the potential for impact on the underlying regionally important aquifer via migration of leachate and the risk to humans via lateral and vertical migration of landfill gas. The FTC Tier 2 Conceptual Site Model (CSM) is shown on Figure 4.1
