**TIER 3 RISK ASSESSMENT**

**FORMER LANDFILL**

**GOWRAN**

**December 2017**

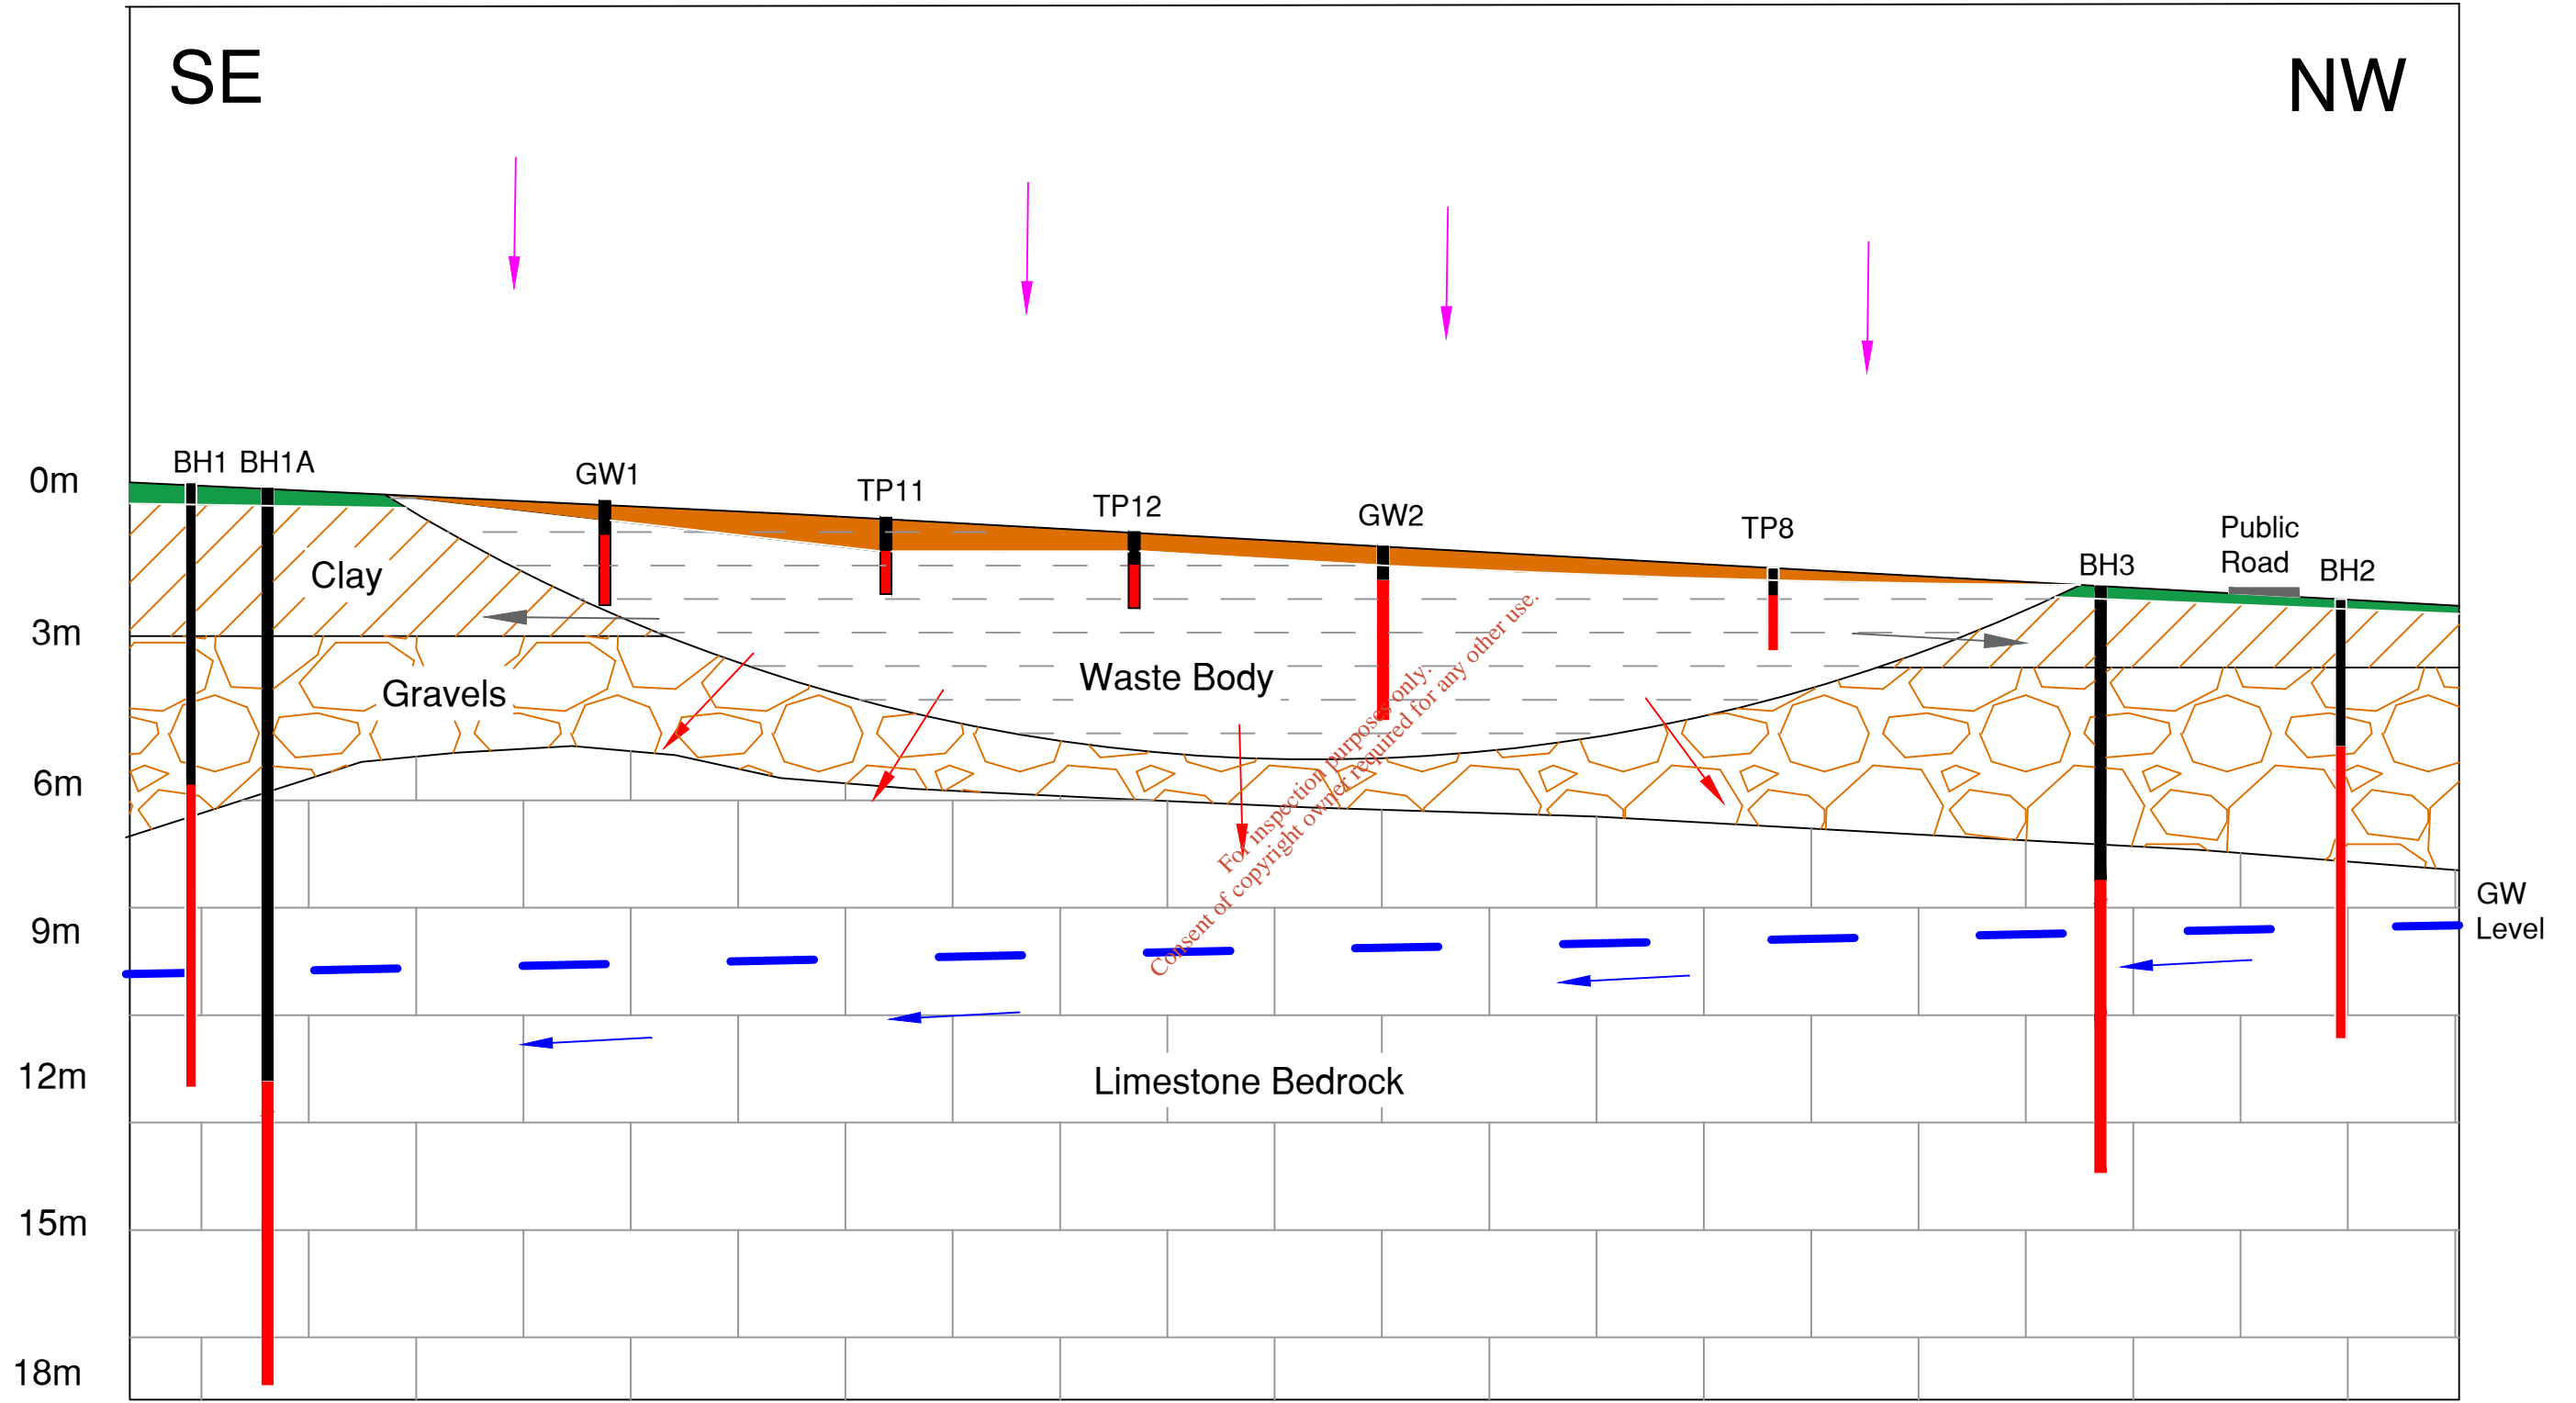
FIGURE No.  
**4.2**

The lateral extent of the waste has been identified and it is contained within the site boundaries and the maximum depth of waste was found to be approximately 5 mbgl toward the southwest of the site and thins toward the boundary. FTC estimated the waste volume to be 20,000m<sup>3</sup> by assuming the entire 4,000m<sup>2</sup> footprint was filled with waste to a depth of 5m. However it is likely to be significantly less than this. OCM consider that the waste volume is likely to be around 12,000m<sup>3</sup>.

The landfill gas monitoring - confirms the presence of elevated carbon dioxide and methane and while gas flow rates are currently low when the site is fully capped, in accordance with the EPA landfill restoration requirements, the potential for lateral gas migration is significant.
