ANNUAL ENVIRONMENTAL REPORT

RILTA ENVIRONMENTAL LTD.

SITE 14-A1 GREENOGUE BUSINESS PARK

JANUARY 2017 – DECEMBER 2017

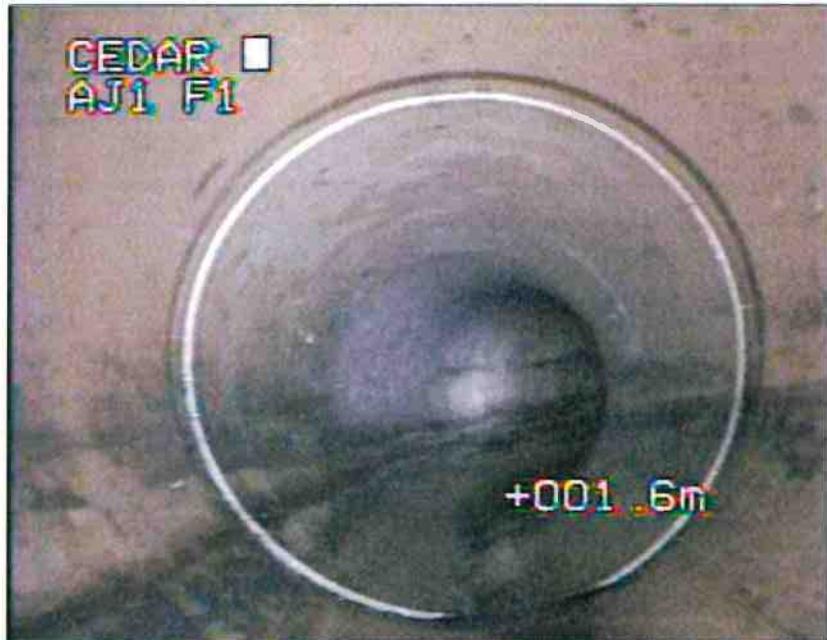
Photo: 1_6A, MPEG #: 051216_1, 00:00:00
7.71m, Finish node type, manhole reference number: F1

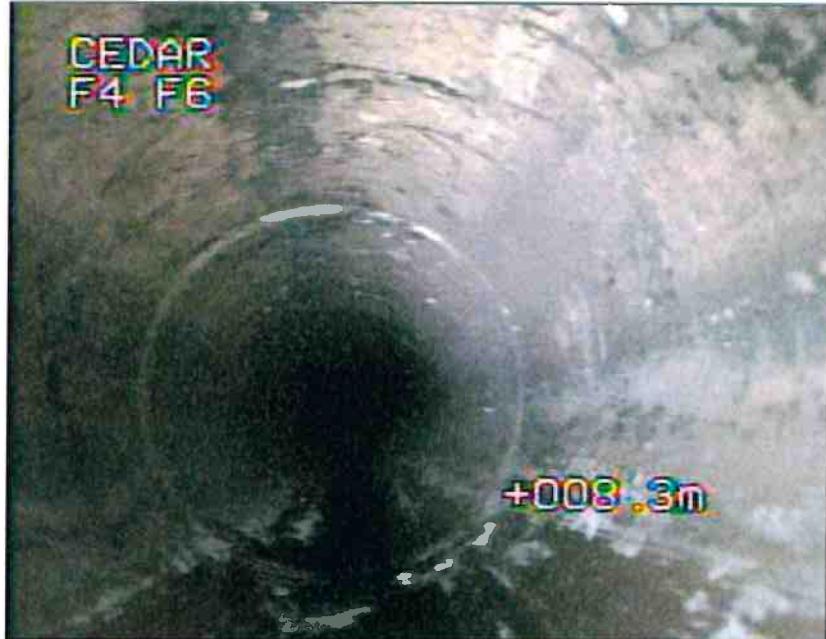
Photo: 7_5A, MPEG #: 051216_1, 00:01:22
8.3m, Cracks, multiple, from 4 to 8 o'clock

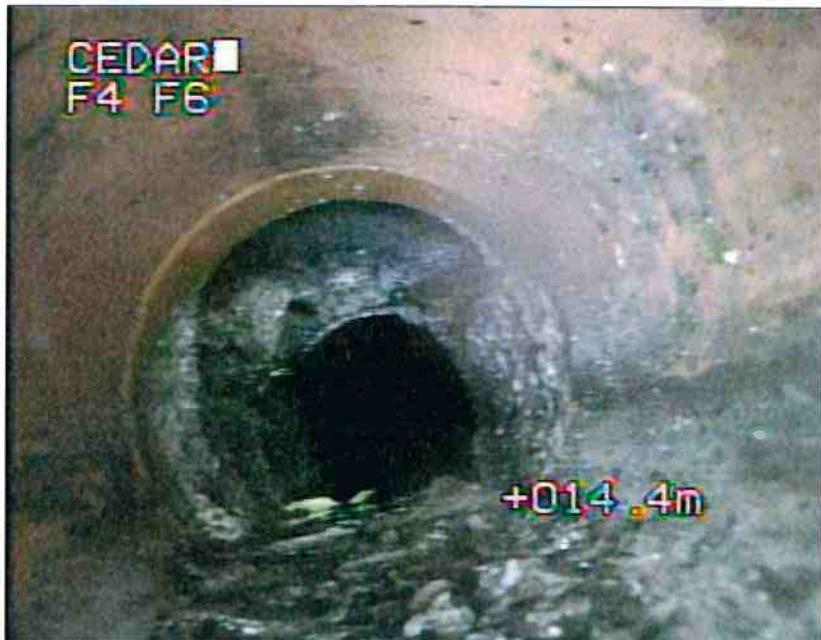
Photo: 7_6A, MPEG #: 051216_1, 00:02:24
14.3m, Settled deposits, hard or compacted, 10% cross-sectional area loss

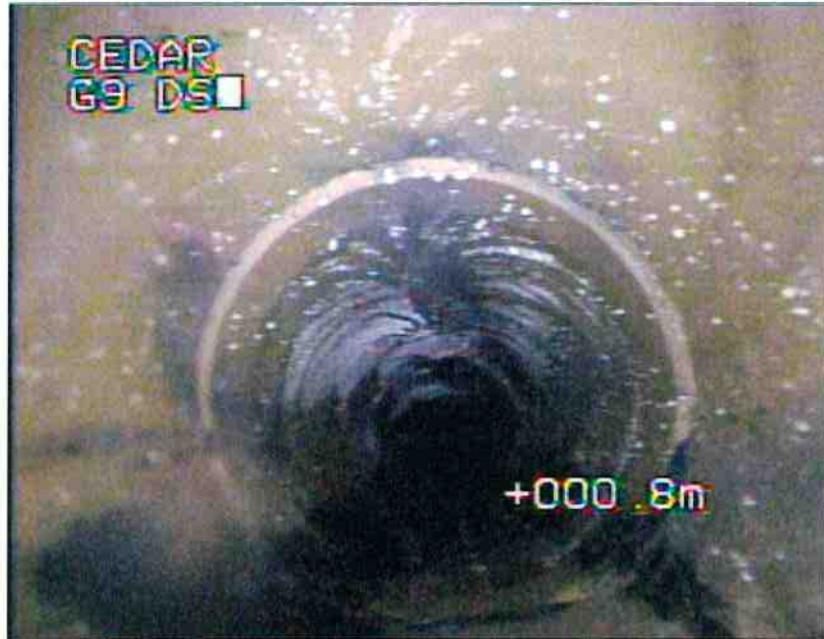
Photo: 22_3A, MPEG #: 051216_1, 00:00:12
0.9m, Sealing ring intruding, from 5 to 7 o'clock

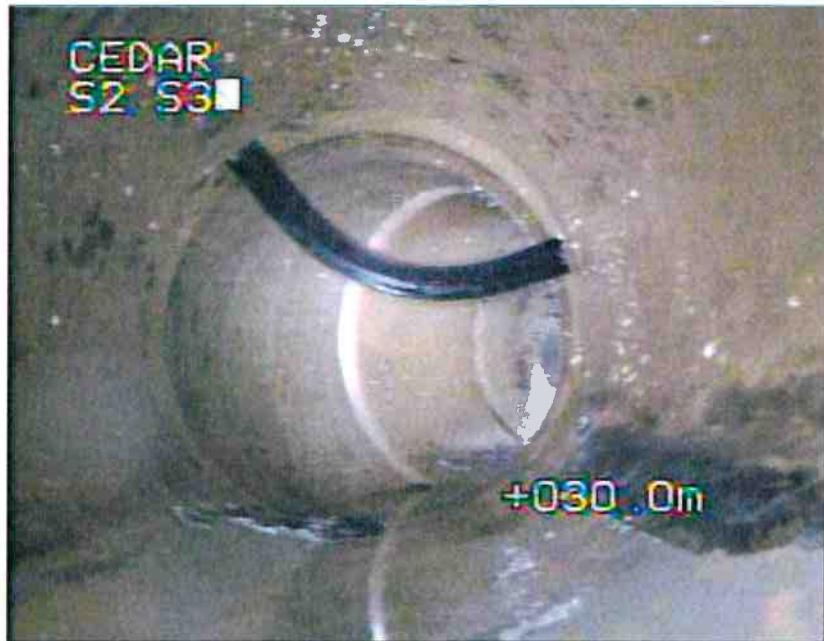
Photo: 23_3A, MPEG #: 051216_1, 00:04:31
30m, Sealing ring intruding, from 11 to 3 o'clock

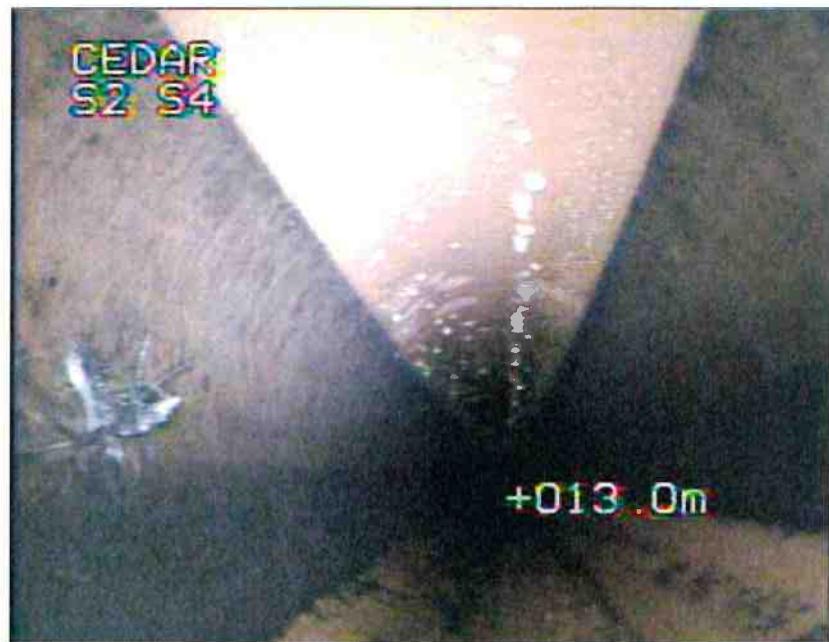
Photo: 24_10A, MPEG #: 051216_1, 00:02:35
13m, Surface damage, other, from 8 to 9 o'clock

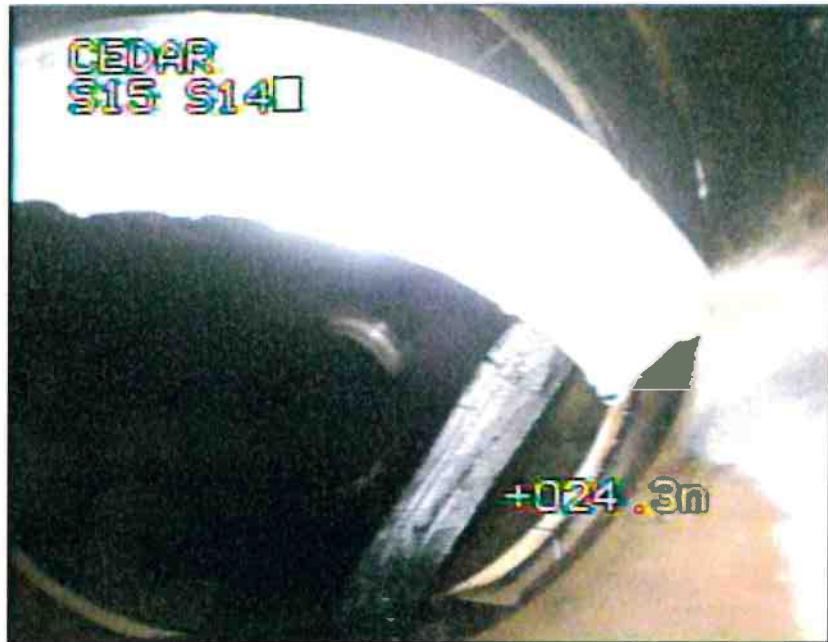
Photo: 47_6A, MPEG #: 051216_1, 00:02:39
24.3m, Sealing ring intruding, from 10 to 6 o'clock

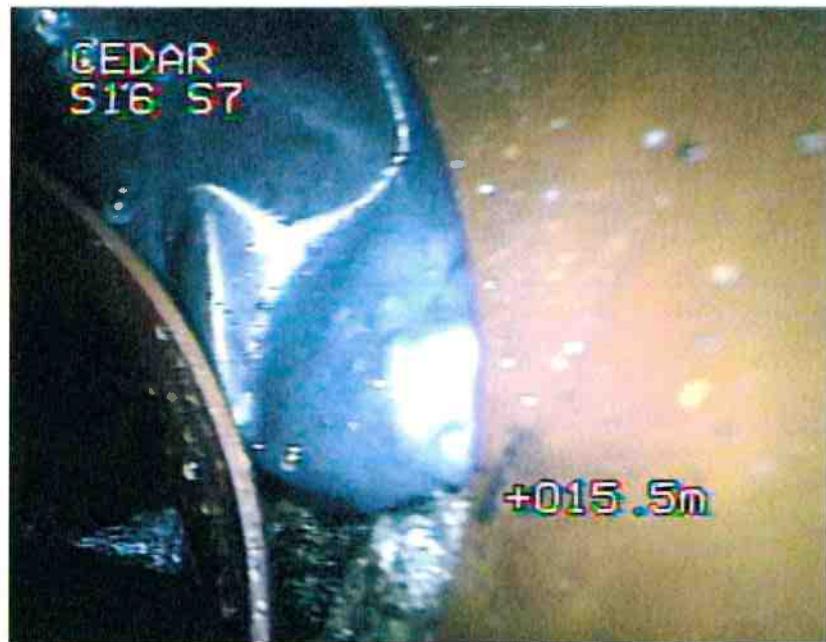
Photo: 49_6A, MPEG #: 051216_1, 00:02:41
15.4m, Joint displaced, large

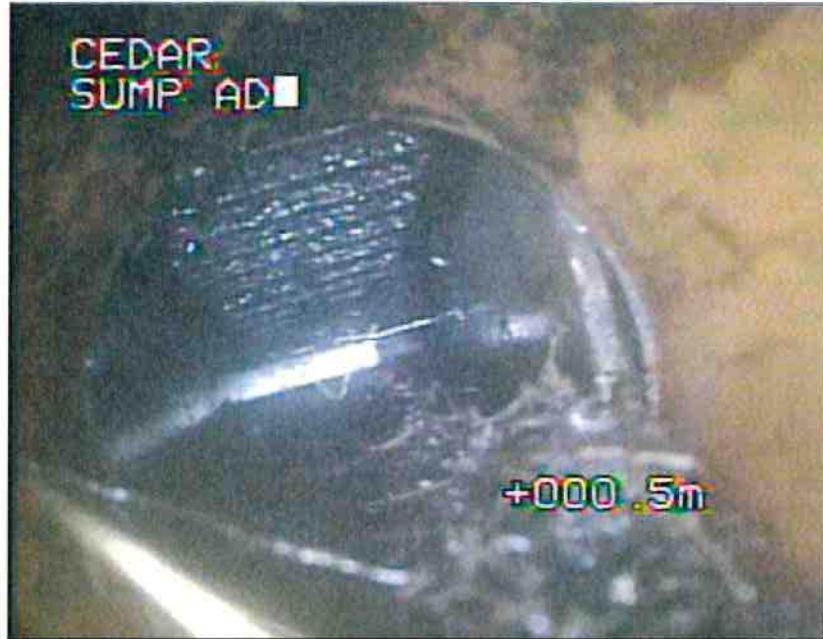
Photo: 50_3A, MPEG #: 051216_1, 00:00:12
0.6m, Roots, fine

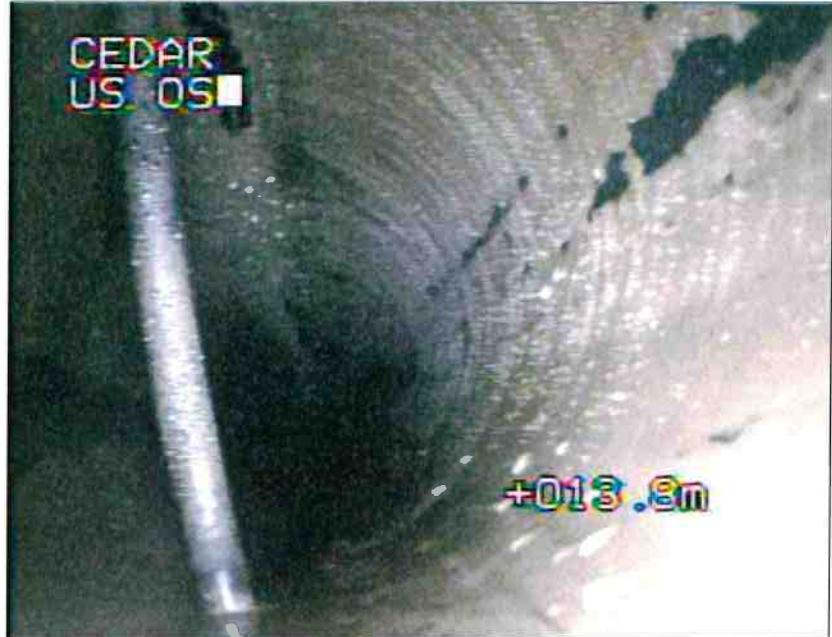
Photo: 52_3A, MPEG #: 051216_1, 00:01:52
14m, Other obstacles protuding through wall, from 12 to 6 o'clock, 5% cross-sectional area loss

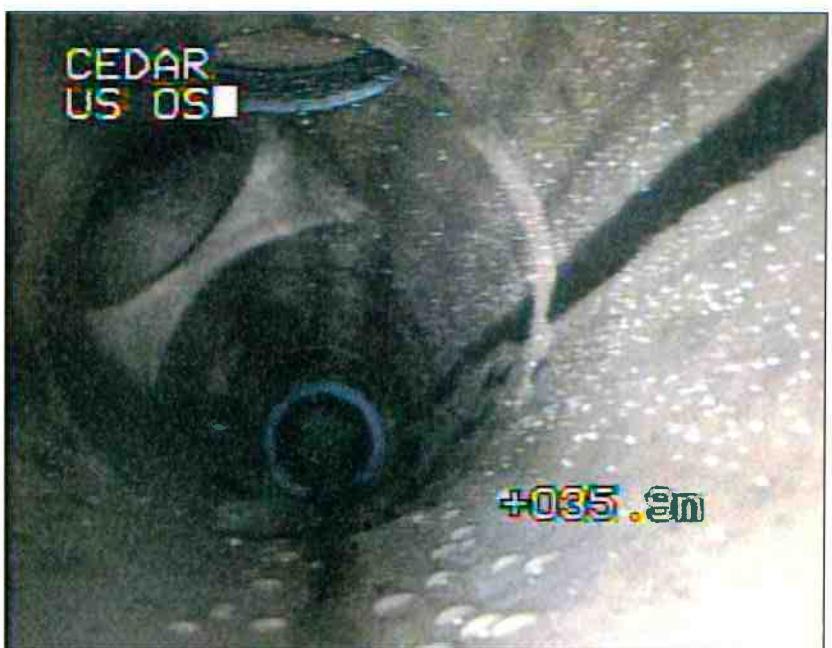
Photo: 52_8A, MPEG #: 051216_1, 00:05:26
36.1m, Connection other than junction, at 10 o'clock, diameter 100mm
