Fassaroe Recovery Facility W0269-01 Annual Environmental Report 2017

This Annual Environmental Report (AER) is prepared for the Fassaroe recovery facility operated by Roadstone Limited. This AER covers the period from January 2017 to December 2017.

The Environmental Protection Agency (EPA) issued a waste licence to Roadstone Ltd., in respect of an inert waste recovery facility at Fassaroe, Bray Co. Wicklow on 3rd March 2011 (Current Licence Number: W0269-01).

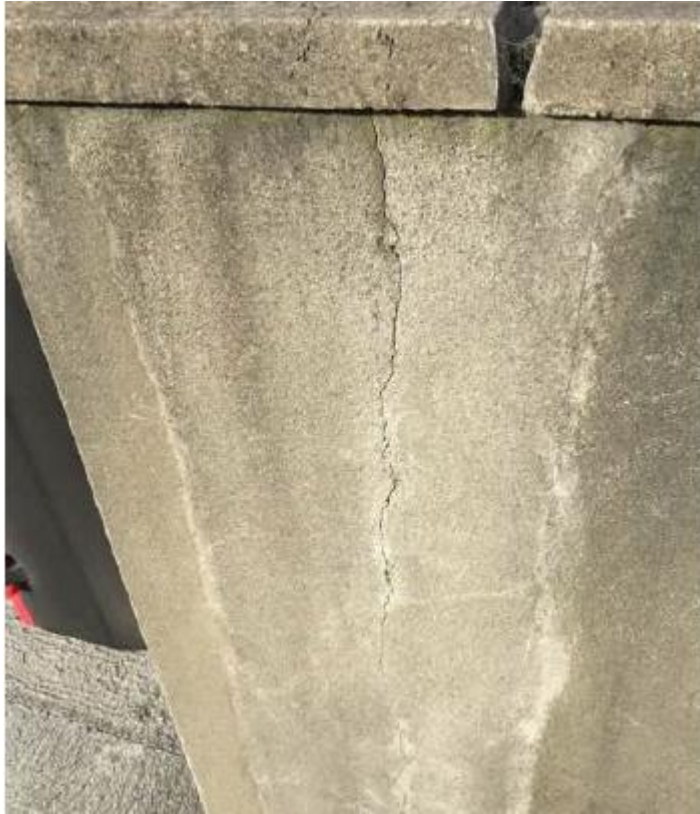
Aspect	Value/Finding	Comment
Date of Assessment	28-Oct 16	
Location	yard	
Bund type	Local	
Bund construction	Block	
Wall integrity defects	Bund partly full of water, walls damaged	
Base Integrity defects	Not determined	Base could not be inspected as bund partly full of rainwater.
Assessment result	Fail	Fail due to cracks in wall

Figure 2-1 Example of crack in bund wall

Repair damaged walls

Protect bund from rain or mark maximum quantity of rainwater
Protect bund walls from vehicle strikes

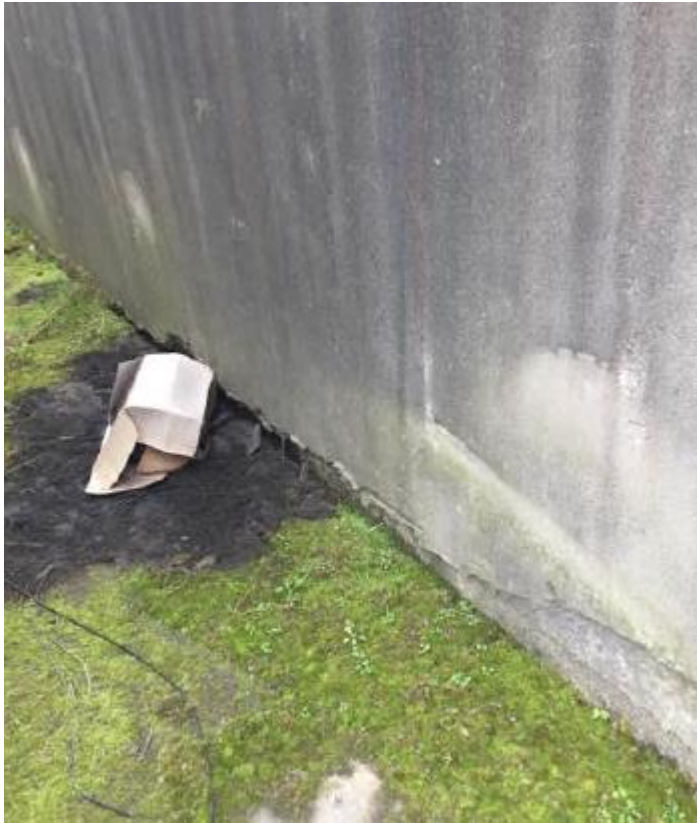
Figure 2-2 Leak from base of bund wall

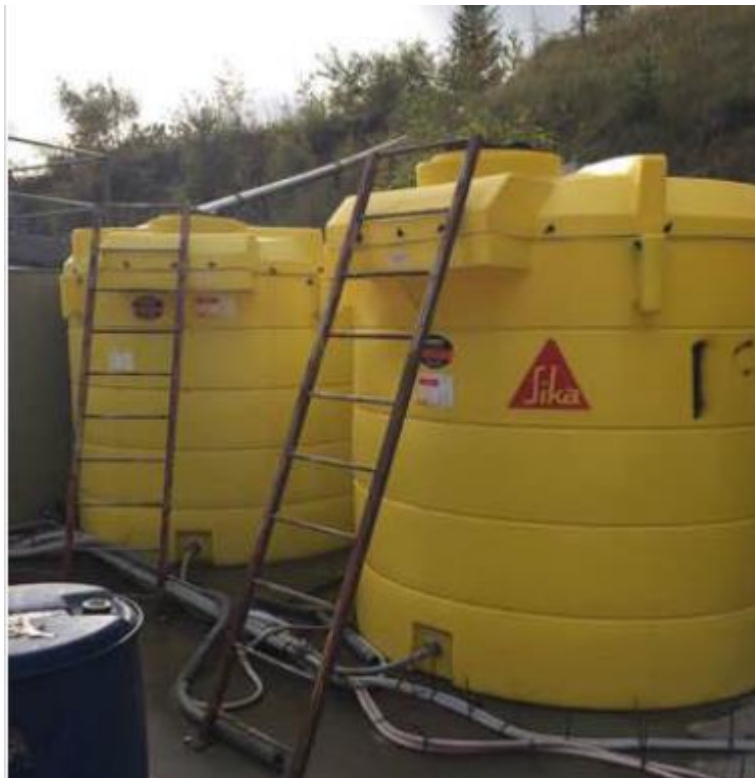
Figure 2-3 Bund identification

Aspect	Value/Finding	Comment
Date of Assessment	28-Oct 16	No comment
Location	concrete plant	
Bund type	Local (self bunded tank)	
Bund construction	Plastic	
Wall integrity defects	walls inspected - no defects	
Base Integrity defects	Base inspected - no defects	
Assessment result	Pass

Fit a self-test for leaks in void and test at monthly intervals.

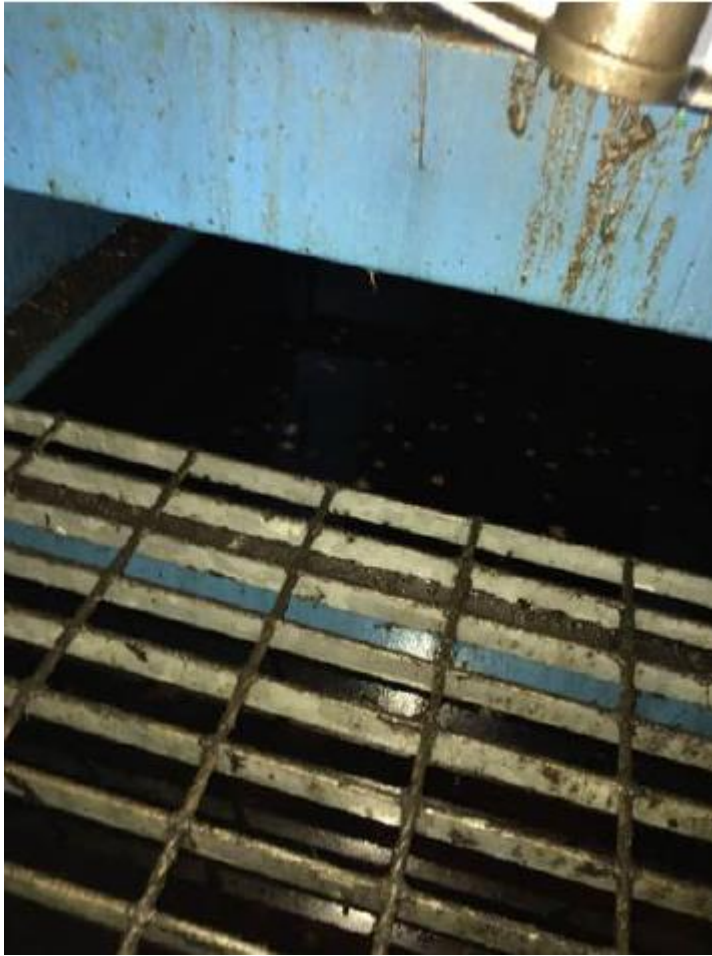
Aspect	Value/Finding	Comment
Date of Assessment	28-Oct 16	No comment
Location	garage	
Bund type	Local (prefabricated)	
Bund construction	Steel	
Wall integrity defects	walls inspected - no defects	
Base Integrity defects	Could not inspect as sump full of oil	
Assessment result	Fail

Aspect	Value/Finding	Comment
Bund capacity, Litres	Not recorded	No spare capacity in sump to retain a spill as sump full of oil.
110% largest tank, litres	N/A	
25% of all tanks, litres	-	
Assessment result	Fail

Figure 2-5 Sump of bund full of oil.

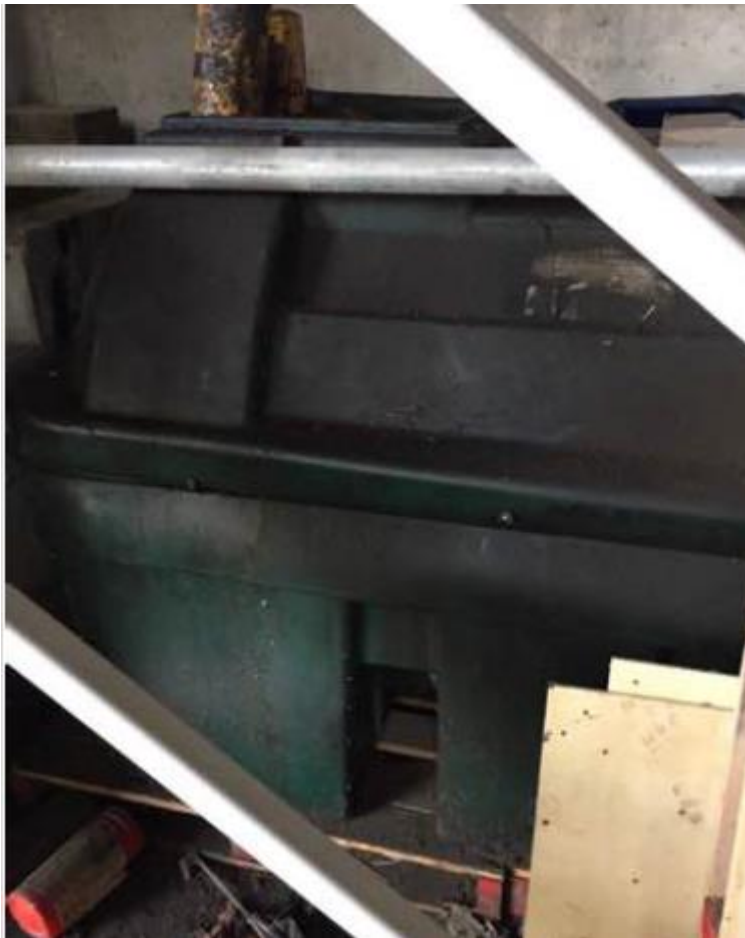
**Figure 2-6 Bund identification**

Aspect	Value/Finding	Comment
Date of Assessment	28-Oct 16	No comment
Location	garage	
Bund type	Local (self bunded tank)	
Bund construction	Plastic	
Wall integrity defects	walls inspected - no defects	
Base Integrity defects	walls inspected - no defects	
Assessment result	Pass

Fit a self-test for leaks in void and test at monthly intervals

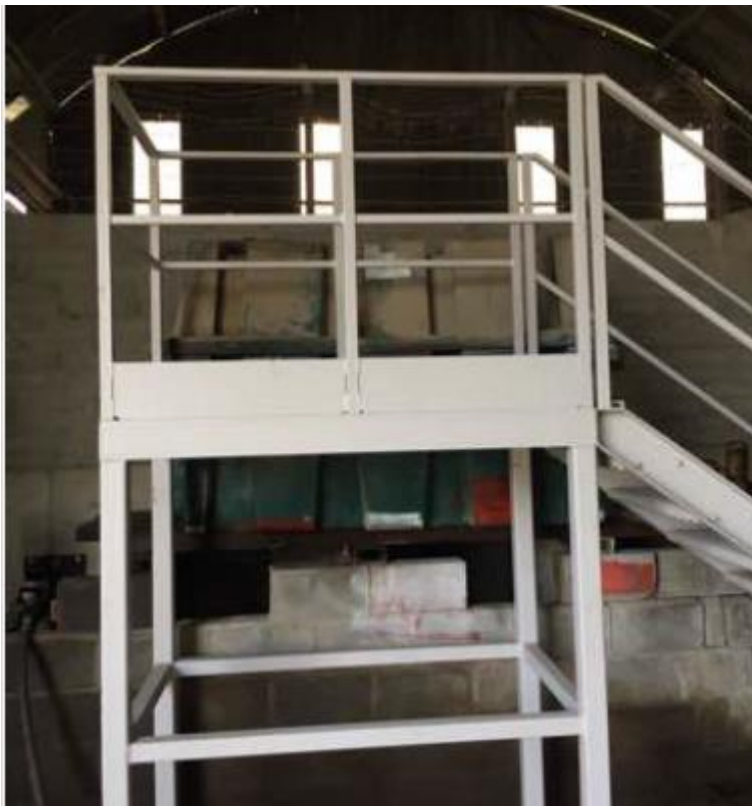
**Figure 2-7 Bund identification**

Aspect	Value/Finding	Comment
Date of Assessment	28-Oct 16	No comment
Location	garage	
Bund type	Local (self bunded tank)	
Bund construction	Plastic	
Wall integrity defects	walls inspected - no defects	
Base Integrity defects	Base inspected - no defects	
Assessment result	Pass

Repair self-test

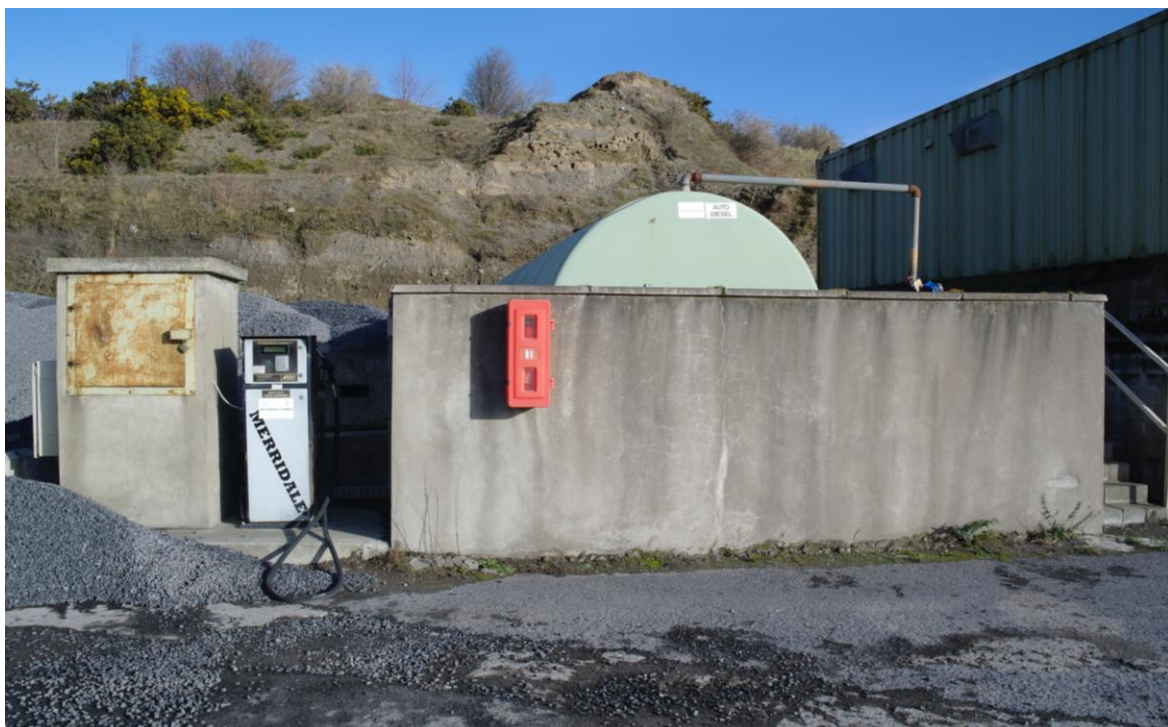
The site contains a 70,000 litre road diesel tank that is used to fuel company vehicles. The tank is protected against damage and leaks by a mass concrete bund, so the likely occurrence of a major rupture to the tank is considered low. However, without mitigation, there is a 'medium' risk of spillage of diesel during re-fuelling operations. The volume and location of such spillage may depend on mitigation measures employed at the site.

Photo 1 - Bunded 70,000 litre Diesel Tank

The severity of a 70,000 litre diesel spill to the gravel aquifer at the site is considered 'very high' as the clean-up costs could run to more than €100,000.

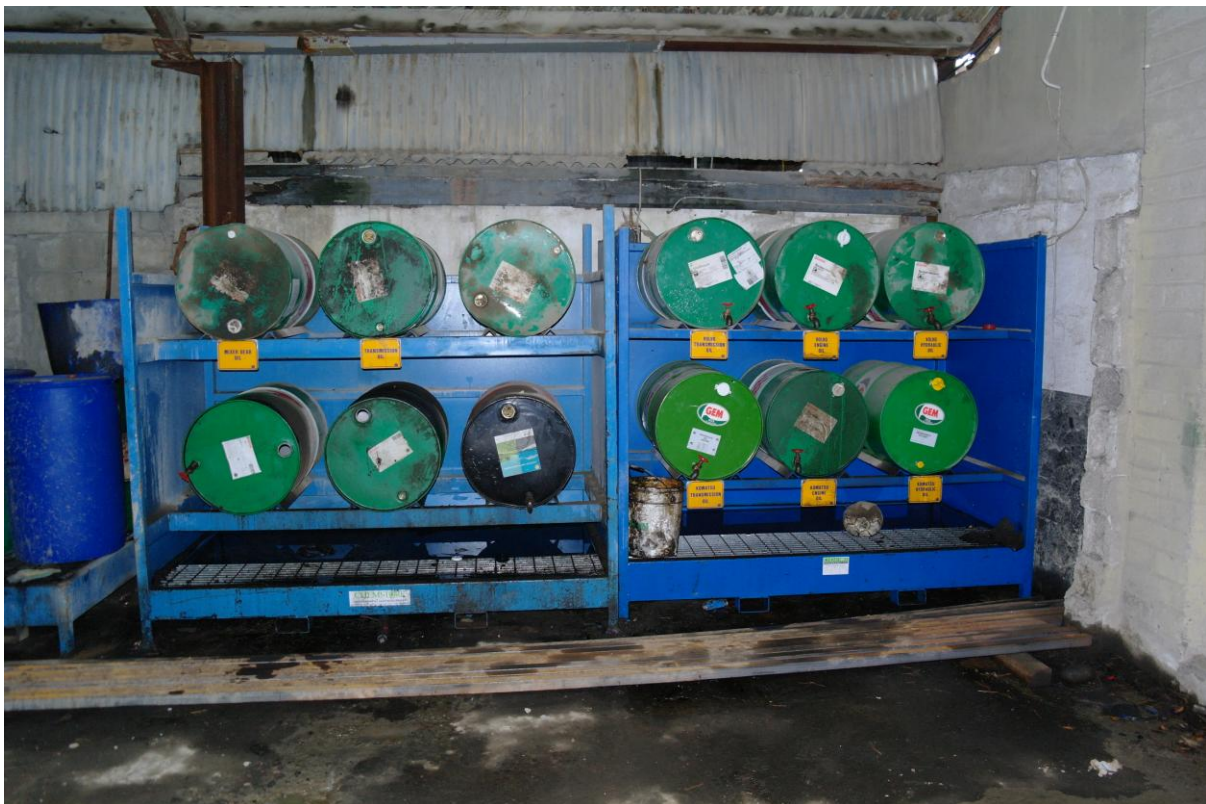
There are a number of substances used on site that have the potential to cause environmental pollution if spilled. These include a 2,500 litre double-skinned tank for gas-oil (machine diesel) for fuelling mobile plant, a smaller waste oil tank and 200 litre drums filled with hydraulic oils, engine oils and transmission oils. These are all stored in the Maintenance Shed close to the site offices and are protected against leaks by bunding.

Photo 2 – Bunded Oil Drums in Maintenance Shed

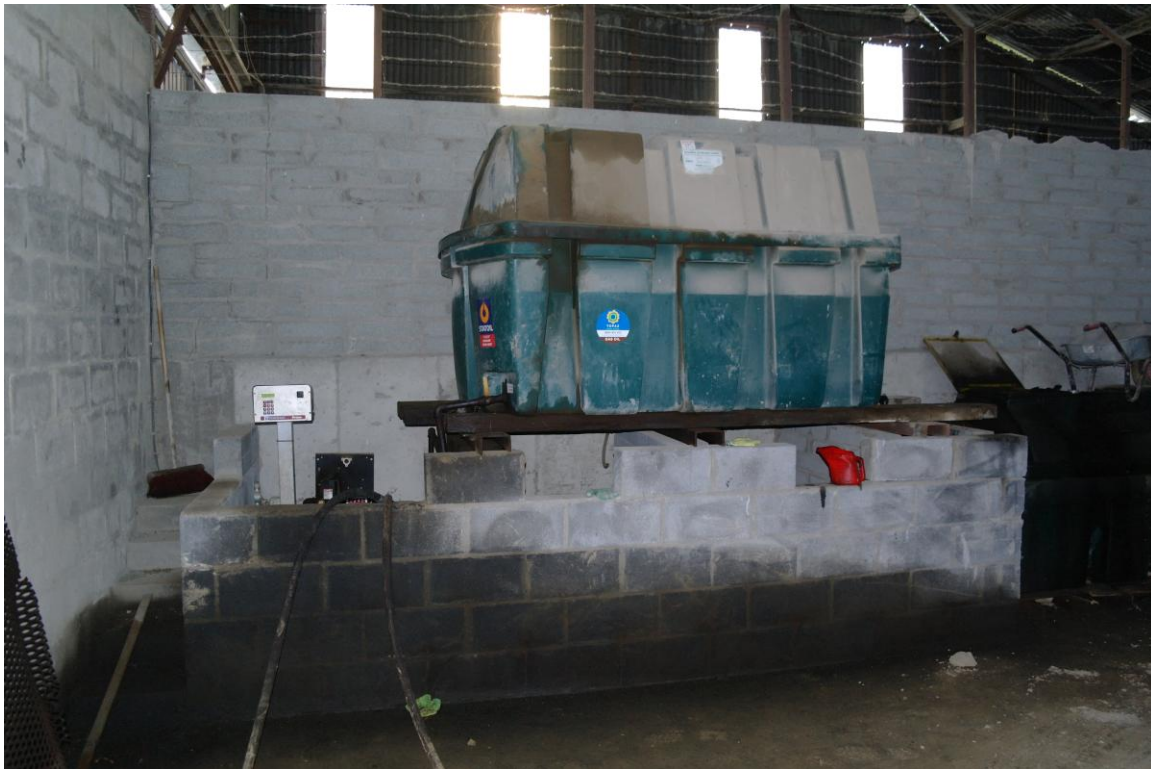
The 2,500 litre gas-oil tank consists of a self-bunded tank that is supported by the walls of a block-work bund (See Photo 3 below). There is a risk that a vehicle colliding with the bund wall would cause the tank to topple outside the bund and spill on the floor of the maintenance shed. The risk of such an occurrence is considered 'high'.

Photo 3 – Bunded Gas Oil (Diesel) Tank in Maintenance Shed

A spill of up to 2,500 litres of gas oil (diesel) in the maintenance shed would be directed to the adjacent yard area. This is an unpaved yard, so we expect a spill of this size to percolate to ground rather than drain to the downgradient site pond, located approximately 200 metres away. The severity of such an event is considered 'medium' with clean-up costs between €10,000 and €50,000.

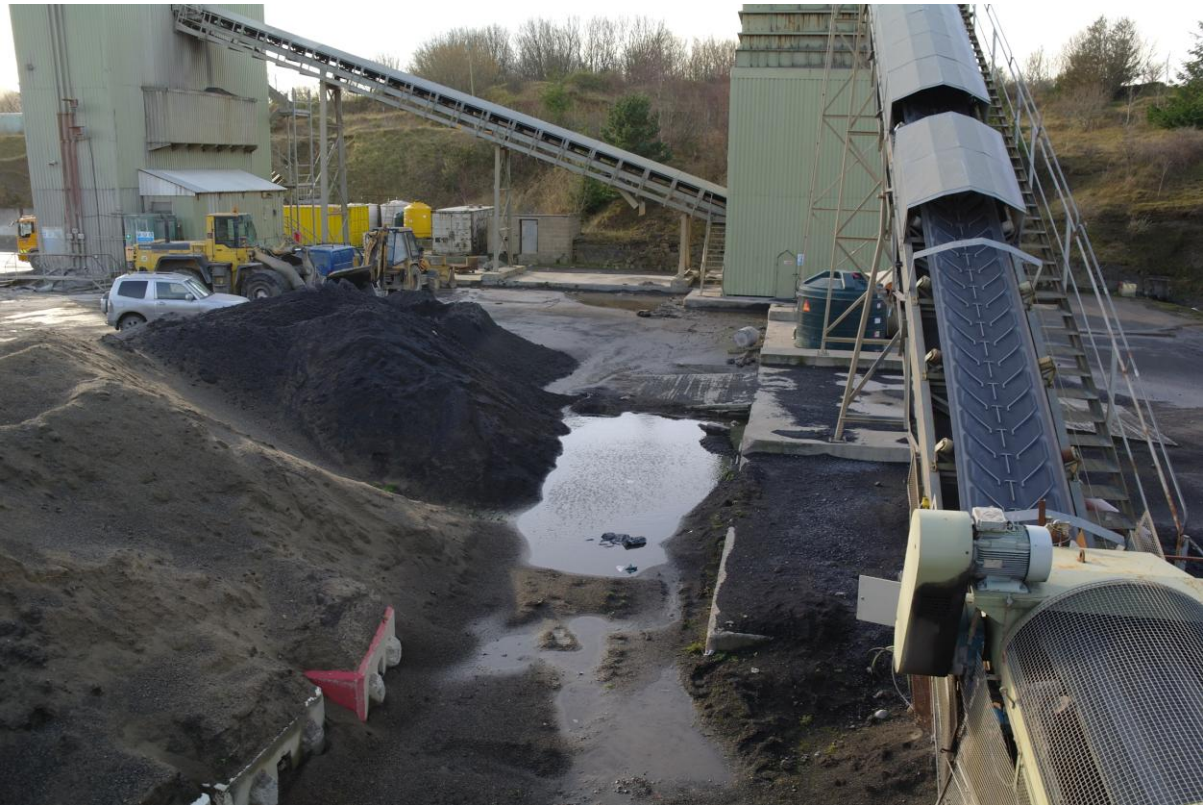
Photo 5 – Yard Drainage Impeded by Concrete Platform

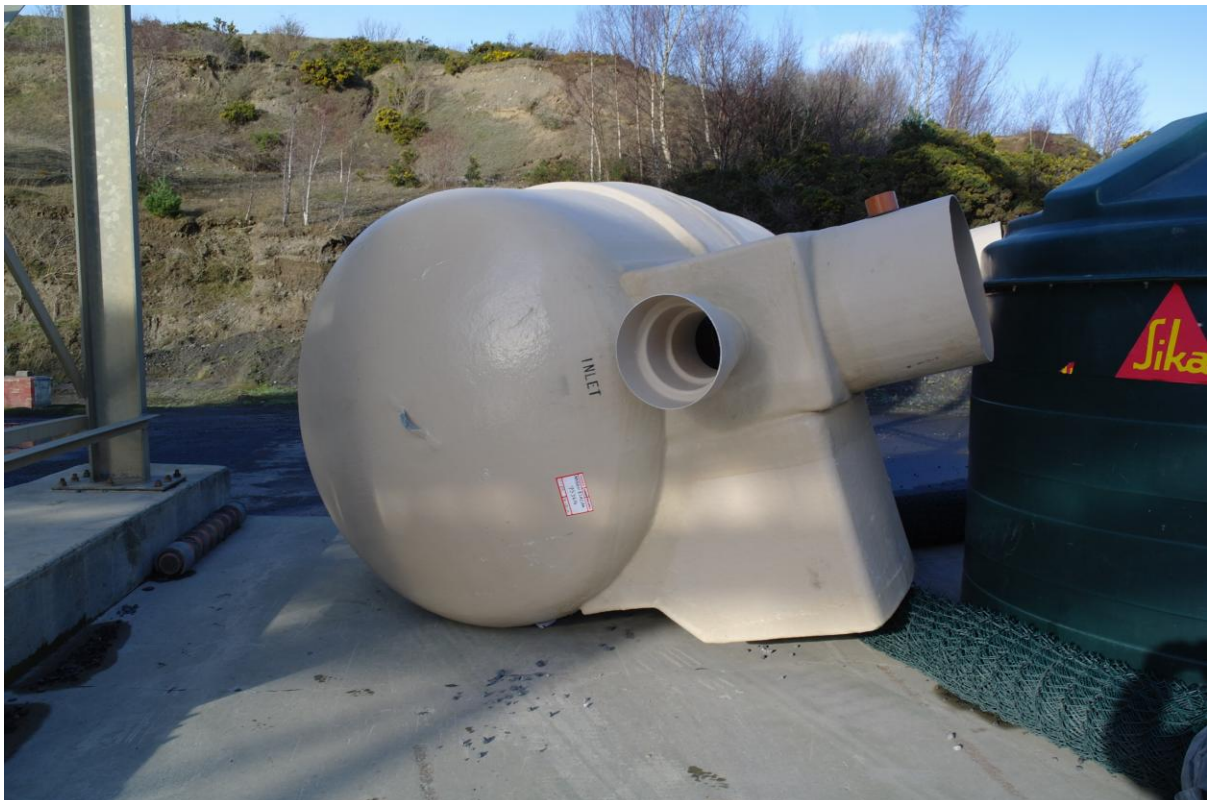
Photo 6 – Hydrocarbon Interceptor Awaiting Installation
