**ANNUAL ENVIRONMENTAL REPORT**  
**RILTA ENVIRONMENTAL LTD.**  
**BLOCK 402 GREENOGUE BUSINESS PARK**  
**LICENCE NO. W0192-03**  
**JANUARY 2017 – DECEMBER 2017**

Rilta Environmental Ltd,  
Greenogue Business Park,  
Rathcoole,  
County Dublin.

Bund Integrity Test Report 2016 / 2017

Block 402 - CCTV Drainage Inspection Report

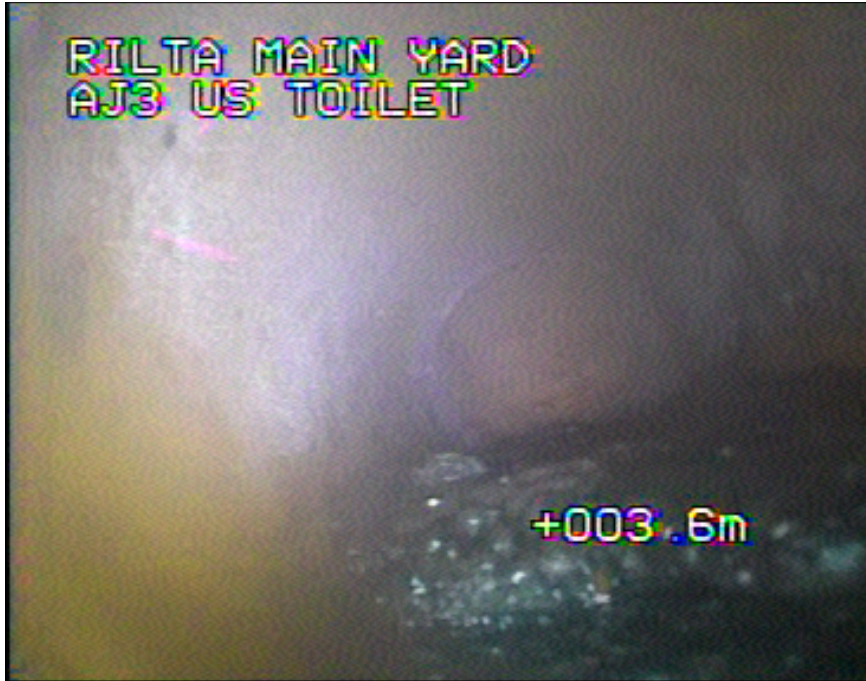
Photo: 10\_5A, MPEG #: 280217\_1, 00:00:35  
 3.6m, Settled deposits, fine, 15% cross-sectional area loss

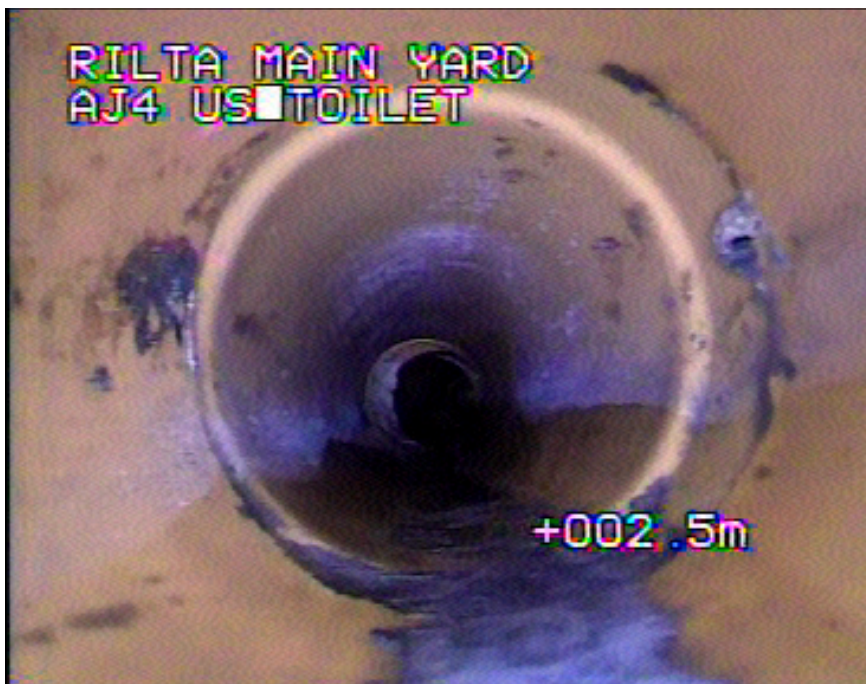
Photo: 13\_4A, MPEG #: 280217\_1, 00:00:36  
2.5m, Open joint, medium

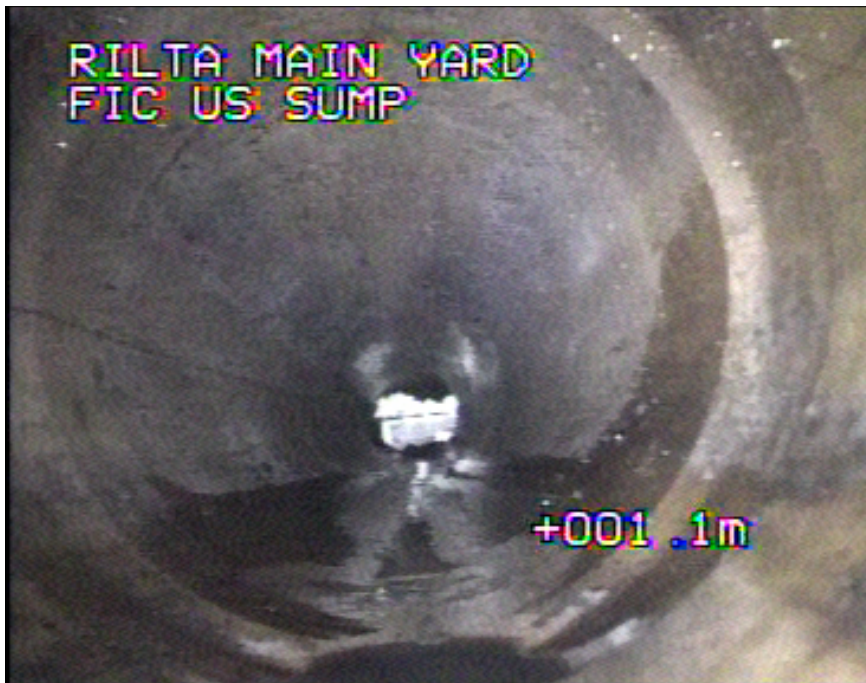
Photo: 19\_3A, MPEG #: 280217\_1, 00:00:27  
1.1m, Open joint, medium

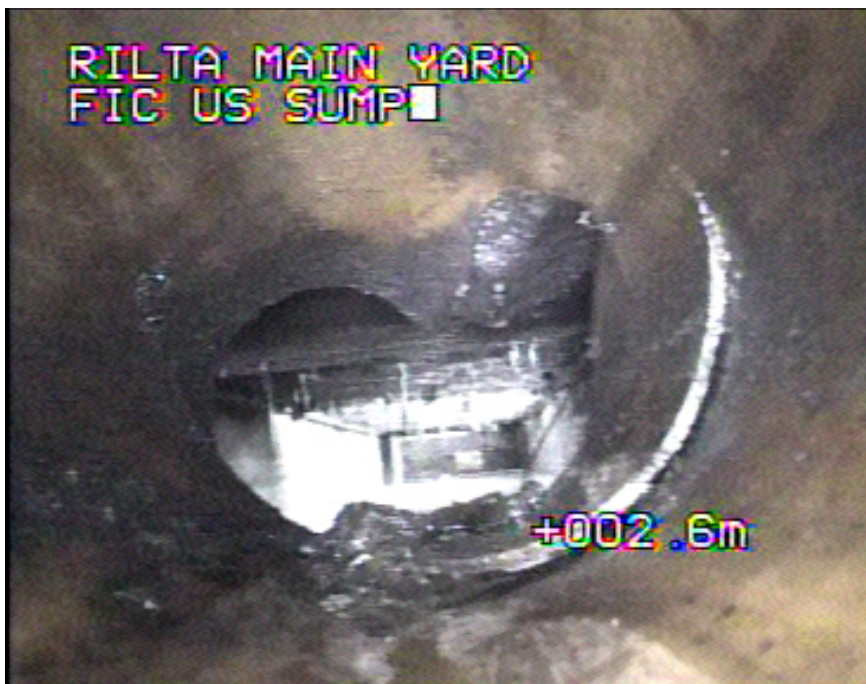
Photo: 19\_4A, MPEG #: 280217\_1, 00:00:51  
2.8m, Fracture, circumferential, from 2 to 7 o'clock

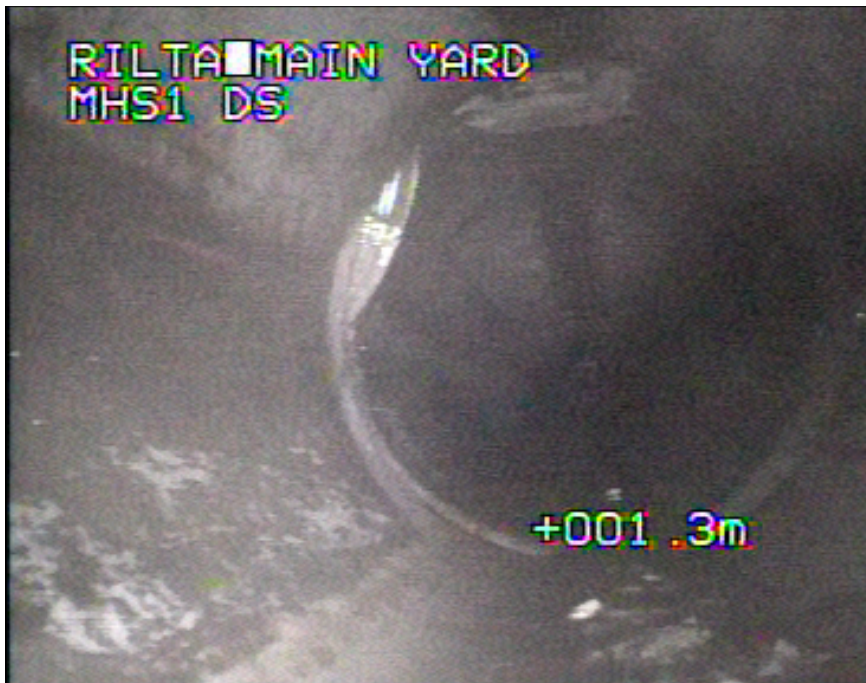
Photo: 27\_4A, MPEG #: 280217\_1, 00:00:47  
1.5m, Sealing ring intruding, from 9 to 12 o'clock

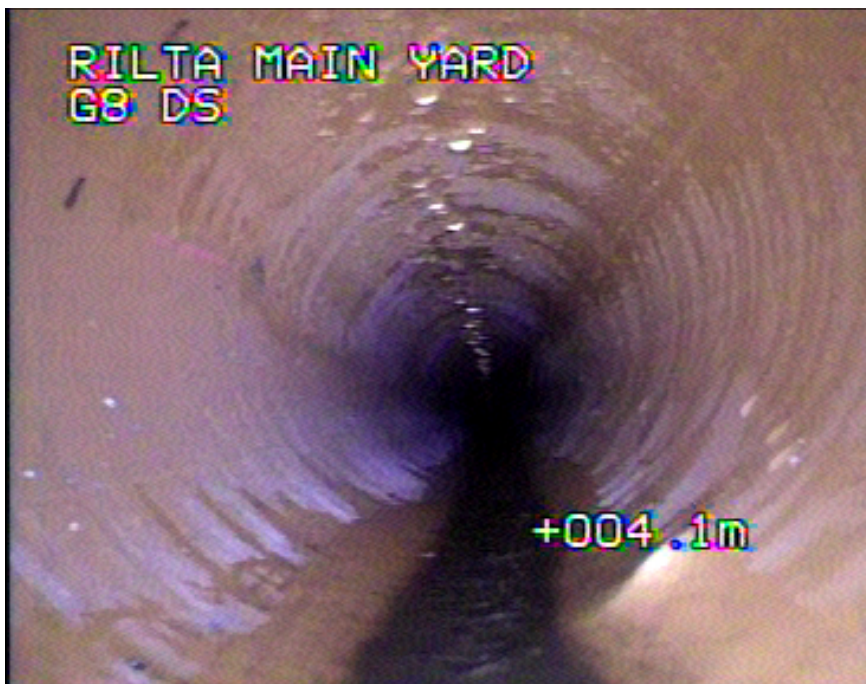
Photo: 42\_4A, MPEG #: 280217\_1, 00:00:36  
4.1m, Surface damage, other, from 4 to 5 o'clock

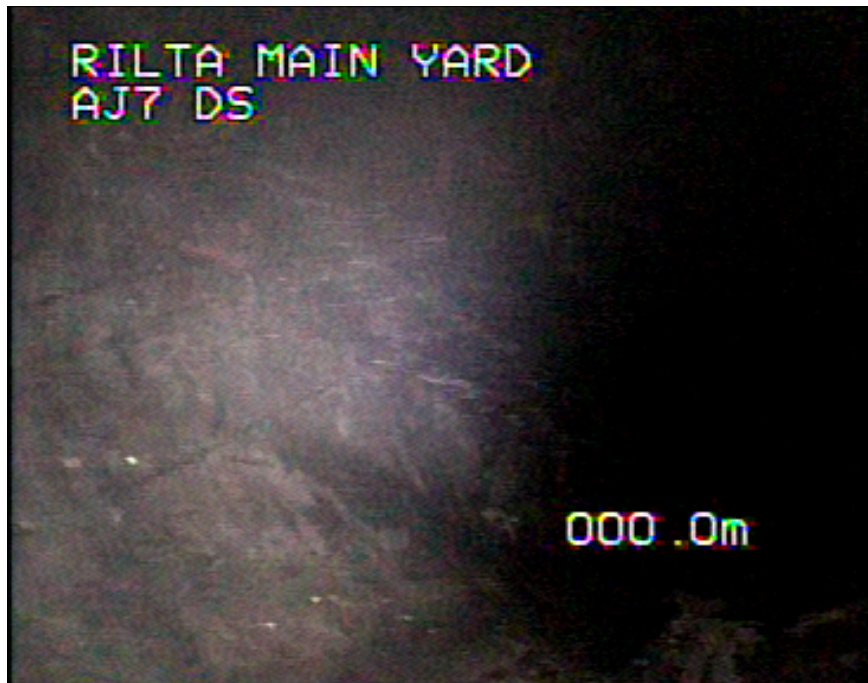
Photo: 45\_9A, MPEG #: 280217\_1, 00:00:00  
39.59m, Other obstacles built into structure, from 1 to 3 o'clock, 75% cross-sectional area loss

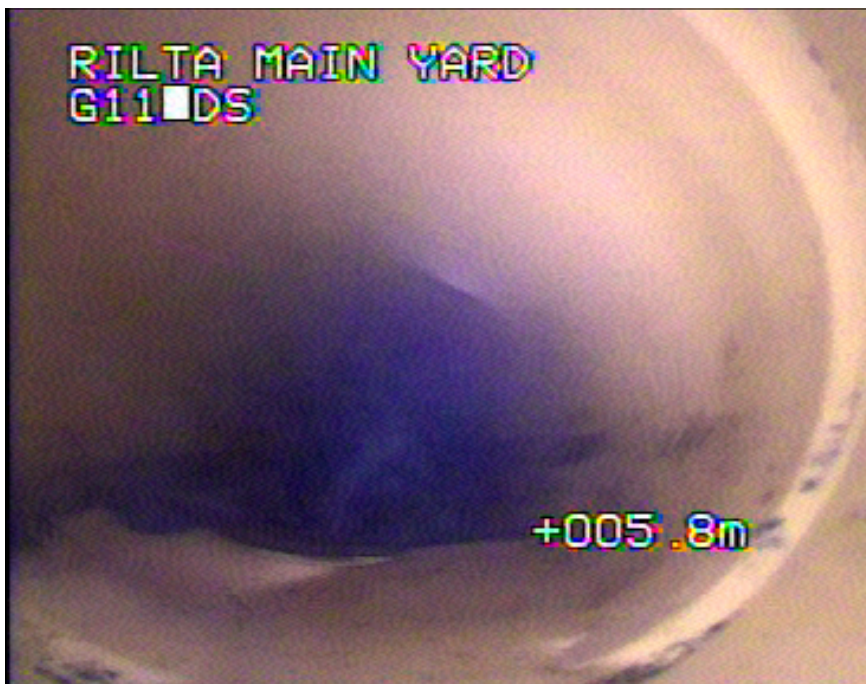
Photo: 47\_4A, MPEG #: 280217\_1, 00:01:48  
5.8m, Deformed sewer/drain, 10%
