# Kildare County Council Environment Section

Waste Management Act 1996 - 2008 Section 22 Sites

Carrigeen Refuse Depot, Clane  
Conceptual Site Model and Risk Assessment

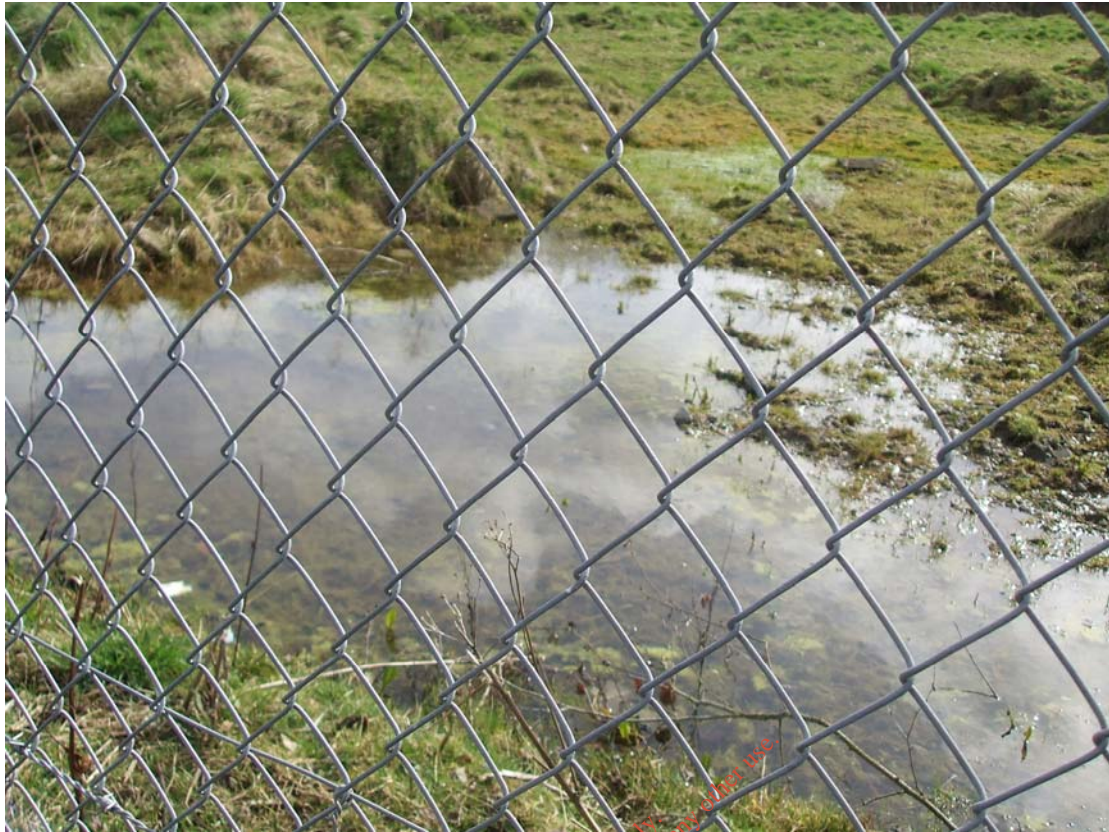
The site has a steep gradient falling from south to north with depressions evident in the scrub section of the site. During the winter months ponding is evident at the northern boundary in particular with a red leachate overflowing onto the road pavement which in turn discharges to a stream on the far side of the cul-de-sac. The road surface is stained a red/rust colour as a result of this runoff.

Photo 7: Area of ponding inside northern boundary fence.

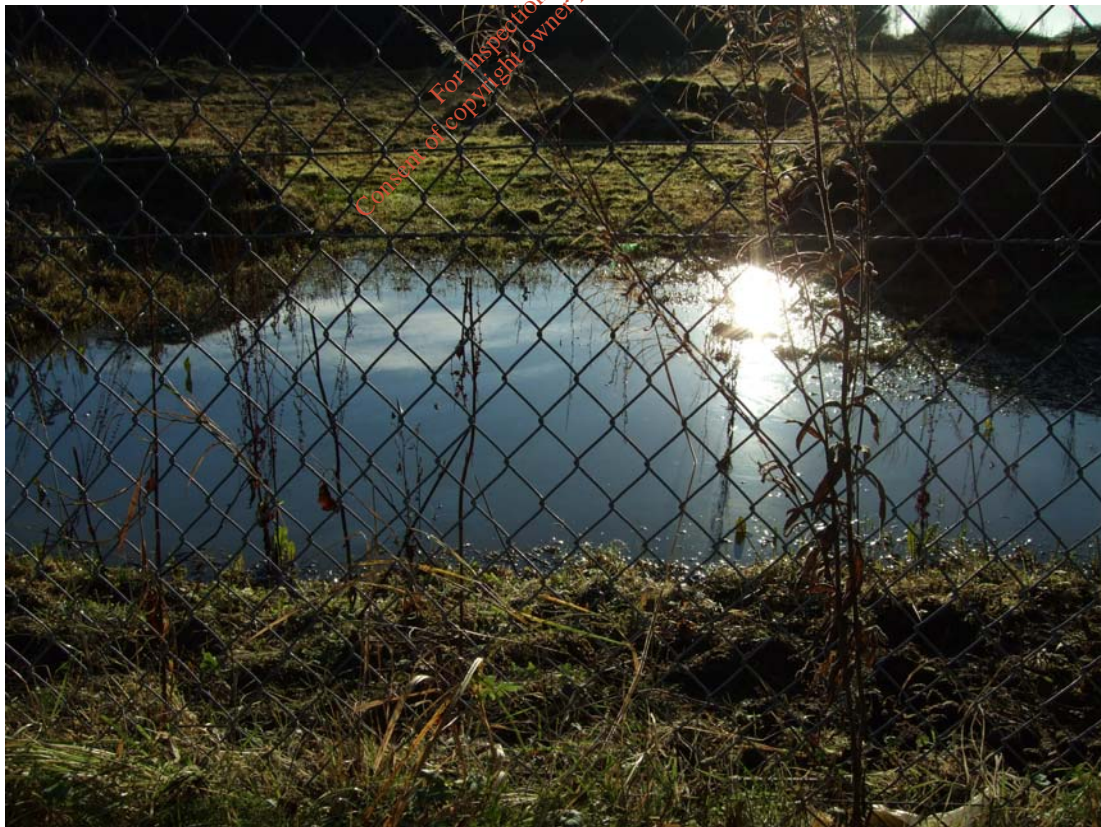
Photo 8: Area of ponding inside northern boundary fence.

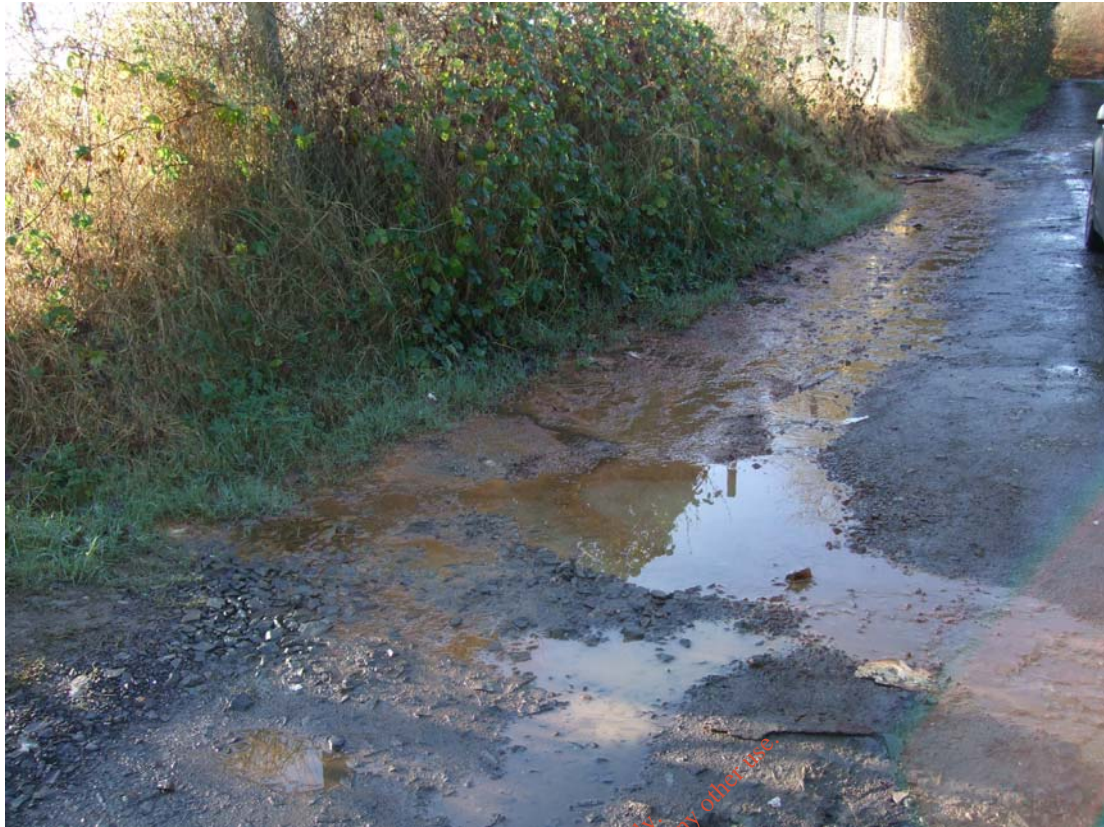
During the wet winter of 2009/2010 Kildare County Council received complaints from the public of a reddish coloured overflow runoff from ponding immediately inside the northern boundary of the site of the Carrigeen Refuse Depot, Clane (Appendix 1: Photo 9, 10, 11 and 12). The leachate flowed across the road surface of the cul-de-sac to a stream draining lands north of the site. This stream discharges to the River Liffey, 85m east of the site.

Photo 9: Leachate runoff onto road from inside northern boundary.

8. Are there any signs of impact on the environment? (If yes, take photographic evidence)		Leachate discharging to stream which discharges to the Liffey. Also aesthetically unacceptable to the public. (See Appendix 1 Photo 9 & 10)
Vegetation die off bare ground		Dead vegetation in areas of ponding in winter months.
Leachate seepages		Reddish leachate evident at northern boundary during winter months.
Odours		No
Litter		No
Gas bubbling through water		No
Signs of settlement, subsidence, water logged areas		Records of depressions in capping layer shortly after capping in 1981. Large depressions are visible in the scrub land and could be attributed to settlement and soil moved to make mounds for quad biking in the past.
Drainage or hydraulic issues		Poor drainage at the northern side of site with ponding evident during winter months.
Downstream water quality appears poorer than upstream water quality		Yes

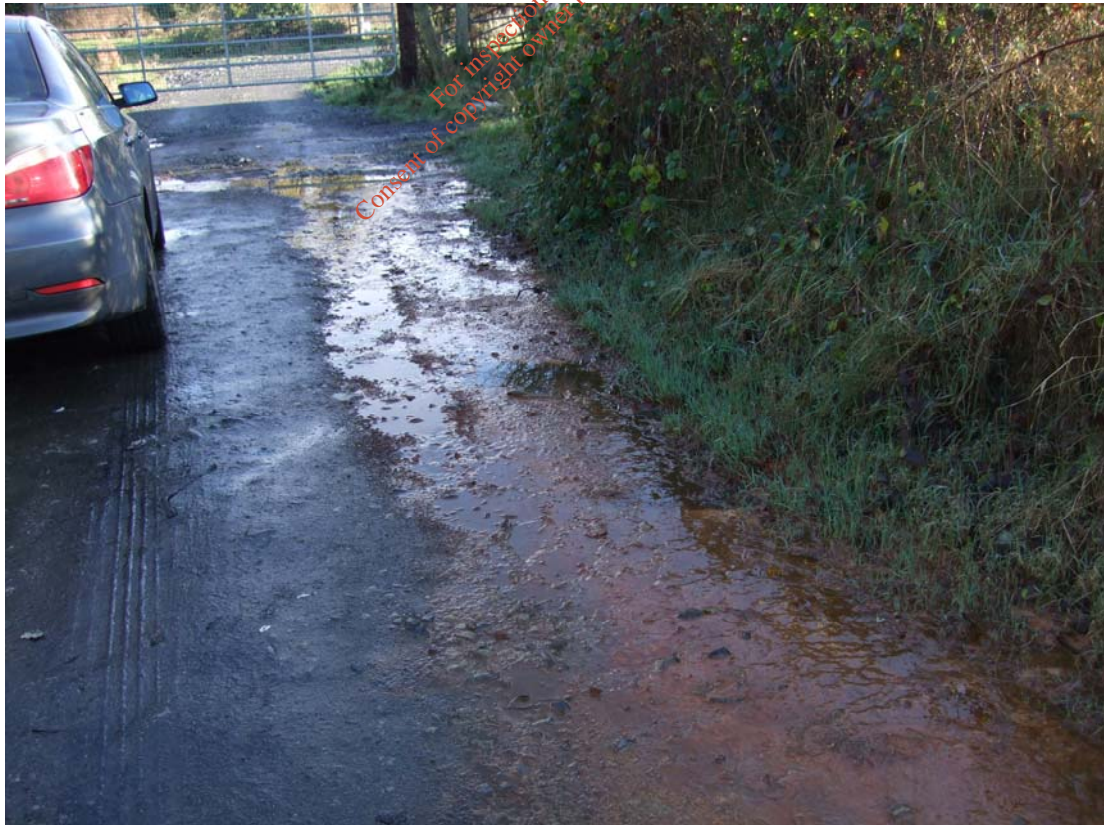
Photo 10: Leachate runoff flowing across the cul-de-sac to stream.

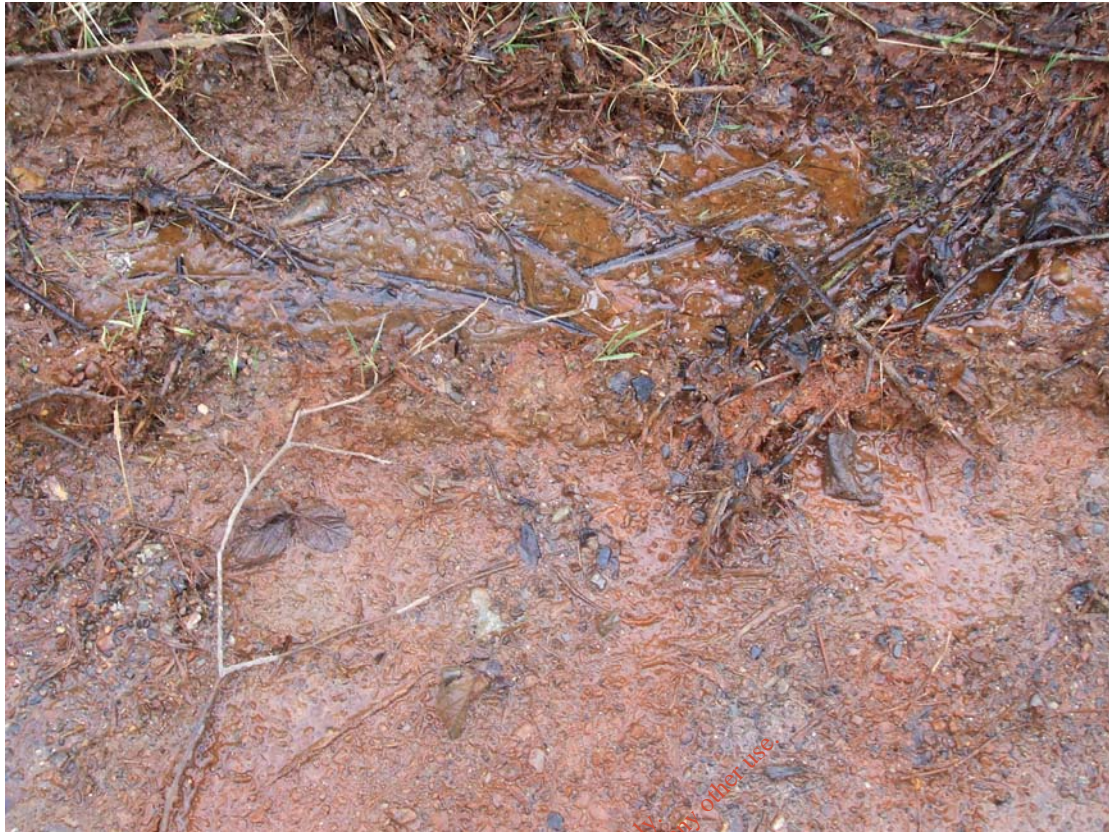
Photo 11: "Reddish" leachate on road pavement.

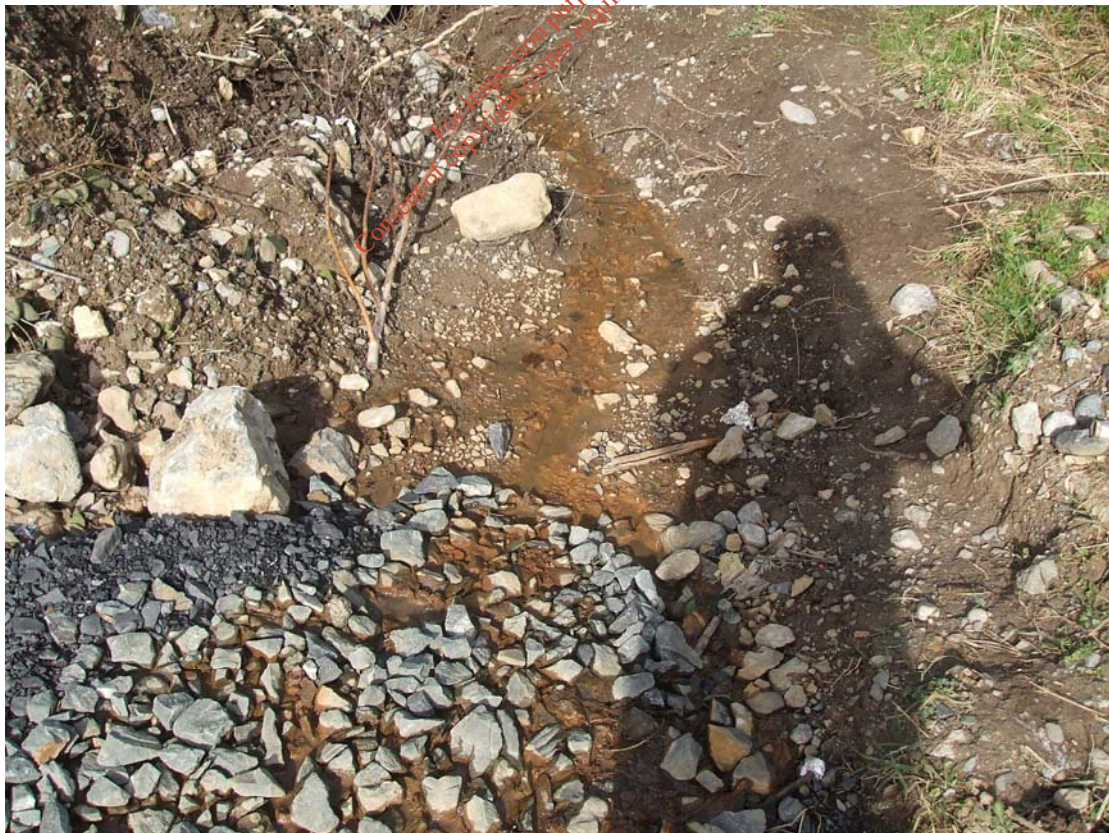
Photo 12: Leachate discharging to stream.
