OFFICE OF ENVIRONMENTAL SUSTAINABILITY

INSPECTOR'S REPORT ON AN APPLICATION FOR A CERTIFICATE OF AUTHORISATION FOR A CLOSED LANDFILL

TO:	Eimear Cotter, Director	
FROM:	Magnus Amajirionwu, Inspector	Environmental Licensing Programme
DATE:	28 March 2019	
RE:	Application by Kildare County Council for a Certificate of Authorisation for a closed landfill at Carrigeen, Clane, County Kildare . Certificate of Authorisation Register Number H0210-01 .

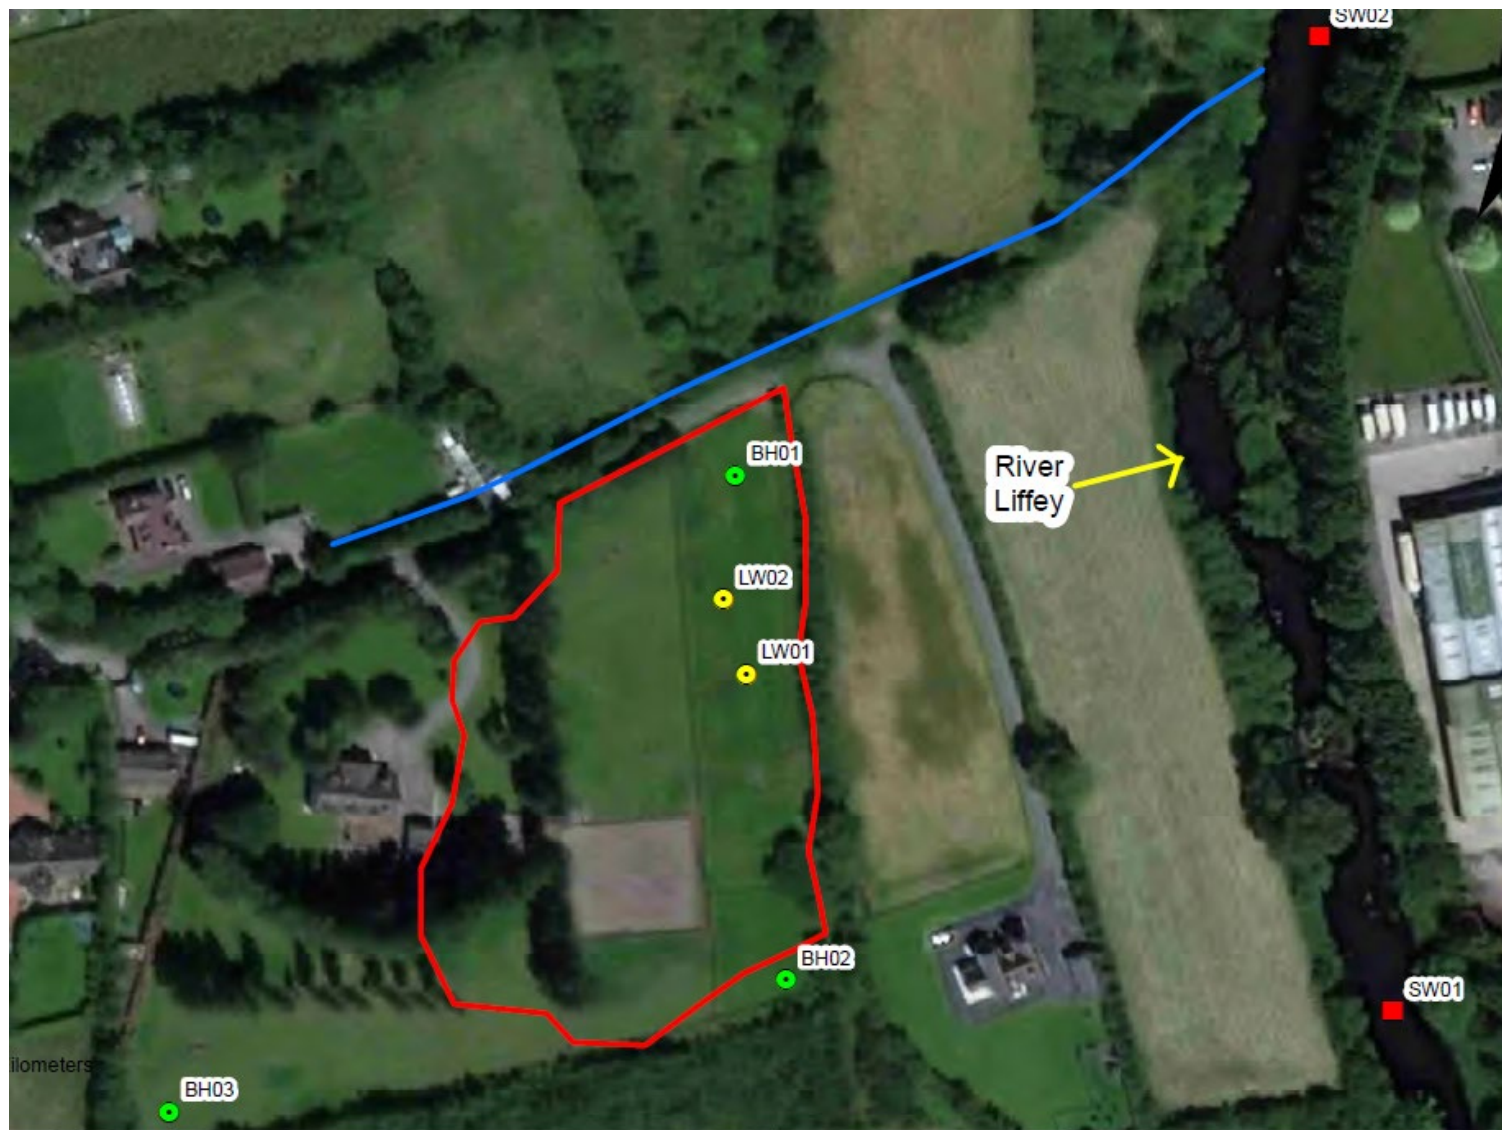
Figure 2 Boundaries at the closed landfill. (Source: Certificate of Authorisation Application from Kildare County Council)

Area of the closed landfill	0.979 hectare shown in Figure 2.
Quantity of waste at the facility	Approximately 31,500 m ³ or 15,750 tonnes estimated (applying the conversion ratio for municipal waste of 0.4).
Characterisation of waste deposited	Waste characterisation indicated domestic, commercial and construction and demolition waste. The municipal waste comprised of general plastic, rags, bottles, textiles, paper and wood. A strong waste odour was observed while excavating in the waste layers at some locations. The construction and demolition (C&D) waste comprised of crushed stone, brick and reworked soils.

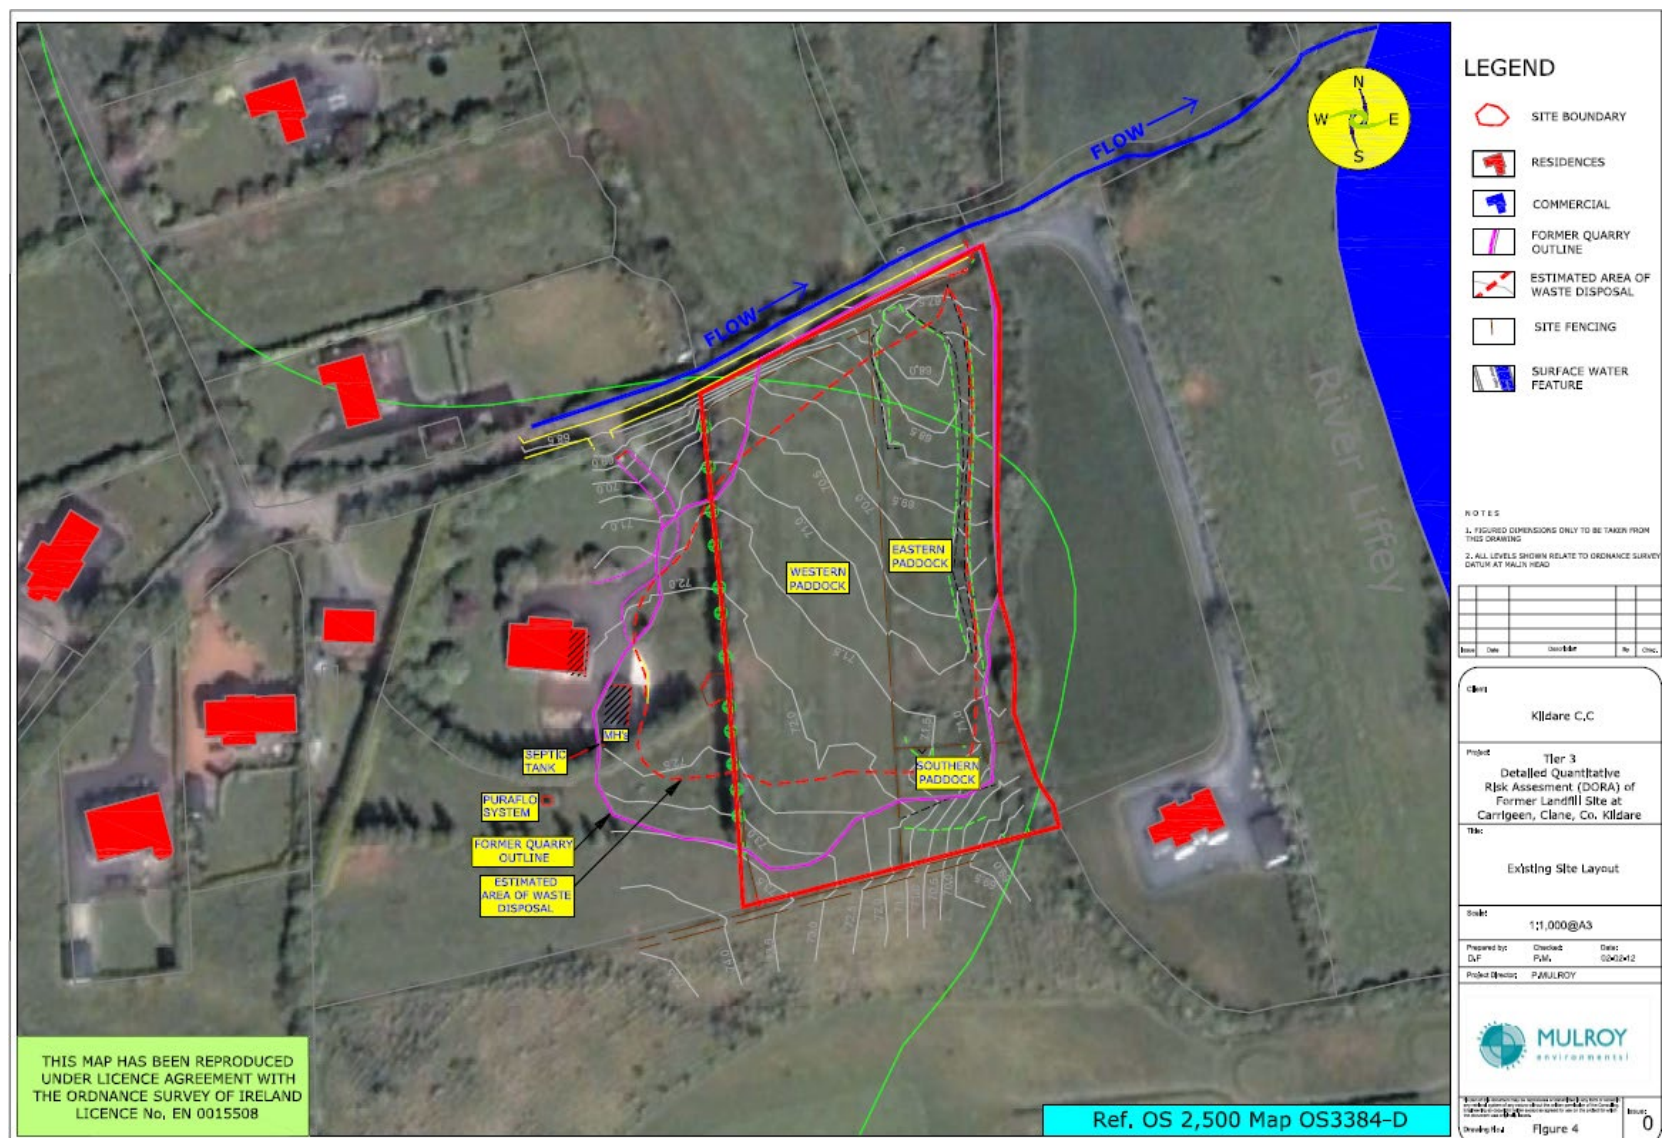
Figure 3 Current site use and surrounding properties. (Source: Certificate of Authorisation Application from Kildare County Council)

Site investigations	<p>Geophysical survey (2010): Indicated that the area of waste material is concentrated in the field to the west of the residential property (Figure 3) but may extend to the front, side and rear gardens of the property as well as into the paddock to the rear of the property. The geophysical survey indicated a waste thickness of approximately 5m in the centre of the site. However, trial pitting, as described below, indicates that in fact there is no waste in the front, side or rear gardens of the property.</p> <p>Intrusive site investigations completed in 2010 included:</p> <ul style="list-style-type: none"> • Excavation of 13 trial pits to depth 4.5 mbgl; • Installation of 3 groundwater monitoring wells (50mm diameter) to a depth of 8 mbgl; • Installation of 2 leachate monitoring wells (50mm diameter) to a depth of 6 mbgl;

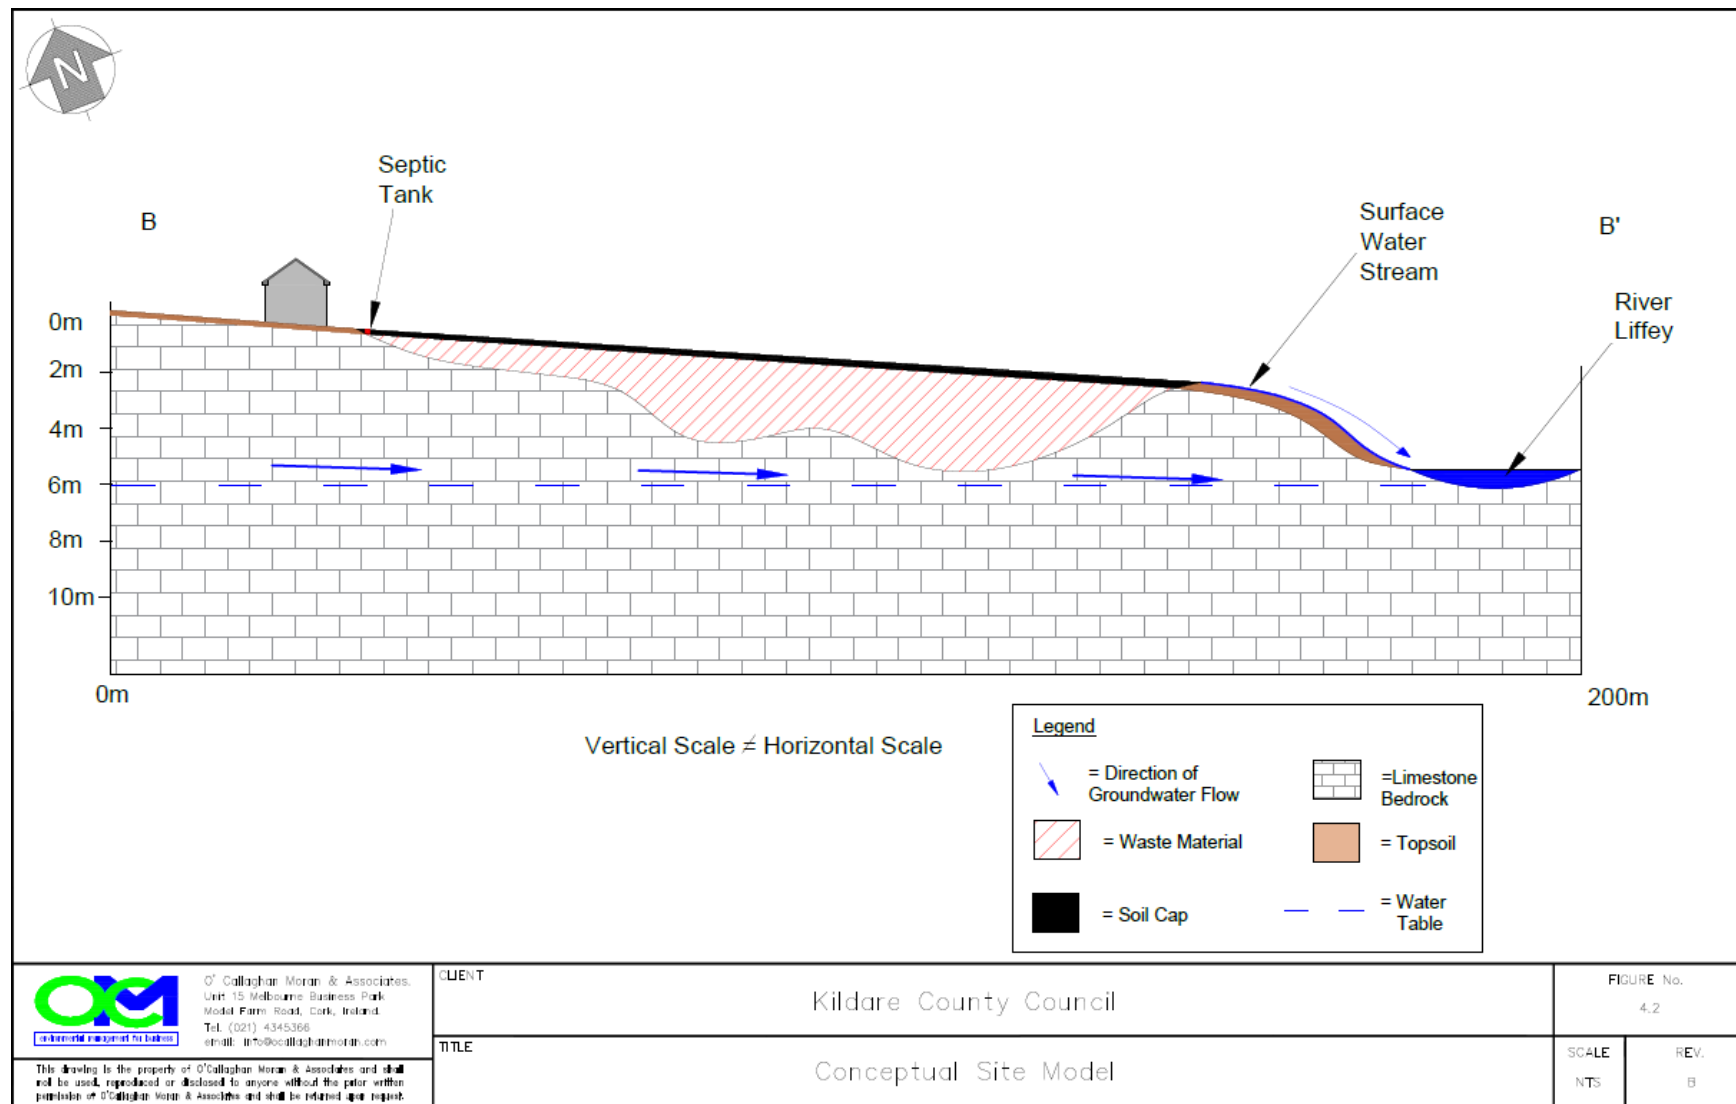
Figure 4 Conceptual site model. (Source: Certificate of Authorisation Application from Kildare County Council)

Conceptual site model	<p>The conceptual site model identified the following pollutant linkages:</p> <ul style="list-style-type: none"> • human health exposure and emission into buildings due to off-site migration of landfill gas; • migration of leachate into the adjoining surface water body; and • migration of leachate into the underlying aquifer and groundwater body. <p>The Qualified Person identified the pollutant linkages that warrant remedial action as:</p> <ul style="list-style-type: none"> • leachate migration to surface water (SPR 8) • human health exposure pathway of off-site migration of landfill gas and emission into off-site building (SPR 10).

<p>The conceptual site model is shown in Figure 4. The source, pathways and receptors can be described as follows:</p> <p>Source:</p> <ul style="list-style-type: none"> - Rainfall on the landfill will preferentially percolate through the cap and into the waste. - Leachate is generated in the waste albeit at low strength. <p>Pathway:</p> <ul style="list-style-type: none"> - Leachate can migrate into surface water body. - Gas migration can occur upwards through the permeable cap and downwards into bedrock beneath the waste. - Gas migration beyond the site boundary. <p>Receptors:</p> <ul style="list-style-type: none"> - Existing houses and users in close proximity of the site. - The bedrock aquifer beneath the site. - The surface water south of the site.
--	---

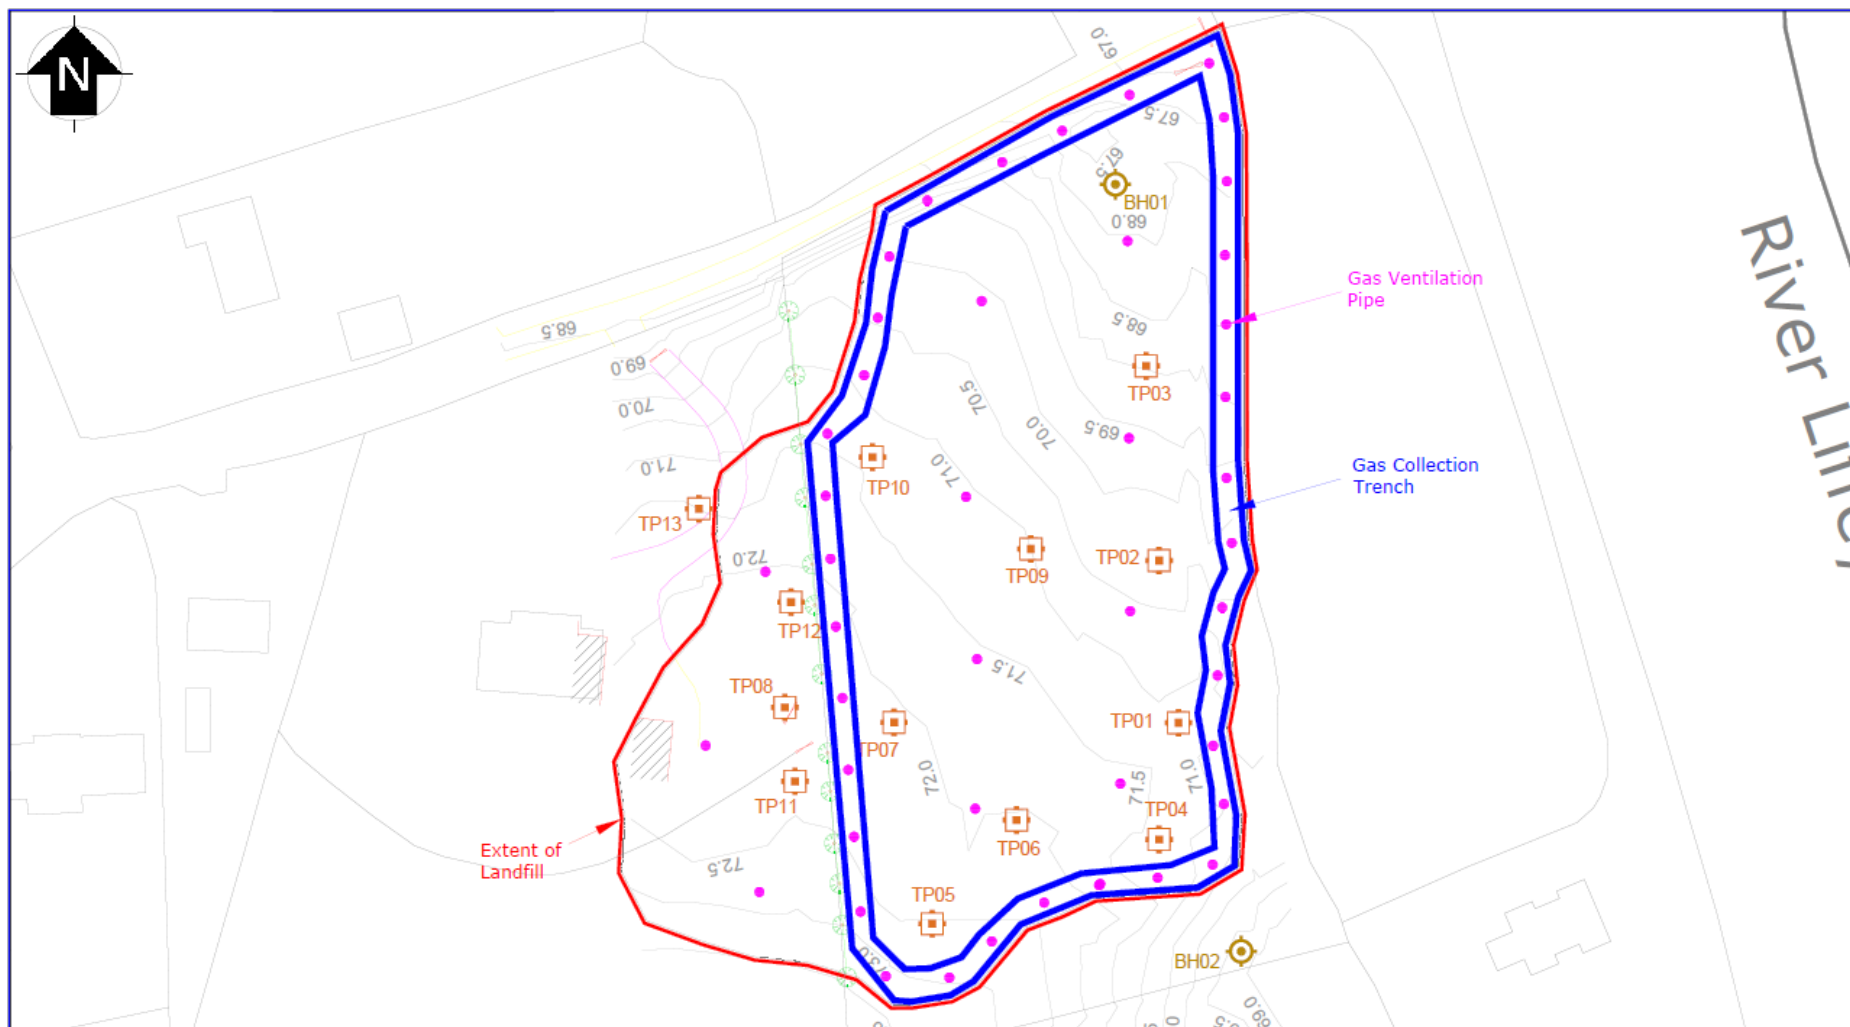
Figure 5: Outline of gas collection trench and gas ventilation pipes. (Source: Certificate of Authorisation Application from Kildare County Council)

Landfill gas	<p>The ongoing generation of landfill gas at the landfill and the close proximity of residential dwellings means there is a potential for gas to migrate and accumulate in a manner that potentially poses a risk to property and people.</p> <p>There is risk posed by the presence of methane from the site. Recorded concentration of methane (CH₄) was observed to range between 0.0 to 39.2 % (v/v), carbon dioxide between 1.3 and 31.9 % (v/v) and Oxygen between 0.01 to 18.7% in 2010 at 33 locations. In 2018, monitoring results indicate that landfill gas is still being generated in the landfill based on the methane 2.4 to 16.5% (v/v) and carbon dioxide 3.7 to 27.8% (v/v) levels detected in the leachate wells at two locations. The spike probe survey did not detect the presence of landfill gas close to the surface of the landfill or along the boundary. However, it is possible that gas migration could be occurring below the probe penetration depth as the probe was merely advanced approximately 0.3-0.5m below ground level.</p> <p>Landfill gas generation and migration is the focus of the risk assessment and proposed remedial actions submitted by Kildare County Council. The remedial measures proposed include the installation of a gas collection trench around the waste body perimeter with a series of gas ventilation pipes. Three vertical ventilation wells are proposed be installed to the west of the gas collection trench to ventilate gas that may be present in the quarry footprint (Figure 5).</p>

<p>grass seeded. The horse paddock in the south of the site will be retained as requested by the site owner.</p> <p>A surface water collection pipe will drain the site and divert run off under the road to the surface water drain located north of the site. It is also proposed to open a trench across the road to connect the stormwater pipe from the landfill area to the drain on the north side of the road.</p> <p>Eight vertical gas ventilation wells will be installed in the cap to reduce the build-up of landfill gas beneath the clay cap. The wells will be of similar construction to the vertical risers in the gas collection trench.</p> <p>The draft Certificate of Authorisation allows for the importation and use of soil and stone to complete the works.</p> <p>Condition 3.14 of the recommended certificate of authorisation provides for a communications programme directed at the occupiers of property in close proximity to the closed landfill site. The communications programme will inform these people of what they should be doing to protect their property and health and well-being from the risk of an incident involving landfill gas.</p>
