Environmental Assessment of Receiving Waters

Comhairle Chontae Luimnigh

Churchtown Landfill Site

27th May 2013

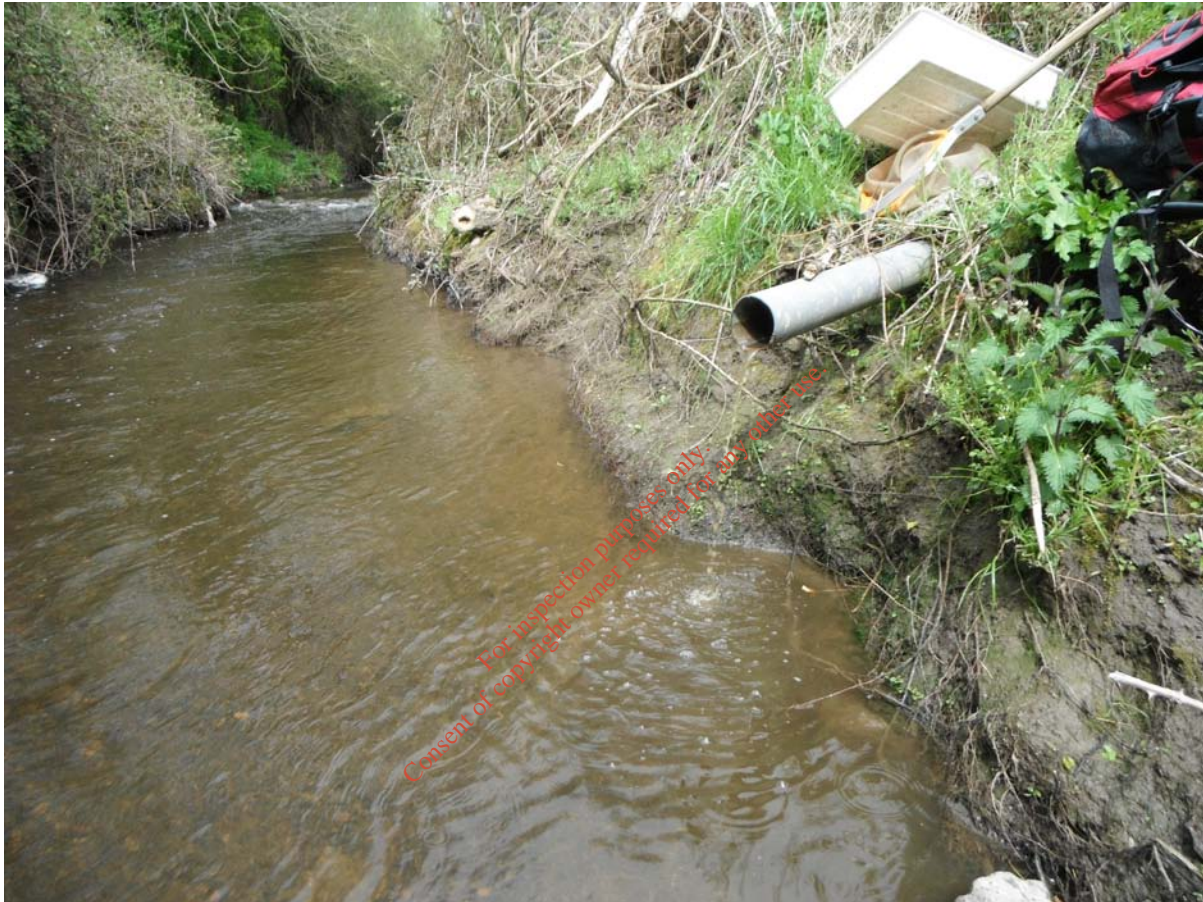
Photo 1. Sampling Site 1 - Doaally Bridge, Dooally River, Newcastlewest, Co. Limerick.

Dooally River Main Channel: The main Dooally River was sampled at three locations-see location map. Site 1 is located upstream of the landfill site, sites 2 and 3 are located upstream and downstream of the confluence of the drainage channel with the main channel. All three samples were indicative of a Q4 or unpolluted status. There was no deterioration in water quality up and downstream of the landfill site.

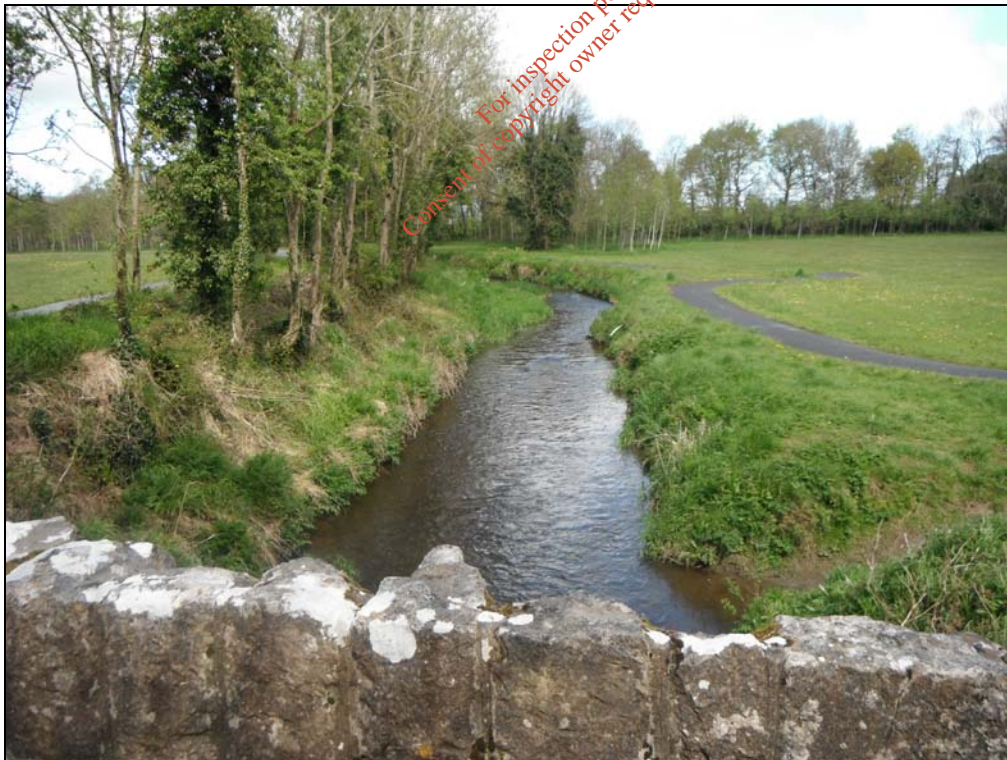
Photo 3. Site 3 – Dooally River, 150 meters downstream of landfill drain, Newcastlewest, County Limerick.

There is no reduction in biological water quality in the main channel of the Dooally River downstream of Churchtown historic landfill site.

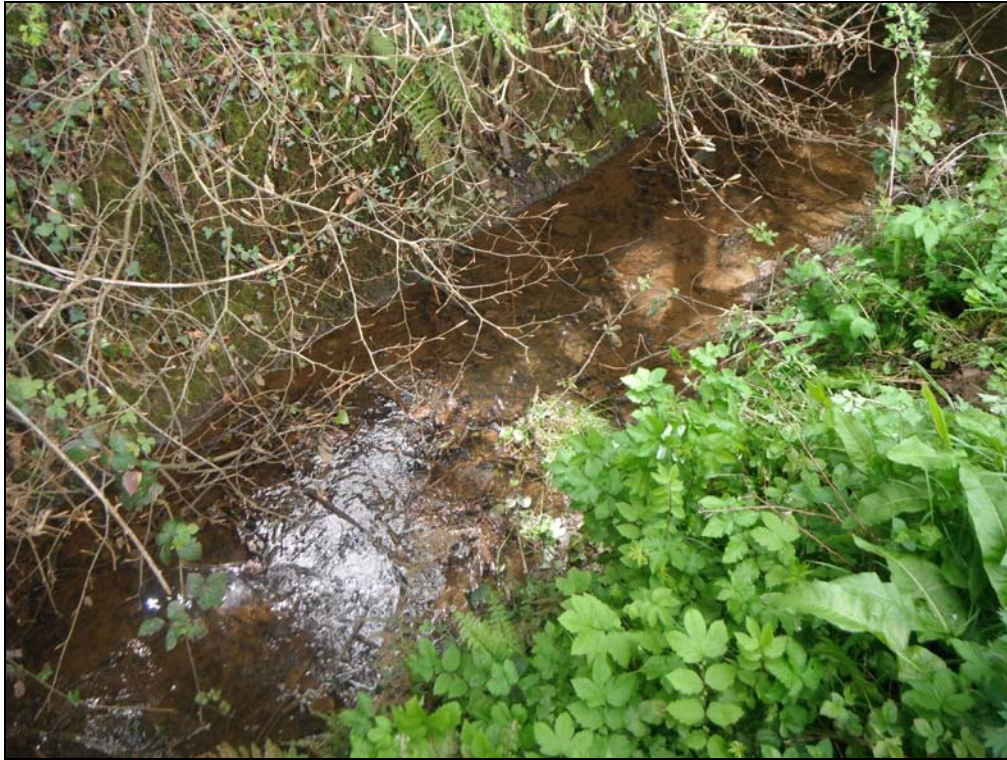
Photo 4. Site 4 – Landfill Drain at Churchtown, Newcastlewest County Limerick.

Drainage Channel The landfill drain was sampled close to its conference with the Dooally River at Site 4 (Photo 4). Only pollution tolerant invertebrates were present in the sample giving a Q1-2 rating (see Table 1). There were no other indications of the presence of organic

pollution, such as algae or sewage fungus which would normally be associated with a sample of invertebrates such as this. Dissolved oxygen here was 75% saturation at the time of sampling but the results of the kick sample suggest that more anoxic conditions are typically prevalent. The drain was sampled in 2012 as part of the Tier 2 Investigation and found not to have elevated parameters of contamination associated with landfill leachate – see Appendix 1 for results.

The drainage channel is not considered a suitable habitat for kick sampling due to its low and intermittent flows.

Further biological and chemical sampling on the drainage channel should be incorporated into the ongoing monitoring programme for Churchtown landfill site.
