Tier 1 Environmental Risk Assessment

Illegal Landfill site

Back Field rear of St Munchin's St

St Marys Park

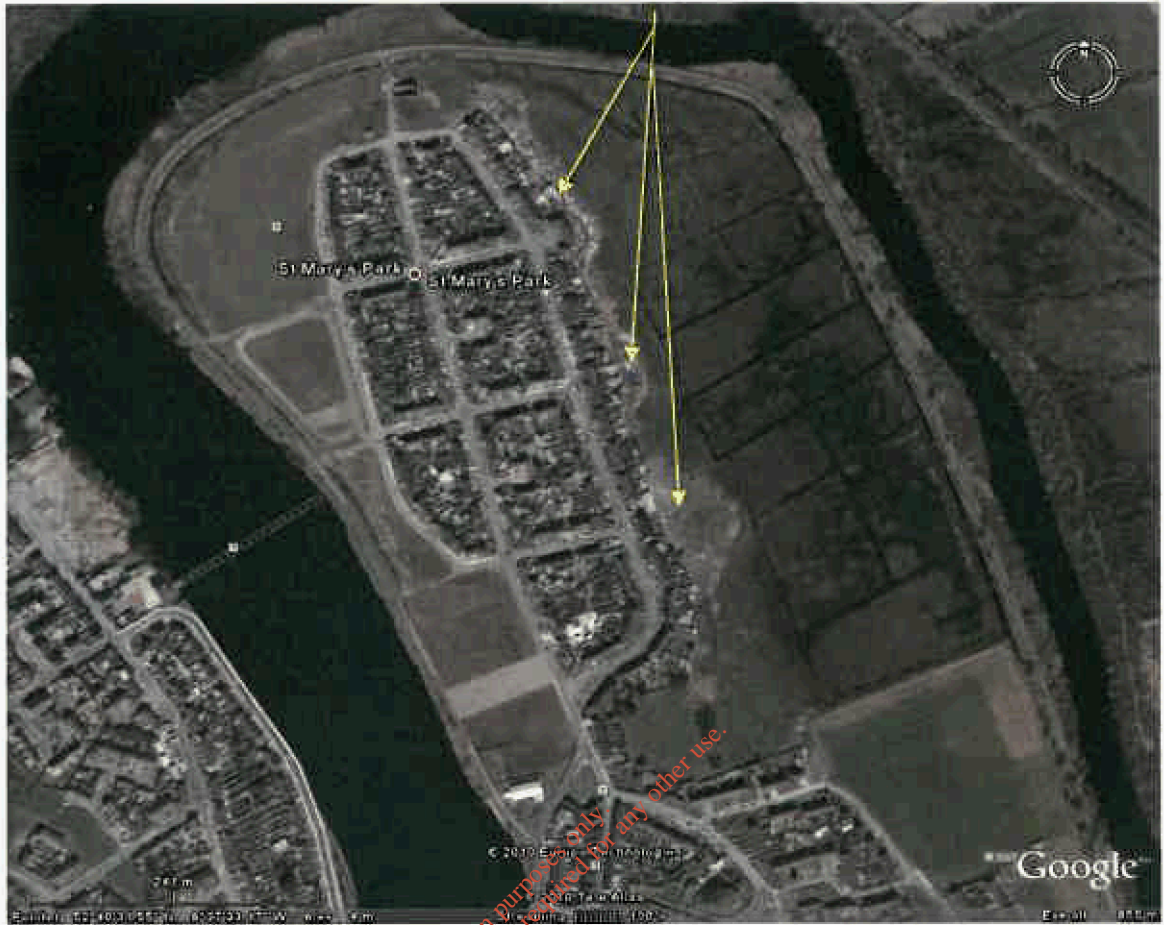
Aerial Photograph from Google Earth (2010)
Area where illegal dumping has occurred.

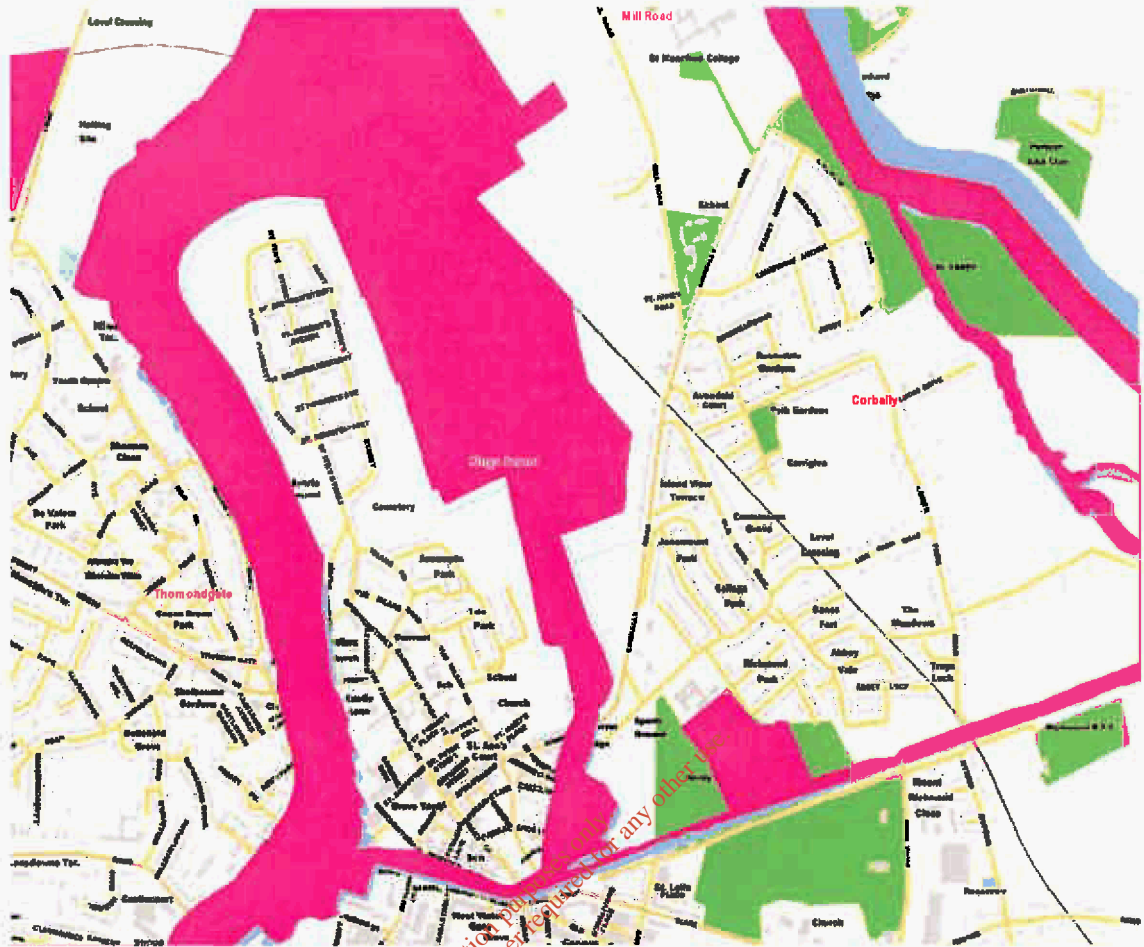
Special Area of Conservation outlined in pink

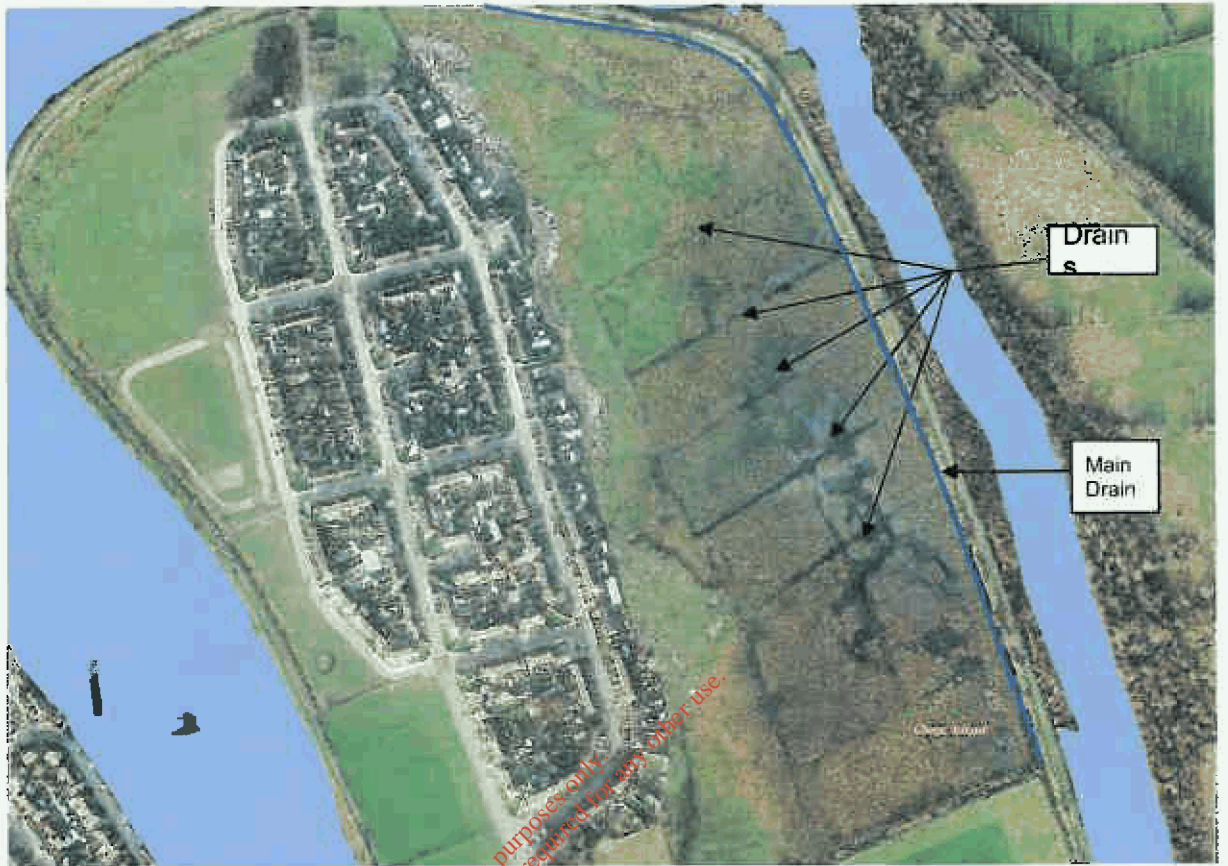
Aerial Photograph from 2004 showing drains

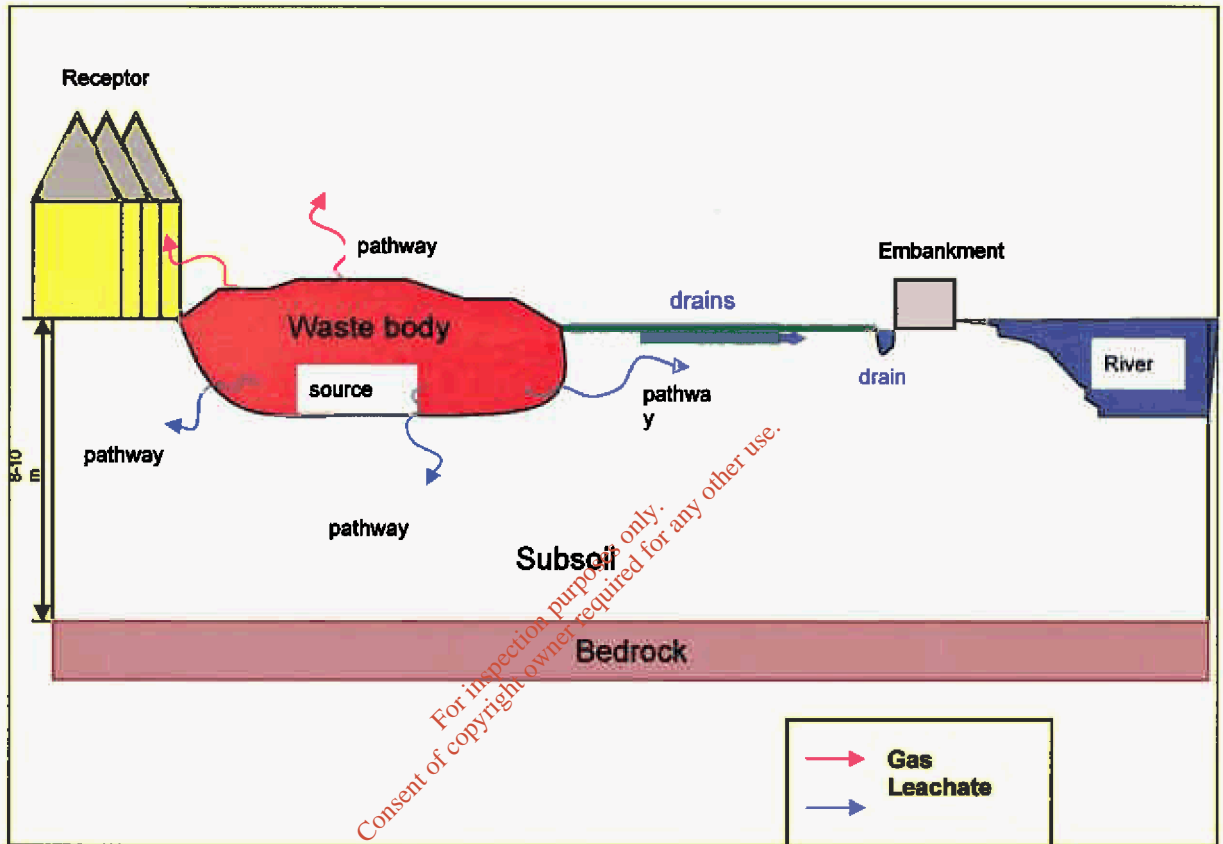
Conceptual Site Model

SPR 8 & SPR 9 > 50% - the site is classified as Class B (moderate risk).
The main issue is the surface water drainage / runoff to the river.
