# TIER 2/3 ENVIRONMENTAL RISK ASSESSMENT

LIMERICK CITY COUNCIL SITE  
ST. MARY'S PARK  
LIMERICK

## APPENDIX 5

### PHOTOS

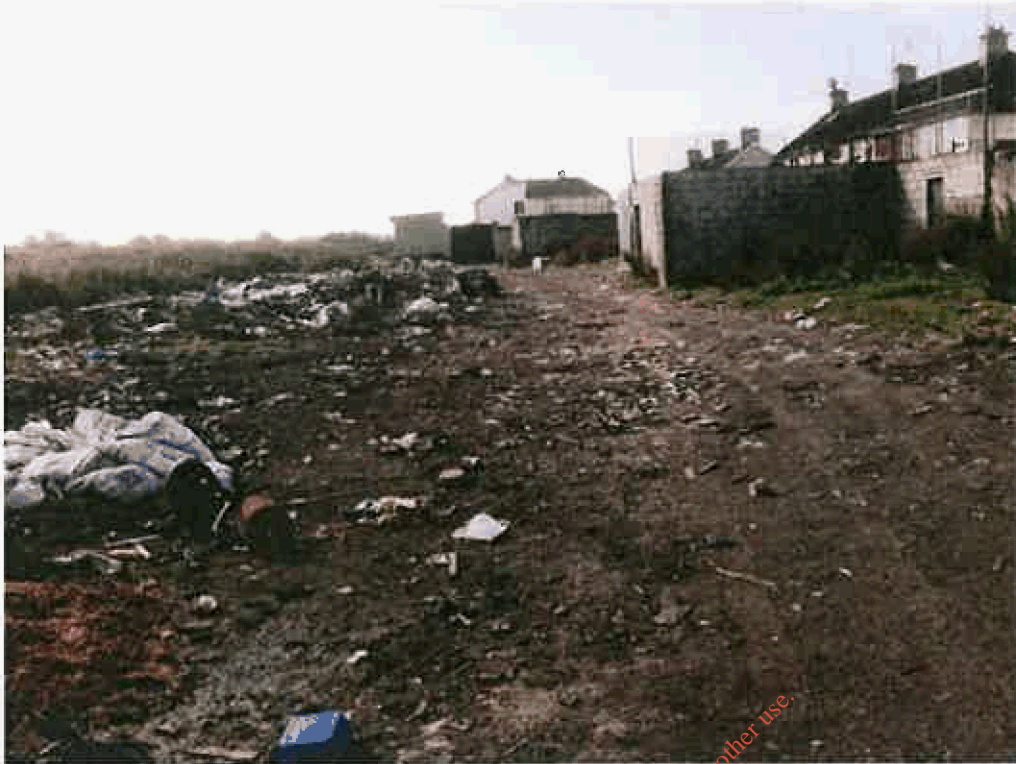
Photo 1 - Access road between rear of houses and the landfill

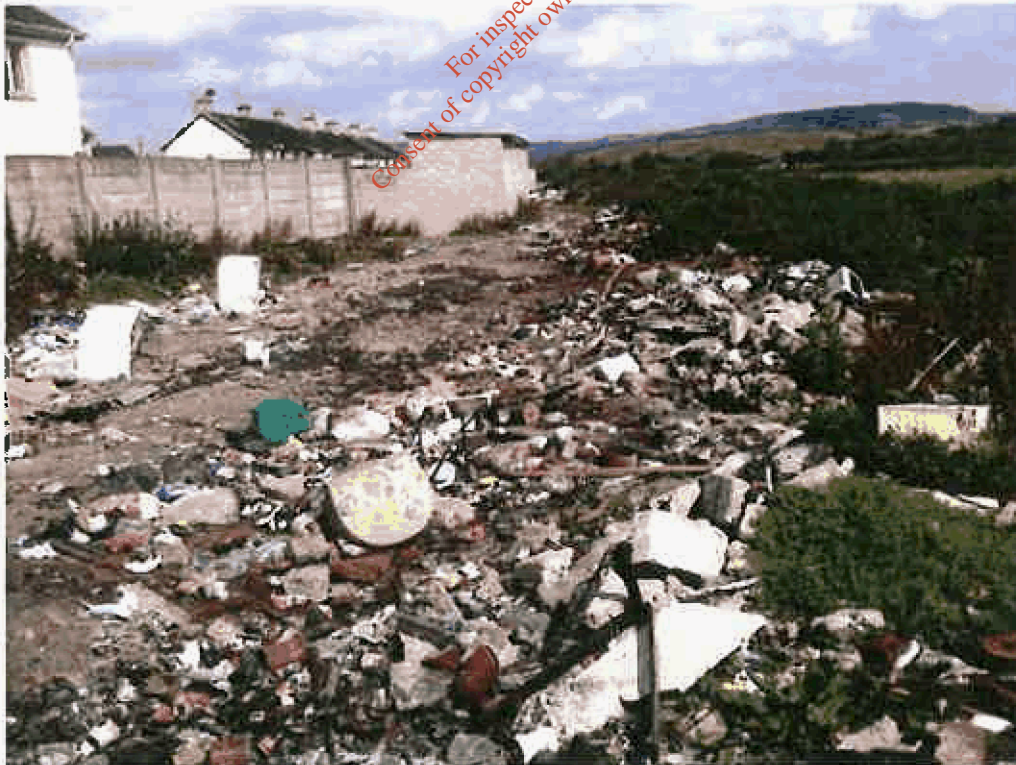
Photo 2 - Type of waste visible on surface of the landfill

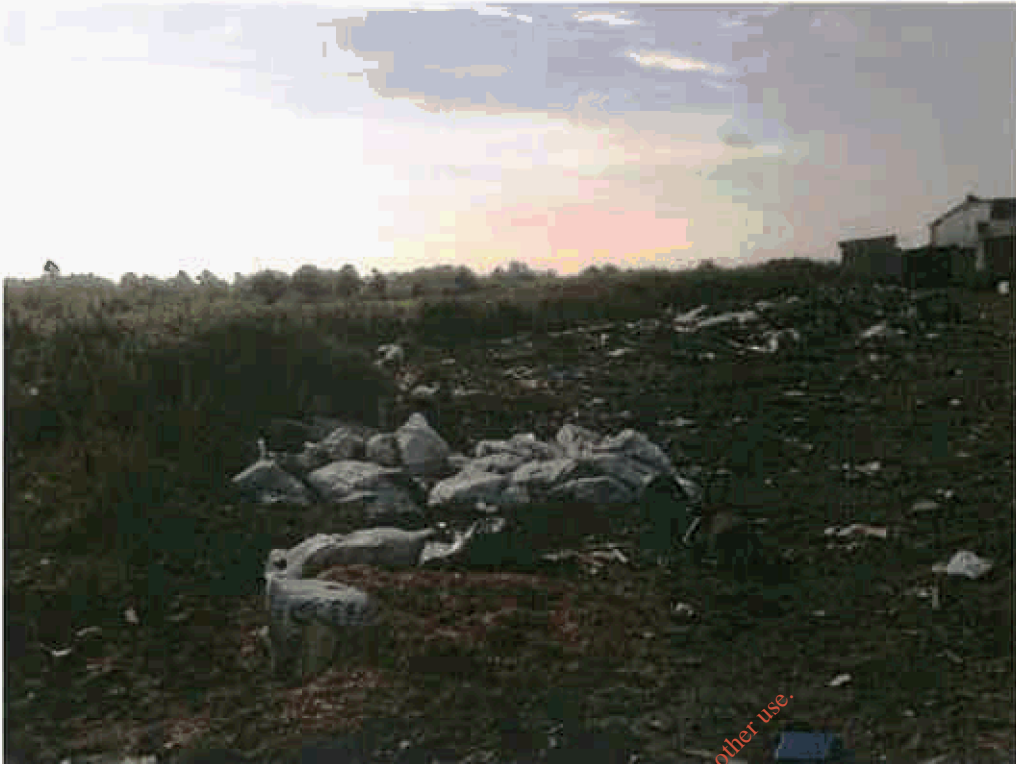
Photo 3 - Manure and other mixed wastes becoming overgrown on the landfill

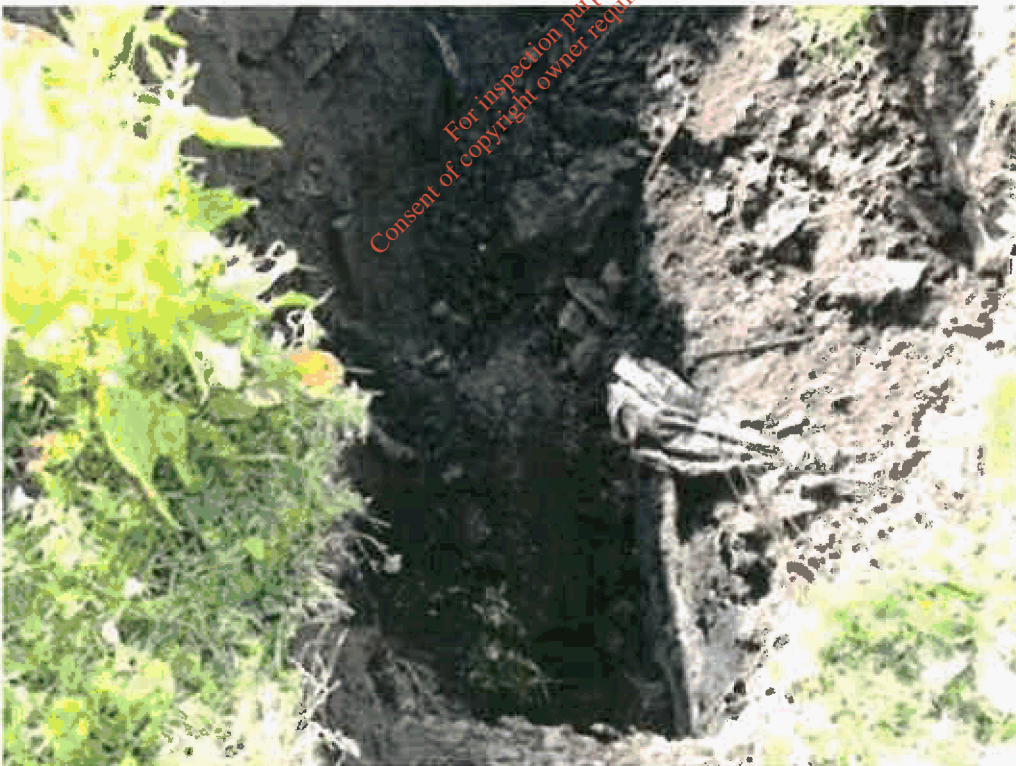
Photo 4- Trial pit excavations showing buried mixed waste beneath
