ARTICLE 14 RESPONSE

Churchtown Landfill Site

IBR1015
Article 14 Response
Final
16 July 2019

Donegal County Council

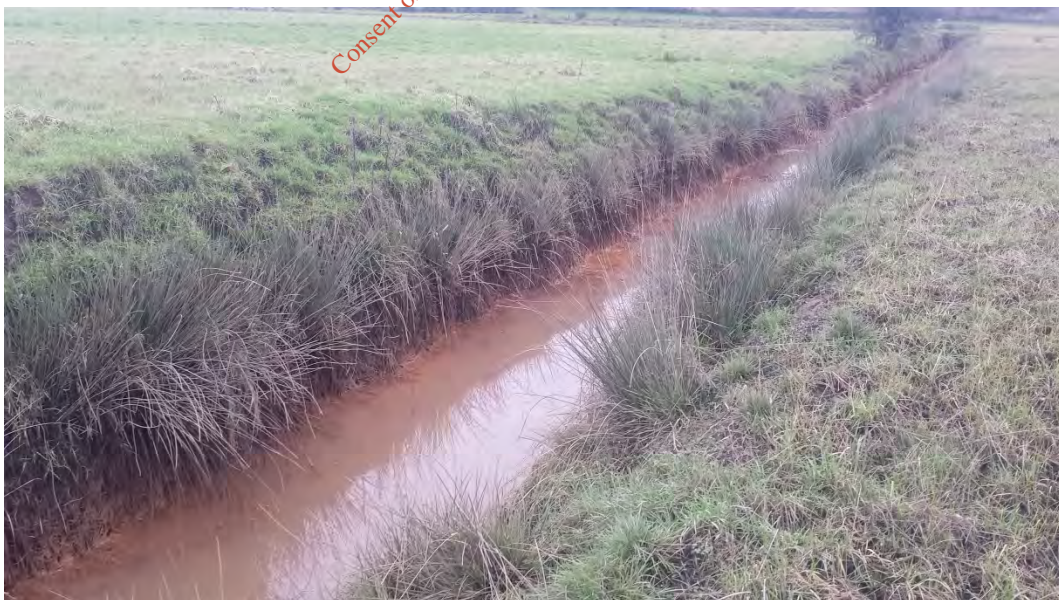
Visual evidence of potential leachate impact on the surface waters in the vicinity of the landfill was observed during the site walkover as is evident in **Photo 5.1**. However, this impact is likely to have been caused prior to current works being undertaken at the site with no observed leachate breakout from the site noted post completed capping works. As mentioned above, leachate will not be contained at the site until completion of the M&E works.

Photo 5.1 Surface water Drain to southwest of waste body

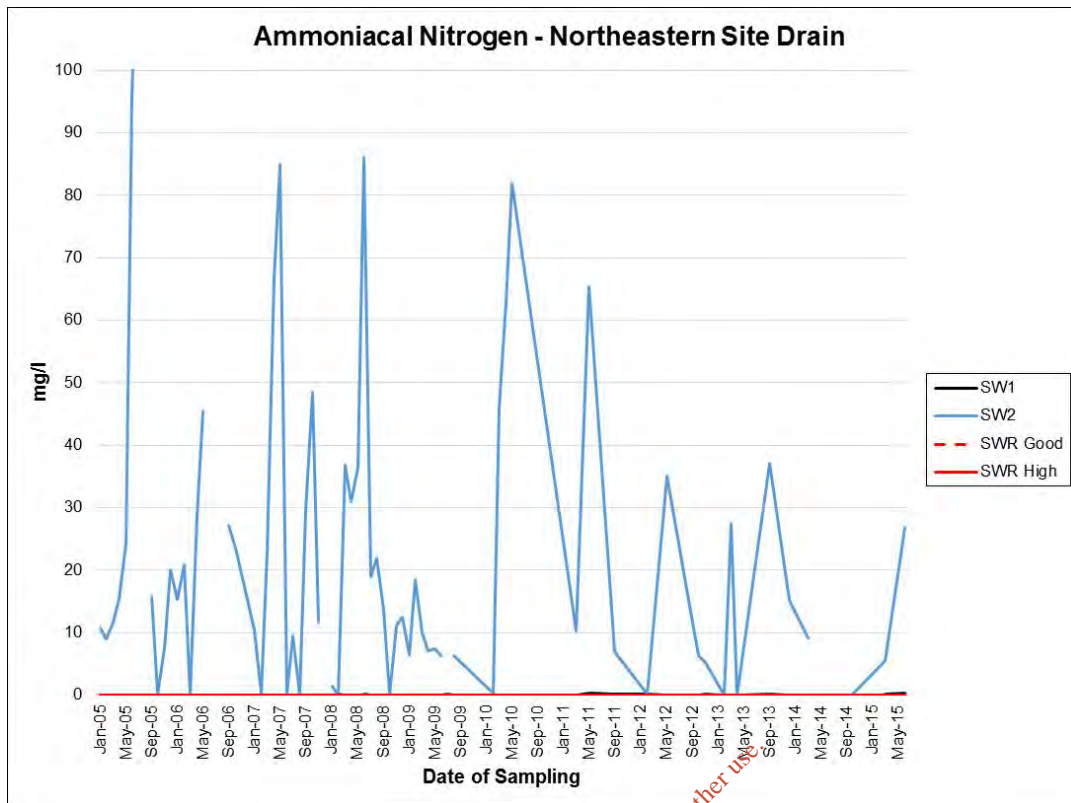
Figure 8.8 Northeastern Drain - Ammoniacal Nitrogen Levels

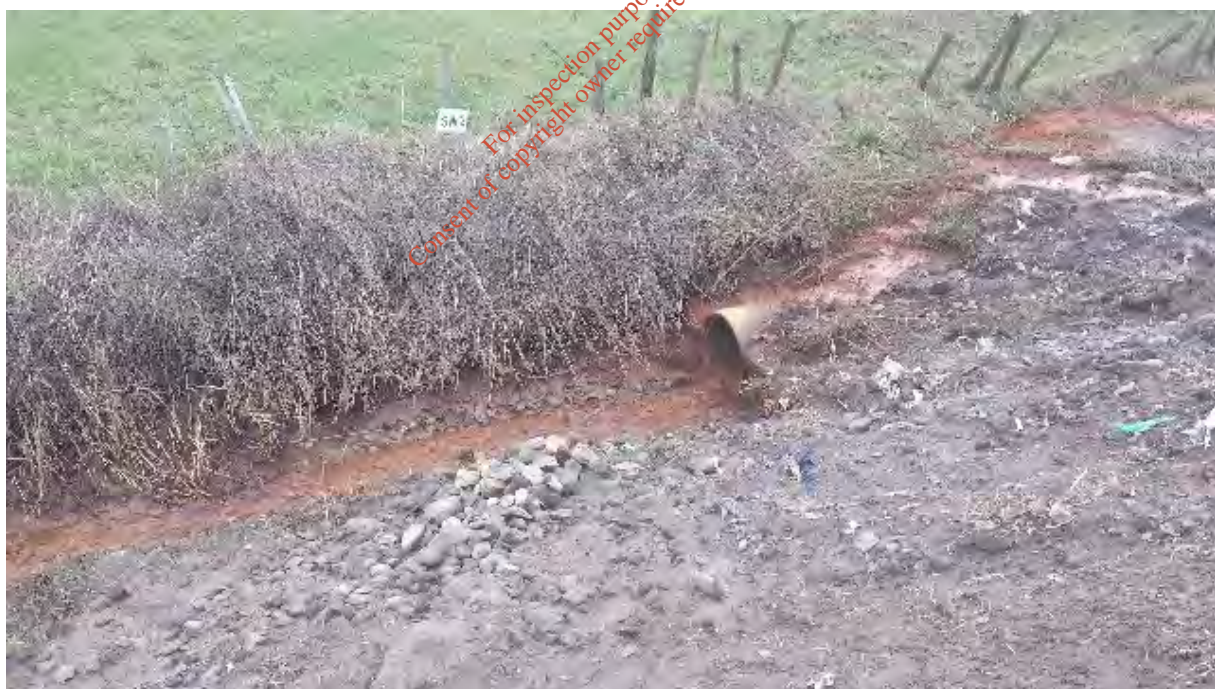
Figure 8.9 Leachate Impact within Northeastern Boundary Drain pre-restoration

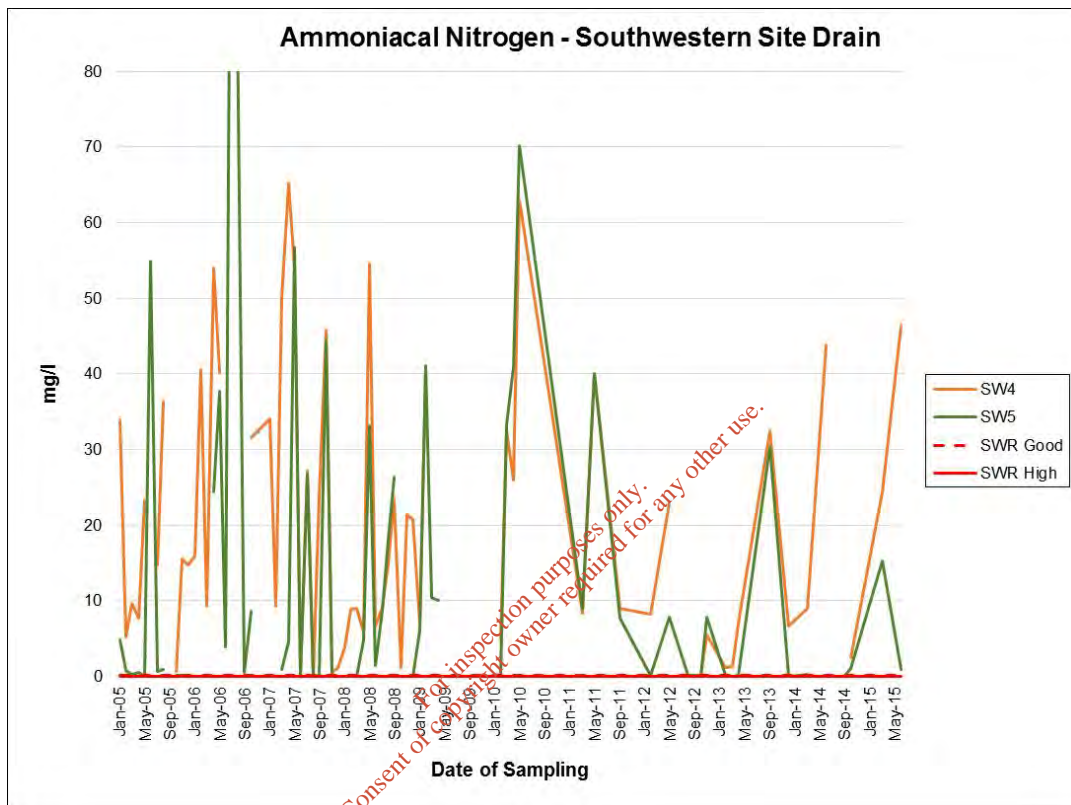
Elevated levels of Ammoniacal Nitrogen have been recorded within the southwestern boundary drain (see **Figure 8.10**) within samples **SW4** and further downgradient at **SW5**. The levels within SW4 range between 0.01 and 65.3 mg/l and within SW5 ranging between 0.01 and 151 mg/l. The levels recorded vary over time with broadly reducing levels noted between 2010 and 2014. However, increased levels have been noted in both locations since mid-2014.

The high levels of Ammoniacal Nitrogen in this drain are, similar to the northeastern drain, resultant from landfill leachate during a time when leachate was allowed to be dispersed to this drain from the flanks of uncapped landfill. These levels are expected to decrease significantly following completion of all remedial works at the site.

Figure 8.10 Southwestern Drain - Ammoniacal Nitrogen Levels

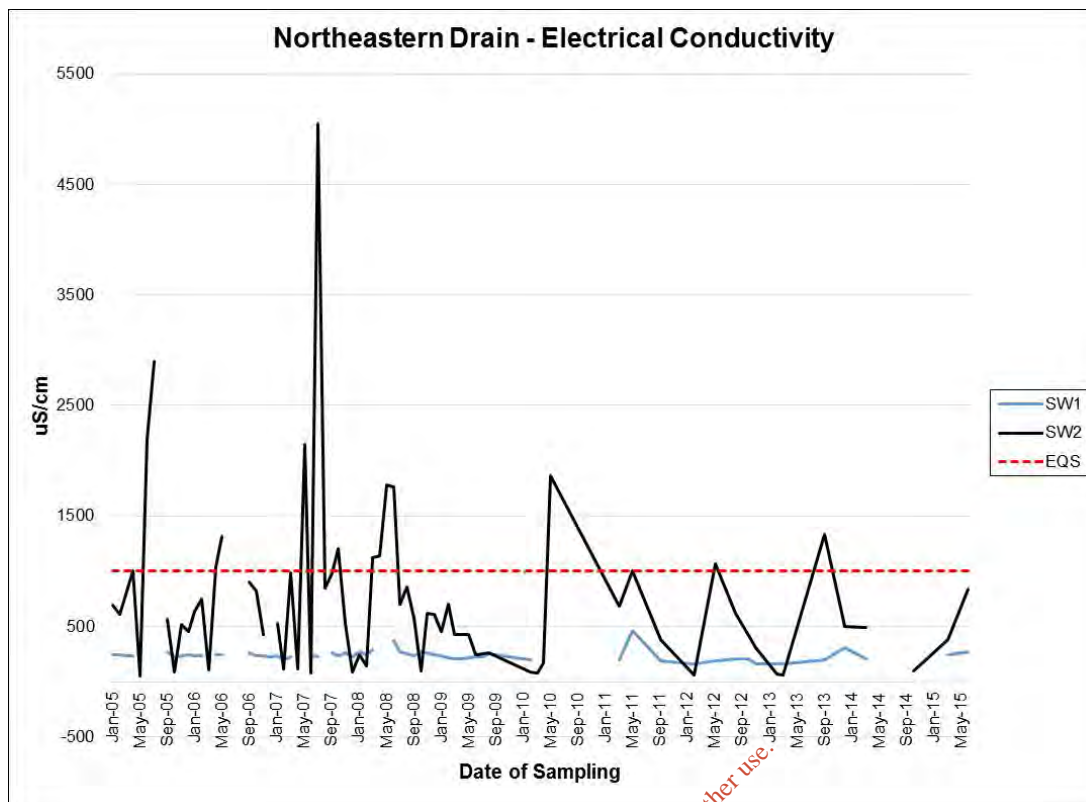
Upgradient EC levels within the northeastern boundary drain *i.e.* **SW1**, are consistently recorded between 200 and 300 $\mu\text{S}/\text{cm}$ whereas EC levels in downgradient sample location, **SW2**, typically recorded a notable increase in EC levels (see **Figure 8.11**) ranging between 50 and 5050 $\mu\text{S}/\text{cm}$.

Figure 8.12 Northeastern Drain - Electrical Conductivity
