TIER 1 RISK ASSESSMENT

FORMER MUNICIPAL HISTORIC LANDFILL

FORMER KINGSCOURT HISTORIC LANDFILL

Walkover Survey Checklist – Kingscourt Dumping Ground

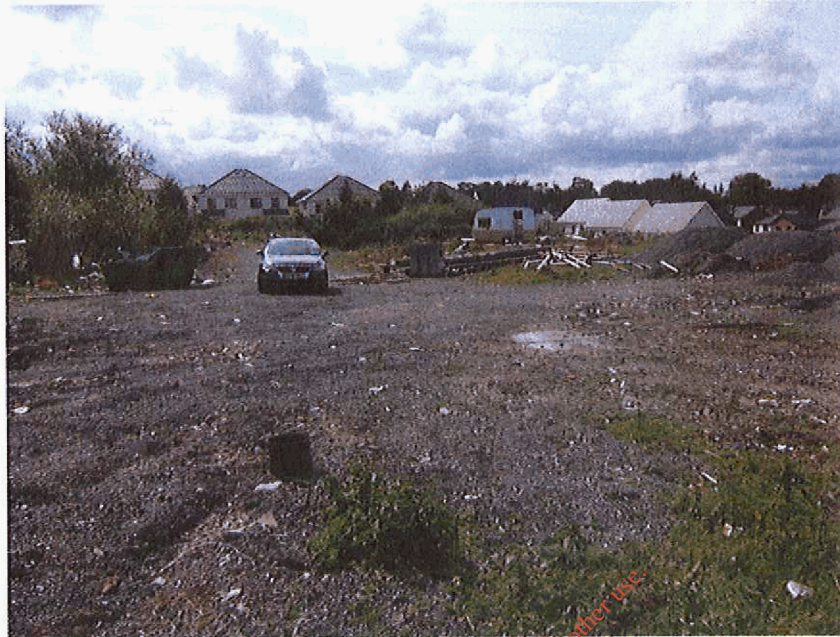
Photo No. 1 – Litter on the upper section of the site.

Replacement of fencing on the eastern perimeter and the removal of litter from the upper sections of the site. Further works may be required depending on site investigations.

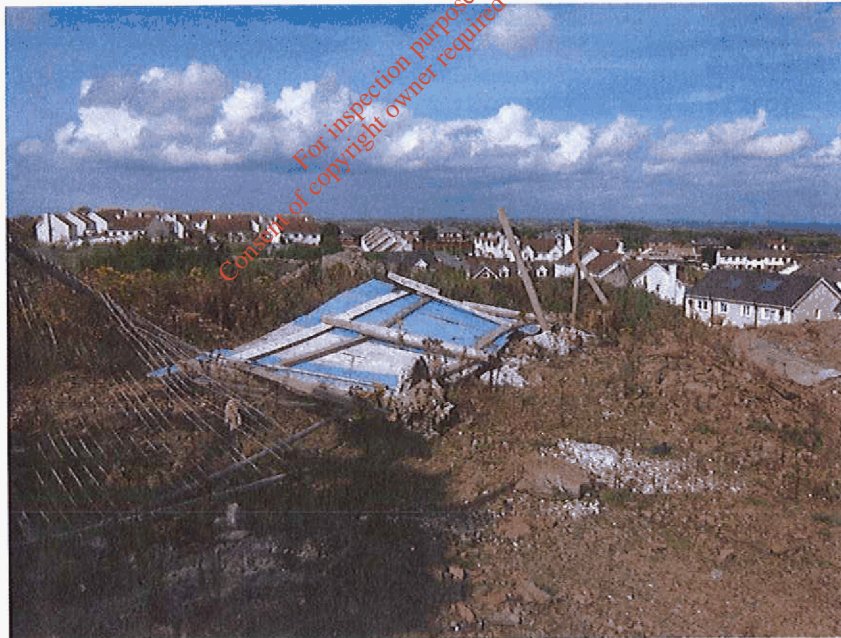
9. Are there any indications of remedial measures? (Provide details)	√	Mesh wire fencing on the northern perimeter with access gates. Wooden fencing on the eastern perimeter. The said fencing has collapsed and requires replacement (refer to photo No. 2).
Capping	√	Possible capping with clay as no waste was observed protruding from the waste body.
Landfill gas collection	√	None evident.
Leachate collection	√	None evident.

Photo No. 2 – Collapsed fencing on eastern perimeter.

10. Describe fences and security features (if any)	√	As above (section 9).
Any other relevant information?	√	N/A
Health & Safety	√	Replacement of fencing on the eastern perimeter. Lands adjacent to the said location have been recently excavated leaving exposed rock faces. Risk of fall from a height by members of the public (refer to photo No. 3).
Remediation	√	Replacement of fencing on the eastern perimeter. Removal of litter from the upper section of the site. Ensure all access points to the site are secured to prevent public access.
General Comments The site was an old quarry and (possibly) deeply infilled with waste. There were no watercourses or drainage ditches in the vicinity of the site thus groundwater would be a potential receptor. The rock is predominately shale (as observed from the undeveloped site on the south eastern perimeter). The area surrounding the site has been heavily developed over the past five years with housing estates enveloping the site. The dump site is located in a densely populated area and therefore public access to the site should be restricted by adequate fencing and warning signage.

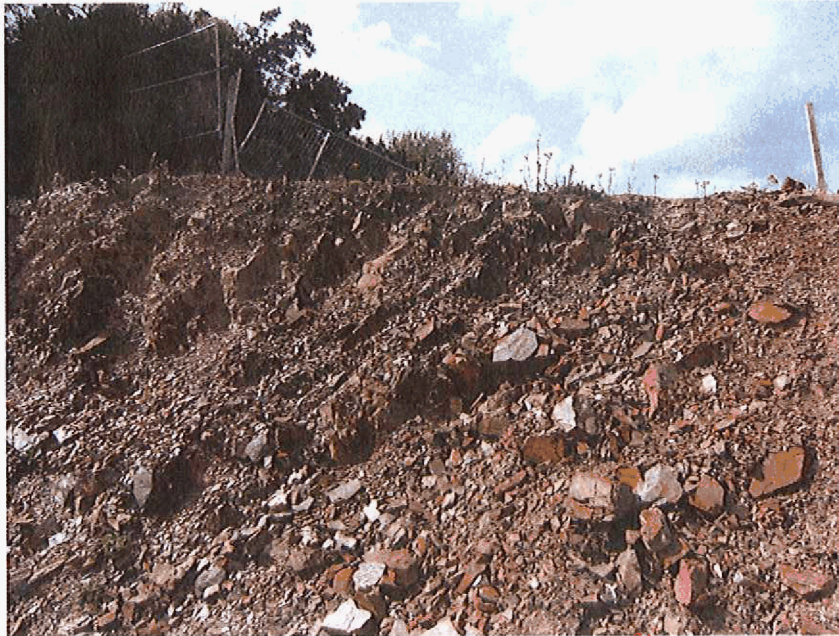
Photo No. 3 – Exposed rock faces on the eastern perimeter.
