TIER 1 RISK ASSESSMENT

FORMER KINGSCOURT HISTORIC LANDFILL

DUNAREE

Historic Unlicensed Sites – Site Registration

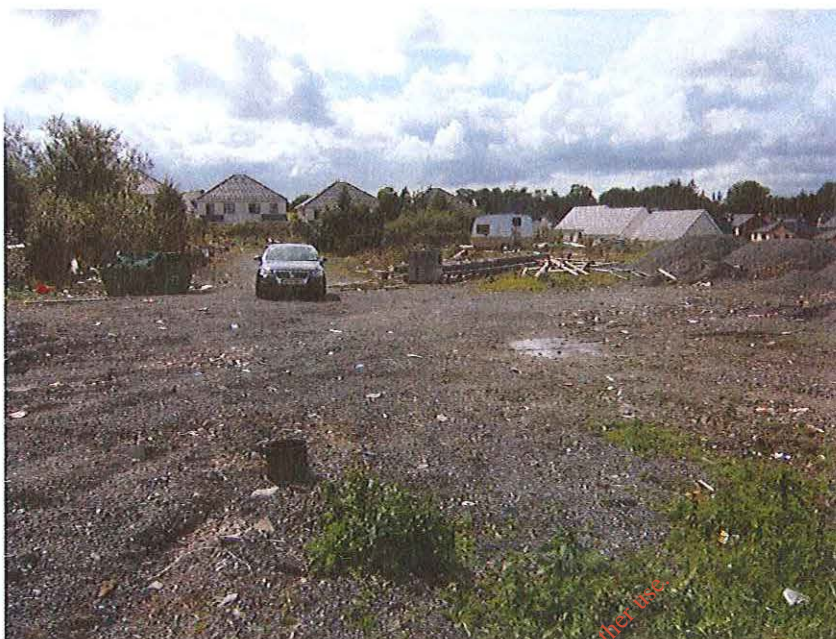
Photo No. 1 – Litter on the upper section of the site.

Replacement of fencing on the eastern perimeter and the removal of litter from the upper sections of the site. Further works may be required depending on site investigations.

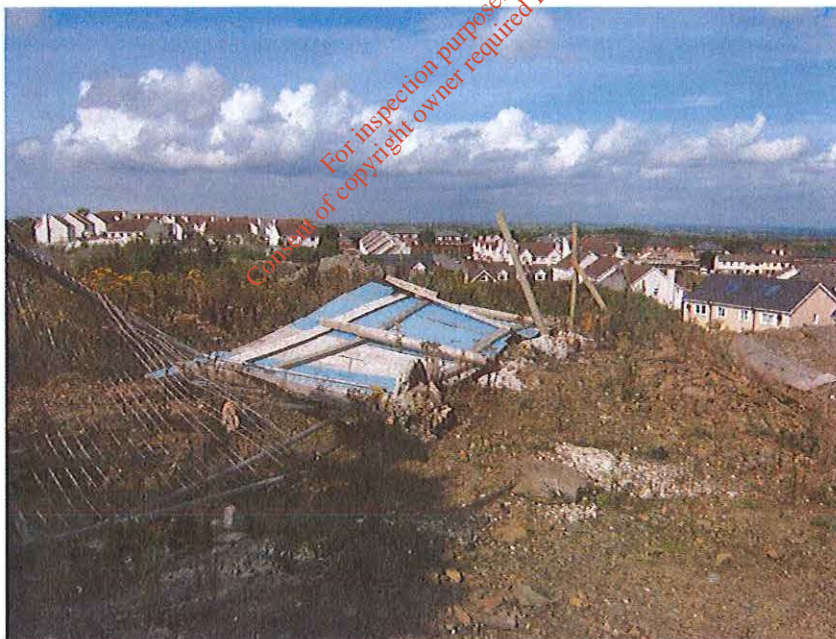
9. Are there any indications of remedial measures? (Provide details)	√	Mesh wire fencing on the northern perimeter with access gates. Wooden fencing on the eastern perimeter. The said fencing has collapsed and requires replacement (refer to photo No. 2).
Capping	√	Possible capping with clay as no waste was observed protruding from the waste body.
Landfill gas collection	√	None evident.
Leachate collection	√	None evident.

Photo No. 2 – Collapsed fencing on eastern perimeter.

10. Describe fences and security features (if any)	√	As above (section 9).
Any other relevant information?	√	N/A
Health & Safety	√	Replacement of fencing on the eastern perimeter. Lands adjacent to the said location have been recently excavated leaving exposed rock faces. Risk of fall from a height by members of the public (refer to photo No. 3).
Remediation	√	Replacement of fencing on the eastern perimeter. Removal of litter from the upper section of the site. Ensure all access points to the site are secured to prevent public access.
General Comments The site was an old quarry and (possibly) deeply infilled with waste. There were no watercourses or drainage ditches in the vicinity of the site thus groundwater would be a potential receptor. The rock is predominately shale (as observed from the undeveloped site on the south eastern perimeter). The area surrounding the site has been heavily developed over the past five years with housing estates enveloping the site. The dump site is located in a densely populated area and therefore public access to the site should be restricted by adequate fencing and warning signage.

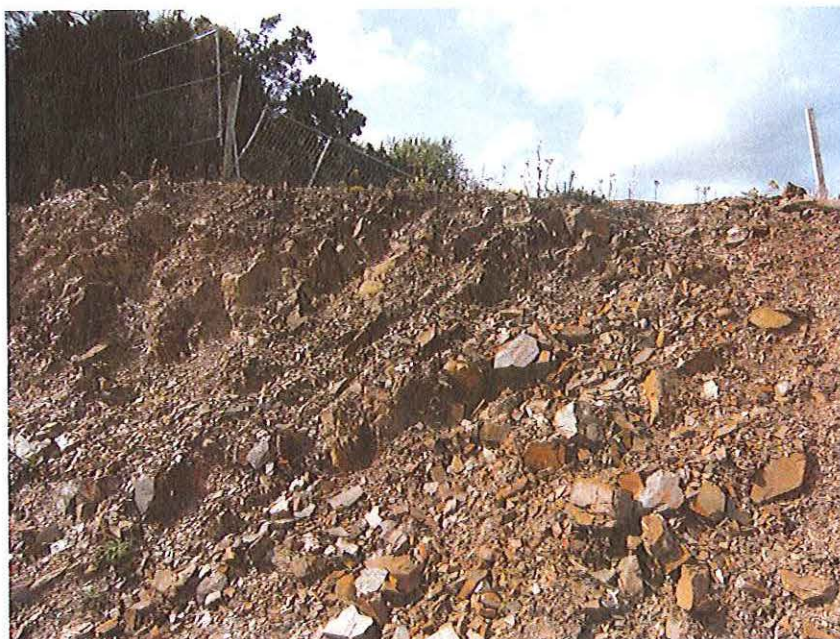
Photo No. 3 – Exposed rock faces on the eastern perimeter.
