TIER 1 RISK ASSESSMENT

FORMER MUNICIPAL HISTORIC LANDFILL

POTTLEBOY

COOTEHILL

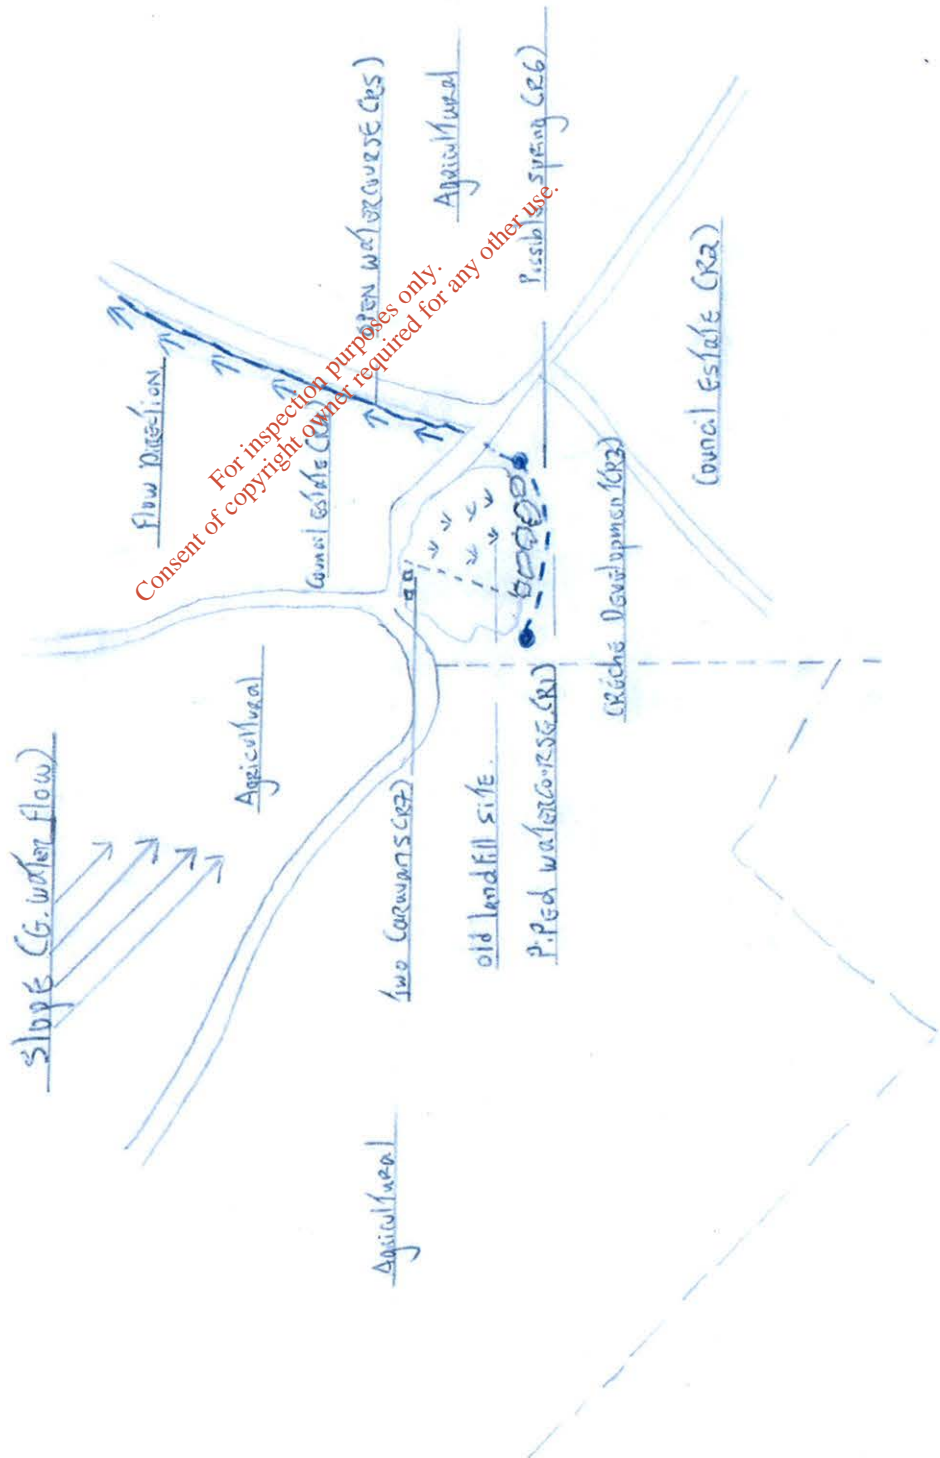
Site Plan

R1/R6 ~ Receptors
