TIER 1 RISK ASSESSMENT

FORMER MUNICIPAL HISTORIC LANDFILL

RANTAVAN

ENVIRONMENTAL RISK ASSESSMENT

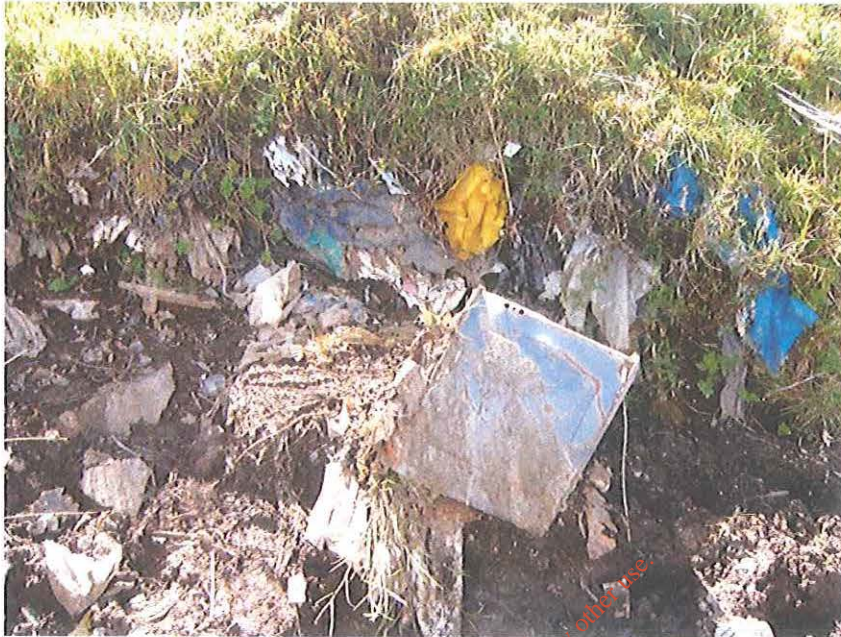
The site is currently grazed by local livestock and is bordered by grassland on the northern and eastern boundary and forestry and scrubland on the southern and western boundary. Waste material protrudes through the capping layer and encroaches on the nearby watercourse (refer to photo No. 1). The site is secure and delineated by mesh wire fencing along the southern perimeter.

Photo No. 1 – Waste protruding from waste body.

The importation of soil and the covering of exposed waste protruding from the waste body. The installation of mesh fencing on the northern and eastern perimeter to prevent livestock access. The piping of the watercourse on the northern and eastern perimeter to prevent interaction with the waste body.

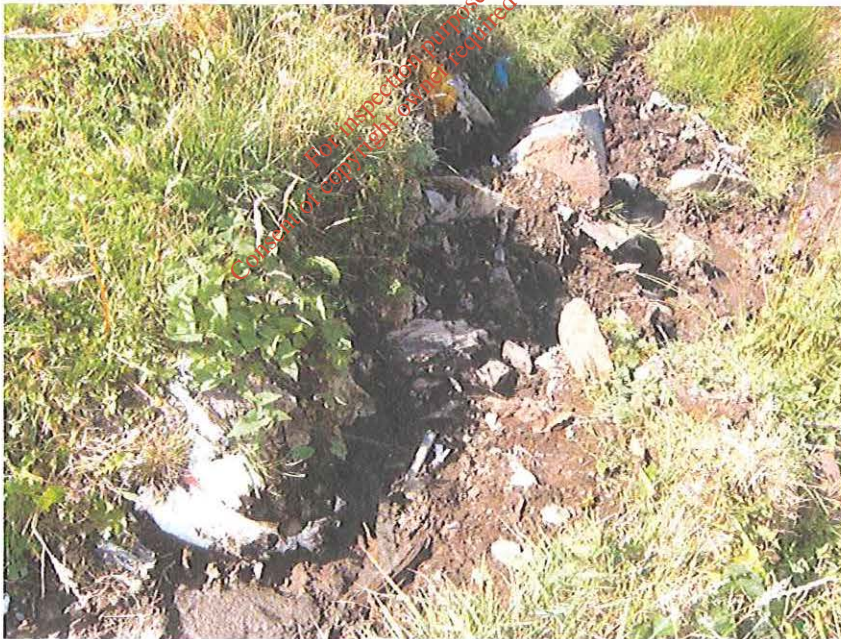
The main receptor is the watercourse on the northern and eastern aspect of the site which is immediate to the site boundary. The watercourse appears discoloured which may be attributed to the dumping ground (refer to photo No. 2). Dwelling houses were noted on the northern, north eastern and south eastern aspect which range from 160 – 340 m from the site boundary. The dwellings in the area are serviced by Mullagh Public Water Supply with the exception of one dwelling which is serviced by a private well (approximately 340 m from the site boundary).

Photo No. 2 – Waste protruding from waste body.

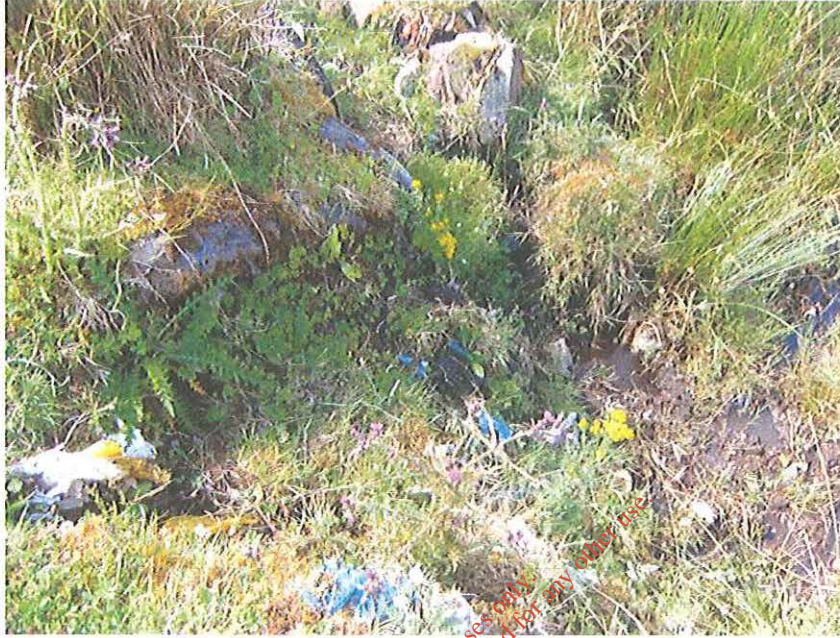
6. Are there any potential sources of contamination (if yes, give details)?	√	Waste protruding from the waste body on the northern and eastern perimeter of the site. The said waste is encroaching on the watercourse due to insufficient soil coverage (refer to photo No. 1, 2 & 3).
Surface waste (if yes, what type?)	√	Surface waste observed which included car tyres, car bumpers, glass bottles, plastic etc (refer to photo No. 4 & 5).
Surface ponding of leachate	√	None evident.
Landfill gas odours	√	None detected – downwind of site (N.E. breeze blowing during time of inspection).

Photo No. 3 – Waste encroaching on watercourse.

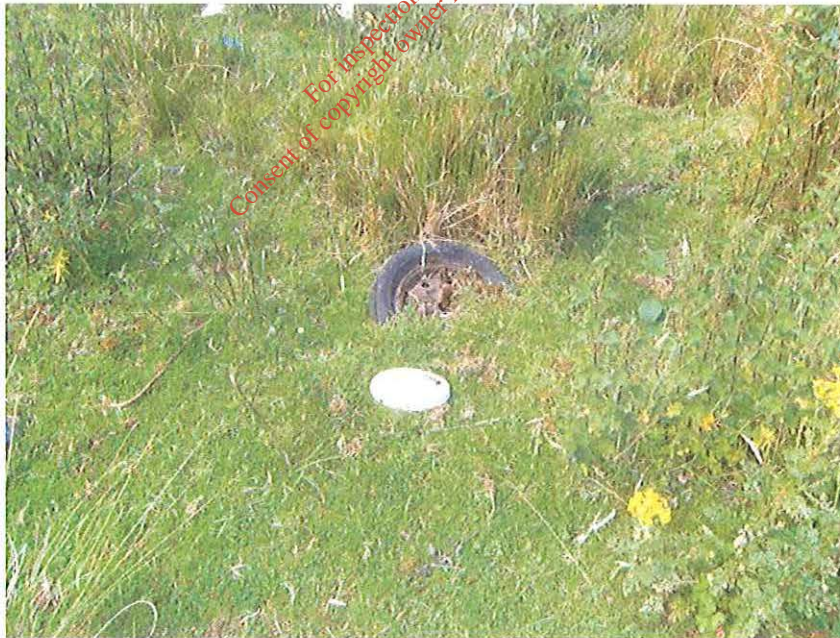
8. Are there any signs of impact on the environment? (If yes, take photographic evidence)	√	Surface waste protruding from the waste body (refer to photo No. 4 & 5). Waste protruding from side of waste body along watercourse.
Vegetation die off, bare ground	√	None evident.
Leachate seepages	√	None evident.
Odours	√	None detected.
Litter	√	None evident. The roadway bordering the site was free from litter.
Gas bubbling through water	√	None evident.
Signs of settlement,	√	None evident.
subsidence, water logged areas	√	Water logged area approx. 20 from gate entrance.
Drainage or hydraulic issues	√	As above.
Downstream water quality appears poorer than upstream water quality	√	Downstream water quality appeared poorer than upstream (refer to photo No. 6 & 7). Watercourse appeared somewhat discoloured down slope of the

Photo No. 4 – Surface waste.

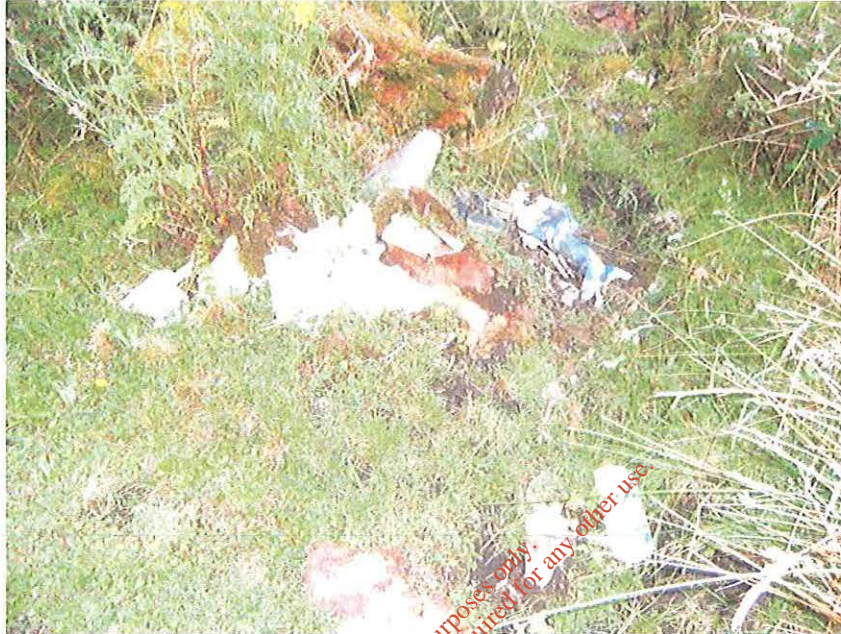
Photo No. 5 – Surface waste.

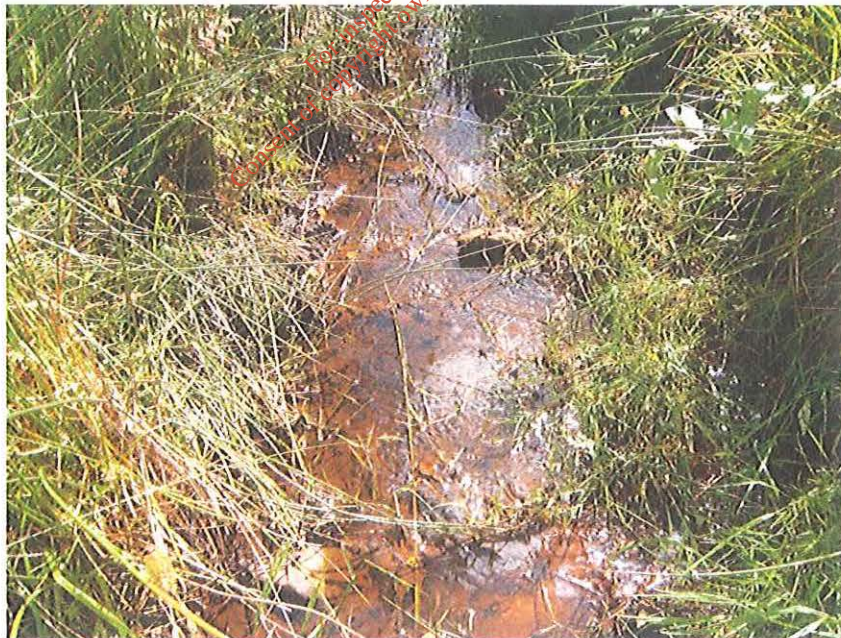
Photo No. 6 – Discoloration in watercourse.

The watercourse immediate to the site boundary appeared discolored. Possible impact due to the waste body encroaching on the watercourse. Further investigations are required to validate same.

Watercourse immediate to site boundary appeared discolored. Further investigations i.e. sampling is required to validate same.

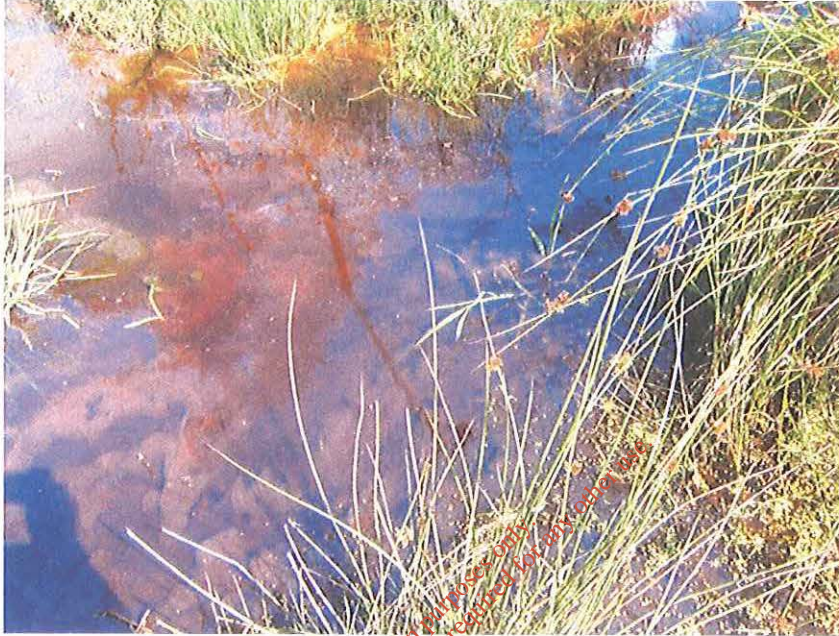
waste body (note: cattle encroaching on the said watercourse and may be impacting on water quality).
9. Are there any indications of remedial measures? (Provide details)	√	Installation of mesh wire fencing along roadway and possible capping with clay.
Capping	√	As above.
Landfill gas collection	√	None evident.
Leachate collection	√	None evident.

Photo No. 7 – Discoloration in watercourse.
