TIER 2 RISK ASSESSMENT

FORMER MUNICIPAL HISTORIC LANDFILL

RANTAVAN

MULLAGH

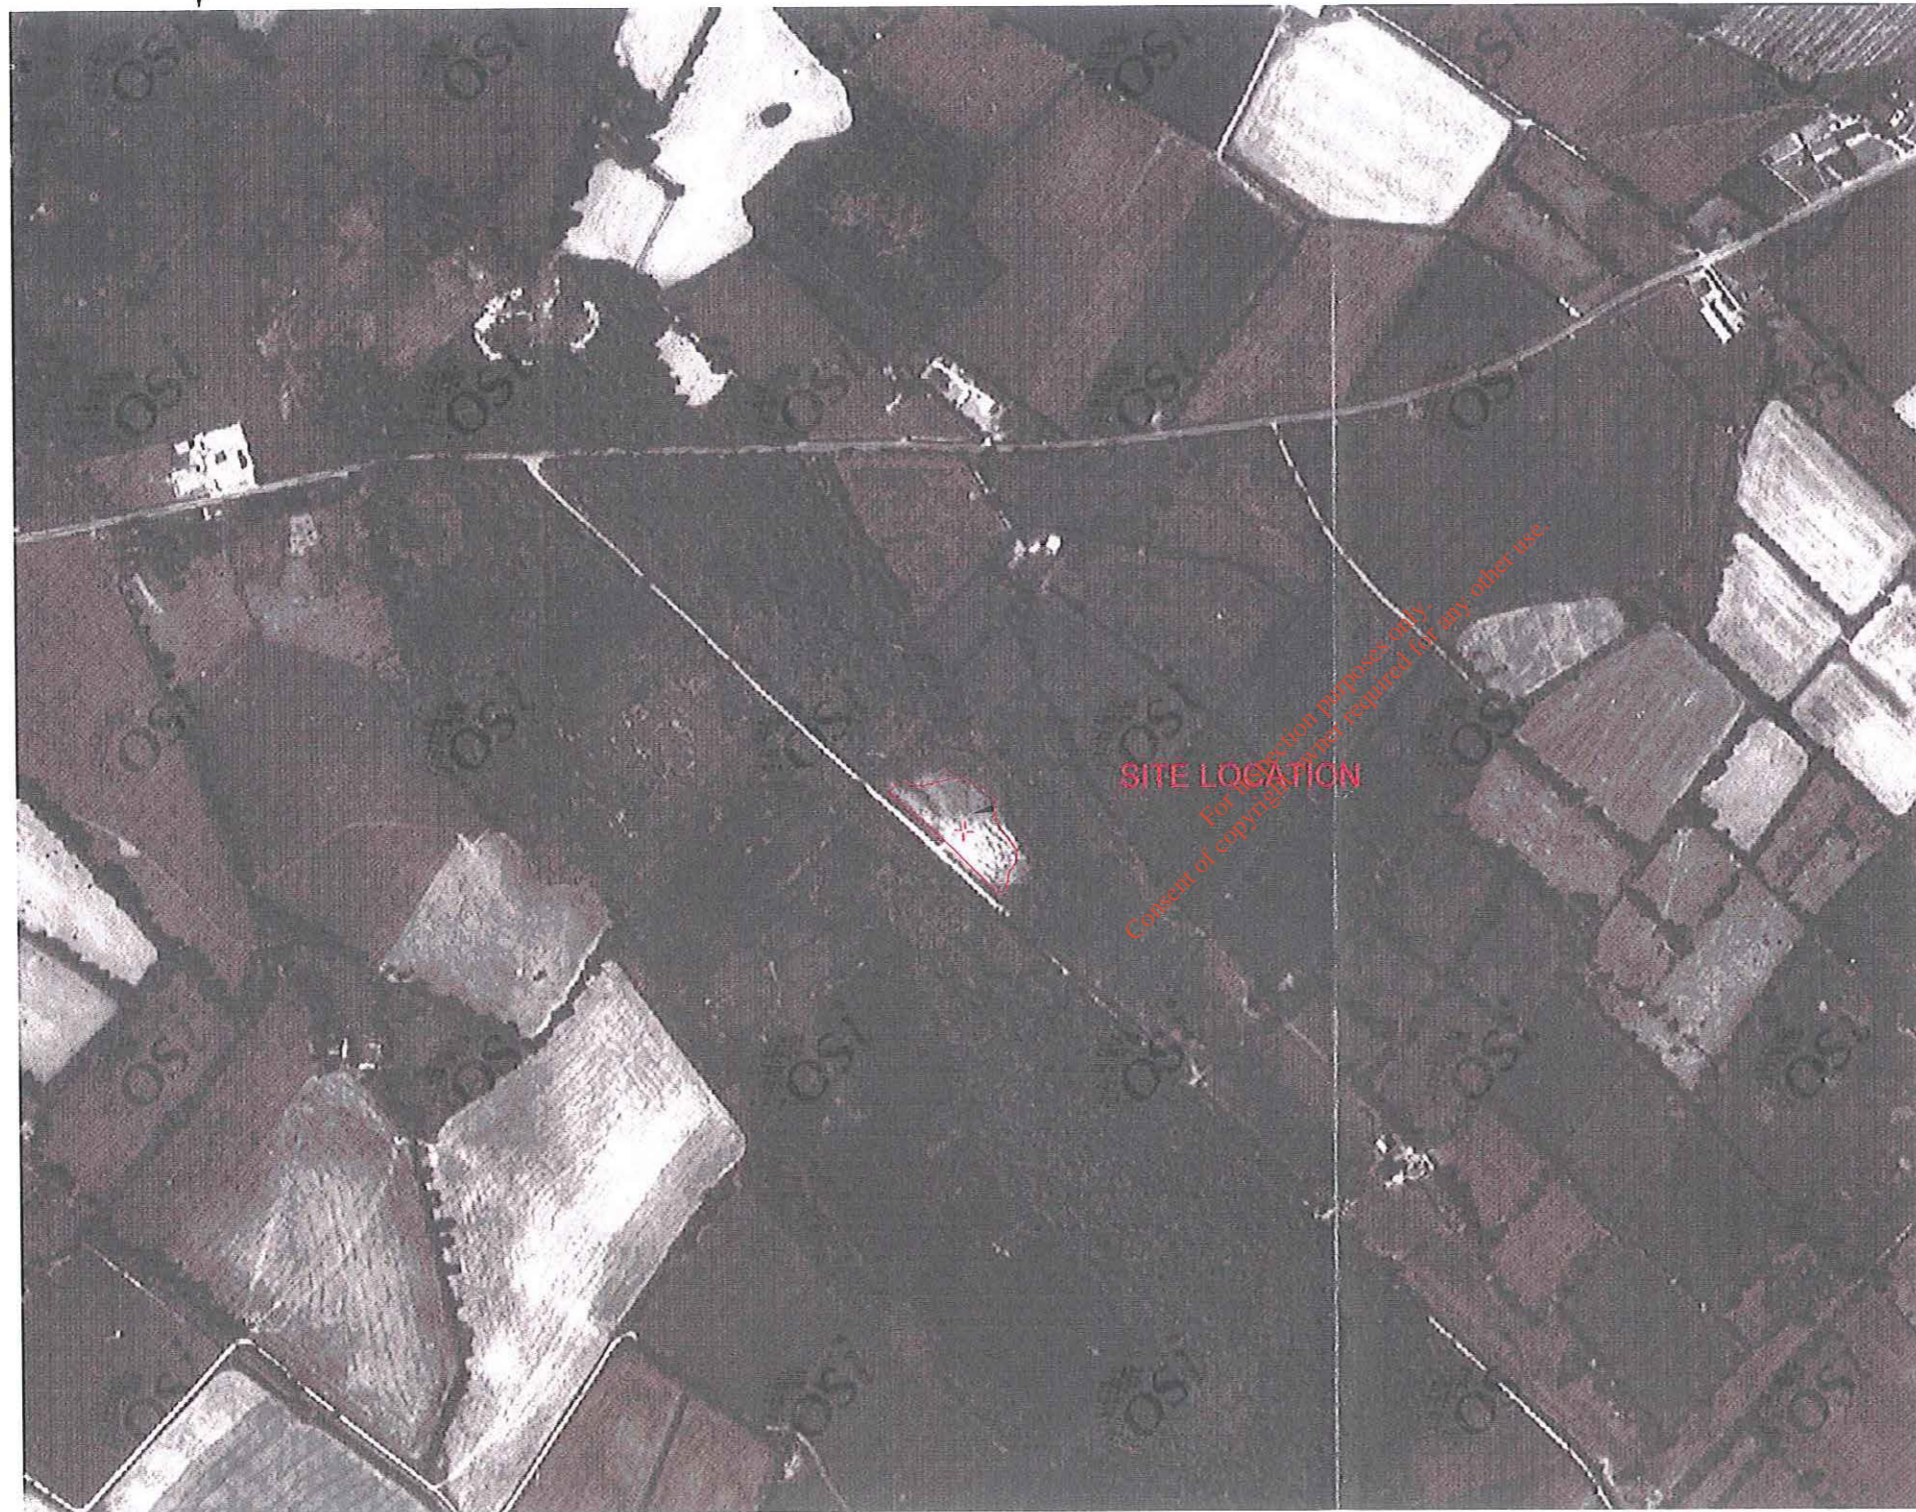
DRAWING No.	REV.
10-198-003

Tipping on the site had ceased by 1989. The outline of the landfill and its waste material can be observed on aerial photography 1995 (Drawing No. 10-198-003). Again the site appears to have been a local and largely informal tip rather than a large organised dump.

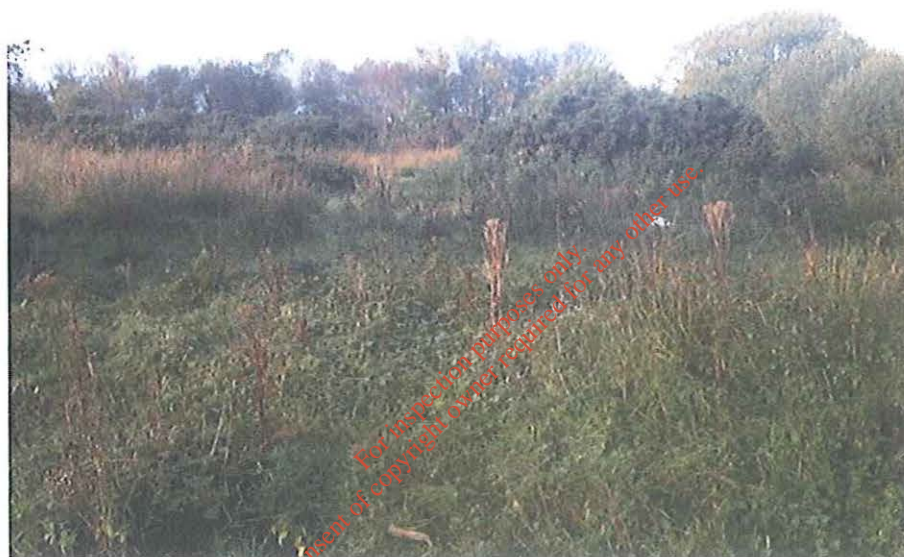
Photograph 1: Overgrown Vegetation prior to Investigation.

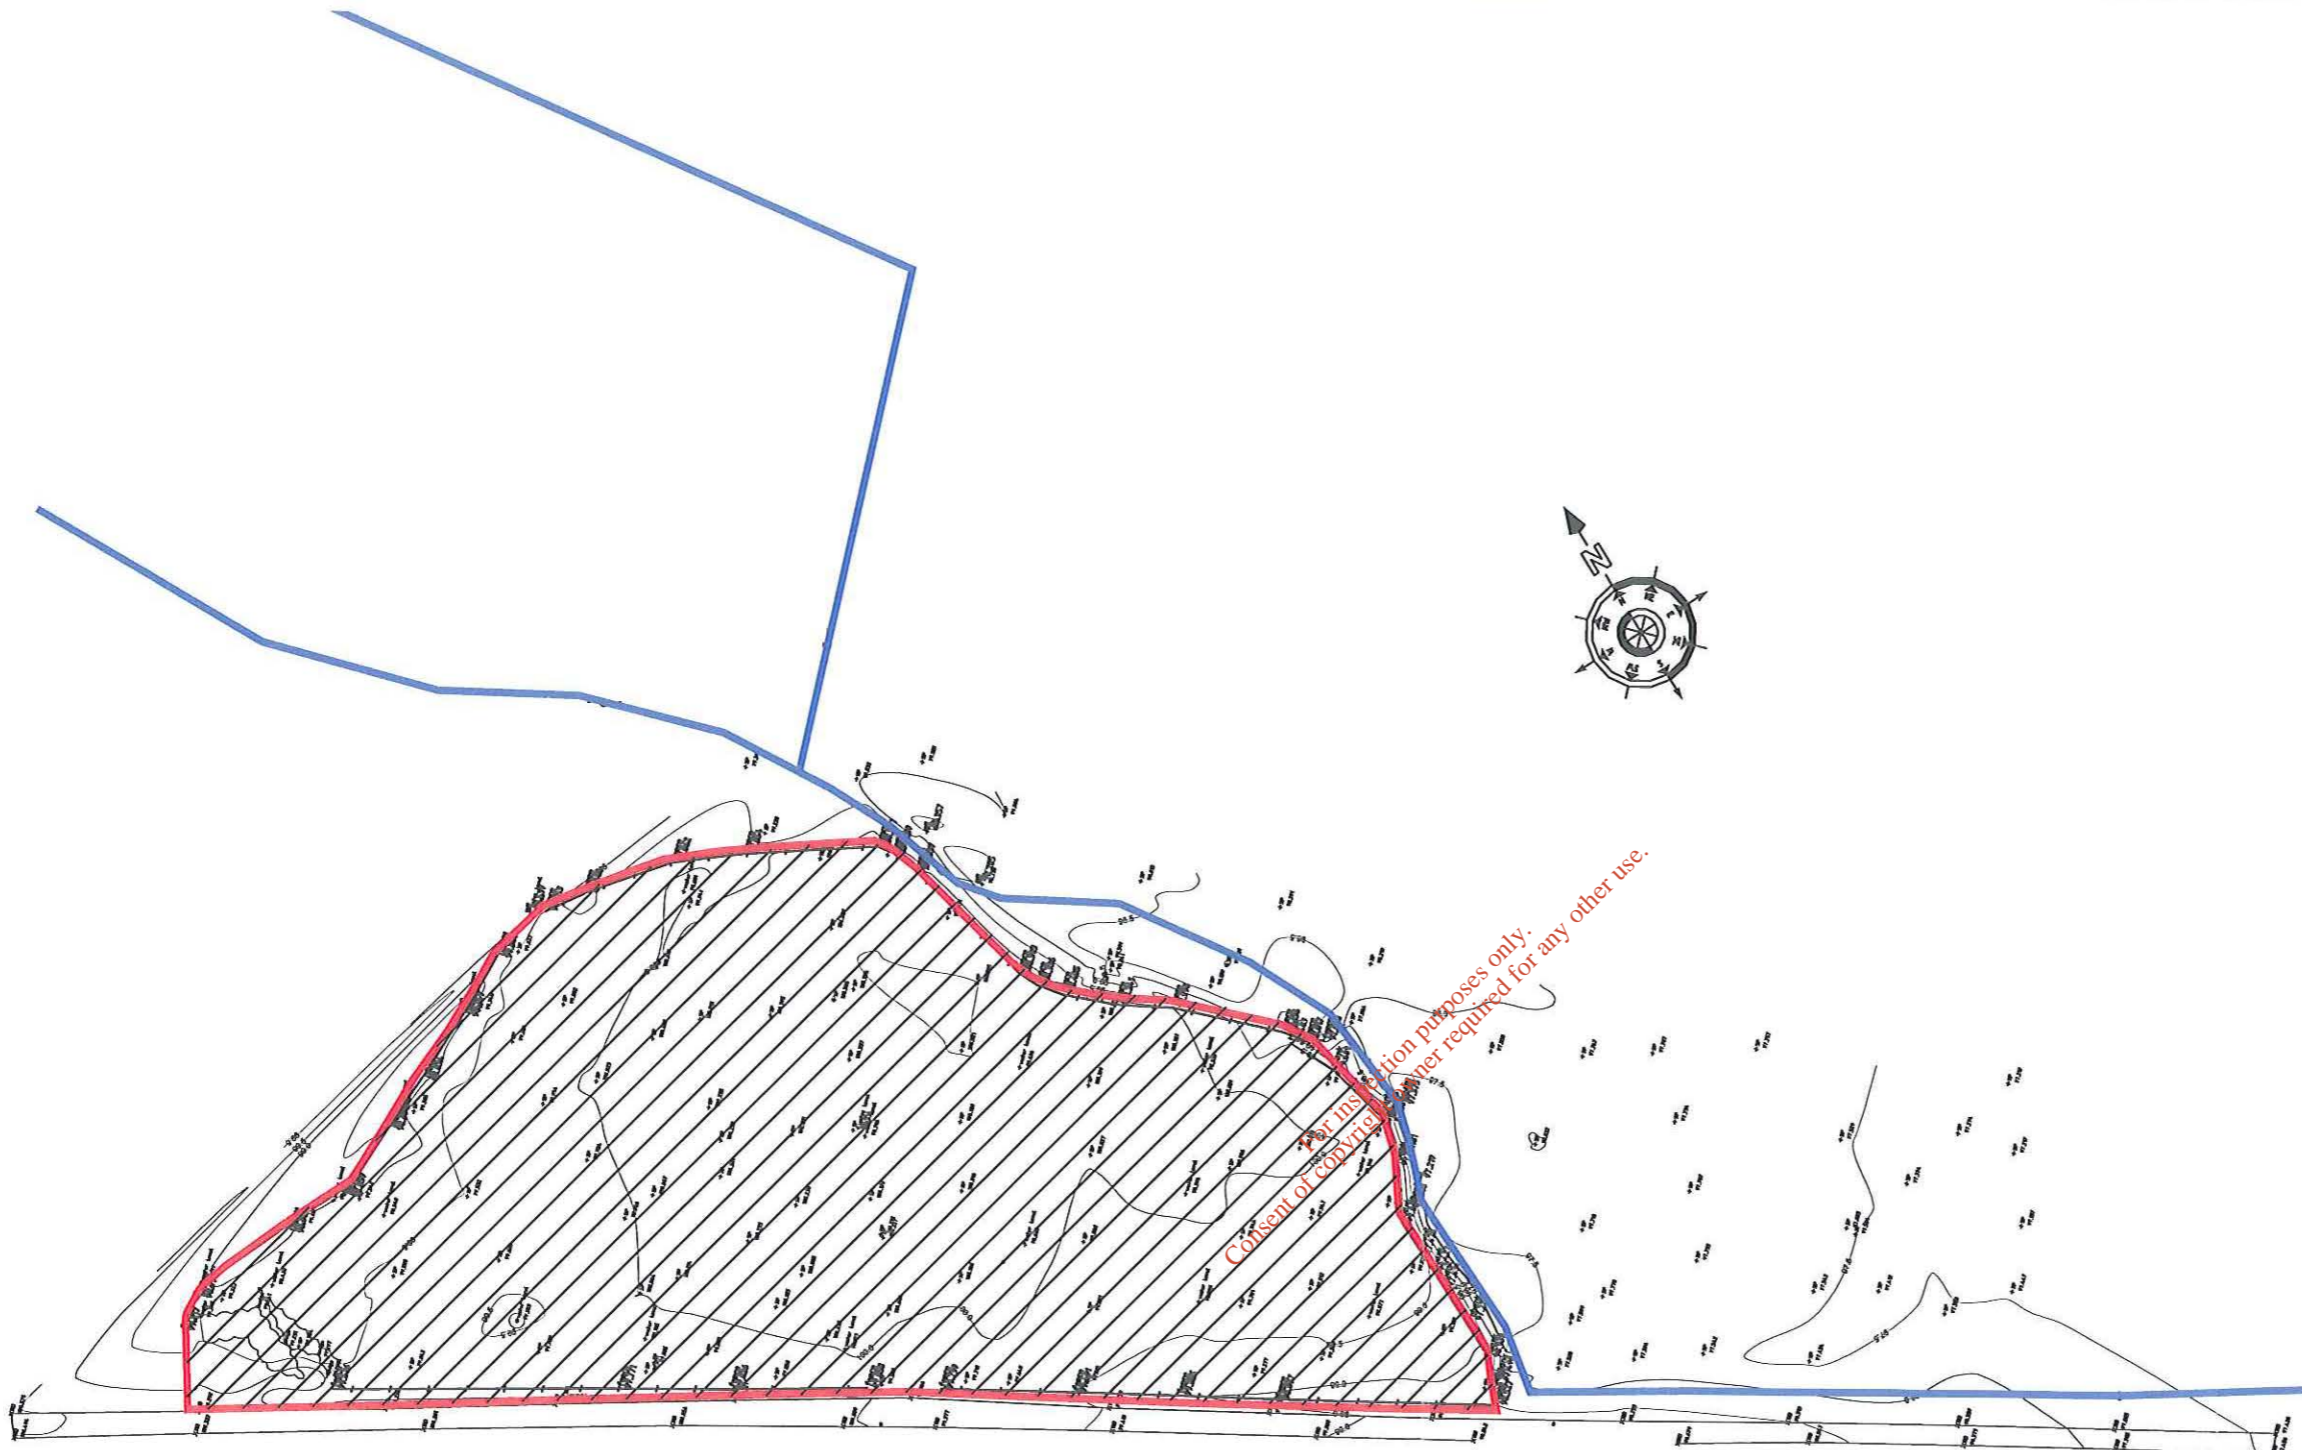
DRAWING No.	REV.
10-198-011

The North-eastern extent of the landfill was defined by a hedgerow and watercourse/drain which separates the site from the adjacent agricultural land. Wastes were encountered in 18 trial holes (TH1 – TH18), but were not found in the three trial holes (TH19, TH20, TH 21) to the Southeast of the landfill. The waste extends from the local road on the Southwestern boundary to the fence on the North-western boundary. The lateral extent of the waste is shown in drawing No. 10-198-011, and covers an area of ca 8,589m². It is estimated, that approximately 18,900 tonnes of waste is deposited at the site.

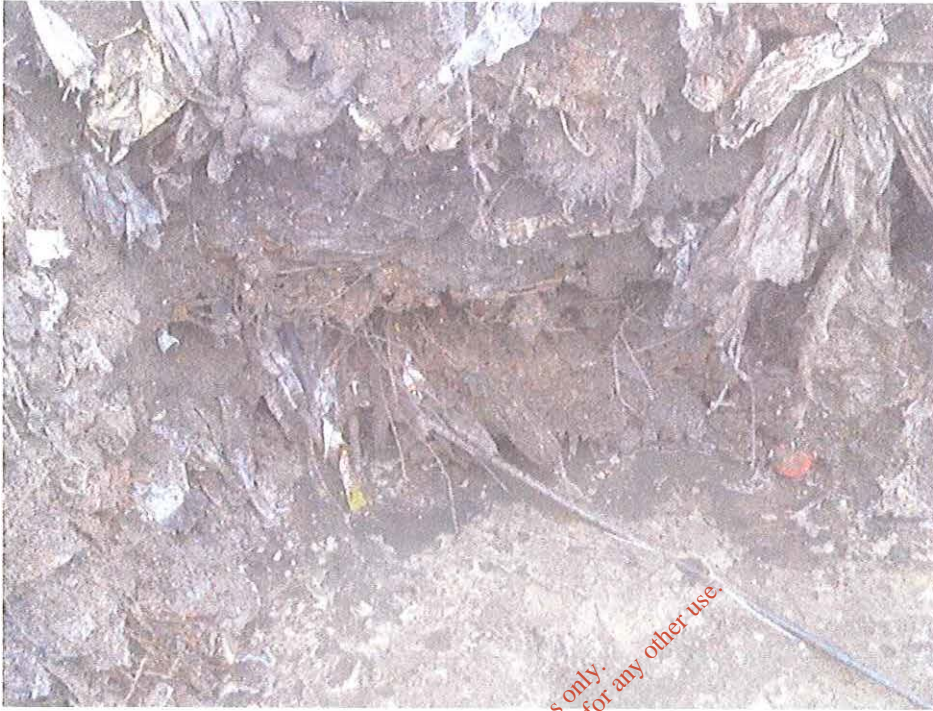
Photograph 2: Waste in TH1

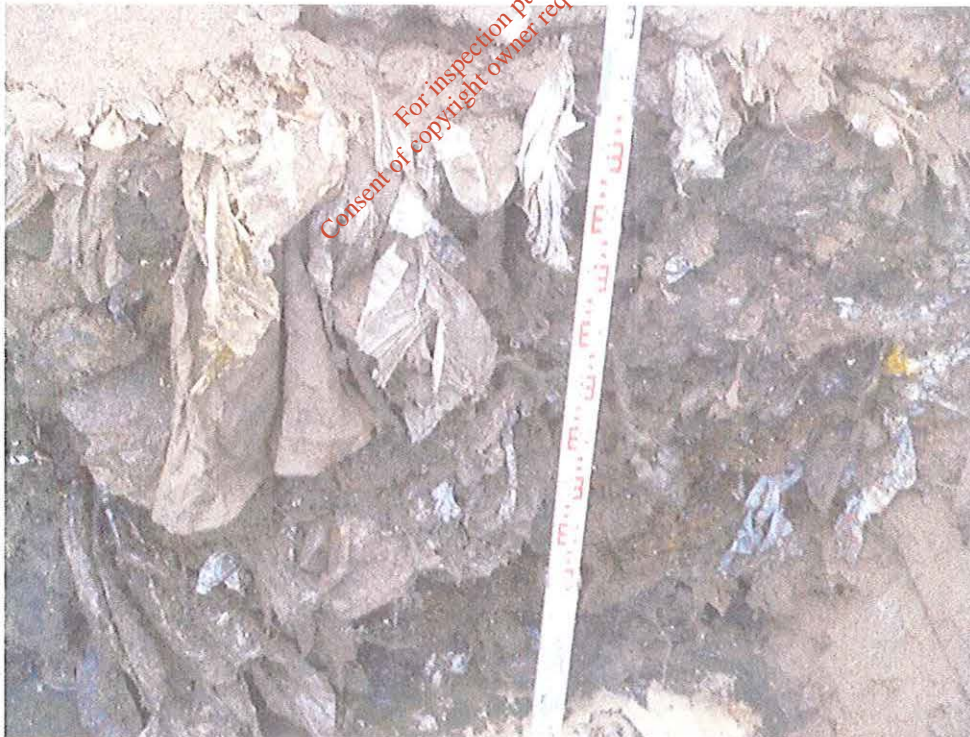
Photograph 3: Waste in TH 3

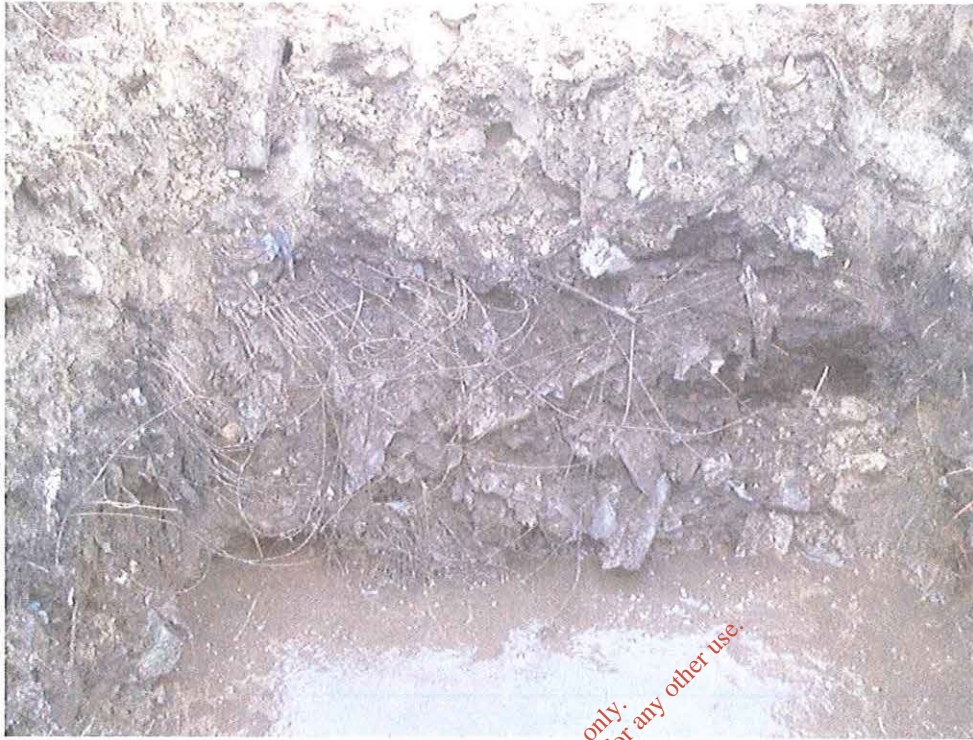
Photograph 4: Waste in TH 7

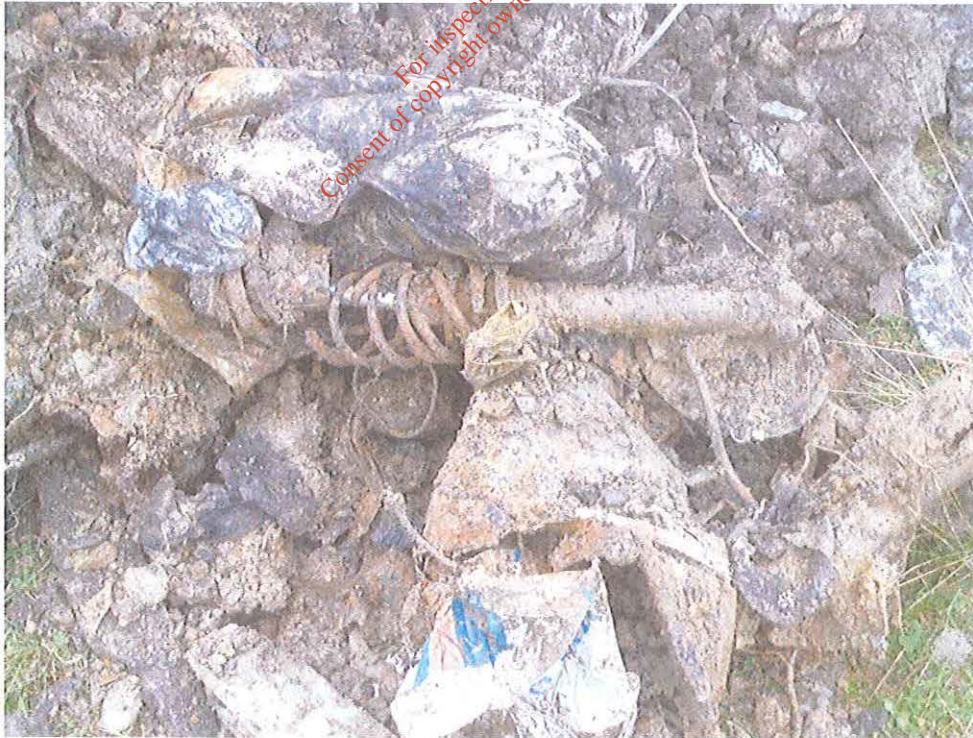
Photograph 5: Waste in TH 8

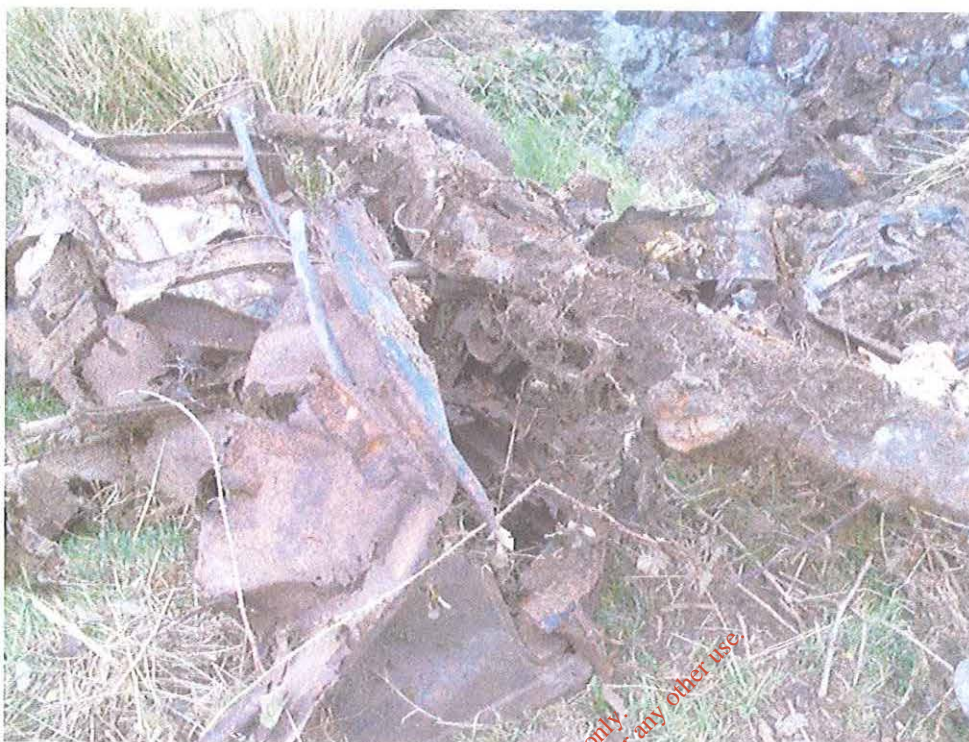
Photograph 6: Waste in TH 9

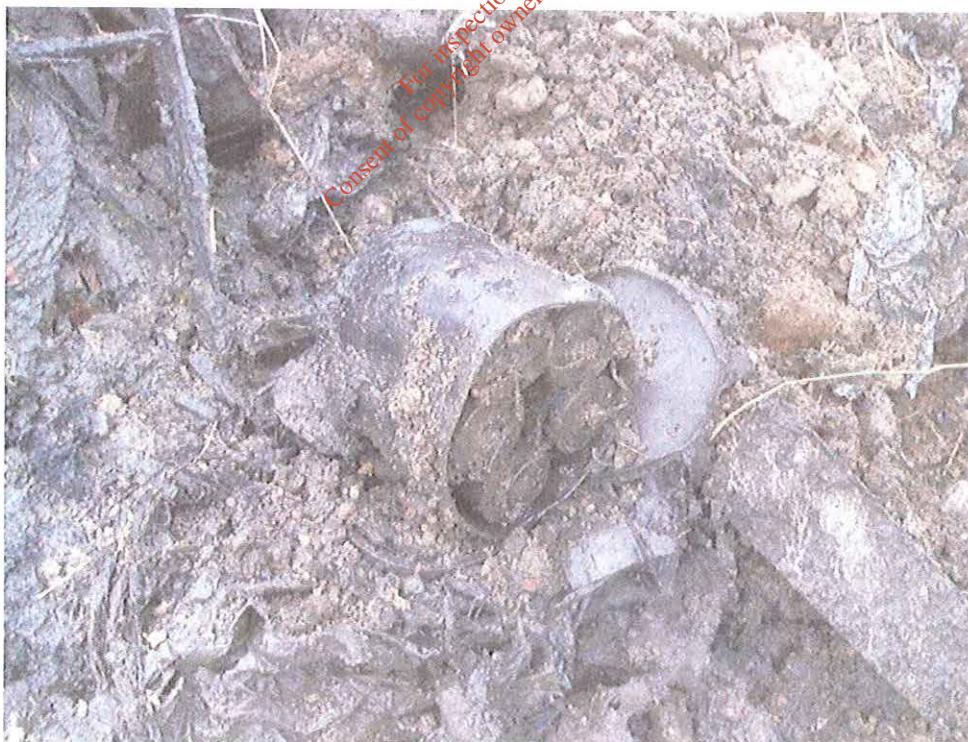
Photograph 7: Waste in TH 13

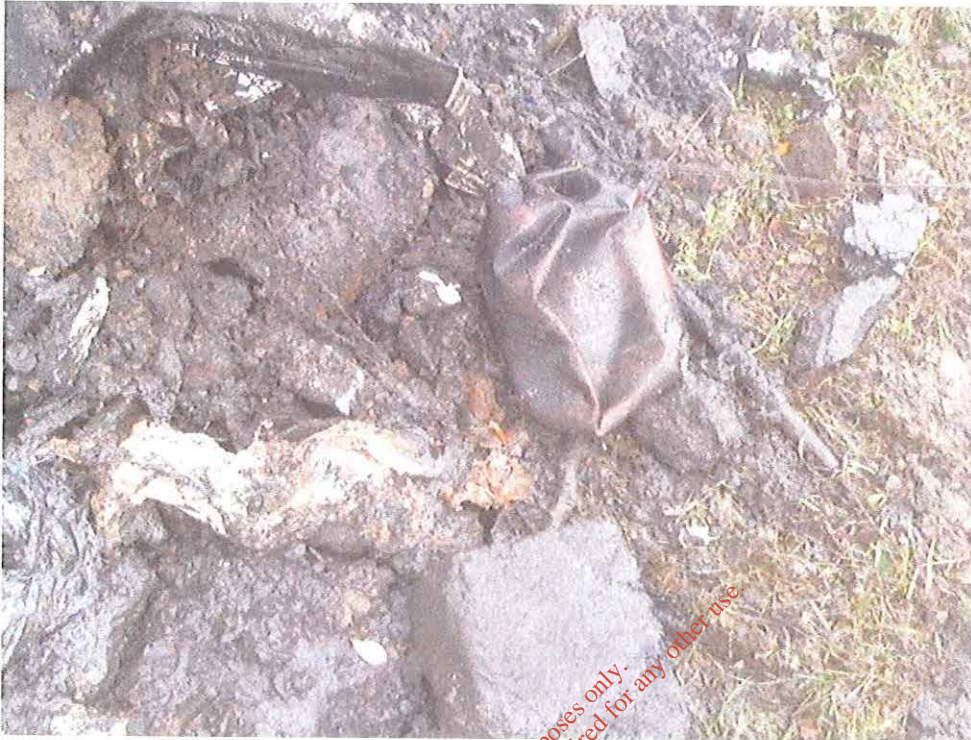
Photograph 8: Waste in TH 16
