TIER 1 RISK ASSESSMENT

FORMER COOTEHILL HISTORIC LANDFILL

POTTLEBOY

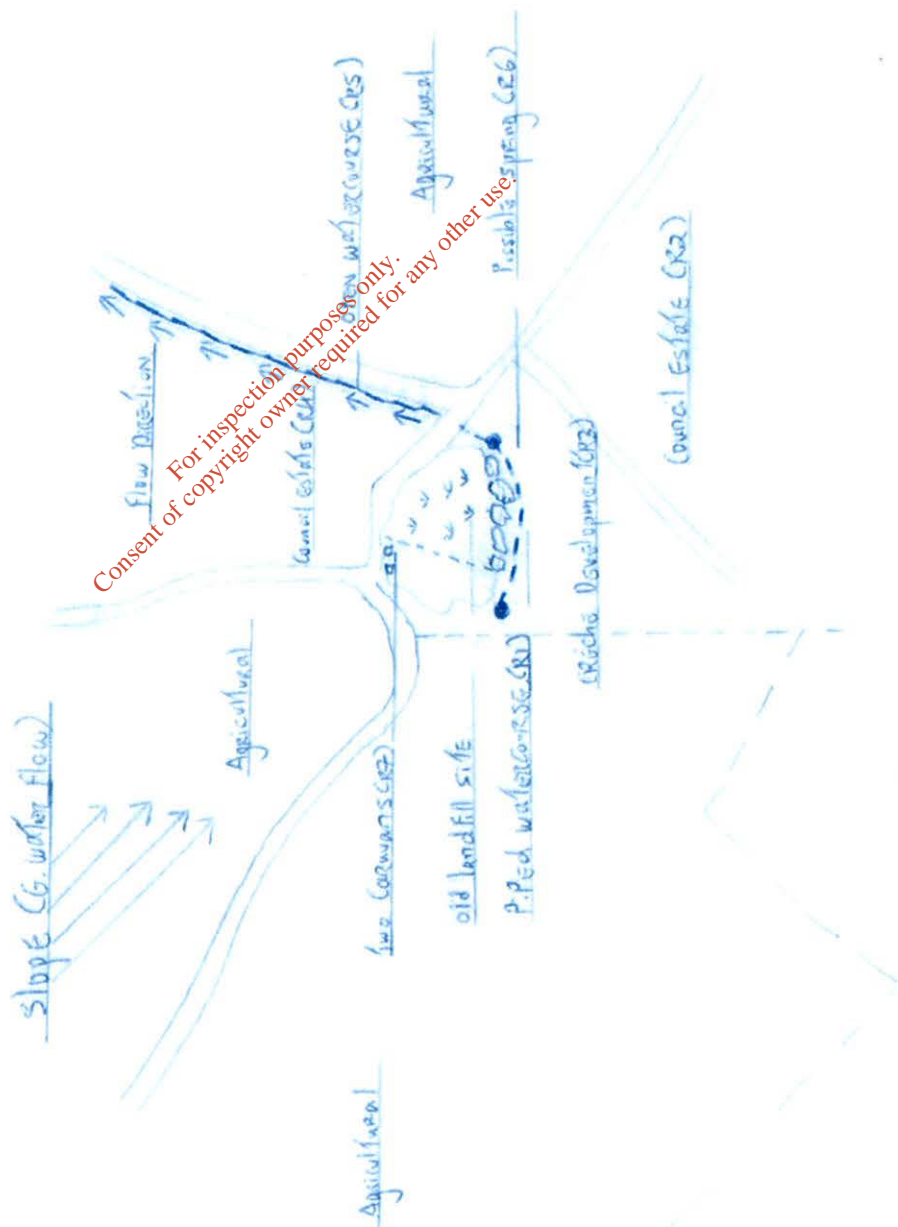
Site Plan

E1/R6 ~ Receptors
